**航空事故調査報告書**  
ノースウエスト航空会社所属  
ボーイング式747-400型  
N663US  
新東京国際空港  
平成3年(1991年)9月19日

平成5年8月26日

航空事故調査委員会議決  
委員長 竹内和之  
委員 吉末幹昌  
委員 宮内恒幸  
委員 東 昭  
委員 東 口 實

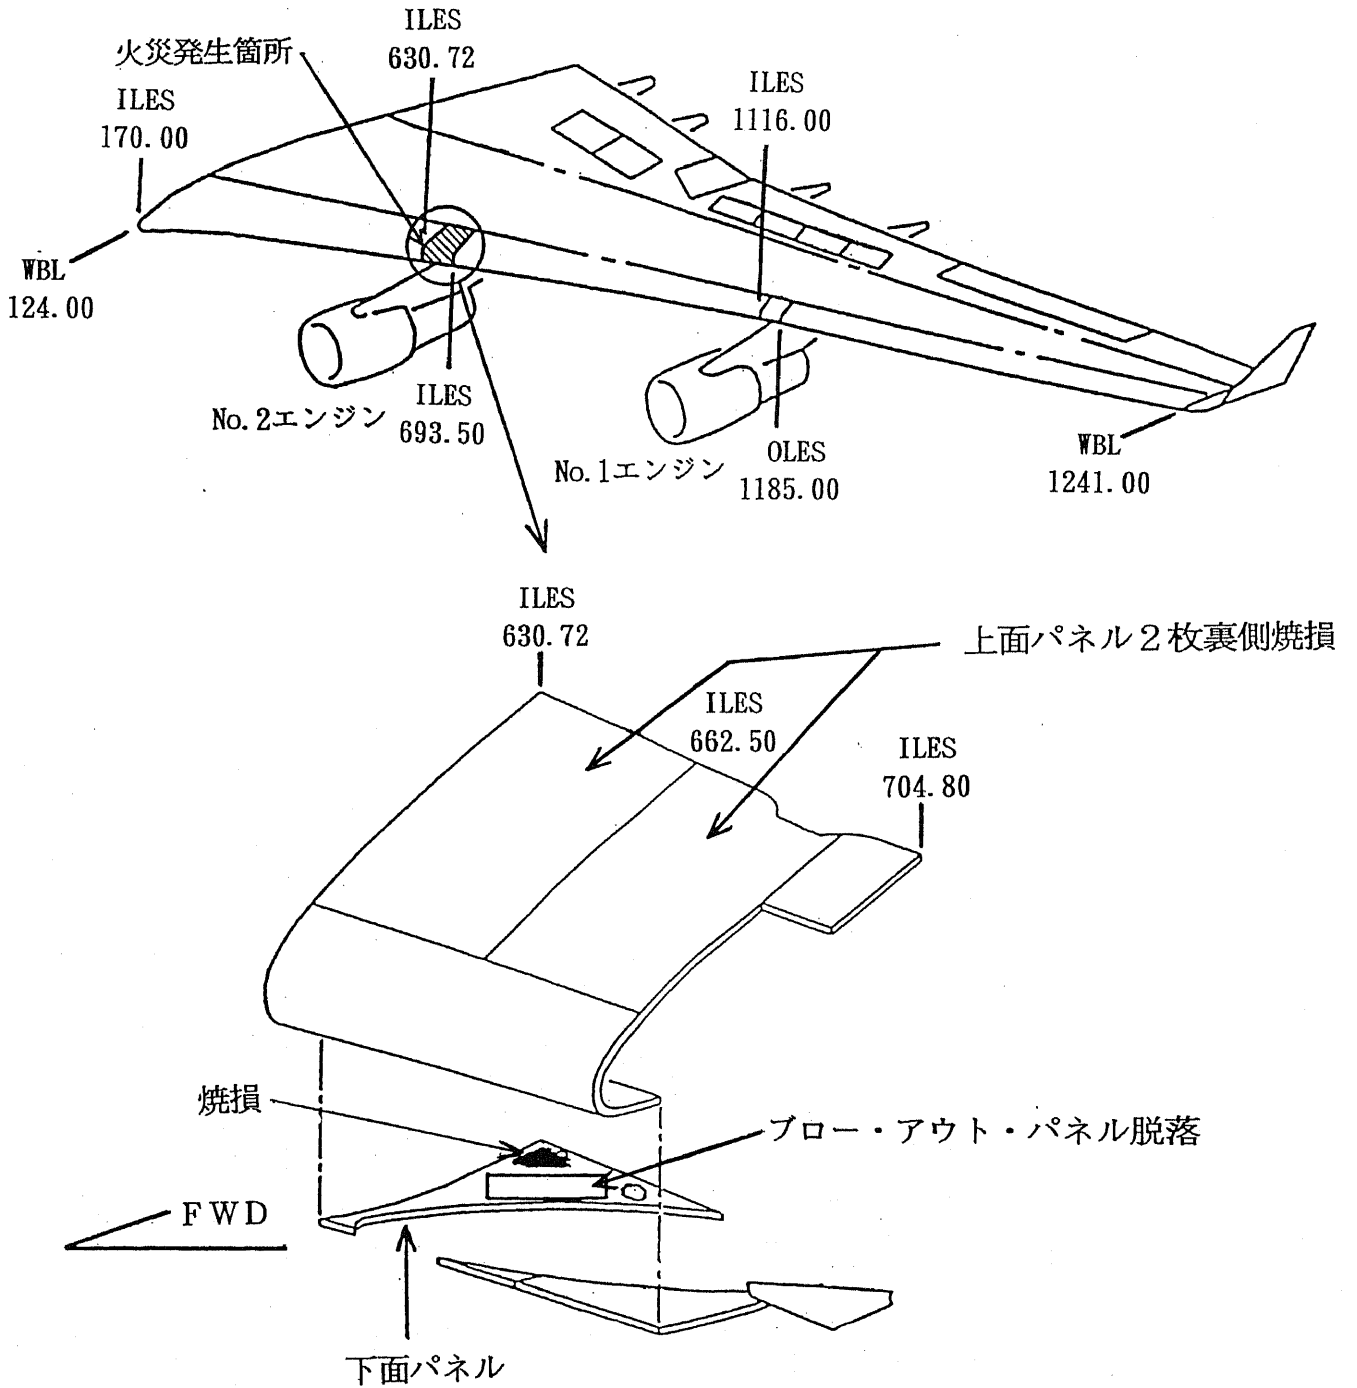
付図 5 左主翼前縁内の火災発生箇所

同機のN o . 2 エンジン燃料フィード・パイプ及びN o . 1 ジェネレータ・フィーダ・ケーブルが接触し互いに擦れ、絶縁被覆が損傷して燃料フィード・パイプとジェネレータ・フィーダ・ケーブルの間でアークが発生した。N o . 2 エンジン燃料フィード・パイプはアークにより、あるいはケーブルとの擦れも関与して孔が生じ、燃料が流出し、これにアークにより引火したものと推定される。この際に左主翼前縁内 (ILES630~693) に装備されていたワイヤ・バンドルが焼損し、短絡または断線してE I C A S に《ELEC GEN OFF 1》アドバイザリ・メッセージを含む各種システム不具合発生のメッセージが表示されたものと推定される。N o . 1 ジェネレータは一旦はオフにされたものの、リセット操作でオンにされたままとなっていたため発電を続け、アークは繰り返し発生したものと推定される。

同機は10時31分UTCごろ成田空港に着陸したが、着陸滑走中の同32分UTCごろ左主翼前縁内で火災が発生したものと認められる。これは、同機が着陸滑走中、速度の減少とともに流入する空気流が少なくなり、ジェネレータ・フィーダ・ケーブルまたは飛行中の火災により損傷したワイヤ・バンドルが短絡して発生する火花あるいはアークにより、流出燃料に引火して火災が発生したものと推定される。この火災によりN o . 2 エンジン・パイロン・ストラット上部の構造部材とともにILES630~693の間に装備されているワイヤ・バンドルが損傷し、アルミニウム合金製の左エンジン消火用配管が溶損したものと推定される。運航乗務員は、「左エンジン火災」の連絡をタワーから受け、N o . 1 エンジンに不具合があると思っていたため、同エンジンを停止するとともに消火措置を行ったと述べているが、消火用ガスは溶損していた配管から火災エリアに放出され、一旦鎮火したものと推定される。

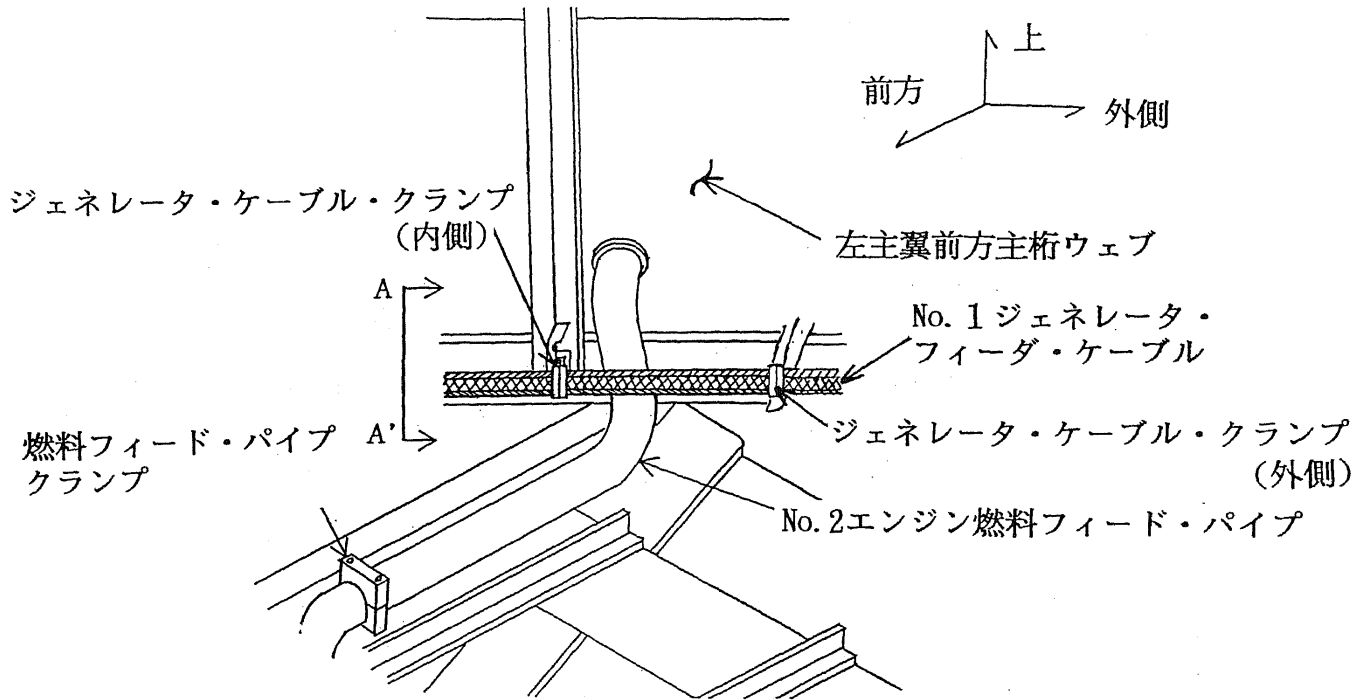
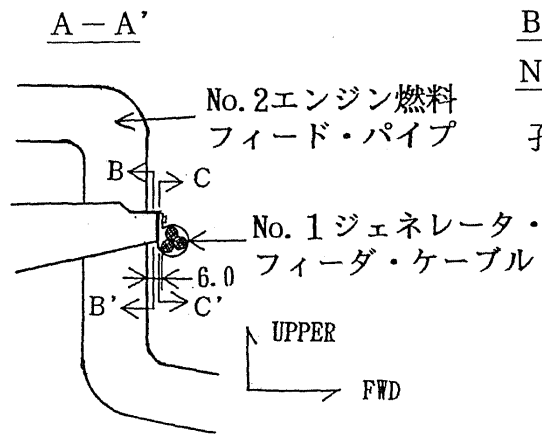
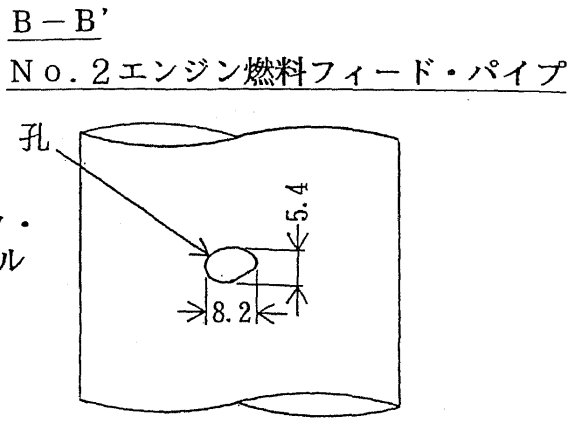
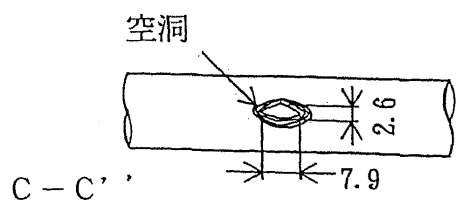
付図6 No.1ジェネレータ・フィーダ・ケーブル及びNo.2エンジン燃料フィード・パイプの損傷状況

ジェネレータ・フィーダ・ケーブルが横切っている後ろ側の位置で、同機の燃料フィード・パイプに長径が8.2ミリメートル、短径が5.4ミリメートルの大きさの孔があいていた。パイプの欠損（孔の面積×肉厚）は約28立方ミリメートルであった。また、孔の周辺部は防錆皮膜が擦り取られており、擦られた痕跡が残っていた。当該部分は長径が9.9ミリメートル、短径が7.1ミリメートルであった。No.2 エンジン燃料フィード・パイプの孔の生じた位置に貼られていた燃料フィード・パイプの識別テープ（材質：ガラス繊維）にもパイプの孔とほぼ同じ大きさの穴があいていた。

当該ジェネレータ・フィーダ・ケーブルはボーイング社の材料規格であるBMS 13-35E (MIL規格W-7072) により製造されたもので、ケーブルの直径は12.15ミリメートル(約0.48インチ)で、導線はアルミニウム合金のより線であり、絶縁被覆はフルオロ・カーボンでコーティングしたポリイミド・テープを3層に重ね巻きしたもの〔厚さ約0.008インチ(約0.2ミリメートル)〕である。ジェネレータの定格は3相交流、115/200ボルト、400ヘルツ、90KVAである。ジェネレータ・フィーダ・ケーブルは、3本が束ねられた状態で主翼前縁内を通っており、クランプを介して主翼前方主桁の前方に取り付けられている。同機においては、No.2 エンジン燃料フィード・パイプに孔が生じていた直前の位置 (ILES680) でNo.1 ジェネレータ・フィーダ・ケーブルが損傷していた。損傷は3本のケーブルのうち、No.2 エンジン燃料フィード・パイプに一番近いケーブルに生じたもので、絶縁被覆にポリイミド・テープの積層が見られる楕円状の擦過痕を伴った損傷があり、アルミニウム合金の導線に空洞があった。損傷はNo.2 エンジン燃料フィード・パイプと接触したことにより生じたものと認められた。導線の空洞は溶解によるものと認められ、放電した形跡を示していた。

ジェネレータ・フィーダ・ケーブルと燃料フィーダ・パイプは、両者の損傷状況から、互いに接触して擦られ、ケーブルの絶縁被覆が損傷しアークが発生したものと推定される。3.1.4項で述べたように、燃料フィーダ・パイプには擦れ及びアークによるものと思われる損傷が生じており、また、ジェネレータ・フィーダ・ケーブルにもアークによると思われる空洞が生じていた。

2.13.4項で述べたとおり、事故後ジェネレータ・フィーダ・ケーブルと燃料フィーダ・パイプの間隙を測定したところ6ミリメートルであった。間隙が2.13.4項に述べたボーイング仕様書 (No.D6-13053Rev.L) を下回っていたのは、同機の製造時からのものか、又は2.14.4項で述べたフィーダ・ケーブルの損傷修理作業によるものかは明らかではない。なお、右主翼の対応する位置の間隙は8ミリメートルであった。

1. N o . 2、N o . 3 エンジン・ストラット内の燃料フィード・パイプ及びジェネレータ・フィーダ・ケーブルに損傷又は擦れがないか検査する。
2. N o . 2、N o . 3 エンジン・ストラット内の燃料フィード・パイプとジェネレータ・フィーダ・ケーブルの間隙を検査し、0.375インチ（9.53ミリメートル）以上の間隙を確保する。
3. 両者の間隙が0.75インチ（19.1ミリメートル）未満の場合はその後500時間を超えない間隔で、また、0.75インチ以上の場合は1,000時間を超えない間隔で上記1及び2項の検査を繰り返す。
4. 全エンジンのストラット・ドレンの検査を行い、その後は1,000時間を超えない間隔で検査を繰り返す。
5. 検査の結果損傷が発見された場合は修理を実施し、燃料フィード・パイプとの間隙が0.375インチを超えるようジェネレータ・フィーダ・ケーブルを移設する。

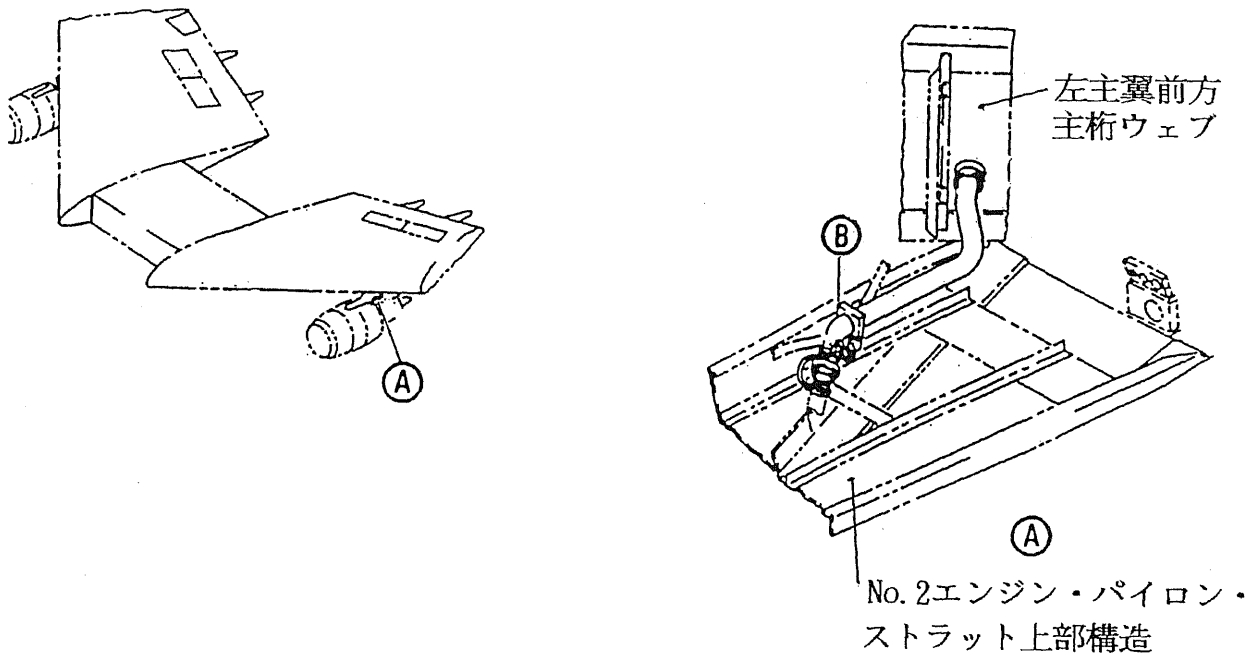
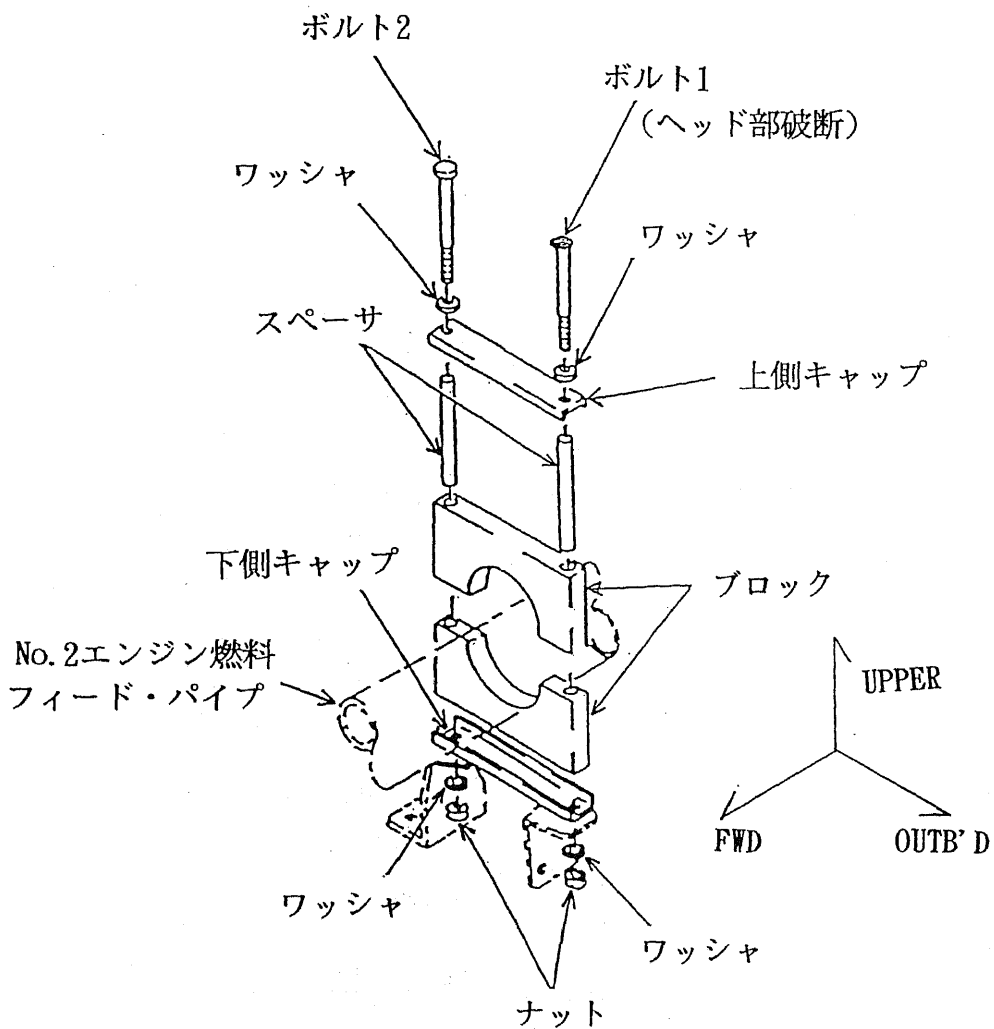
付図 7 No.2エンジン燃料フィード・パイプ・クランプ

同機の当該クランプの外側のボルト・ヘッド部が破断していた。クランプの部品を目視及び走査電子顕微鏡等により観察した結果は次のとおりであった。

ヘッド部が破断しており、破断面の中心部に約1.5ミリメートル×1.5ミリメートルの菱形状の平面があり、その周囲はざらざらした面であった。

ボルト1の破断面全面をカドミウムが覆い、そのうち約3分の1は球状になっていた。特に中心部の菱形状の平面部の周囲に球状カドミウムが集中していた。

2.3.2項及び2.13.5項で述べたとおり、調査時No.2エンジン燃料フィード・パイプ・クランプの2本のボルトのうち外側のボルト・ヘッド部が破断しているのが認められた。この破断面の電子顕微鏡及びX線成分分析装置による調査の結果、破断面全体がカドミウムで覆われていた。また、破断箇所には伸び変形はなく、破断面には静的破壊を生じた際に見られるディンプルはほとんど認められなかった。

火災によりボルトに施されていたカドミウム・メッキが溶解するだけの熱を受け、スパーサ（アルミニウム合金製）とボルト（鉄合金製）の熱膨張率の相違からボルトに熱膨張による引っ張り応力が加わり、カドミウム脆性が生じて伸び変形を伴わずに破断したものと考えられる。溶解したカドミウムはボルト破断後、その破断面に付着したものと考えられる。

また、3.2.2項で述べたとおり飛行中は大規模な火災は発生しなかったものと推定され、ボルト・ヘッド部が熱を受けて破断したのは、着陸後の火災の際であったものと考えられる。

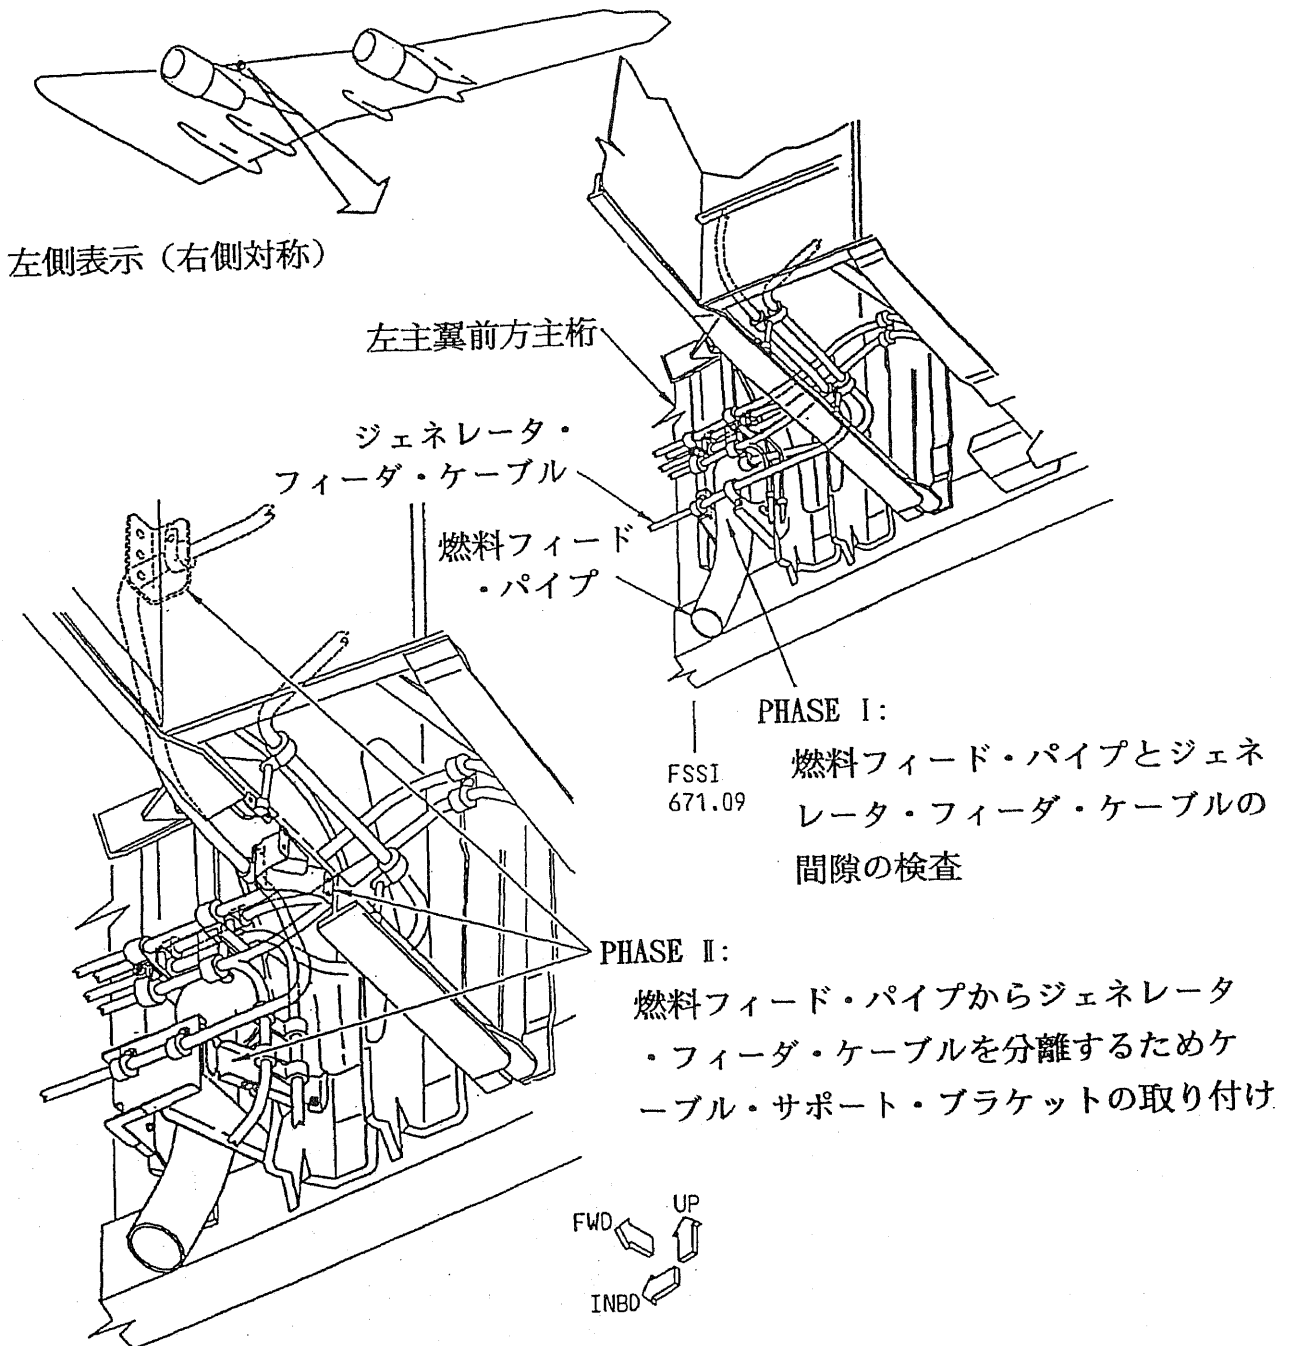
# 付図 10 ボーイング社 S B による NO. 1 ジェネレータ・フィーダ・ケーブル ・サポート・ブラケット取り 付けの改修

本サービス・レターはボーイング式747-400型機に適用するもので、外側と内側のエンジンの間でジェネレータ・フィーダ・ケーブル・クランプが破損し、フィーダ・ケーブルと構造部材が接触してフィーダ・ケーブルの絶縁被覆が摩耗し、アークが発生しジェネレータがトリップした事例があったため、クランプ突出部を上向きからサポート・プレートを介した下向きに変えて、クランプの曲がりや破損を防止することを推奨している。

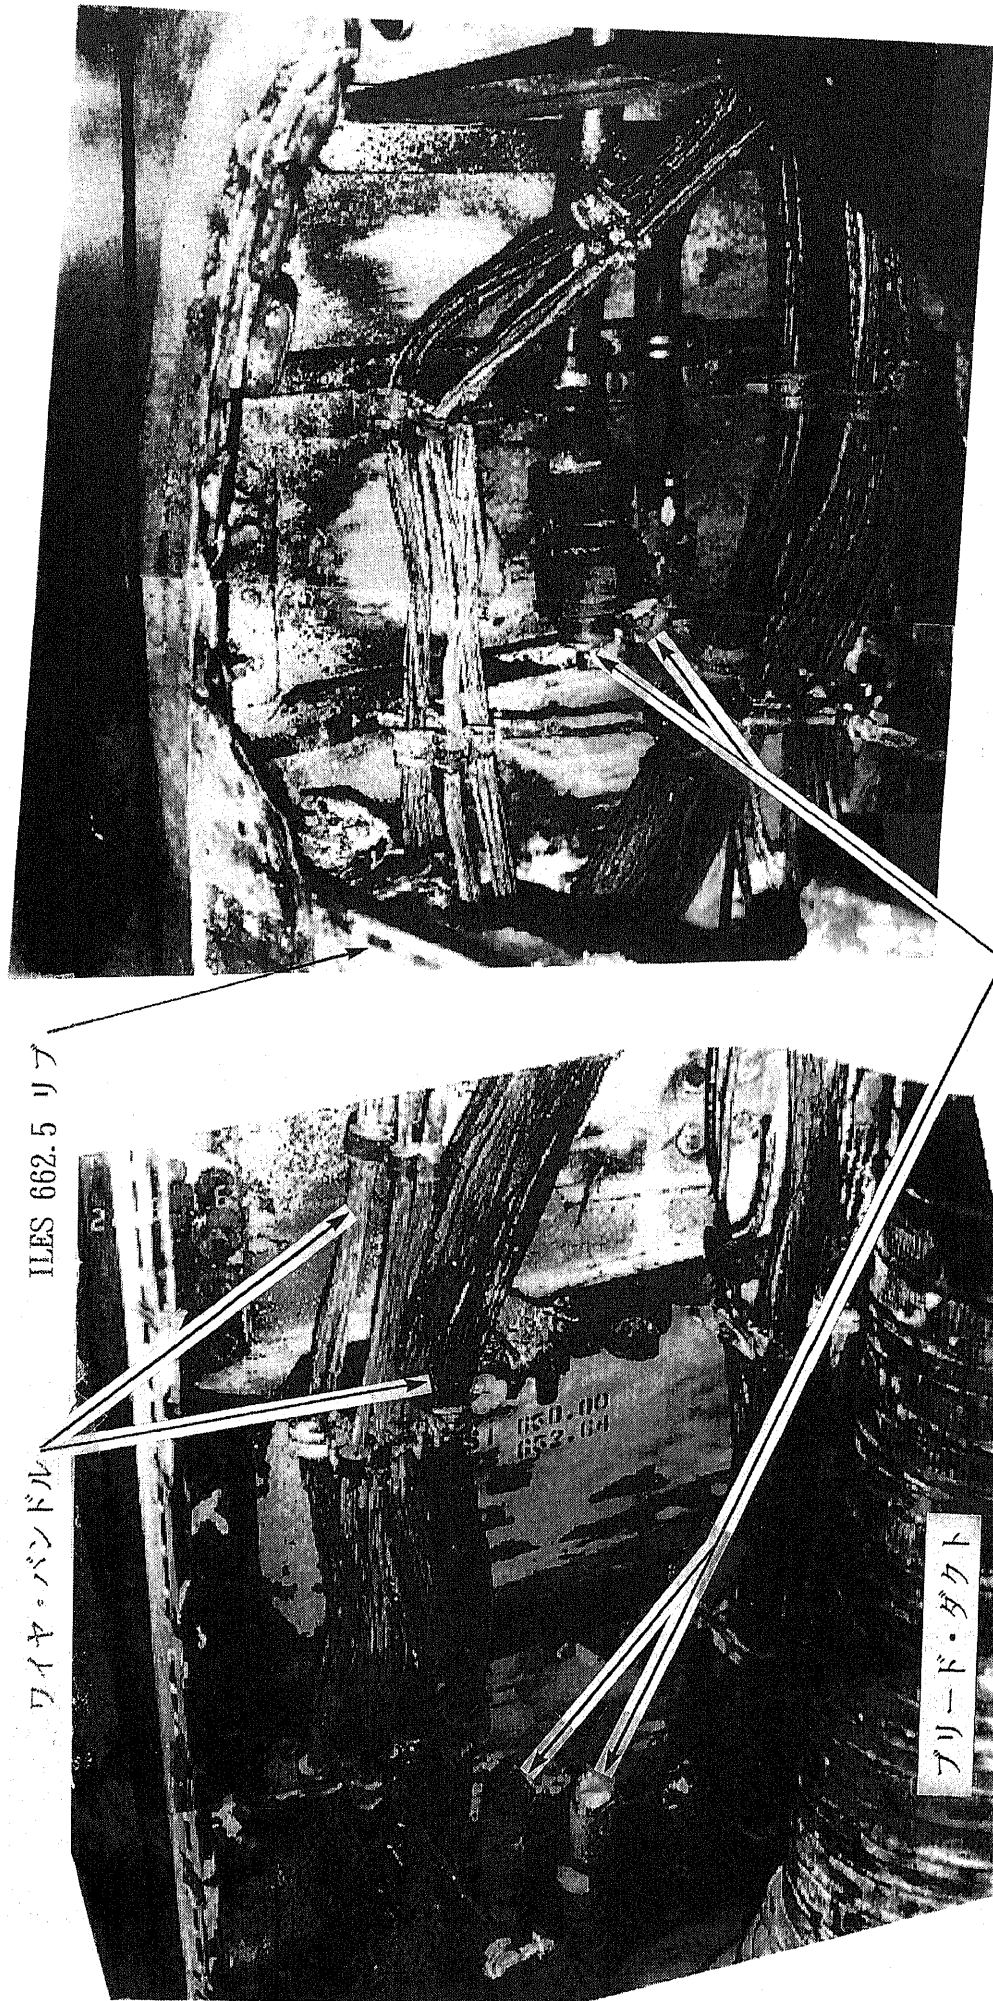
写真2 左主翼前縁内の焼損したワイヤ・バンドル、エンジン消火用配管等

4.1.6 左主翼前縁内で発生した火災により、当該エリアに装備されていたワイヤ・バンドル、エンジン消火用配管等が焼損したものと認められる。ジェネレータ・フィード・ケーブルの損傷、ワイヤ・バンドルの損傷等により、エンジン・オーバーヒート、ブリード・ダクト・リーク等のメッセージが表示され、ジェネレータ、前縁フラップ、燃料投棄等のシステムに不具合も発生したものと推定される。

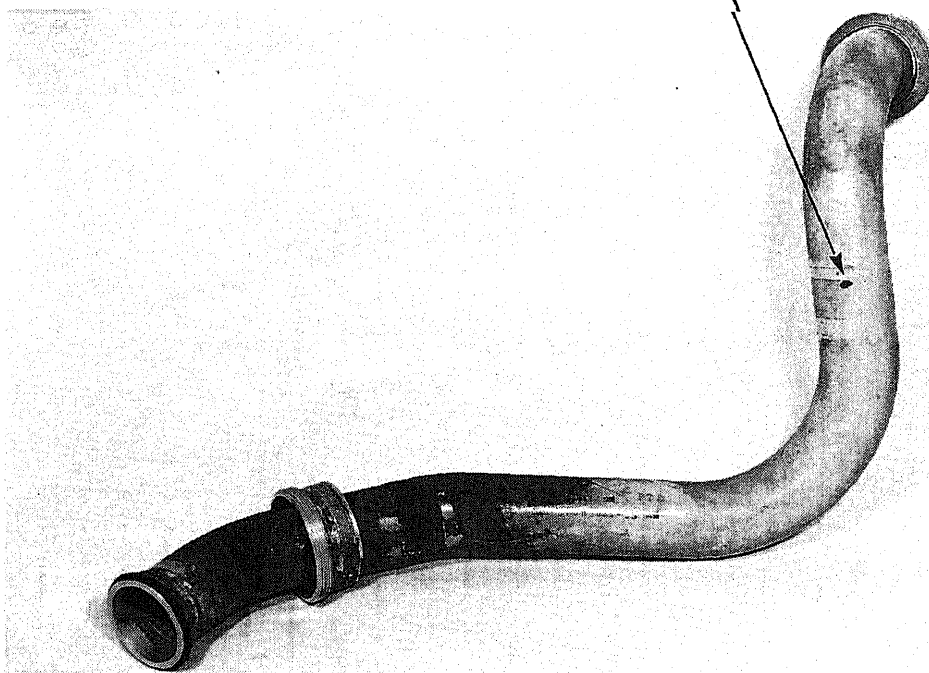
写真3 No.2エンジンの燃料フィード・パイプ

No.2エンジン燃料フィード・パイプの損傷部(孔)

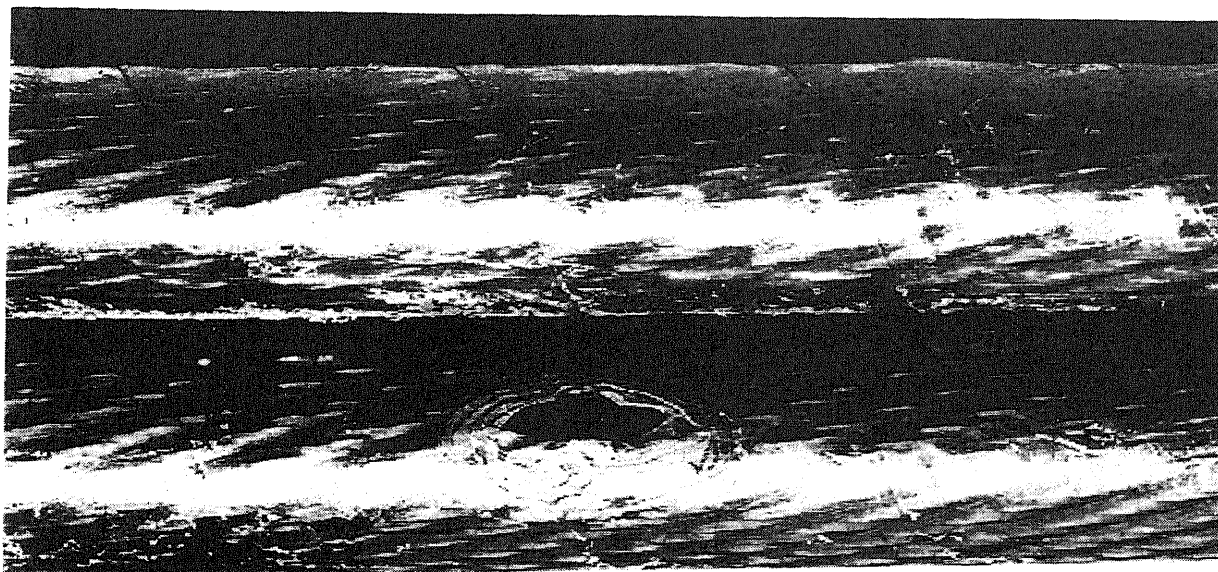
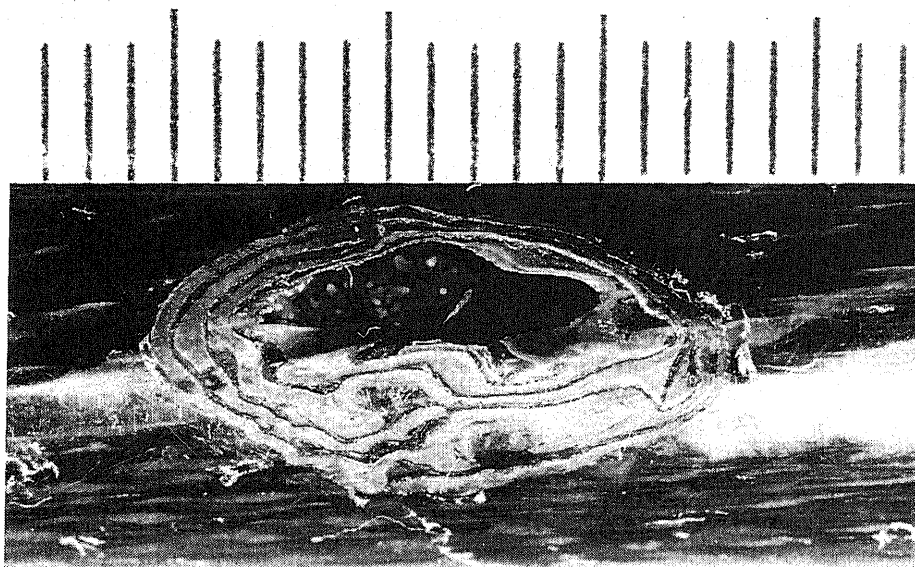
写真6 No.1ジェネレータ・フィーダ・  
ケーブルの損傷部（空洞）

なお、雷のような高電圧が引き金となってアークが生じることが考えられるが、2.13.3項で述べたとおり、同機のジェネレータ・フィーダ・ケーブルの絶縁被覆の損傷した孔のまわりに、このようなアークでは形成されることがないポリイミド・テープの積層が明瞭に見られる擦過痕が楕円状に残っていたことから、同ケーブルのアークによる溶損は雷が引き金となったものではないものと推定される。

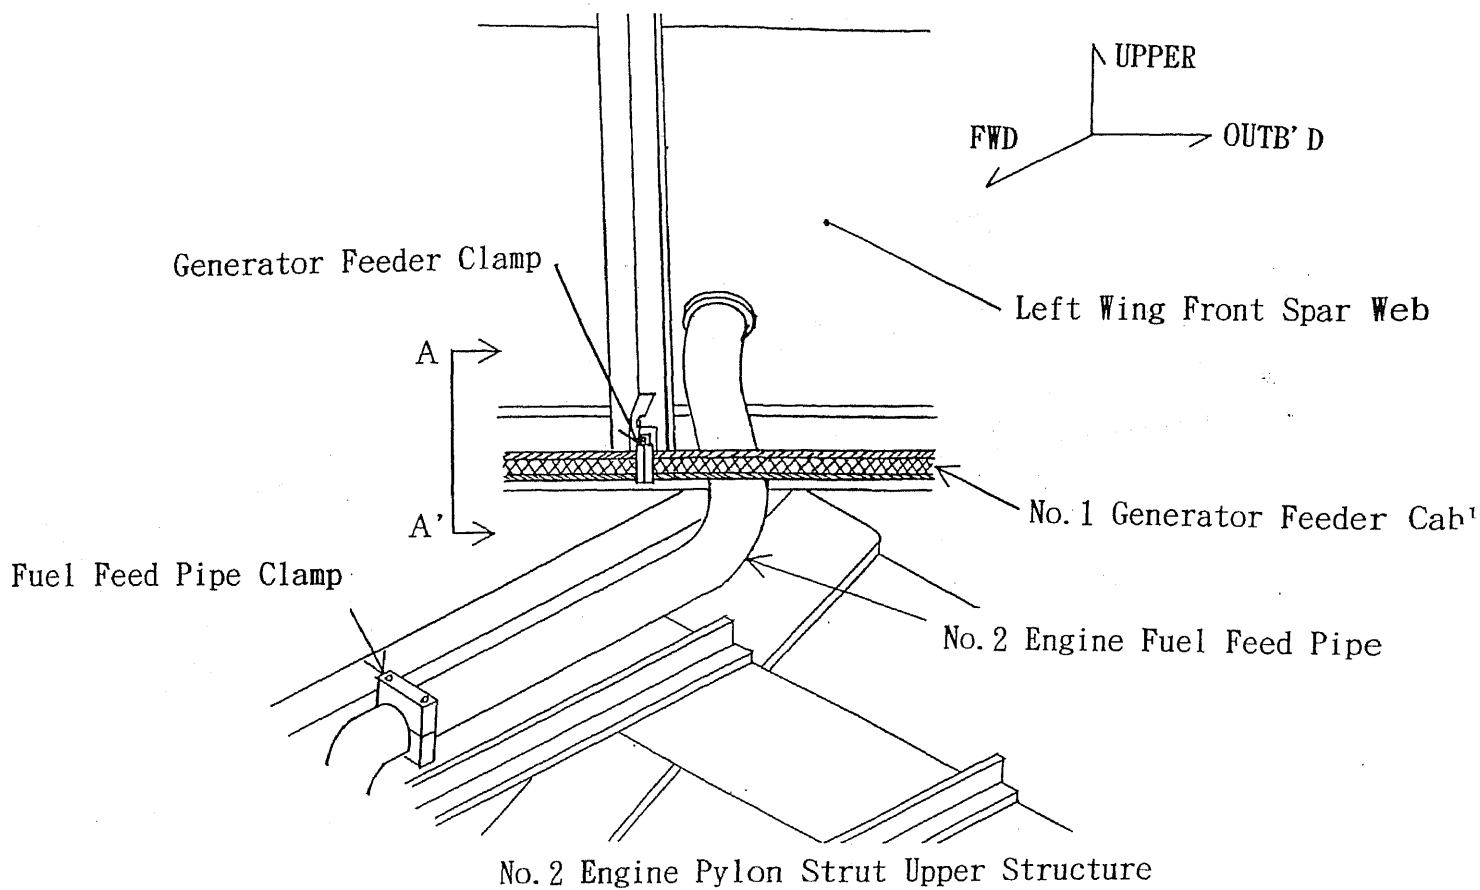
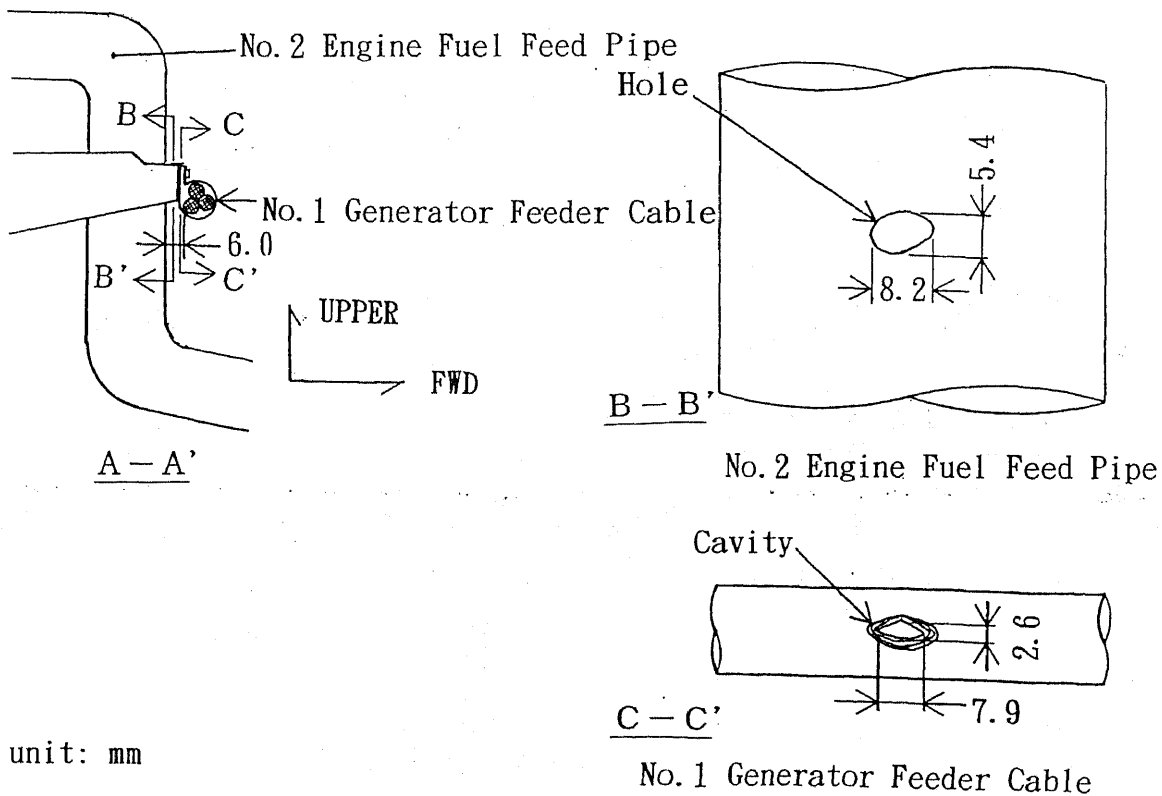
Attached Fig. 6 Damage to No. 1 Generator Feeder Cable and No. 2 Engine Fuel Feed Pipe

- \* No.2 engine fuel feed pipe: damaged (hole)
- \* No.1 generator feeder cable: damaged (cavity)
- \* No.2 engine fuel feed pipe  
clamp bolt: fractured,  
block: burned
- \* Wire bundles: burned
- \* Piping for fire extinguisher for No.1 and No.2 Engine: melted
- \* Wires of electric motor for driving leading edge flaps: burned

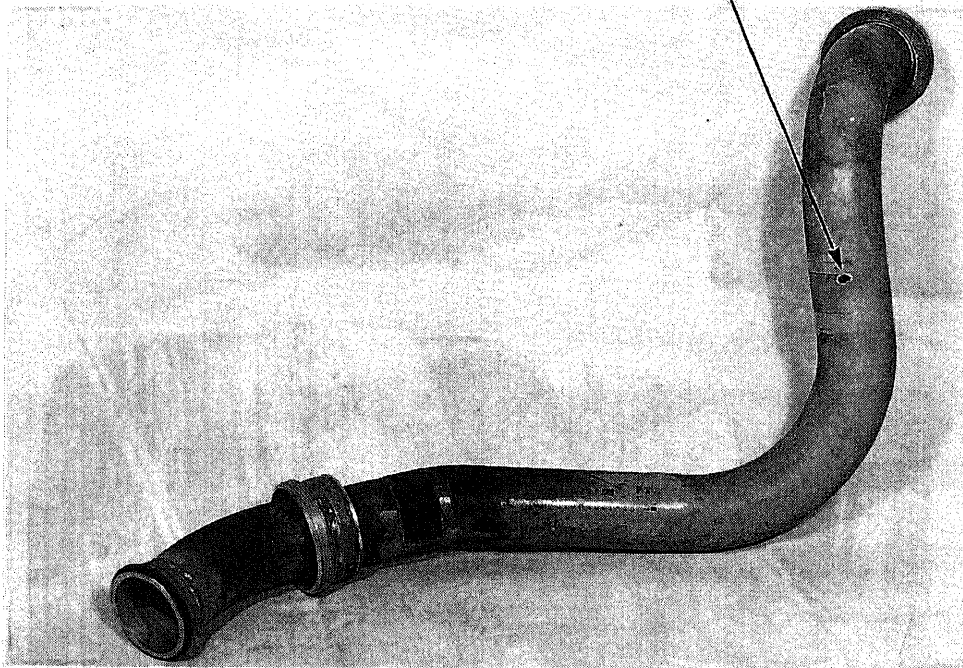
Photo. 3 No. 2 Engine Fuel Feed Pipe

Damaged Portion of No. 2 Engine Fuel Feed Pipe (Hole)
