**航空事故調査報告書**  
**ノースウェスト航空会社所属**  
**ボーイング式747-251B型N637US**  
**新東京国際空港**  
**平成6年（1994年）3月1日**

平成8年11月7日

航空事故調査委員会議決

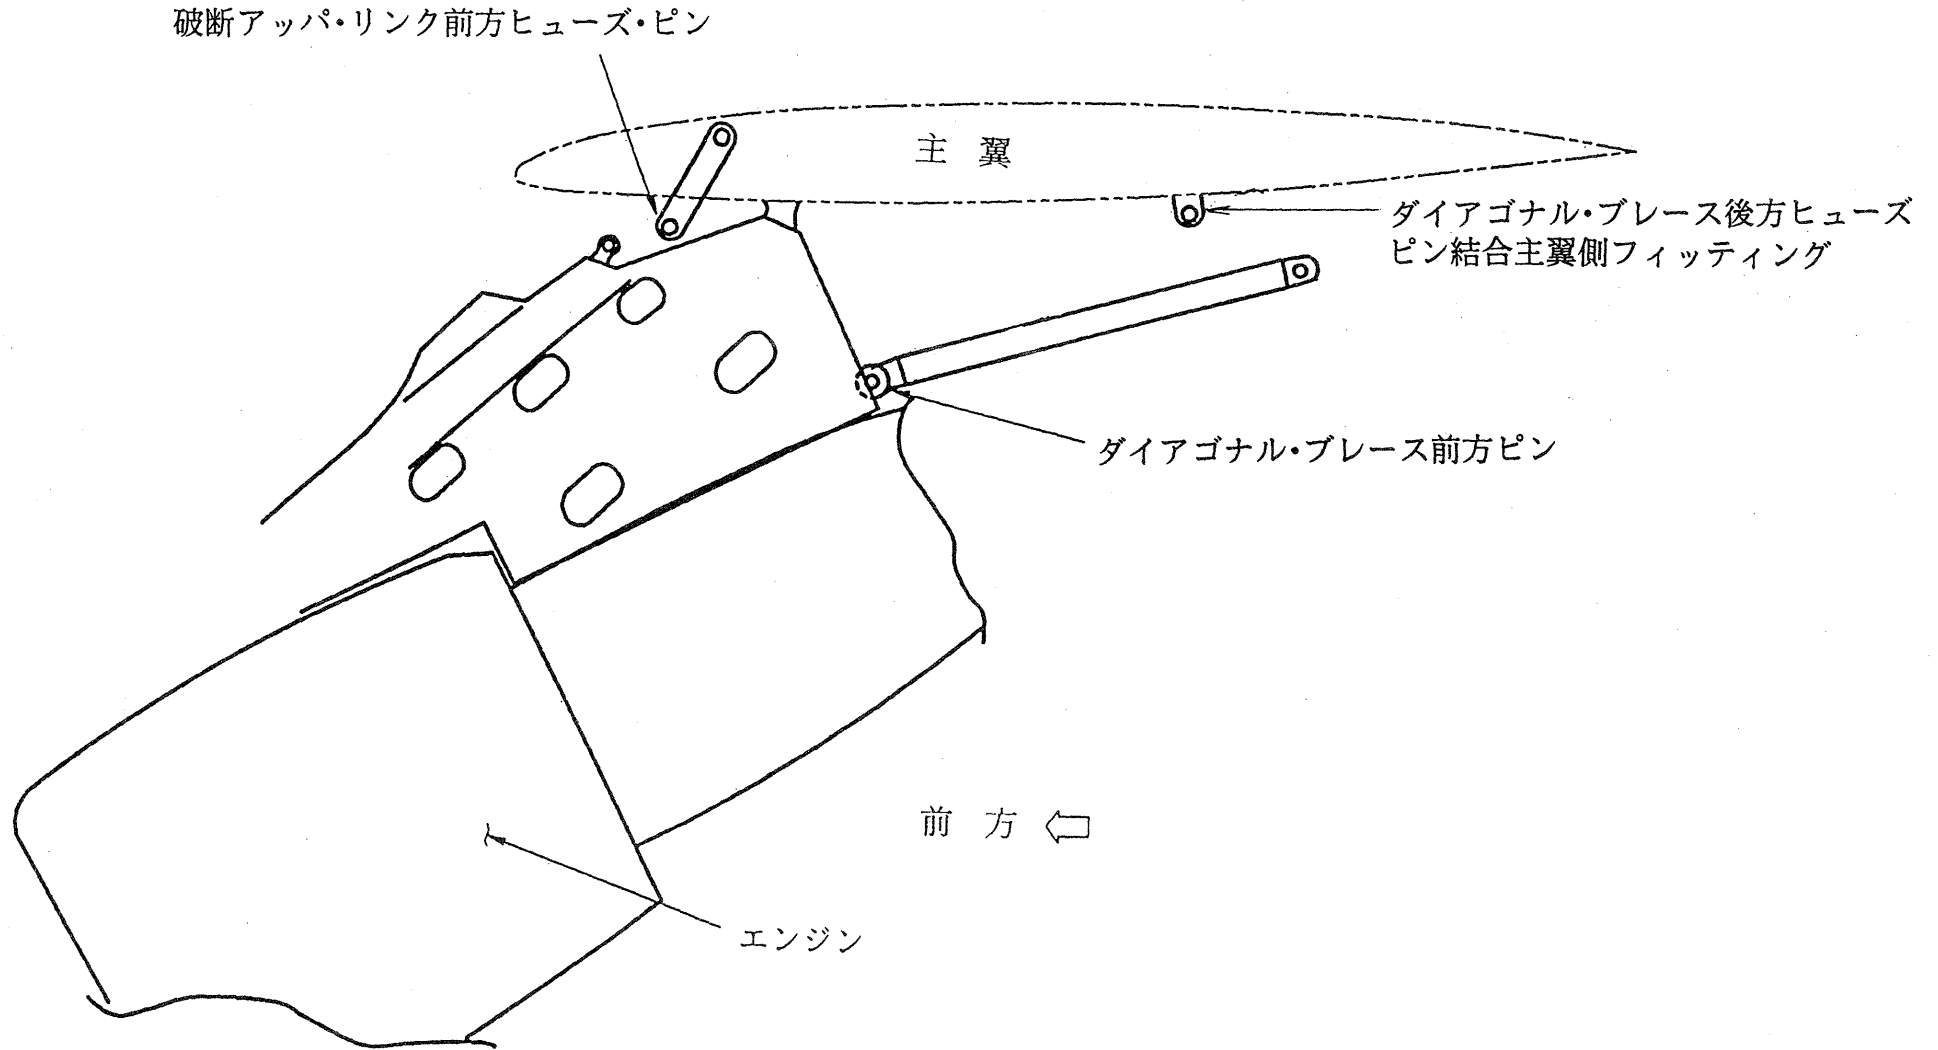
付図3 No.1エンジン・ナセル・ストラット部状況図

同機のNo. 1 エンジンは、ナセル・ストラットの主翼への取付け部であるアップ・リンクが、前方ヒューズ・ピンの破断により前方結合部で外れ、またダイアゴナル・ブレースが、後方ヒューズ・ピンのずれにより後方結合部で外れたため、ミッド・スパー・フィッティングを支点として前部が垂れ下がって接地しているのが認められた。（付図3及び写真1、2、3 参照）

機体調査の結果、ダイアゴナル・ブレースが後方結合部で外れてフェアリング・ドア内に垂れ下がり、また、アッパ・リンク前方結合部のヒューズ・ピンが破断しており、No. 1 ナセル・ストラットは2個所のミッド・スパーによってのみ支えられた状態となり、その結果、エンジン前部が垂れ下がって滑走路面に接地したものと認められる。

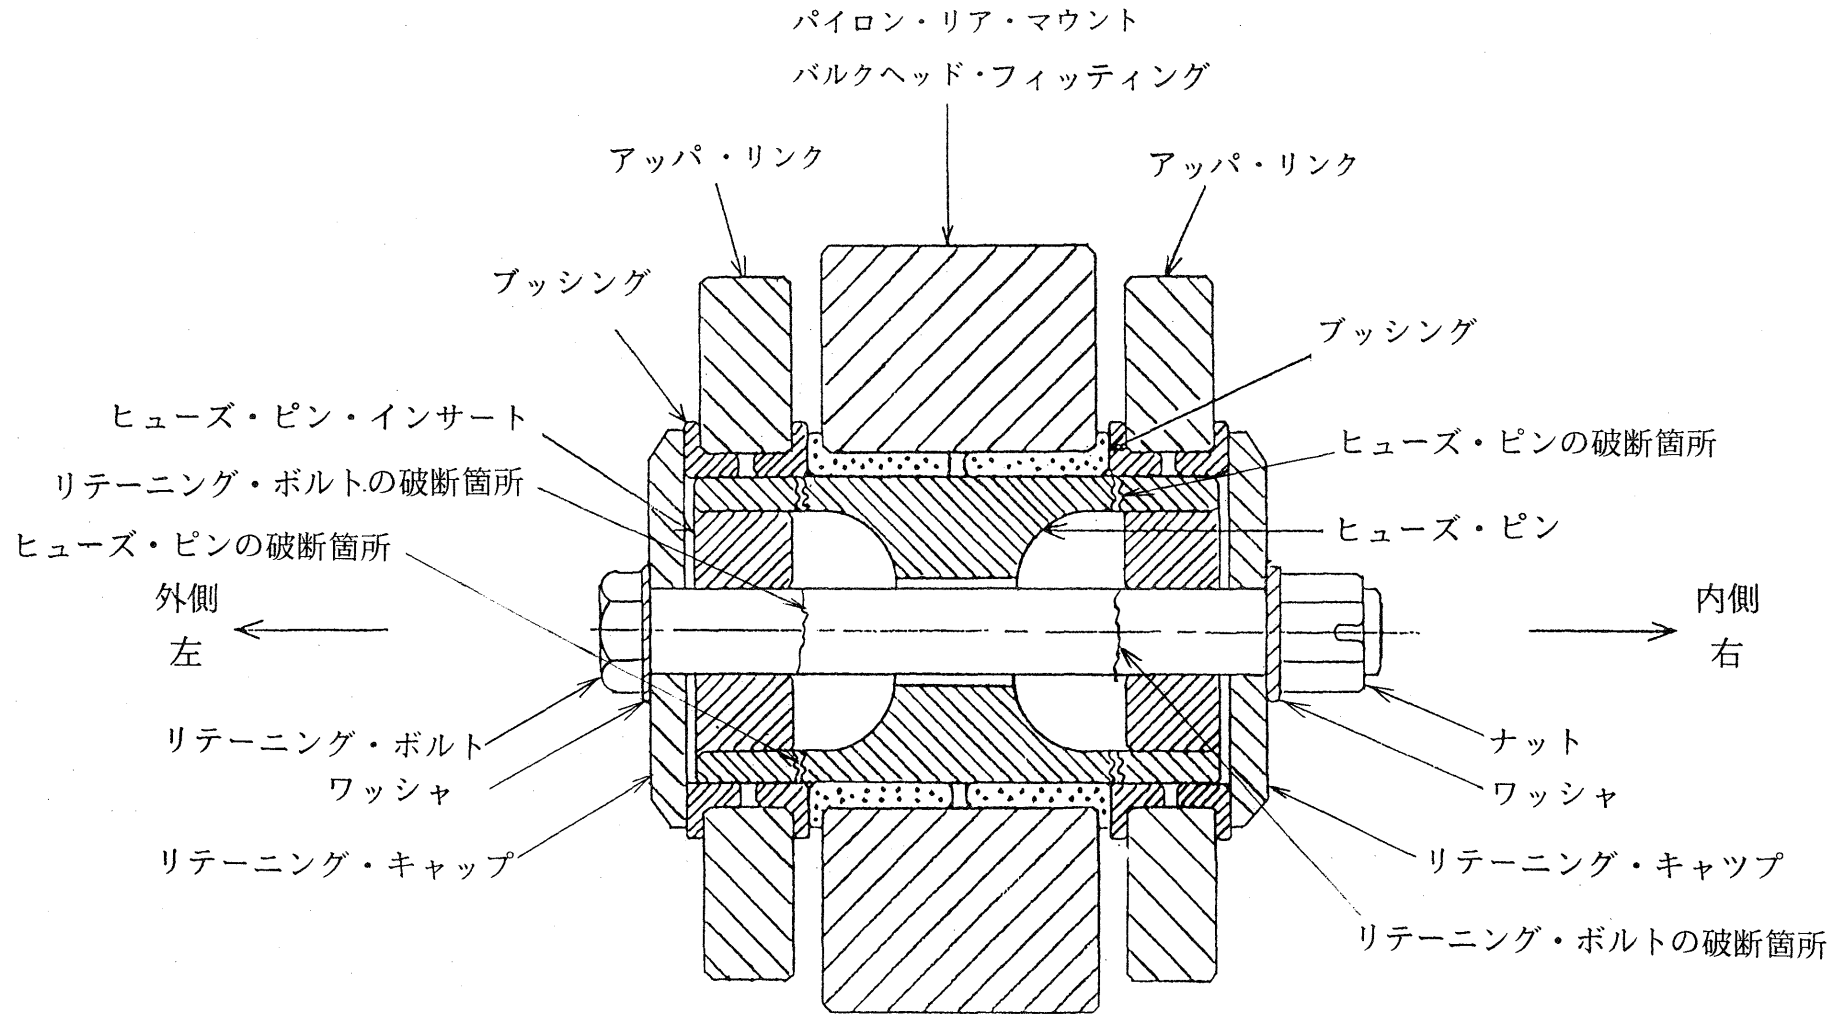
付図4 アッパ・リンク前方ヒューズ・ピン

前方ヒューズ・ピンは3つの部分に破断し、真ん中の部分はリア・マウント・バルク・ヘッド・フィッティングに取付いたままで発見され、両端の部分は両方ともアッパ・リンクから脱落して、ストラット内に落ちているのが発見された。

当該ヒューズ・ピンのプライマリ・リテーナは、キャップ、ボルト及びナットにより構成されるアセンブリであるが、ヒューズ・ピンの破断に伴って、ボルトが3つの部分に破断し、キャップ及び破断したボルトはヒューズ・ピンに付いたままでストラット内に落ちているのが発見された。(付図4及び写真5、6 参照)

- (4) 前(2)及び(3)項に述べたことから、アップ・リンク前方ヒューズ・ピンが破断したのは、ダイアゴナル・ブレースの結合部が外れたため、スラスト・リバーサの作動と着陸滑走中の上下運動に起因する荷重が、アップ・リンク前方ヒューズ・ピンの設計破断強度を超えて作用したためと推定される。

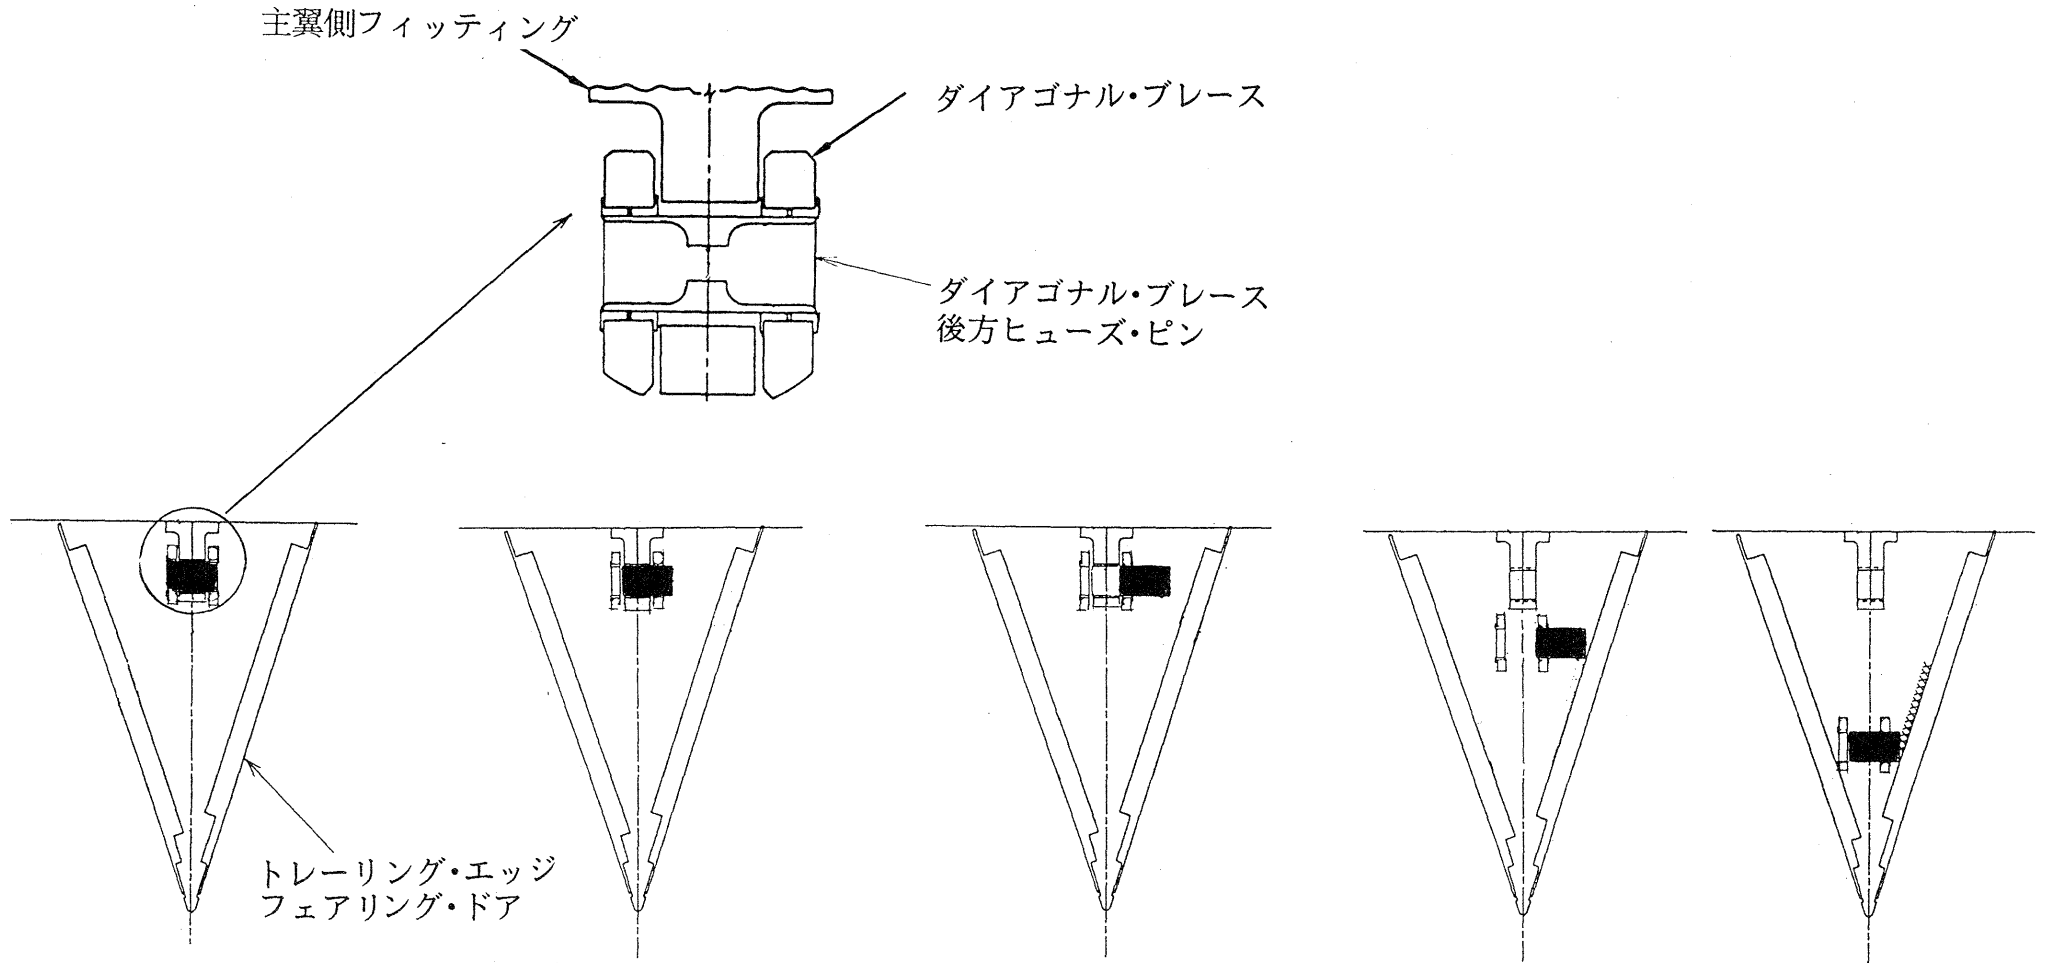
付図5 ダイアゴナル・ブレース後方ヒューズ・ピン抜け出し状況図

セカンダリ・リテーナが、運航中に破損又は外れて紛失する可能性はその大きさから考えられず、むしろ、C点検終了時、ヒューズ・ピンは装着されていたが、セカンダリ・リテーナは装着されていなかったものと推定される。

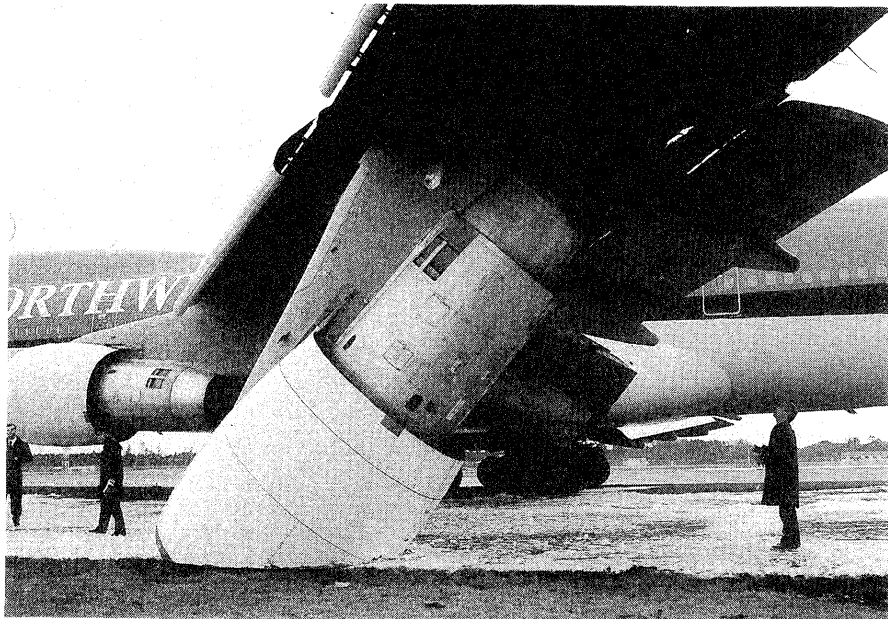
写真2 事故機のNo.1エンジン部

滑走及びその後の地上走行中に地上を引きずられたことによる破損が認められた。

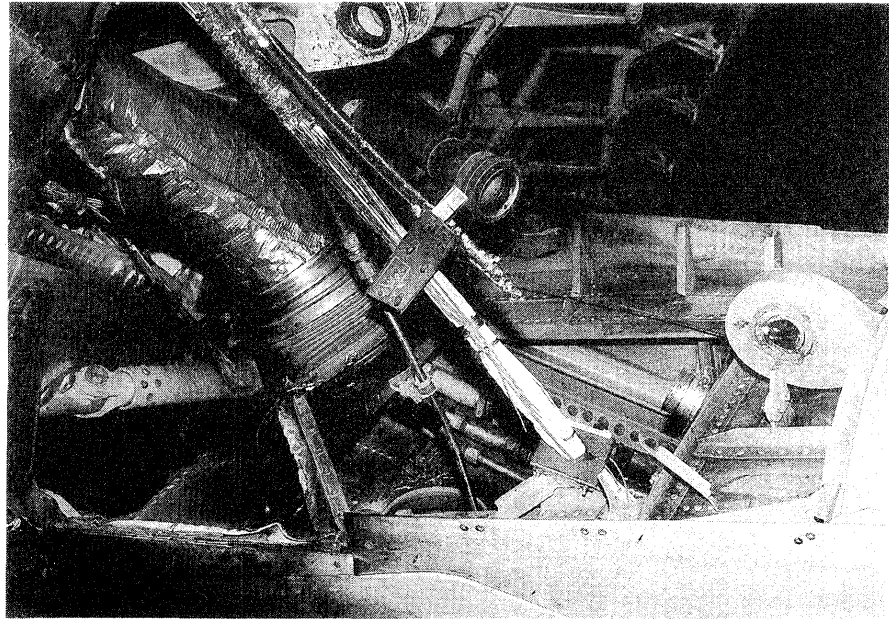
写真3 No.1 ナセル・ストラット上部  
部（分離部）

現場での外観調査の結果、同機は、No. 1 エンジンのナセル・ストラットの主翼への結合部であるアッパ・リンクの前方ヒューズ・ピンが破断してアッパ・リンクが前方結合部で外れていた。

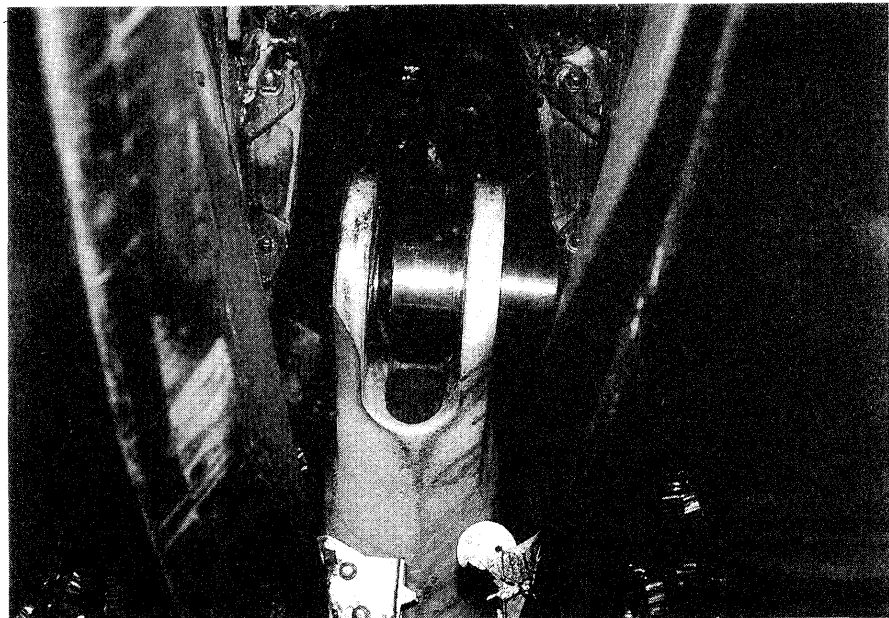
写真4 No.1 ナセル・ストラット・  
ダイアゴナル・ブレース後方  
ヒューズ・ピン及び同ブレース  
後部

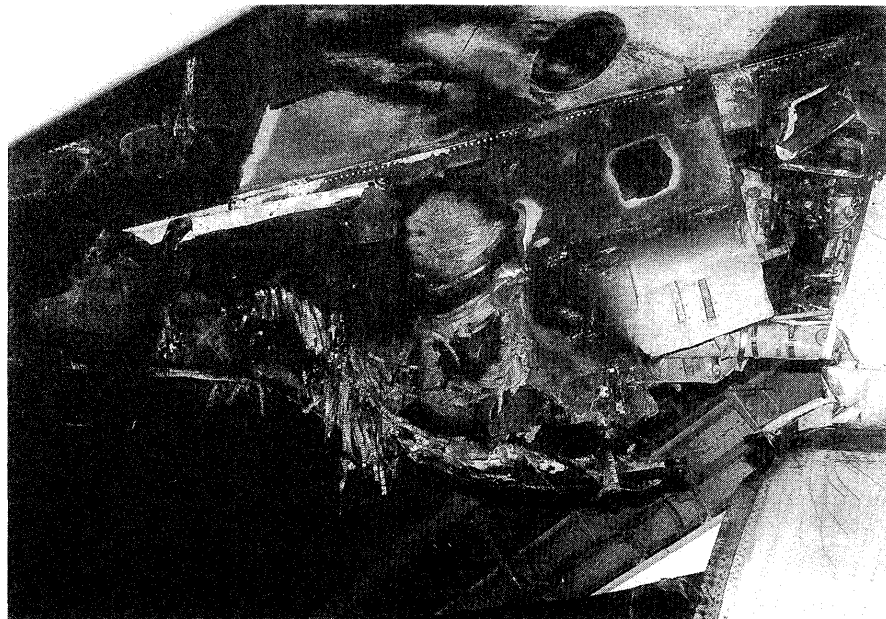
- (5) No. 1 ナセル・ストラットのミッド・スパー・フィッティング及び結合部  
ミッド・スパー・フィッティング及び同ヒューズ・ピンに異常は認められなかった。
- (6) No. 1 ナセル・ストラット及びその周辺、その他の損傷（写真5 参照）
- ・ サイド・ブレースはストラット側結合部で破断していた。
  - ・ No. 1 ハイドロリック系統のリザーバ・タンクに配管されたリターン系統のパイプが、タンク部で破損すると共に、タンクに損傷が生じ、ハイドロリック・オイルはすべて流出しているのが認められた。これらの損傷はナセル・ストラットの前方部が垂れ下がったことにより生じたものと認められ、また、火災により焼損していた。
  - ・ ナセル・ストラットと主翼の間の燃料フィード・パイプが主翼及びストラット側で結合部から分離し、また、ブリード・エア・ダクトもストラット側結合部で分離しており、損傷していた。
  - ・ 3本のジェネレータ・フィーダ・ケーブル及びスラスト・コントロール・ケーブル1本が破断し、いずれも一部焼損していた。
  - ・ ストラット・リア・エンジン・マウント・バルクヘッド・フィッティングとアッパ・リンクとの結合部の穴が、アッパ・リンクの方向に長円形に変形しているのが認められた。
  - ・ フェアリング内のリターン・フィルタ・モジュール、ケース・ドレイン・モジュール、プレッシャ・モジュール、エアー・ドリブン・ハイドロリック・ポンプは焼損していた。
- (7) フラップ  
前縁フラップは下げ位置にあった。  
後縁フラップは25ユニット下げ位置であった。
- (8) 操縦室内のレバー等の位置  
操縦室内の主要なレバー及びスイッチの位置は次のとおりであった。
- ・ フラップ・レバー 25ユニット下げ
  - ・ エンジン
    - スラスト・レバー 全エンジン : アイドル
    - スラスト・リバーサ・レバー No. 1 エンジン : フル・リバーサ位置
    - その他のエンジン : アイドル (フル・ダウン) 位置

3.3.5 No.1エンジン前部の垂れ下がりに伴って、破損したハイドロリック配管及びリザーバ・タンクから漏洩した同オイルが高温のタービン・スリーブ内に流入して発火した火災が、破損した燃料系統から漏洩した燃料に引火し、当該ナセル・ストラット後方部に火災を発生させたものと推定される。

写真5 焼損したNo. 1 ナセル・スト  
ラット・トレーリング・エッジ・  
フェアリング

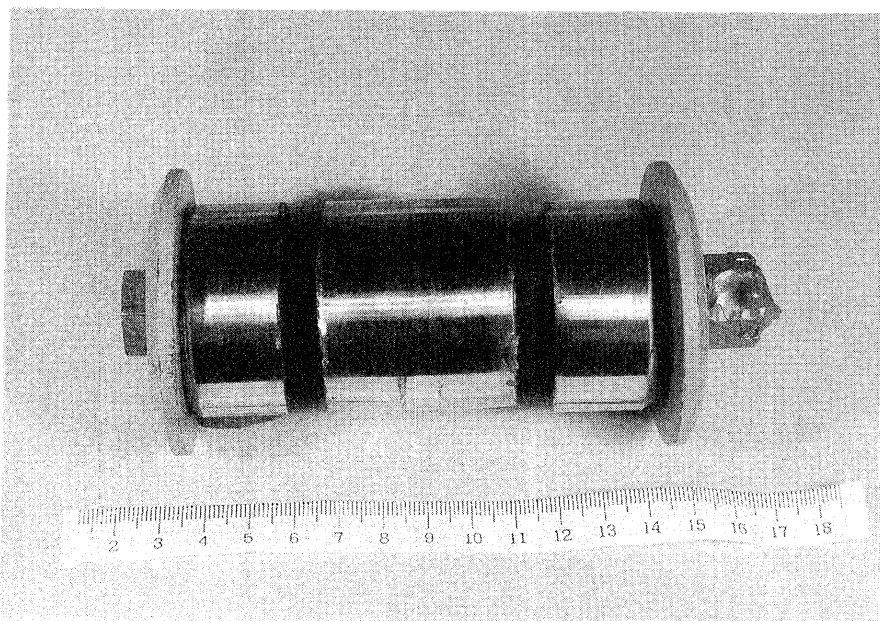
同ピンについて、走査型電子顕微鏡を使用して、破断面の調査を実施した結果、同ヒューズ・ピンはアッパ・リンク軸方向に作用した過大な引張り荷重のため、剪断破壊したものと推定される。

また、破断面に疲労の痕跡は認められず、材料傷、腐食、メッキ不良などの異常も見いだせなかった。

写真6 破断したアッパ・リンク前方  
ヒューズ・ピン

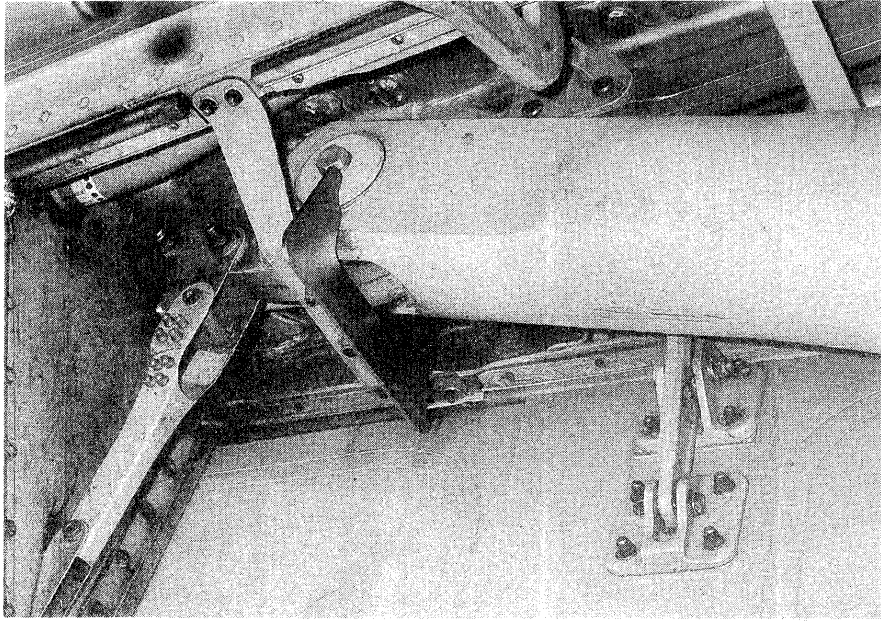
写真 8    ダイアゴナル・ブレース後方  
             ヒューズ・ピン・セカンダリ・  
             リテーナ

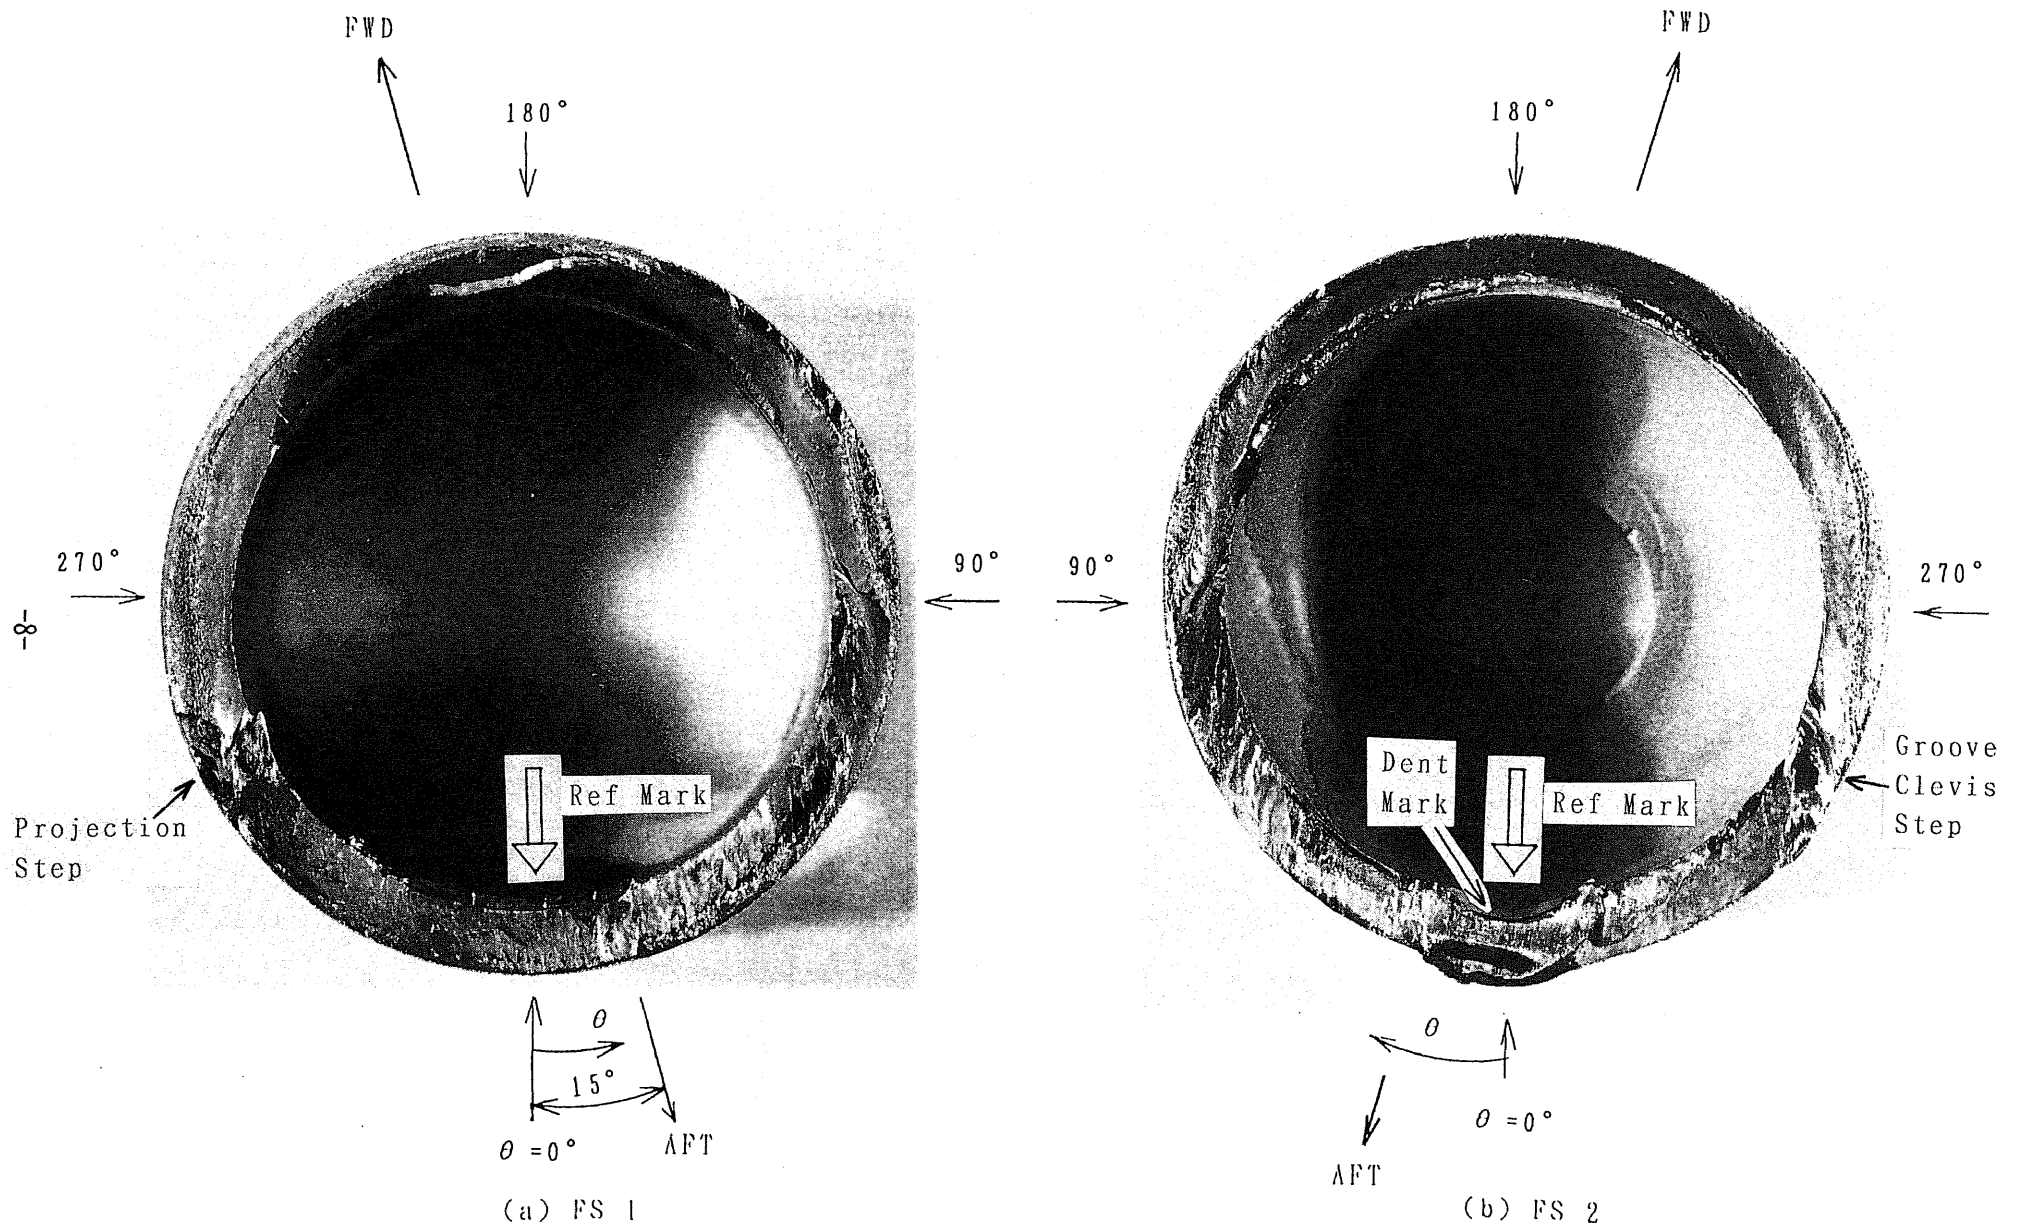
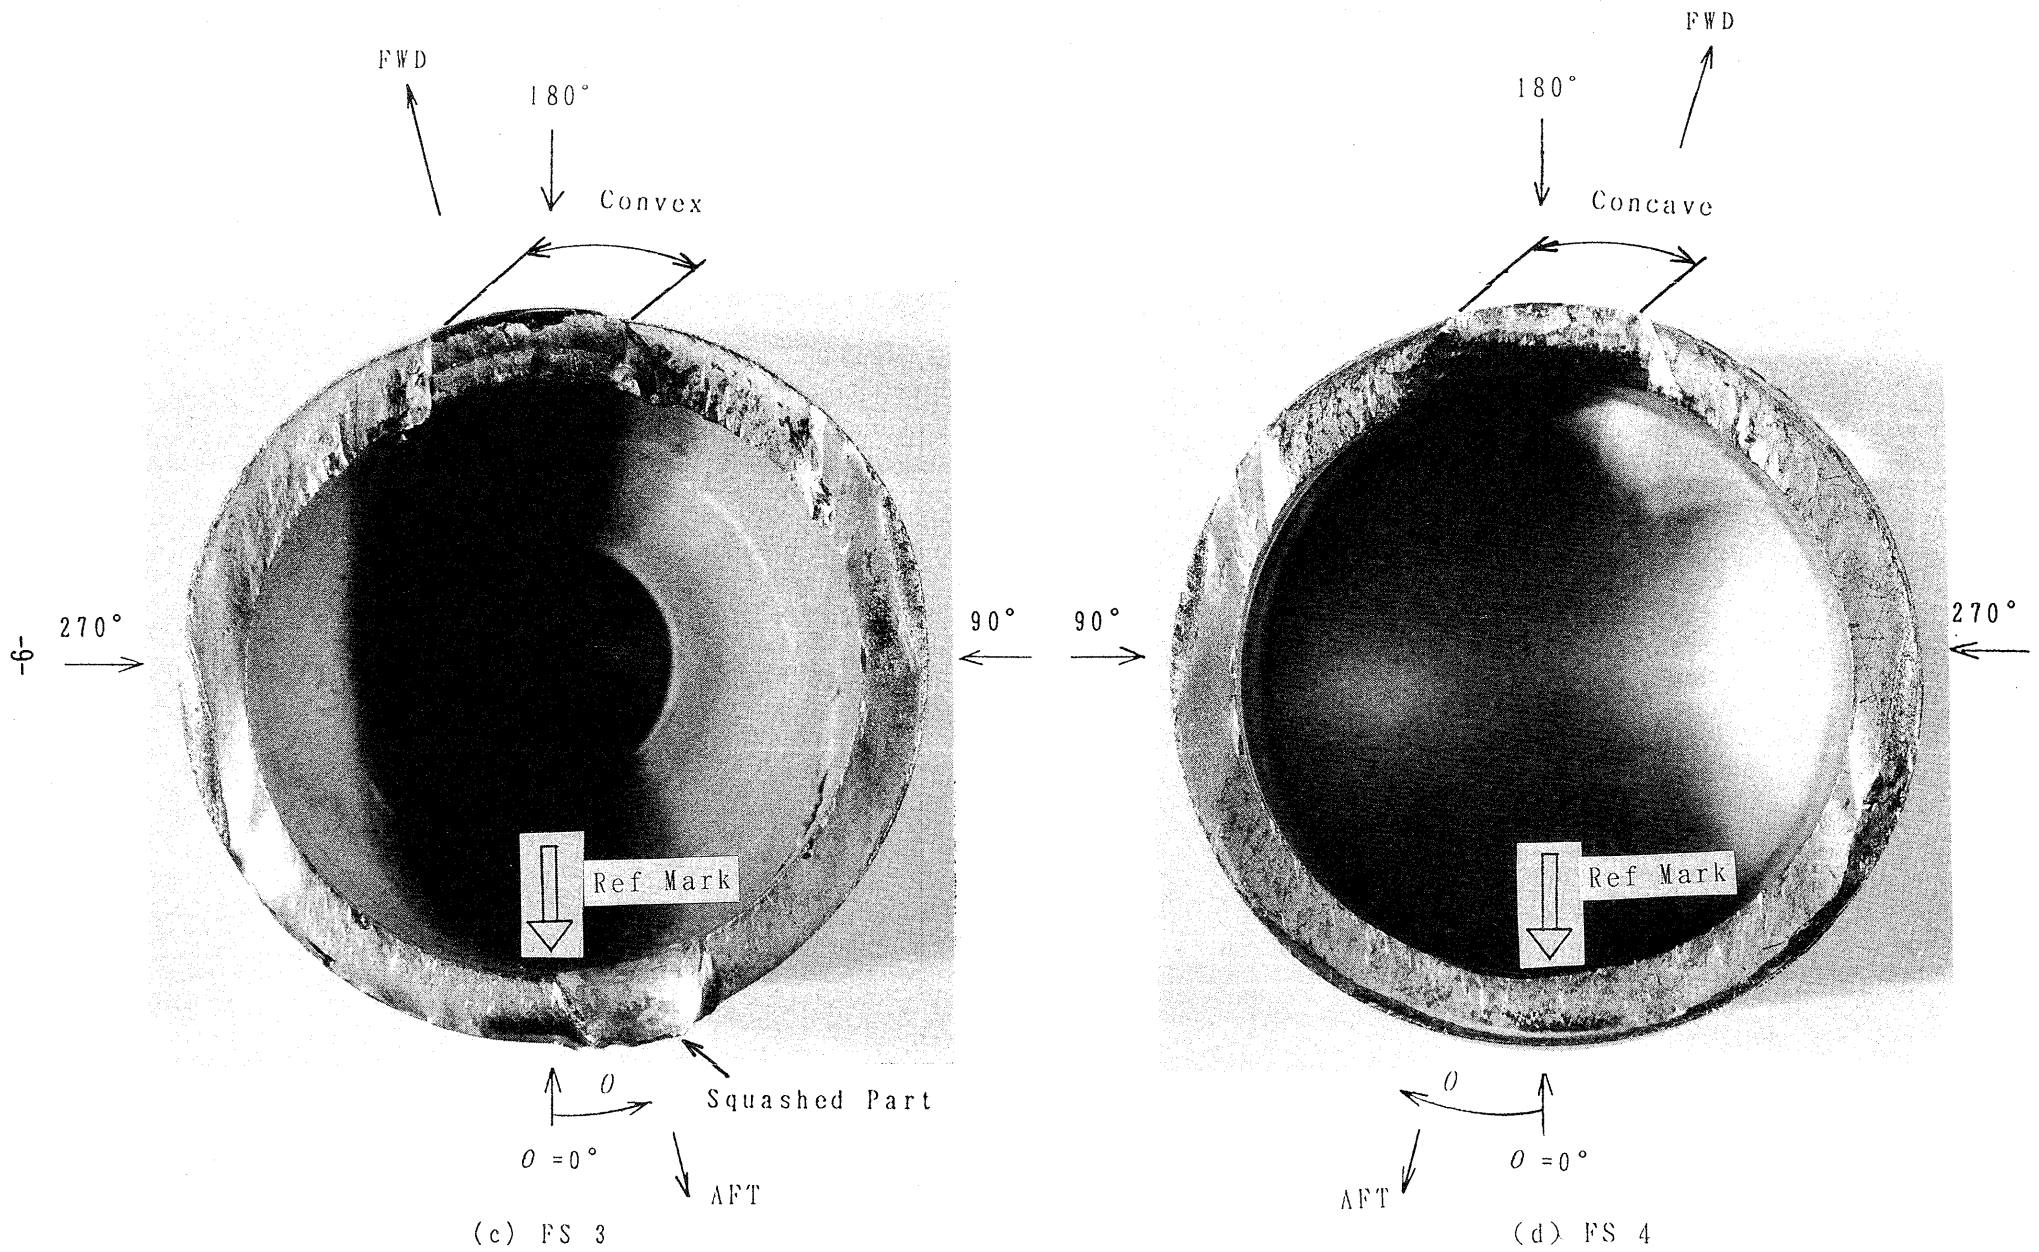
各破面は、何れも0°と180°を中心とするほぼ±60°の範囲では、剪断破壊の特徴である伸長ディンプルが多く認められた。

各破面の90°と270°を中心とする約±30°の範囲では、ディンプルの長さは短くなり、引張り破壊の特徴である等軸ディンプルも部分的に認められた。

疲労の痕跡は認められず、材料傷、腐食、メッキ不良などの異常は見いだせなかった。

図6. Upper Link FWD Fuse Pin 破面のマクロ観察(その1、FS1と2)

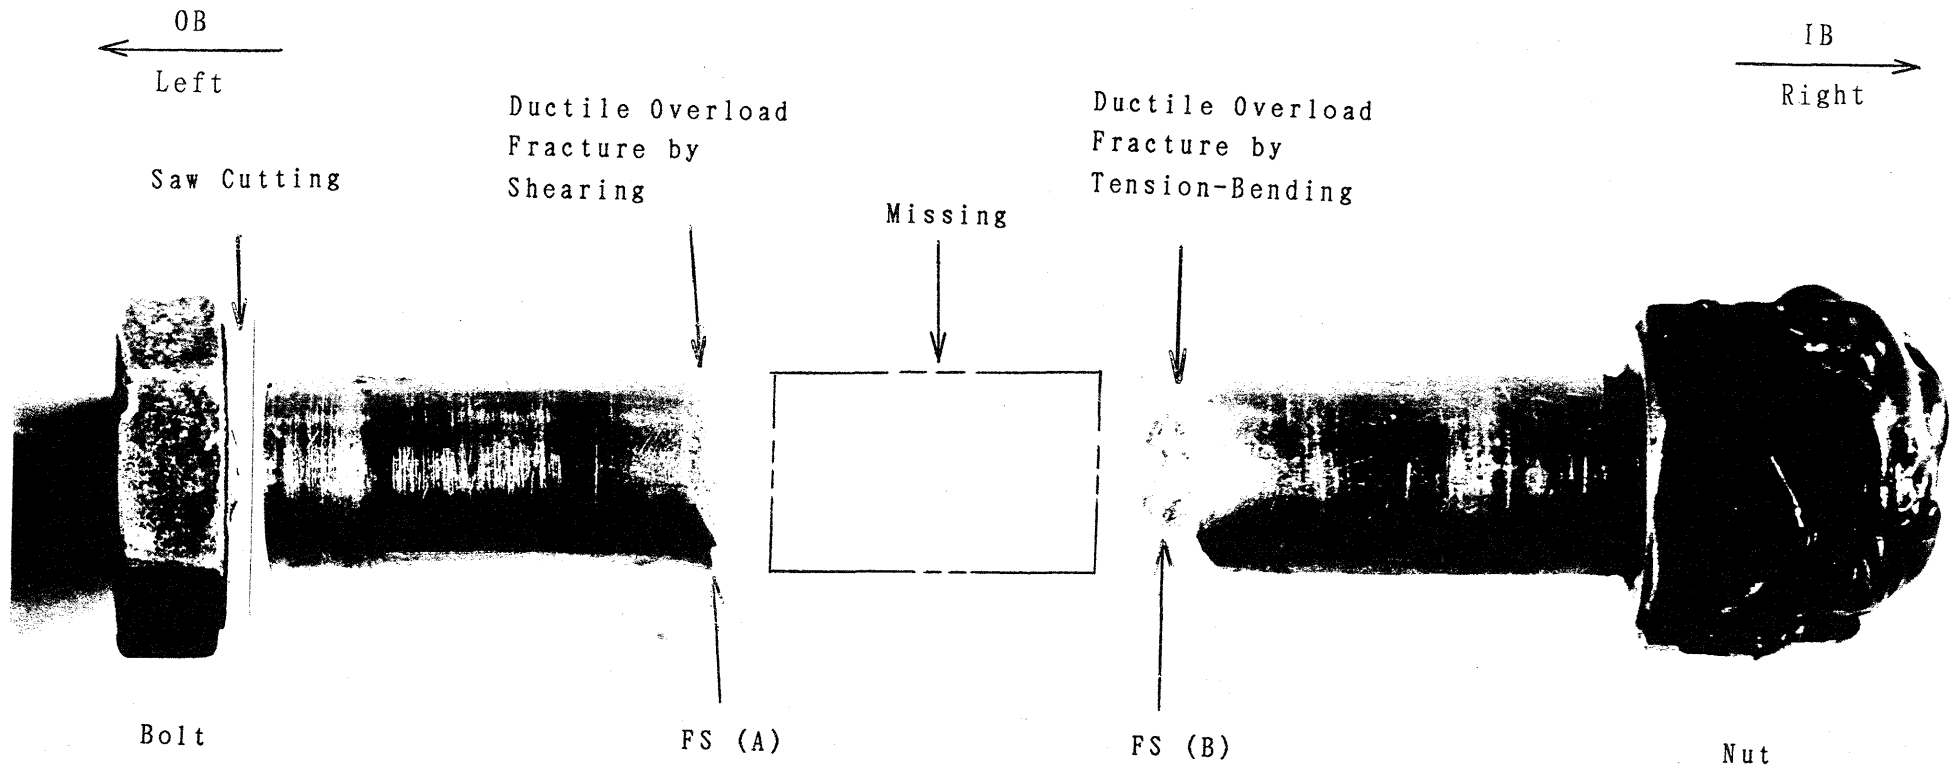
また、ピンを固定していたプライマリ・リテーナ・ボルトも、ピンと同位置で過大な荷重の作用により剪断破壊したものと推定される。

図12. Upper Link FWD Fuse Pin 締付け用ボルトのマクロ観察

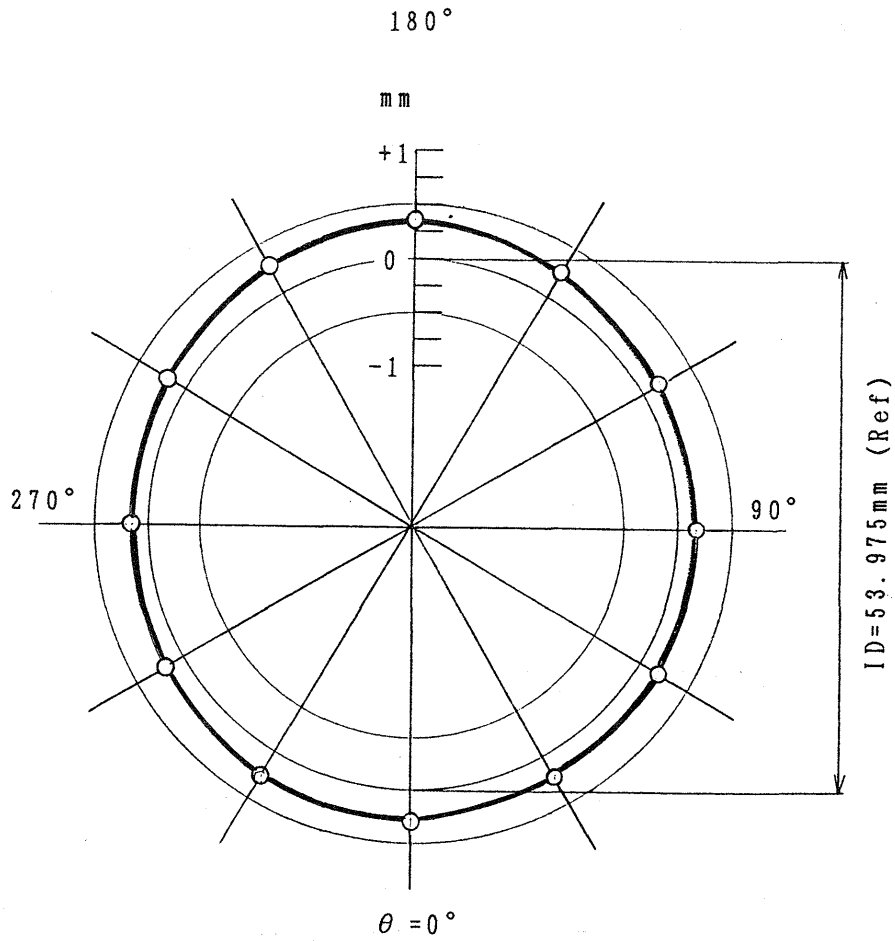
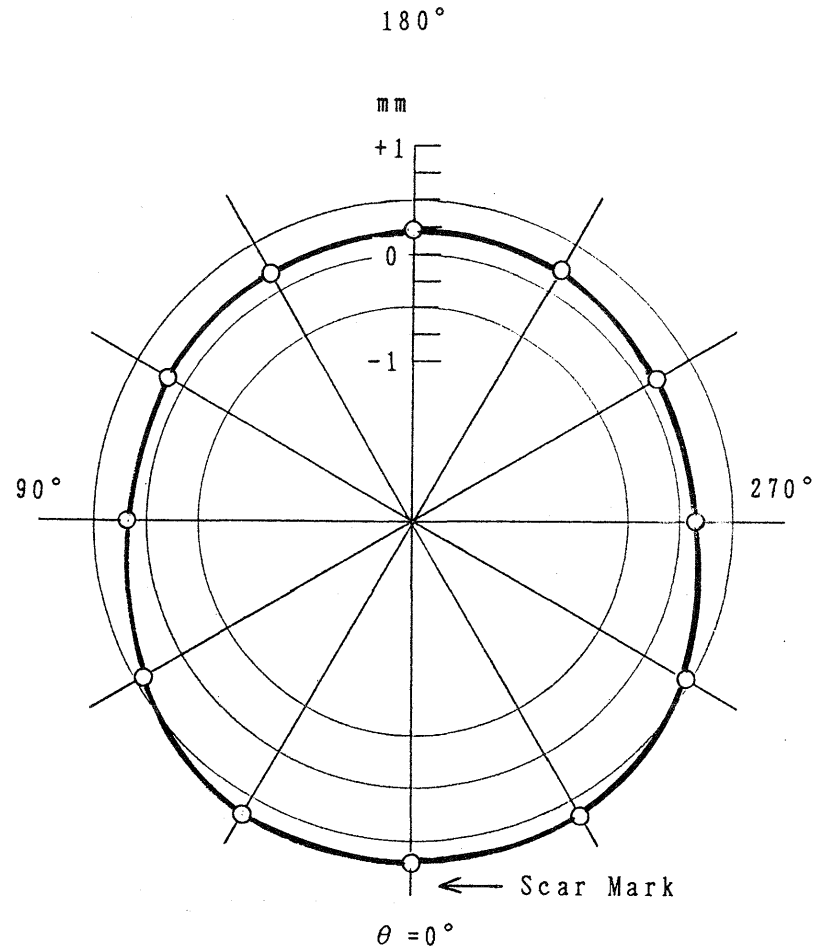
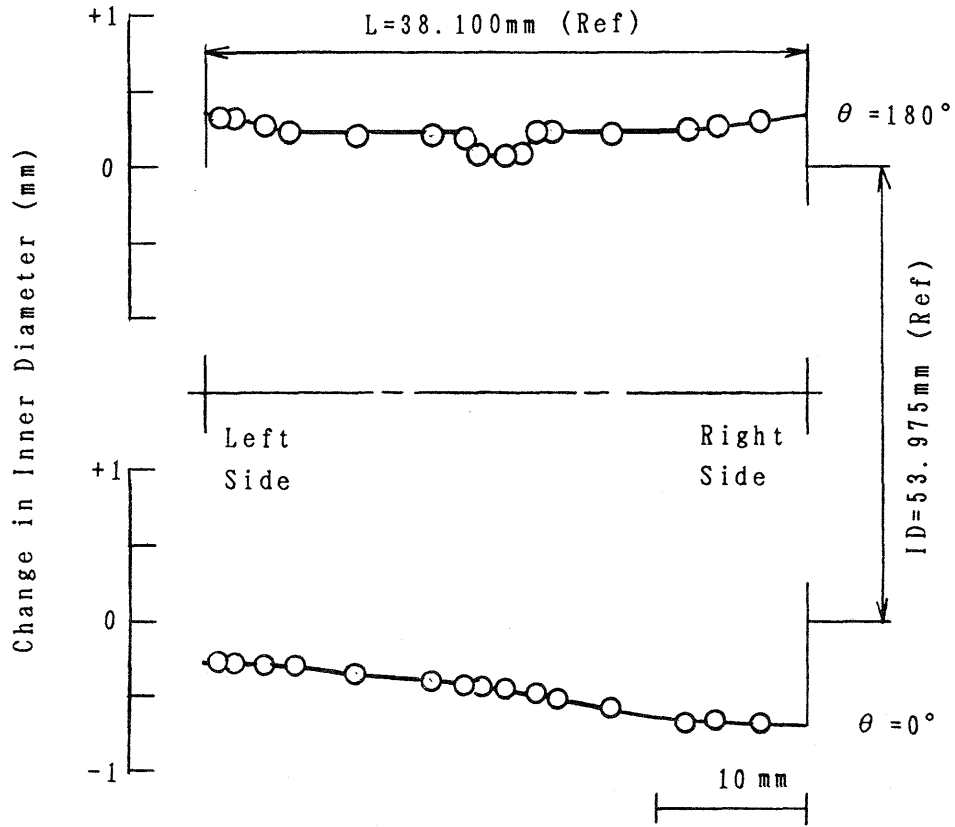
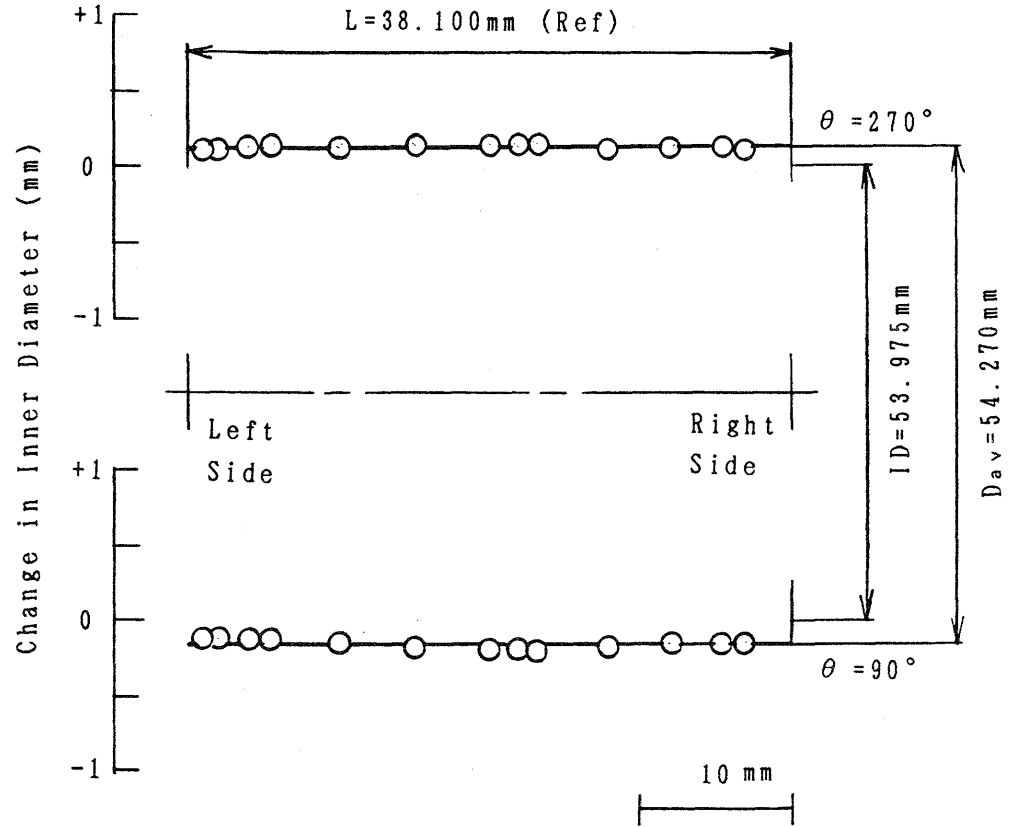
当該穴の変形測定を行ったところ、穴はやや楕円形に変形しており、内径は $90^{\circ}$  -  $270^{\circ}$ 方向にくらべ、 $0^{\circ}$  -  $180^{\circ}$ 方向では約 $0.4\sim 0.8\text{mm}$ 大きくなっていた。

この変形が過大な荷重の作用によるものと仮定すると、ボーイング社の材料仕様の降伏応力とフィッティング形状寸法から、作用した荷重は約 $1,003\text{kN}$ と推算できる。この力は同ピンに作用する剪断応力に直すと $857\text{MPa}$ と推算でき、これは、破断したヒューズ・ピンについて測定したビッカース硬さより求められる引張り強さ $1,365\text{MPa}$ からミーゼスの式（剪断応力=引張応力/ $\sqrt{3}$ ）で推算される剪断強さ $788\text{MPa}$ を上回り、かつ、ボーイング社の材料仕様の引張強さの値からミーゼスの式で推算されるヒューズ・ピンの剪断強さを超えるものである。

図15. Pylon Rear Mount Bulkhead Fittingの内径変化  
(現場(成田空港)において型取りしたシリコンゴムを用いて測定)

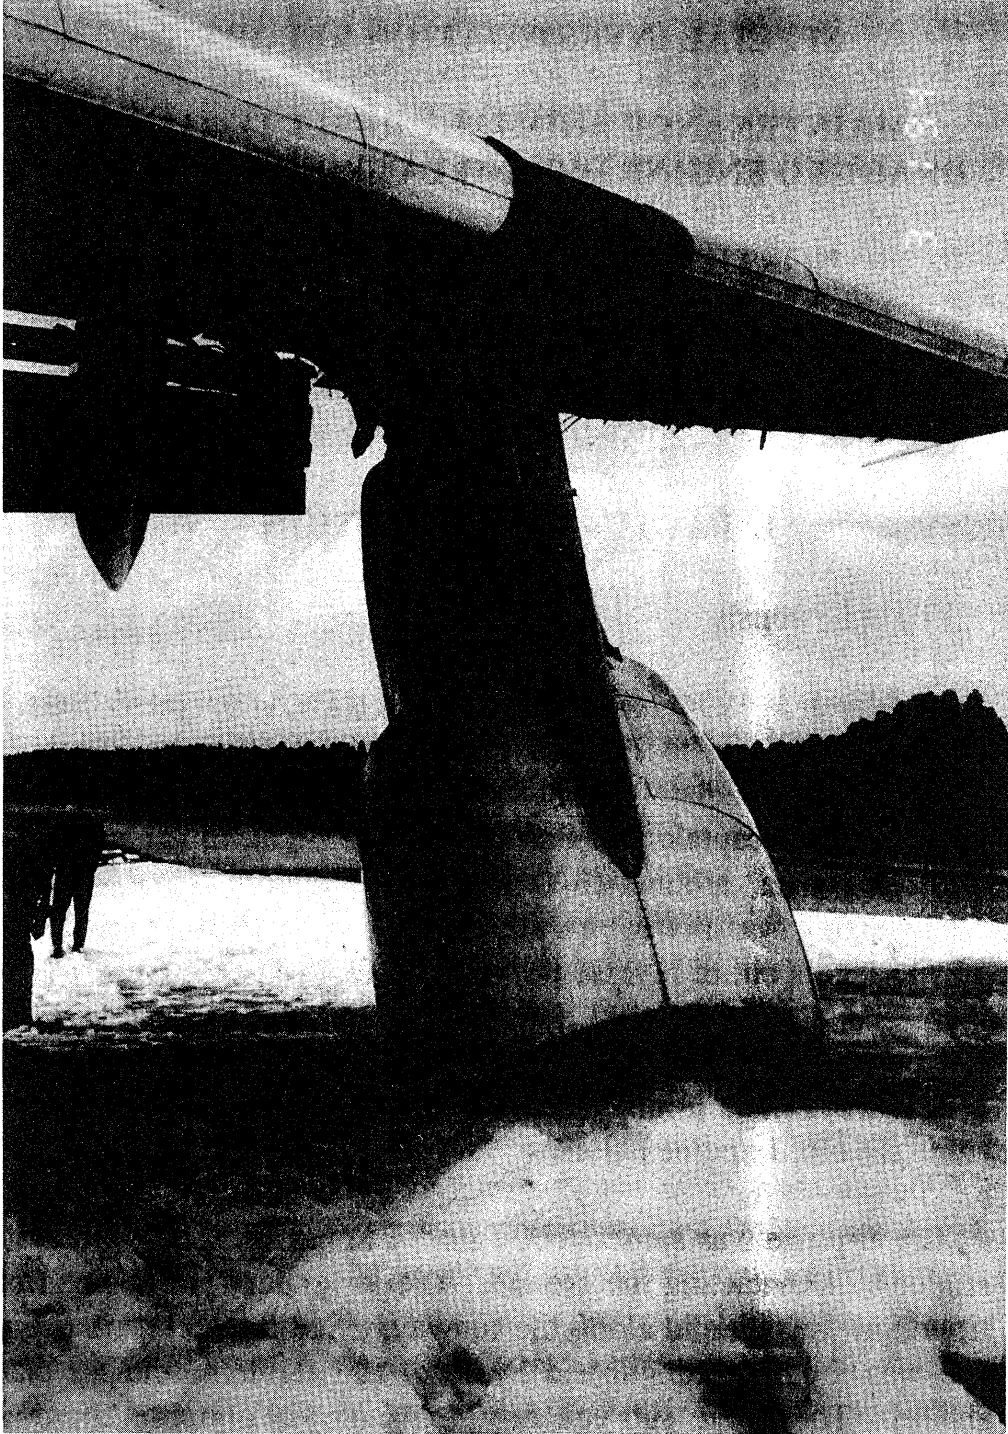
Figure 1.--No. 1 engine.

The airplane was subsequently stopped on a taxiway, with the front of the No. 1 engine still contacting the ground. The lower forward engine nose cowl had been ground away as it slid along the runway. (See figure 1). A fire near the No. 1 engine was rapidly extinguished by local fire fighters, and all passengers remained aboard. They were subsequently deplaned via portable boarding stairs about 30 minutes after the airplane was brought to a stop. There were no injuries.
