Chapter 1 Aircraft accident and serious incident investigation

1. Summary of major investigation report

Aircraft 1 The tail rotor became uncontrollable while the aircraft was flying, and the aircraft rapidly lost its altitude and crashed into terrain.
 (All Nippon Helicopter Co., Ltd. Eurocopter EC135T2, registered JA31NH)
 Full text of the investigation report : http://www.mlit.go.jp/jtsb/eng-air_report/JA31NH.pdf

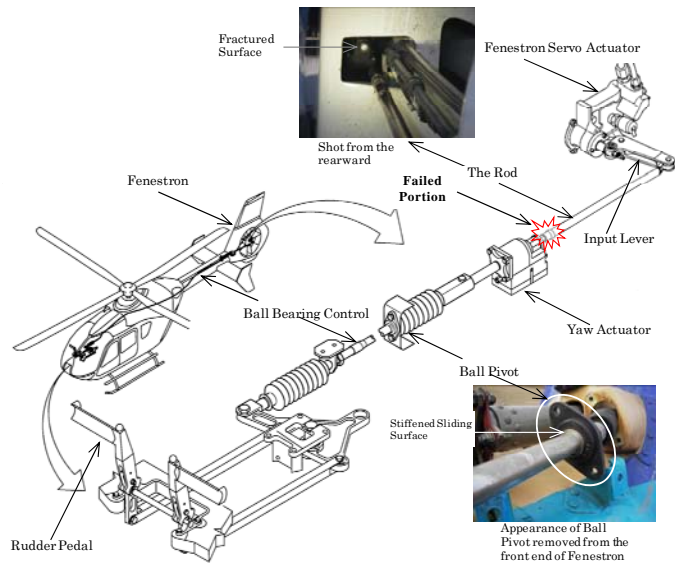
TR control system

- a. A periodical check for the tail rotor (TR) control system, including the ball pivot, was performed on March 9, 2006, in accordance with the maintenance manual. There was neither looseness in the threaded part of the TR control rod (the Rod) nor abnormality with the ball pivot. But it was stated by the maintenance service company involved that

Based on the findings, it is highly probable that the threaded part of the Rod had become loose and the ball pivot had become stiff sometime after the periodical inspection and as a result, a crack had been created in the threaded part of the Rod.

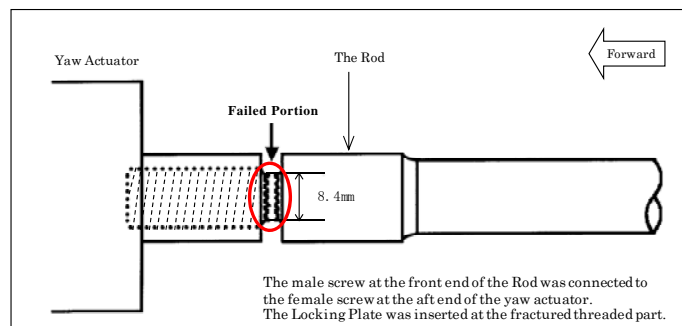
Failed portion of the Rod

d. After the accident, it was found that the Rod had been fractured in the threaded part. In view of the result of an observation of the fracture surface, it is highly probable that the Rod had been fractured by a fatigue failure due to repetitive loads.

g. As to the failure of the Rod, it is highly probable that the repetitive bending loads in excess of the fatigue strength had been applied on the Rod because the bending loads on the Rod had increased by the operation of the rudder pedal and the movement of the yaw actuator under the condition that the joint of the Rod and the yaw actuator had been loosened and the ball pivot had been stiffened due to corrosion, and also because the stress concentration had occurred due to the resonance phenomenon with the airframe vibrations and the loosening of the joint.

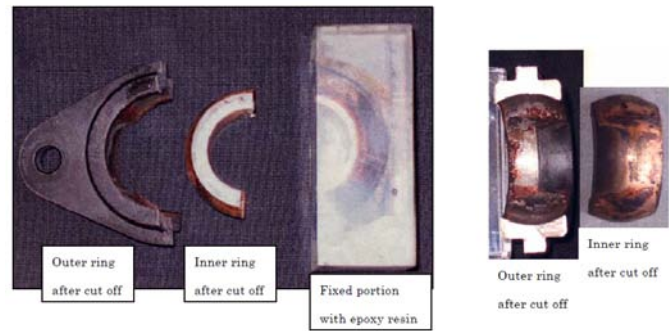
Ball pivot after cut off

e. After the accident, it was found that the ball pivot had become stiff in the sliding surface due to corrosion. It is highly probable that the unusual feeling in the rudder pedal movement, which had been reported by several pilots before the occurrence of the accident, was caused by the stiffening of the ball pivot in light of remarks in the maintenance manual.

f. As to the stiffening of the sliding surface of the ball pivot, it is highly probable that the phenomenon had occurred because the red rust was formed due to galvanic corrosion or crevice corrosion on the contact surface between the inner ring of copper-based alloy and the outer ring of iron-based alloy and it expanded in volume in the space between the two rings, restricting the movement of the two rings.

As to the stiffening of the ball pivot, it is highly probable that the phenomenon had occurred because the red rust was formed due to the corrosion of the contact surface of the inner ring and the outer ring and it expanded in volume in the space between the two rings

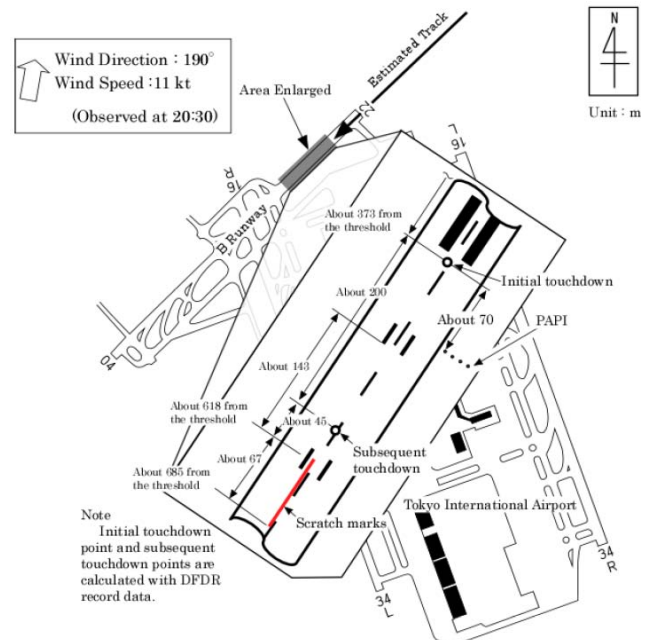
Scratch marks on the runway 22

A Boeing 737-800, operated by Air Nippon Co., Ltd., which was on a regularly scheduled service as All Nippon Airway's flight 298 under the agreement of joint transportation, made a tail strike with the surface of runway 22, Tokyo International Airport, upon landing at around 20:23 JST, and the aircraft sustained damage.

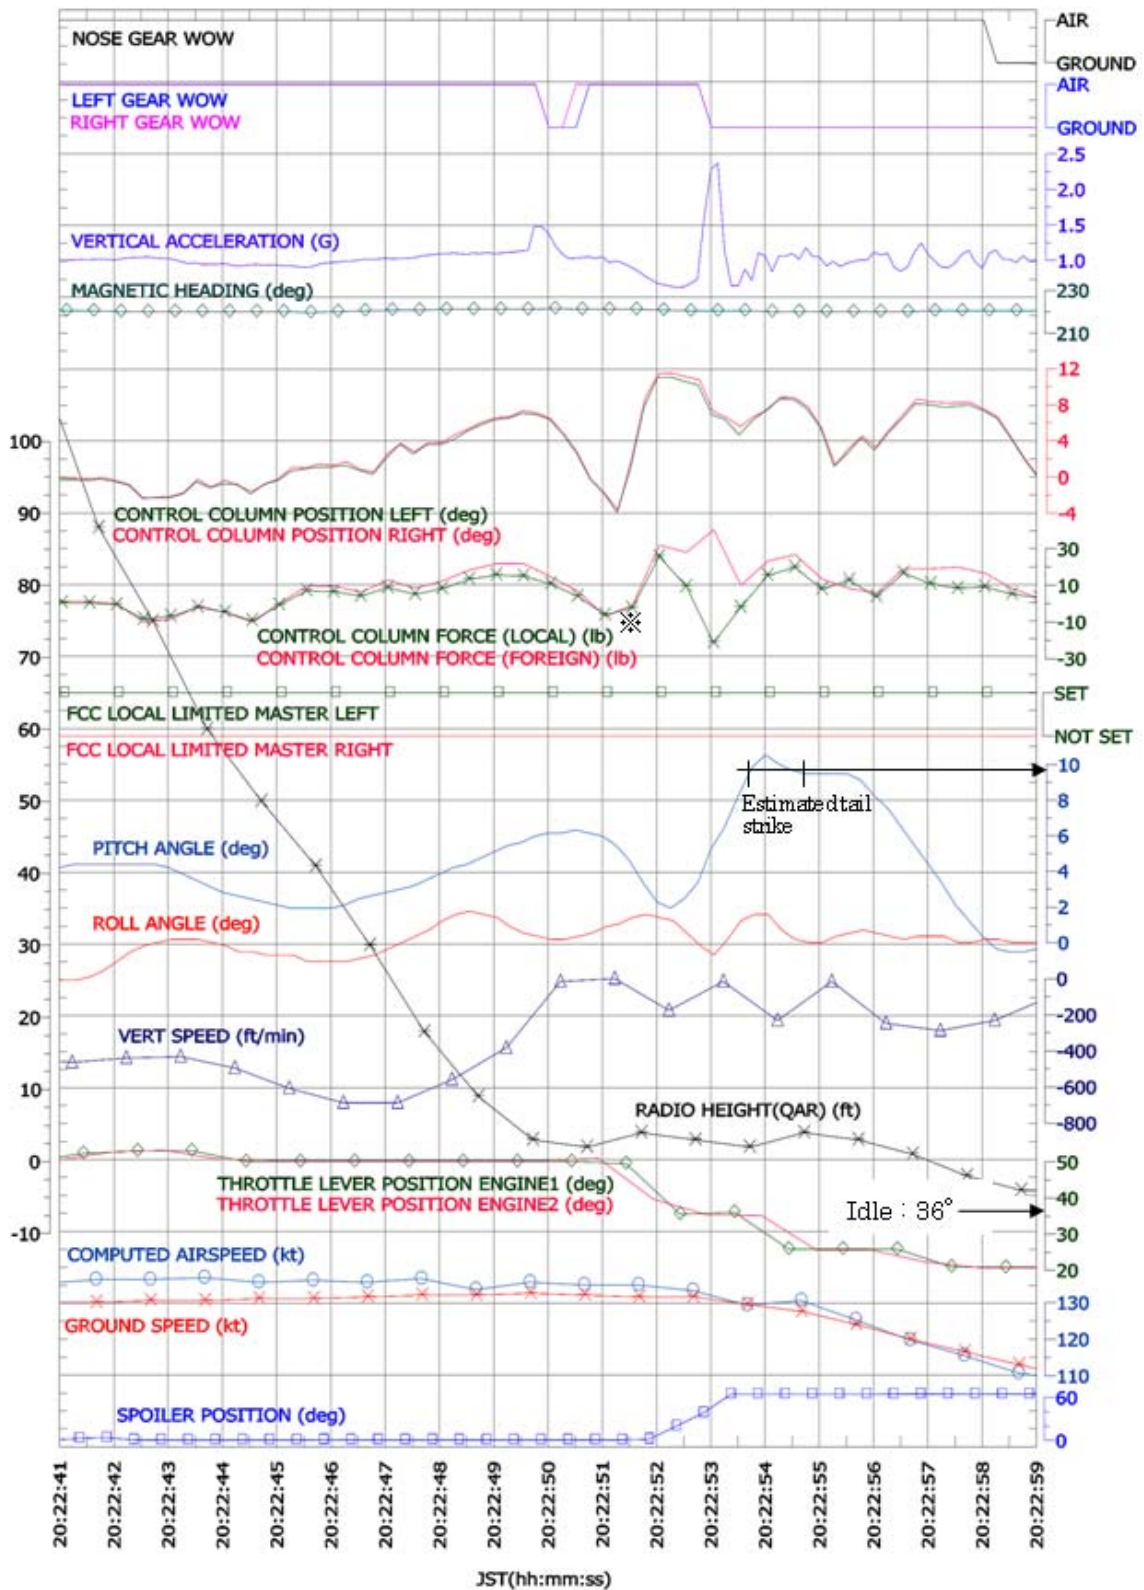
DFDR (Digital Flight Data Recorder) records

The FO was correcting the glide path near 150 ft, which the PIC mentioned had been lower near 200 ft, by adding thrust and increasing the pitch angle. Then he pushed the CCP*1 after the aircraft passed 90 ft. It is highly probable that this input is linked to the decrease in the pitch angle after the aircraft flew over the runway 22 threshold at an altitude of approximately 60 ft RA and a delayed increase in the descent rate.

The FO stated that he felt the interval between automatic call-outs*2 of “Fifty” and “Forty” was shorter than usual. It is probable that his statement corresponds to the

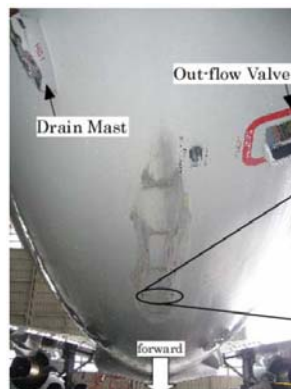
Damage on fuselage

In this accident, it is highly probable that the aircraft, under the FO's piloting, was damaged in its aft fuselage as it made a tail strike at the second touchdown following the bounce immediately after the initial touchdown, with the continued nose-up attitude in addition to the compression of main landing gear struts by the large vertical acceleration.

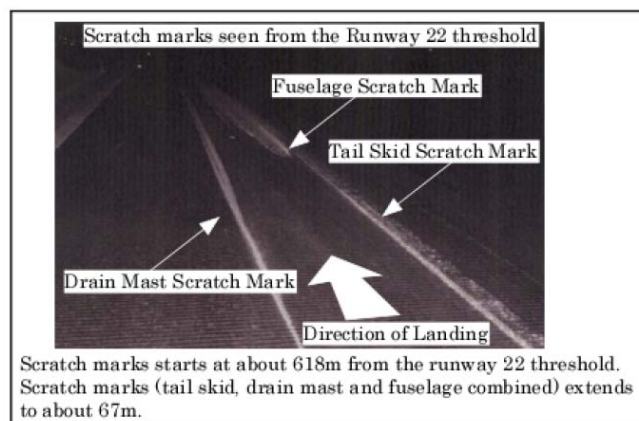
Scratch marks on the runway 22

exceeded 9° as a result of the combined effects of a bigger CCP value and a pitch up moment generated by the deployment of spoilers which took place from 20:22:52 to past 20:22:53.

It is highly probable that the effects of the FO's large push-pull movements with the control column during the bounce led the pitch angle, which had been earlier reduced at one time with a delay, to become large and with an added nose-up moment generated by the deployment of spoilers, the pitch angle increased to over approximately 9.7° and consequently the aircraft made a tail strike*³ with its fuselage damage.

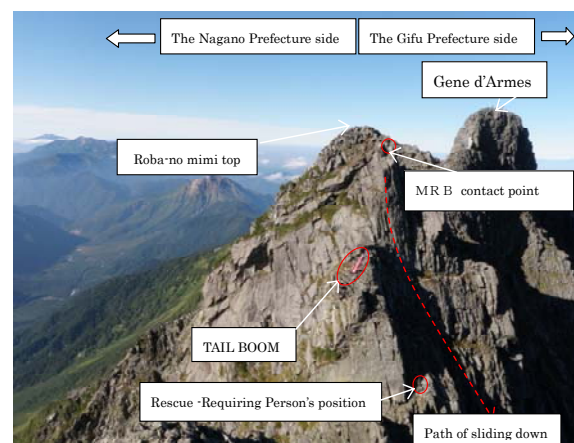
Layout of accident site

c. It is somewhat likely that the aircraft's altitude was suddenly lowered while it was hovering because of the influence of complex air currents typical of higher mountainous areas and when the aircraft moved backward with its altitude lowered, it became difficult for the captain to maintain the position of the aircraft relative to the mountain across the valley, which he had identified during the initial hovering, and that this made it difficult for him to precisely adjust the position and altitude of the aircraft and as a result, the aircraft moved backward and its main rotor blade (MRB) hit one of the rock walls.

- a. It is probable that because the right side of the MRB's rotating plane hit the rock wall, the transmission leaned backward and at the same time, the MRBs were damaged, and they became unable to keep a proper rotation and hard hit the left side of the tail boom, fracturing it.
- b. It is probable that the engines of the aircraft were normally operating and that there was no abnormality with the aircraft.
