# JAPAN TRANSPORT SAFETY BOARD ANNUAL REPORT 2012

Japan Transport Safety Board

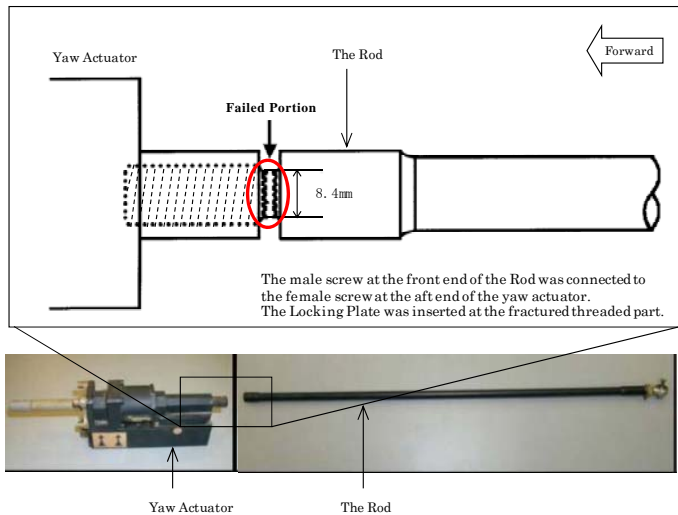
**Failed portion of the Rod**

d. After the accident, it was found that the Rod had been fractured in the threaded part. In view of the result of an observation of the fracture surface, it is highly probable that the Rod had been fractured by a fatigue failure due to repetitive loads.

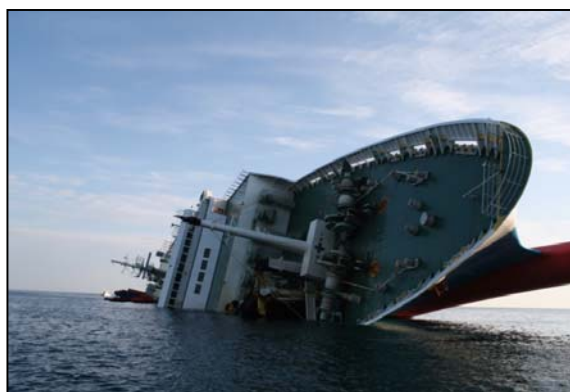
**ARIAKE, listing and grounding on its side**

Ferry ARIAKE, operated by Maruei Ferry, Co. Ltd. (Company A), was boarded by a master with 20 crew members. It had 7 passengers, and was loaded with 150 containers and other items. At around 05:06 hrs, while proceeding south-westward in Kumanonada, ARIAKE heavily listed to starboard and grounded on its side off Mihama Town, Mie Prefecture.

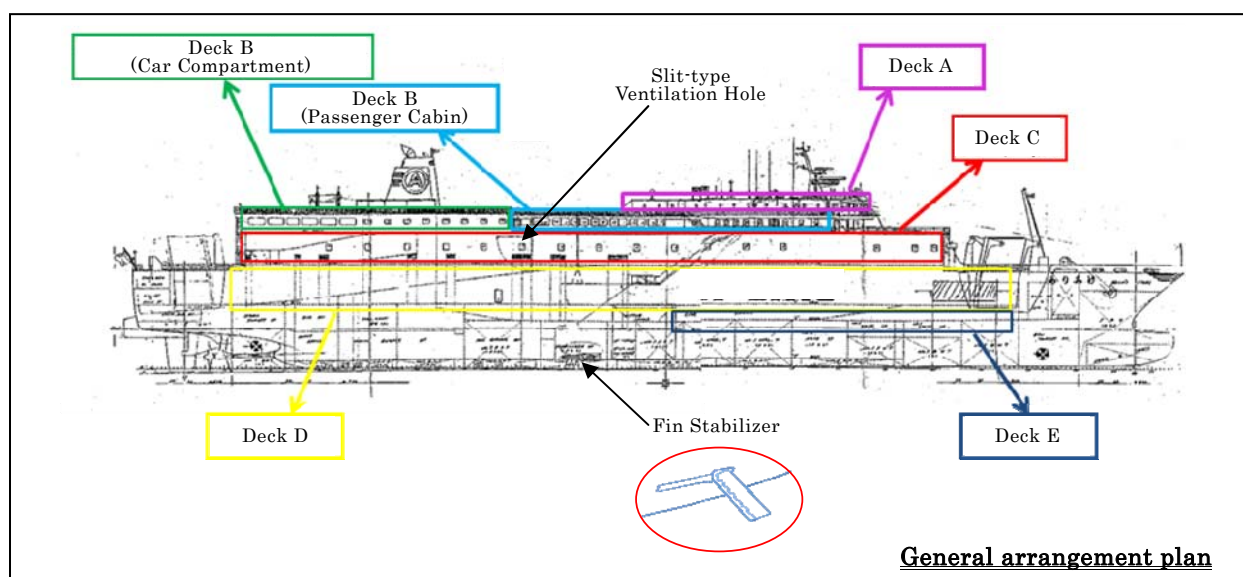
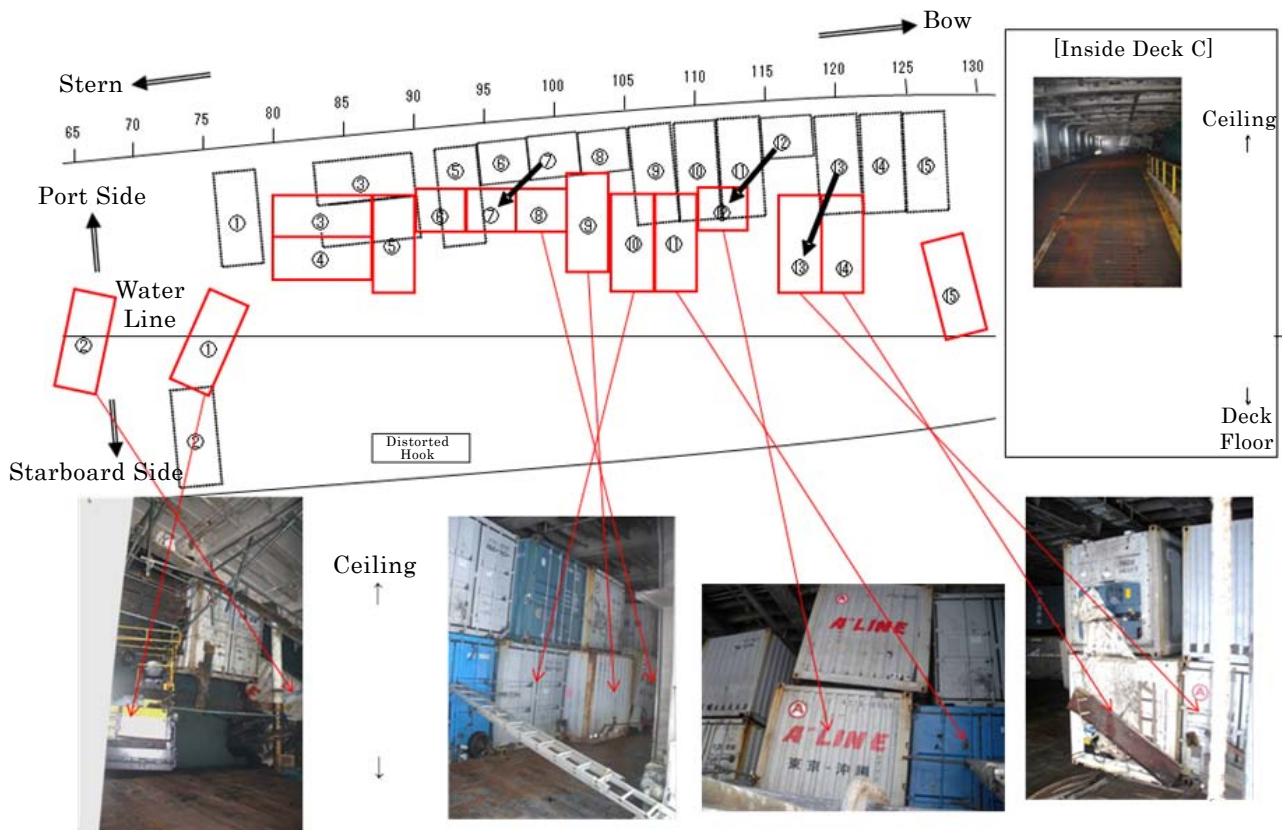
**Shifting of containers and trailers**

- a. Company A, although having installed lashing gear and equipment on the ship, had not considered specific lashing-procedures for containers or trailers, and had not prepared manuals for effective lashing procedures to prevent excessive shifting of cargo. In addition, the maximum coefficient of static friction between the deck and the containers, the supporting pads and the racks was approximately 0.4, corresponding to the coefficient of static friction between steel and steel, judging from the fact that: the car deck was not coated with paint compatible with the car ferry construction standards at the time of the accident; there was another incident of container shifting occurred prior to the accident; and the non-slip deck coating had abraded away.
