JAPAN TRANSPORT SAFETY BOARD ANNUAL REPORT 2013

ANNUAL
REPORT

2013

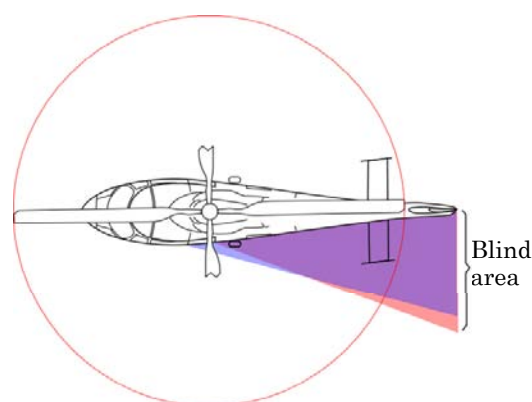
Blind Area in Aft Left Section of the Aircraft

(3) It is not certain whether the pilot in command took actions for confirming or made instructions for confirming obstacles in the aft on the left side before having the aircraft hover to the left to adjust its position, but it is very likely that the looking out toward the left aft was not appropriate.

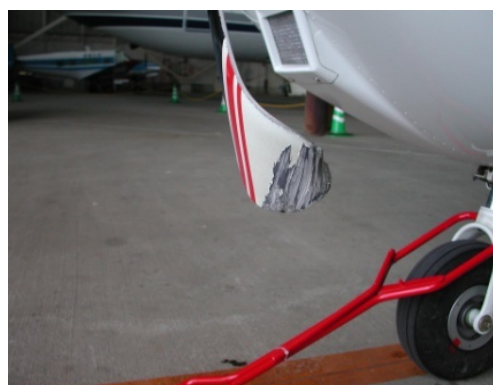
Damaged Propeller Blade

As 70 mm inward bending of the blade tip needs at least 17.2° of pitch-down attitude, the student pilot had possibly pushed the control wheel or failed to apply back elevator pressure to hold the pitch-down attitude, resulting in the nose-low contact with the runway.

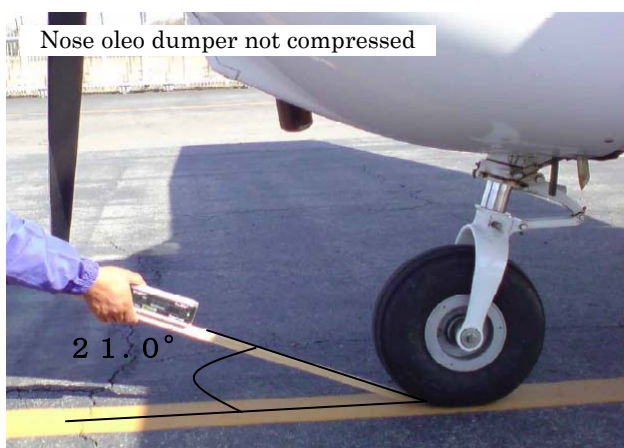
Nose oleo dumper not compressed

21.0°

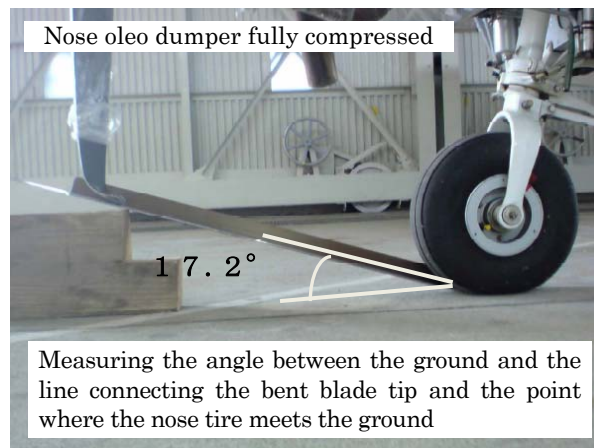
Nose oleo dumper fully compressed

17.2°

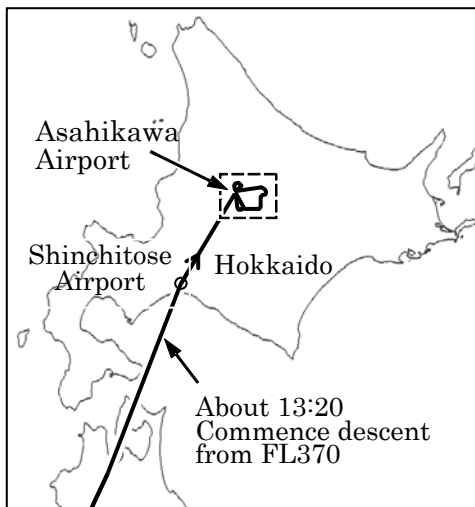
Estimated Flight Route

Probable causes: It is highly probable that this serious incident occurred because the aircraft experienced a ground proximity and its flight crew took an emergency maneuver responding to its EGPWS*1 warnings during its descent toward its destination aerodrome, Asahikawa Airport, under the ATC instructions.

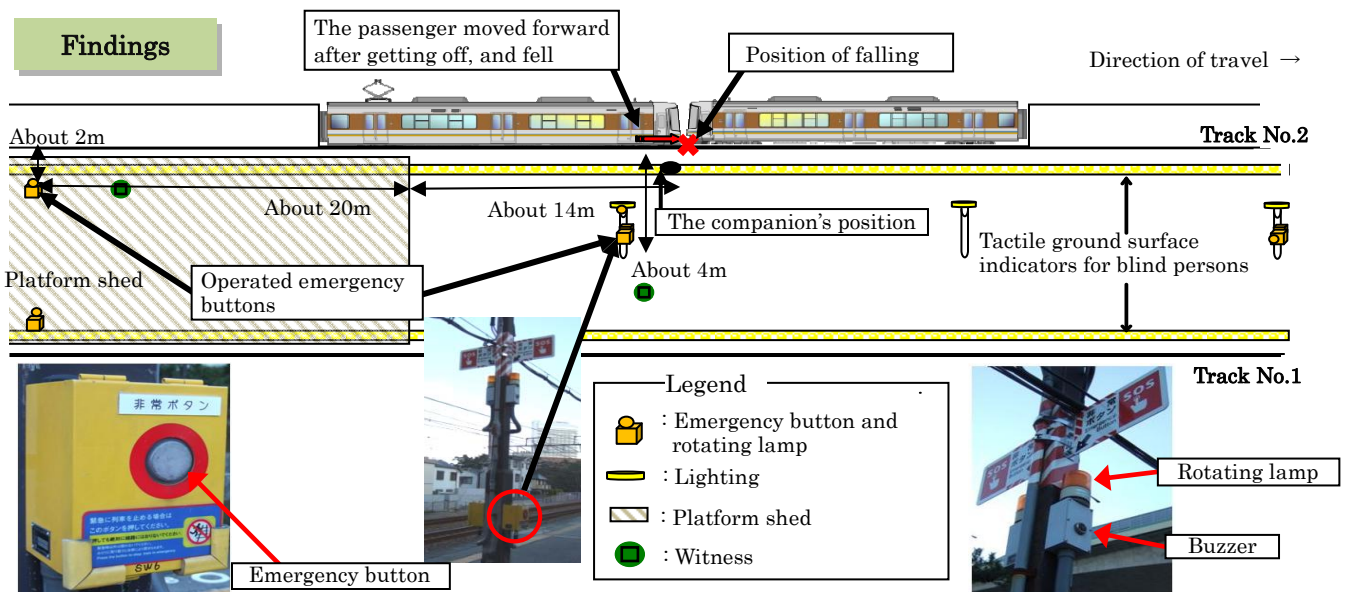
Schematic drawing of the accident site

It is highly probable that the passenger walked along the train in the direction of travel after getting off the train, and fell from the platform into the space between the 4th and 5th cars (without a vestibule diaphragm for falling protection). It is somewhat likely that alcohol drinking was involved in the falling from the platform.

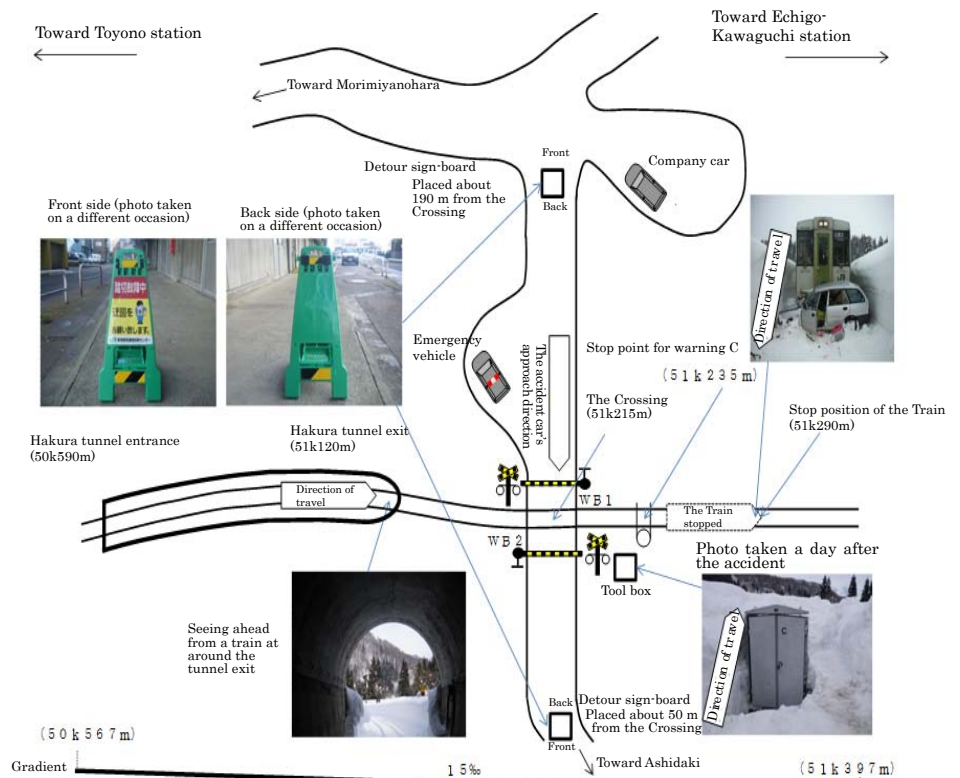
Schematic drawing of the accident site

It is probable that the existence of any oncoming train was not checked because (i) level crossing guard A assumed that there would be an interval of more than 10 minutes in the operation schedule between westbound and eastbound trains, and (ii) level crossing guard B assumed from the work schedule given by A that the train would come at about 12:30.

It is probable that the tall heaped snow around the level crossing obstructed the visibility for noticing a train approaching and absorbed the traveling sound of a train.

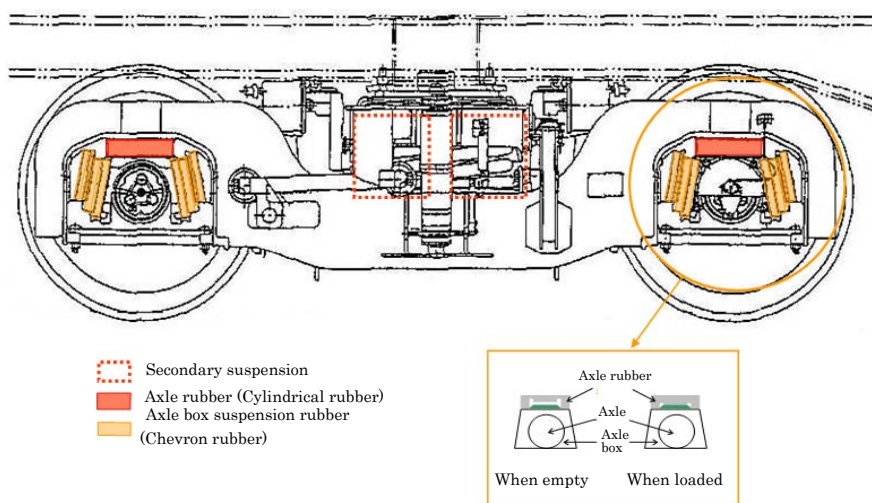
Axle box suspension of the derailed freight cars

It is somewhat likely that due to aged deterioration for having been used since it was newly made, the spring of the axle suspension (axle rubber and axle box suspension rubber) for the freight cars became stiffened and the track followability was decreased. On the other hand, it is somewhat likely that the cars of the train were shaking at the curbed section at around the derailment point where a large track irregularity was observed. It is probable that the large track irregularity observed between 9k553m and 9k558m had largely changed the load and lateral force of the outside wheel of the first axle in the rear bogie of the derailed freight car, and contributed to the occurrence of derailment by making the derailment coefficient larger at around a point with a relatively large track irregularity.

Probable cause: It is probable that the accident occurred because after running along a 406-m-radius left circular curved track, the outside (right) wheel of the first axle in the rear bogie of the 9th freight car of the train ran on the rail and was derailed to the right due to the decreased wheel load at first, and the second axle also ran on the outside (right) rail and was derailed. It is highly probable that the reason for the overturning of the 9th freight car which entered the premises of Namegawa station in a state of being derailed was that the front bogie and the derailed rear bogie of the 9th freight car ran on different tracks after passing the turnout, and the car body became unbearable to running. It is probable that the front bogie of the 10th freight car was derailed after running into wrong track because it was pulled by the rear bogie of the 9th freight car which ran into wrong track.

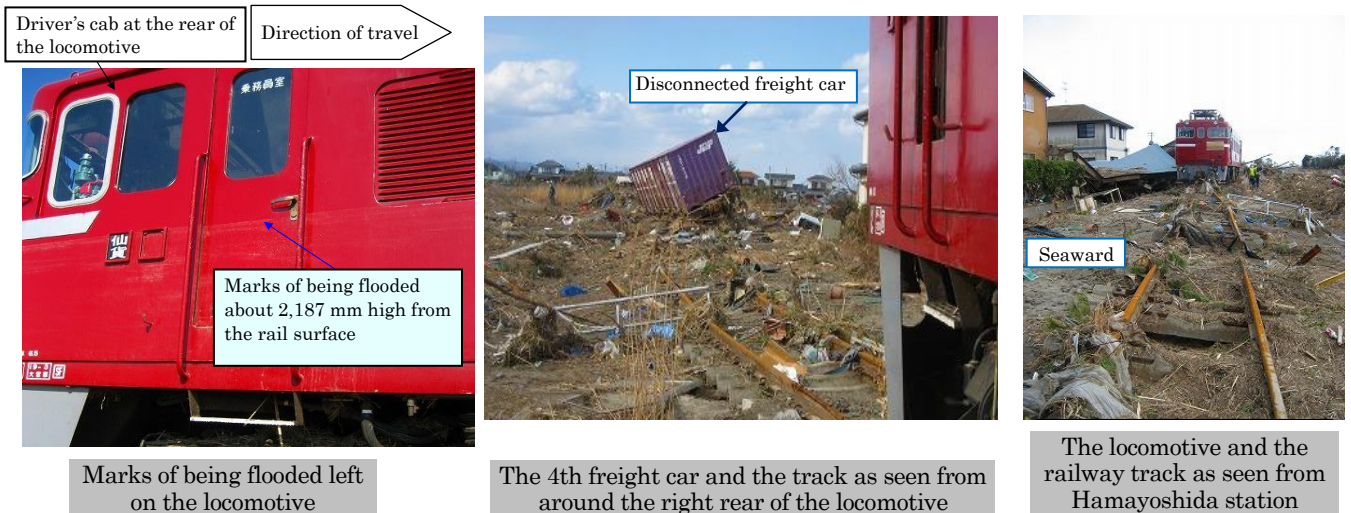
According to the findings that the train hit by the tsunami had marks of being flooded on the surface of the locomotive at a position about 2,187 mm from the rail surface, it is somewhat likely that the freight cars were flooded to the level almost half as high as the height of the loaded containers. It is probable that for that reason, 20 freight cars (all container cars) were derailed by the force of the tsunami and buoyancy, and were scattered around while some of the freight cars were disconnected as their couplers became disengaged, and others were washed away to the right (mountain side).

It is probable that the reason for the locomotive not being derailed was that the mass of the locomotive was larger than that of the freight car when fully loaded, that there were houses on the left of the locomotive (seaward), and that the disconnected freight cars weakened the force to derail the locomotive.

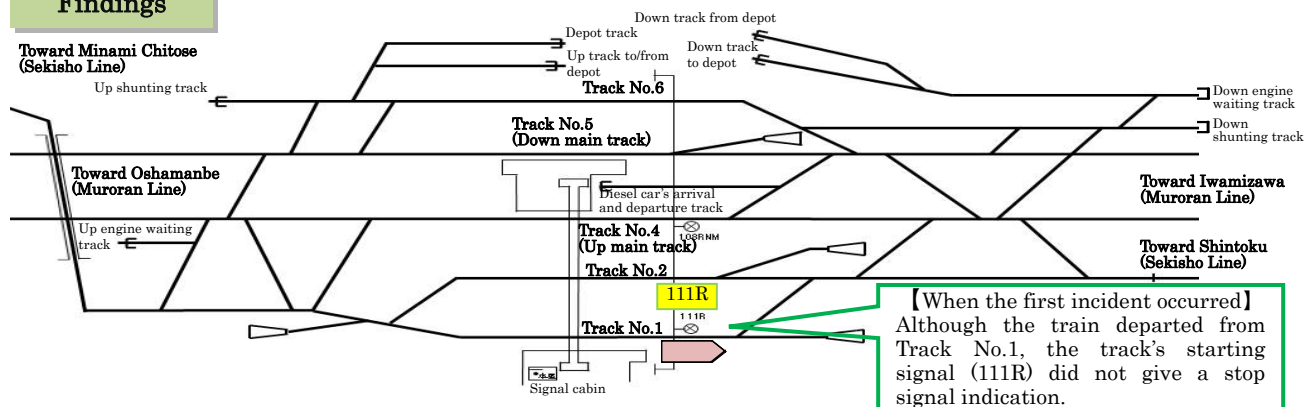
Schematic diagram of Oiwake station's premises

All of the four incidents were caused by the work to improve signal facilities, and from the aspect of signal facilities, they all have an almost identical occurrence mechanism. To be precise, with respect to the wiring work for adding a new relay circuit to the existing signal facility, adoption of an improper work method created a circuit which allowed the electric current to flow to the signal control relay of the starting signal when setting a route for Sekisho Line and Muroran Line at the same time, which then created a situation in which the starting signal did not give a stop signal indication even when the train entered the track circuit in the protection area of the signal.

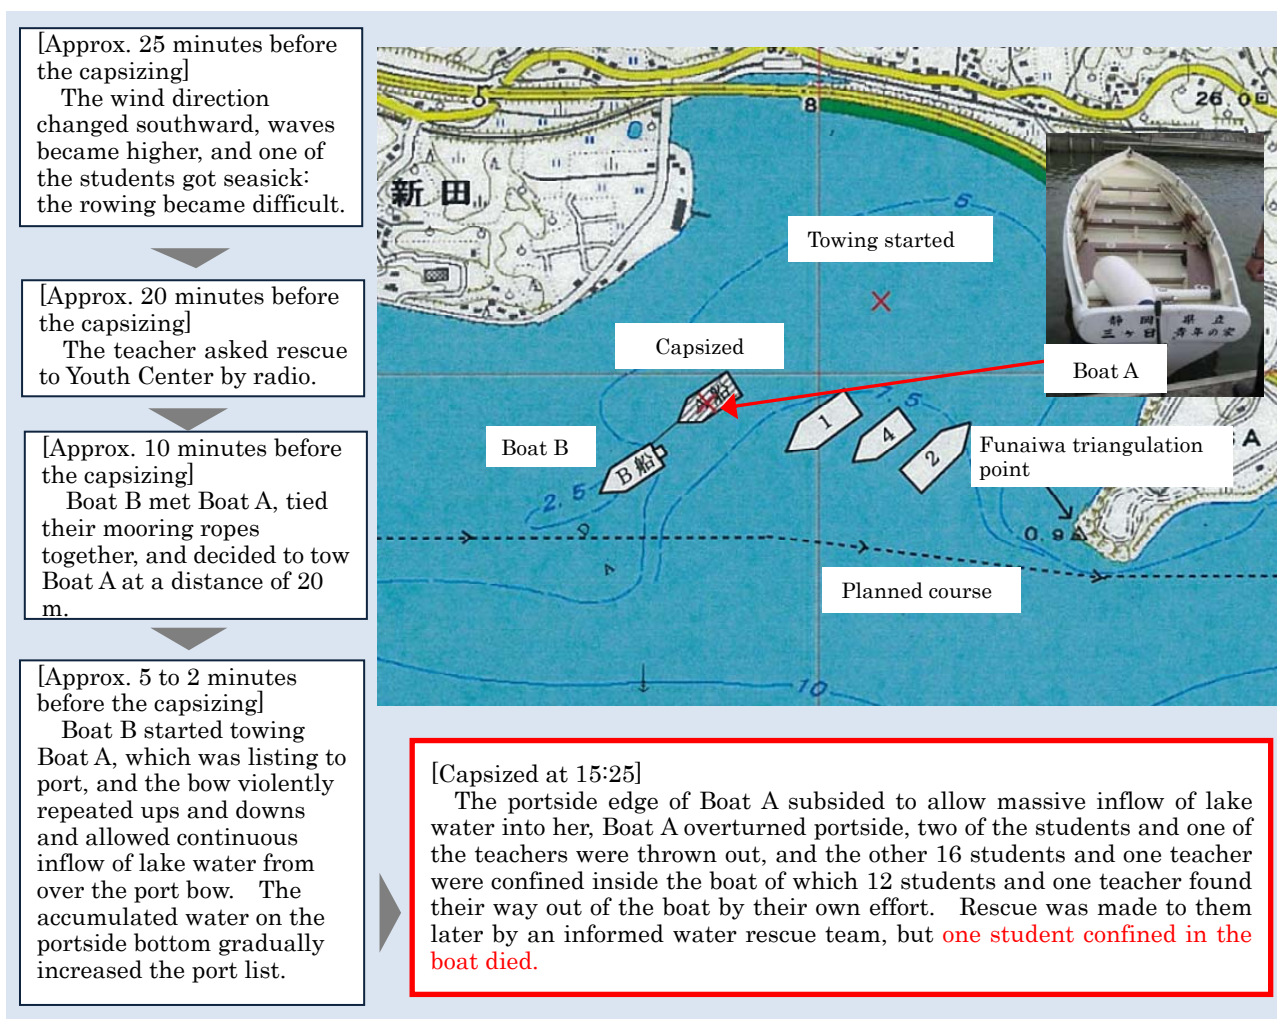
Probable causes: The probable causes of this accident are as follows. Under rainy weather of which heavy rain, thunder, gale, high-wave and flood advisories had been forecast, Boat A was used for an outdoor exercise for the junior high school at the Youth Center and was engaged in a cutter rowing training without a trainer along an east course, which is a usual way of the training, off the north shore of Lake Hamana. The gale and wind grew stronger to render the rowing difficult, and the director of the Youth Center went for rescuing on Boat B, and towed Boat A obliquely to port with continuous inflow of lake water thereinto from the port bow. When being towed in those states southwestward off the south of Sakume, the Boat A's port list developed under increasing flowed-in water accumulation on her bottom and caused the portside oars to catch water and to turn her bow to port. Sometime later, the students sitting on the starboard side lost balance and were shifted toward portside, to further increase the port list. Consequently, the port side submerged, lake water flooded into the boat, and the boat overturned portside.

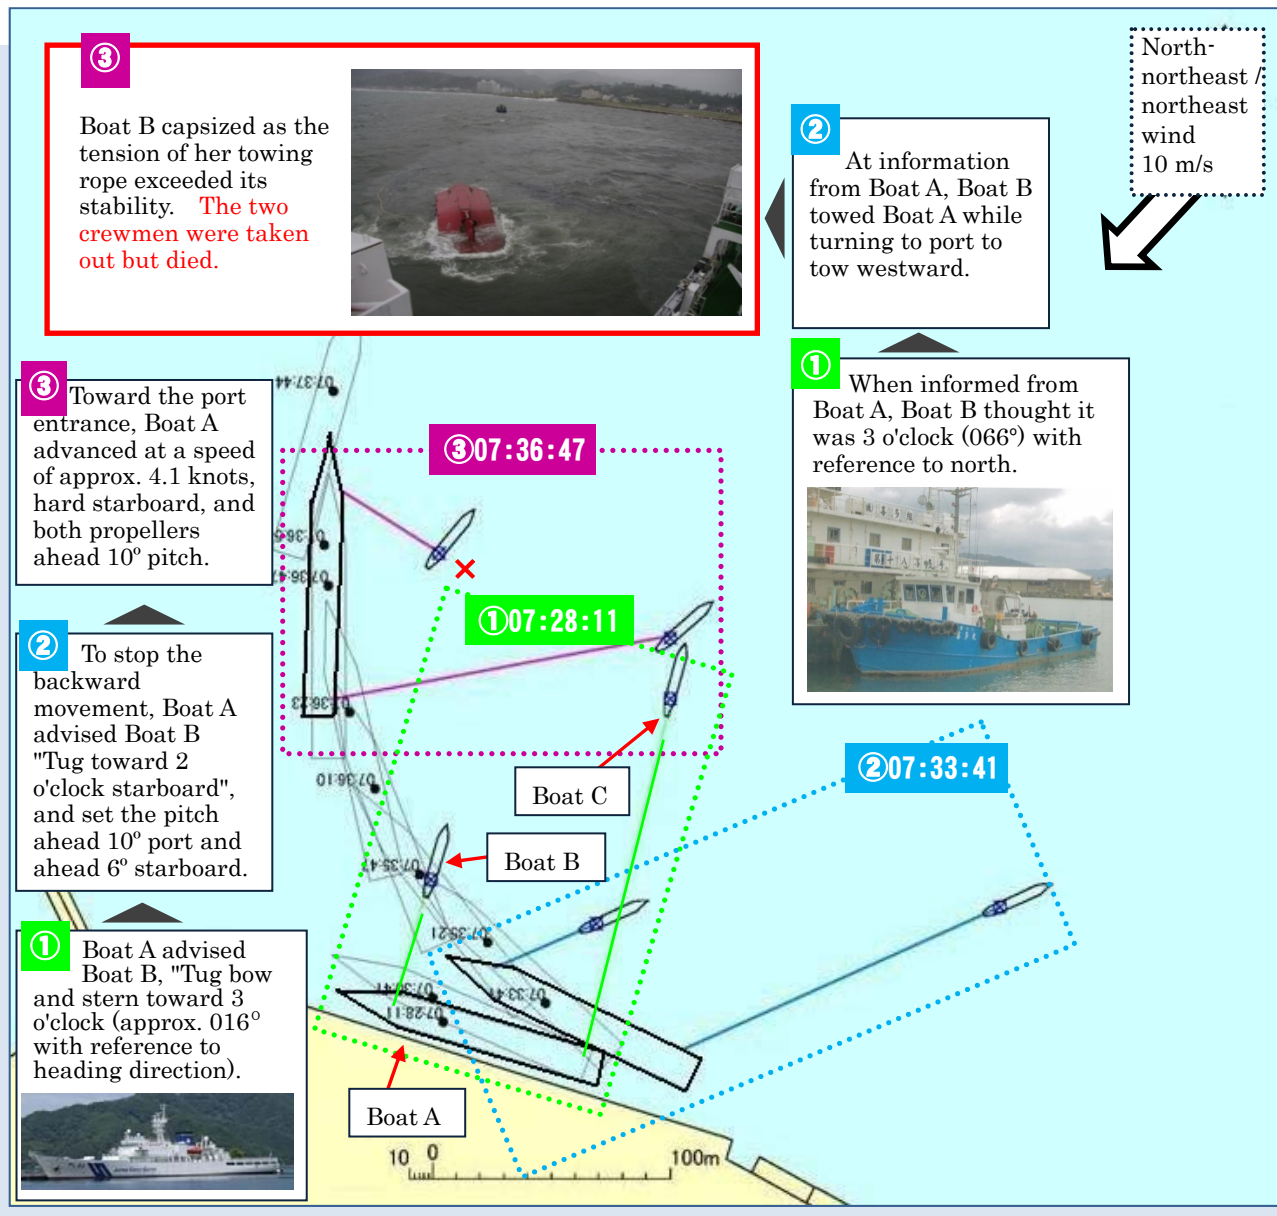
Probable causes: It is probable that when Boat B, along with Boat C, was towing Boat A to assist the departure of Boat A from Wajima Port, with the towing rope tied at the bow of Boat A, under north-northeast to northeast wind velocity of approx. 10 m/s and wave-height of approx. 3 m, Boat B capsized because the tension of her towing rope exceeded her stability.

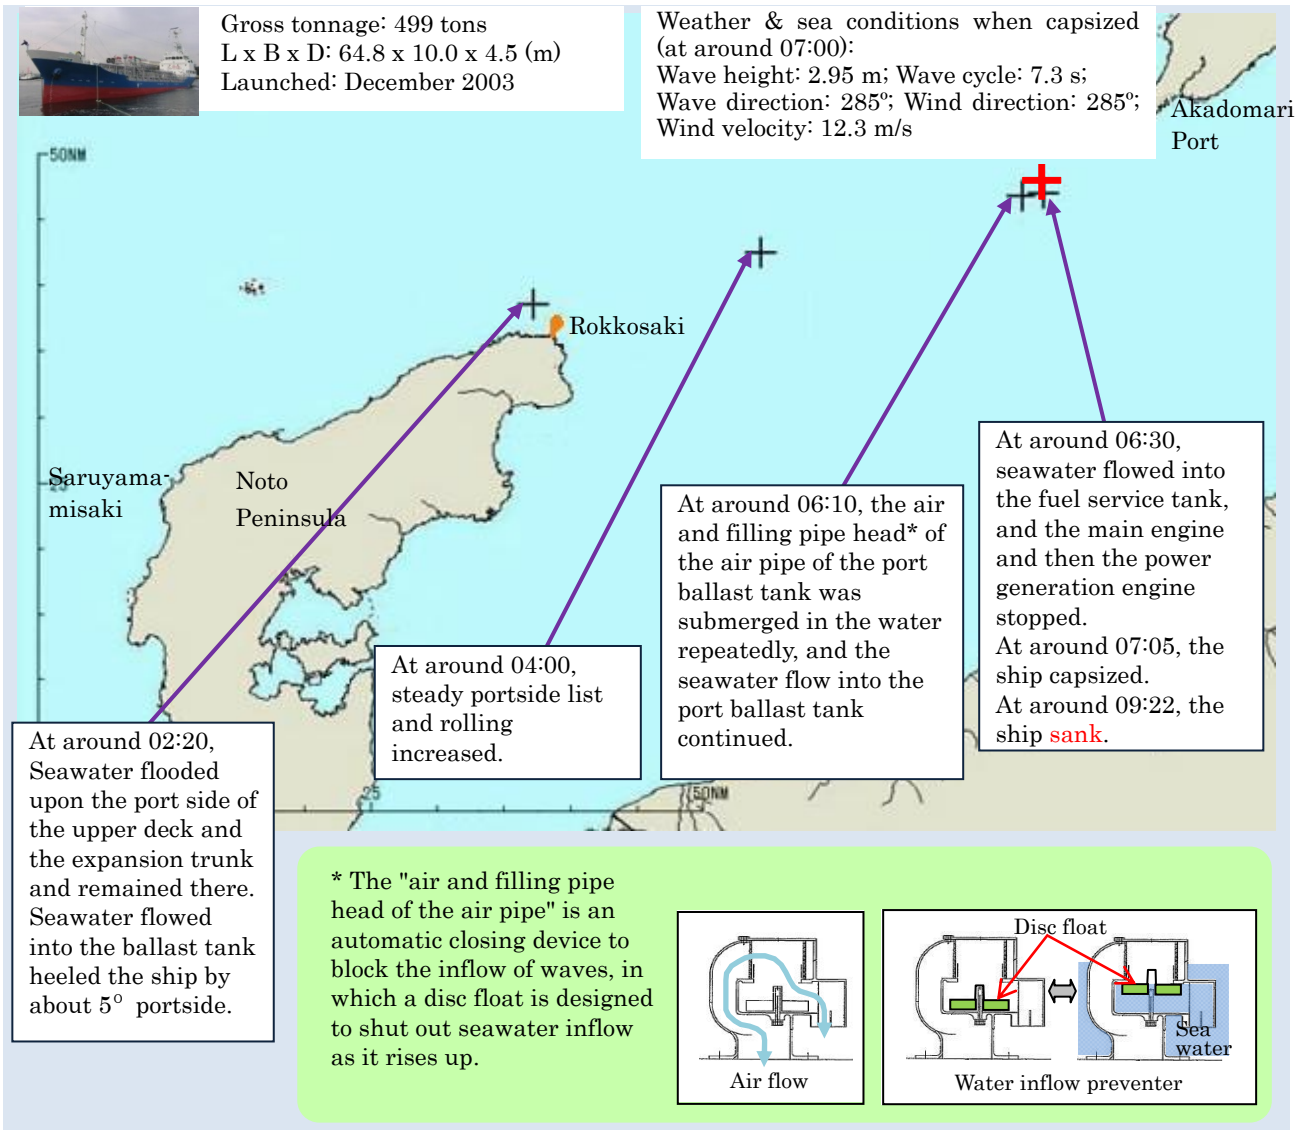
Probable causes: It is probable that this accident occurred as follows. When this ship was sailing off Saruyama-misaki toward Akadomari Port in a quartering sea from port side, the water inflow preventive function of the air and filling pipe head of the air pipe of the port ballast tank failed to function and allowed seawater to flood upon the port side of the deck and the expansion trunk and to continuously stay. The seawater that flowed into the ballast tank increased the list of the ship to port and caused to repeatedly submerge the air and filling pipe head of the air pipe. Flowed-in seawater from the air pipe into the port ballast tank continuously increased the port list to consequently turn over and sink the ship.

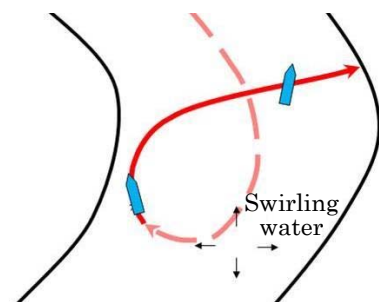
It is probable that, having been brought in an equilibrium between the pressure of strong current from upstream and the propelling force of the outboard motor, the boat moved obliquely toward a rocky area on the left bank side until the bottom of the starboard bow ran aground on a rock, to incur **port stern submergence and overturn**.

Probable causes: It is probable that this accident occurred as follows. While cruising down along the route on the river Tenryugawa, this boat deviated her course from the center to the right-hand side of the swirling water which had arisen in the water area of this accident and was forcibly turned toward upstream direction. The boatman on the stern then increased the propeller speed by the throttle of the outboard motor, to bring about equilibrium between the pressure of strong steam from upstream and the propelling force of the outboard motor. In the equilibrium, the boat could not turn her bow upstream due to the strong downstream at the left bank side but was obliged to obliquely move toward a rocky area on the left bank side and to run aground the rock. Submergence started from her port stern and the boat was overturned.
