## Chapter 2 Aircraft accident and serious incident investigations

## 2 Procedure of aircraft accident/incident investigation

## 7 Summaries of recommendations and opinions

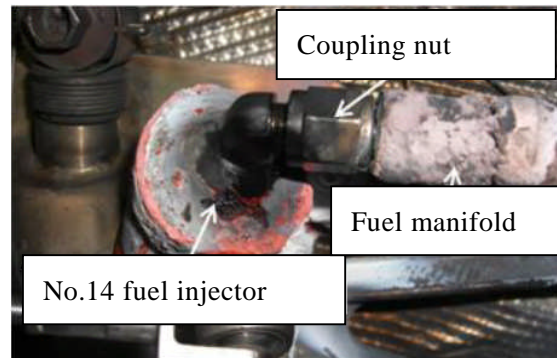
Nut area where a leak was confirmed

Wet motoring check discovered that there was a fuel leak around the coupling nut installed on the fuel manifold used to joint with No.14 fuel injector. On further detailed investigation, it was confirmed that the said coupling nut was loose. When the said coupling nut was tightened according to the specified torque, fuel leak was no longer confirmed.

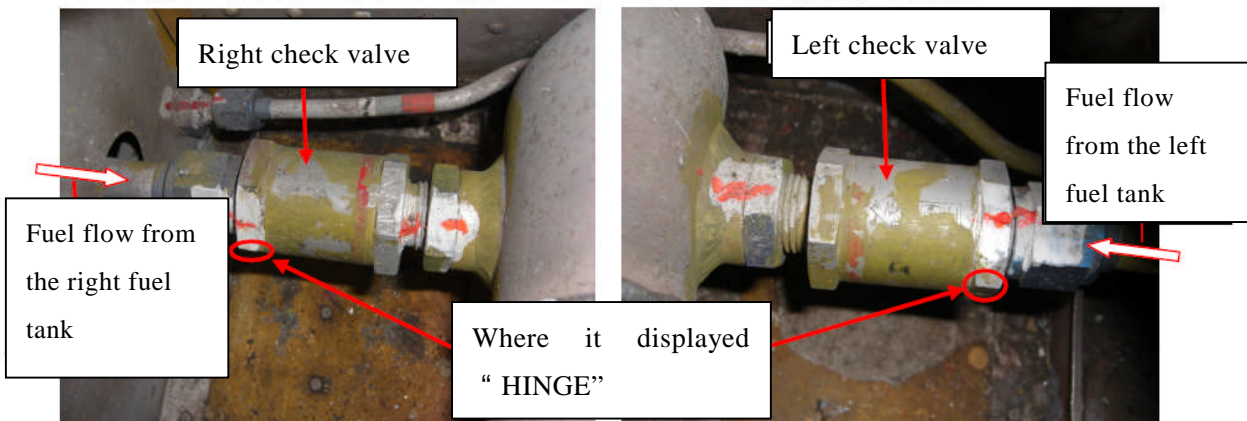
- Check valve that was actually installed (photos taken from the front)

The service manual of this aircraft states “ When installing the check valve at the exit of the fuel injection nozzle in models up to #100, install the valve so that the side which indicates ‘HINGE’ is installed on top” as a caution. However, the said check valves on the left and right were installed sideways, which were shifted by approximately 90 to 120 degrees from the specified position. Investigation to determine whether or not this matter directly affected this accident is in progress.

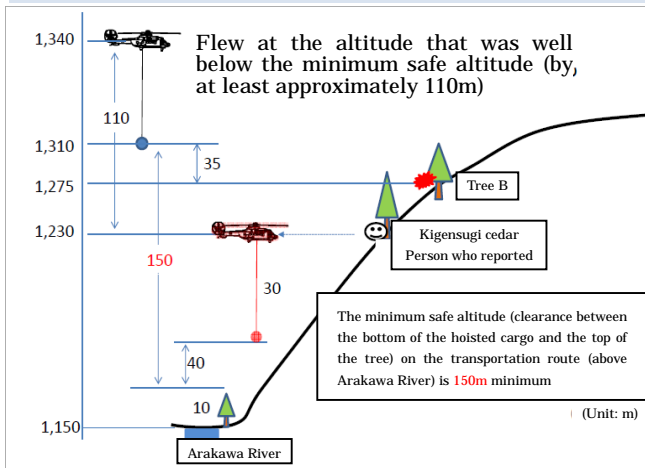
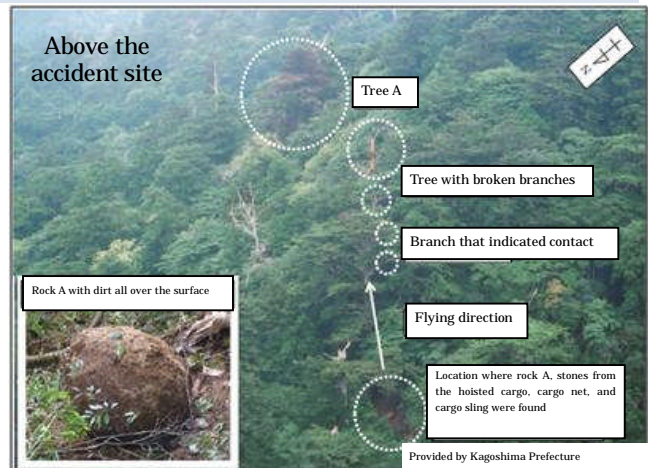
It is somewhat likely that the pilot restrained the climbing during the turn to avoid the cloud because the opening between the flying altitude and the cloud base was small when they started the left turn, despite the fact that the aircraft at the time of the accident had sufficient climbing capability could avoid collision with ground objects.

It is somewhat likely that the pilot misjudged the clearance between the bottom of the hoisted cargo and the top of the tree because it was difficult to watch left downward since the aircraft turned left, whereas the pilot was sitting on the right seat and became the turning was made, an approximately 30m long hoisted cargo.

Probable causes: In this accident, it is probable that the helicopter, while flying in the mountain valley with underslung external cargo, made a left turn to return back, crashed after nearing the slope with its underslung cargo caught in ground objects during the maneuver. The post-crash fire consumed the helicopter and the pilot and loadmaster suffered fatal injuries. The following are possible reasons why the helicopter came close to the slope during the left turn, and the underslung cargo came to be caught in ground objects: executable OGE hovering for turn-back was not carried out; en route altitude was well below Minimum Safety Altitude; the climb rate was restrained during the left turn as the clearance under the cloud base was small; and the miss judgment on clearance between the cargo and the ground objects.

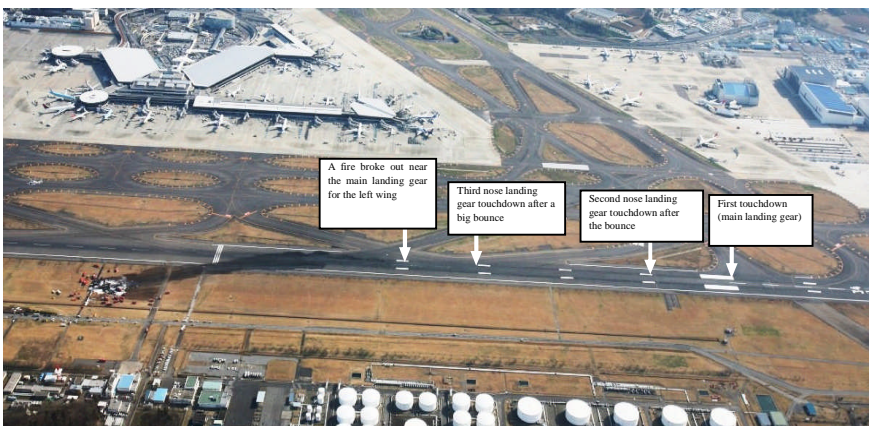
In this accident, when the airplane landed on Runway 34L at Narita International Airport, it fell into porpoising. It is highly probable that the left wing fractured as the load transferred from the left MLG to the left wing structure on the third touchdown surpassed the design limit (ultimate load).

Summary of the accident: On March 23 (Monday), 2009, about 06:49 Japan Standard, a McDonnell Douglas MD-11F, operated by Federal Express Corporation as the scheduled cargo flight FDX80, bounced repeatedly during landing on Runway 34L at Narita International Airport. During the course of bouncing, its left wing was broken and separated from the fuselage attaching point and the airplane caught fire. The airplane rolled over to the left being engulfed in flames, swerved off the runway to the left and came to rest inverted in a grass area. The Pilot in Command (PIC) and the First Officer (FO) were on board the airplane, and both of them suffered fatal injuries. The airplane was destroyed and the post-crash fire consumed most parts.

It is highly probable that the aircraft bounced after the touchdown due to the facts that it received strong ground reaction force due to the sink rate (approximately 7 fps) that was greater than usual and that the lift at the time of touchdown was great enough to bounce the aircraft (vertical acceleration rate immediately before the touchdown was approximately 1.24G)

The Federal Aviation Administration require the Boeing Company to study the possibility of design change for the MLG support structure and matters mentioned below in order to prevent the recurrence of similar accidents and minimize damage to be caused by such accidents.

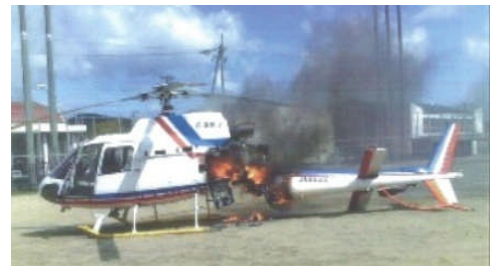
[Situation of the emergency landing]  
Flame and grey smoke came from near the rear hold, and the tail boom fell off

It is highly probable that the wiring was in contact with the cargo when the cargo was moved or stored/removed

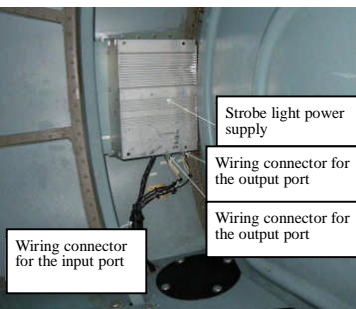
[Situation of the strobe light power supply]

This is because the wiring was not designed and structured so that it was fully protected so as to prevent it from being damaged due to the movement of cargo and to preclude the risk of a fire when it was damaged or destroyed.

The strobe light power supply (\*1) was installed behind the right side of the rear hold, and the input/output wiring extended from the device toward under the floor. However, the wiring was not protected from contacting cargo with rigid housing, etc.

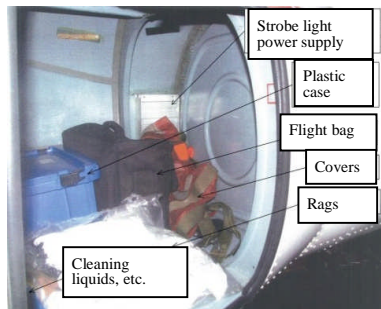
[Situation of the embarkation in the rear hold]

It is also possible that since it was not covered with nets to prevent its movement, embarkation in the rear hold damaged the wiring, which was not fully protected from damage due to the movement of the embarkation.

In this accident, it is possible that since measures were not taken to prevent the movement of embarkation in the rear hold using a floor tie-down net, the embarkation moved during the flight, and then damaged the wiring of electrical equipment in the hold, causing a fire.

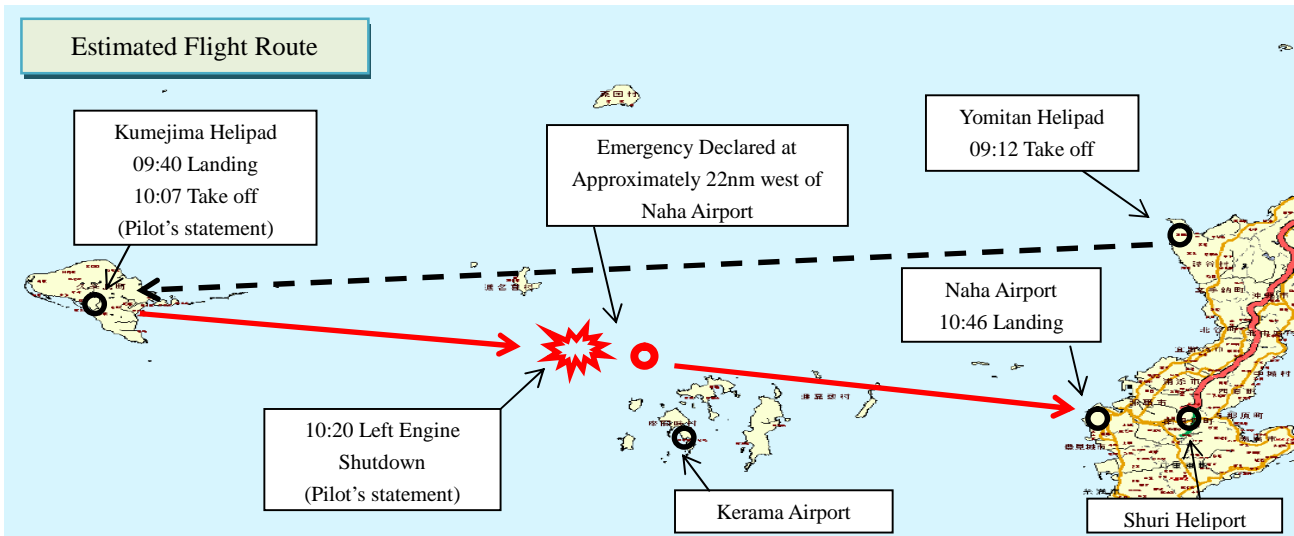
Summary of the accident: The aircraft took off from Kumejima Helipad at 10:07 Japan Standard Time on March 28, 2009 for emergency patient transportation. When the helicopter was flying over the sea enroute to Shuri Helipad on the main island of Okinawa, its left engine stopped around 10:20 at about 800 ft (about 240 m) about 6 nm (about 11 km) northwest of the Kerama Islands. It changed the destination to Naha Airport and landed there at 10:46. There were six persons on board, consisting of the pilot in command (PIC) and a mechanic, a doctor and a nurse as medical personnel, and an emergency patient and an attendant, but no one was injured. The inside of the left engine of the helicopter was destroyed, but there was no outbreak of fire. .

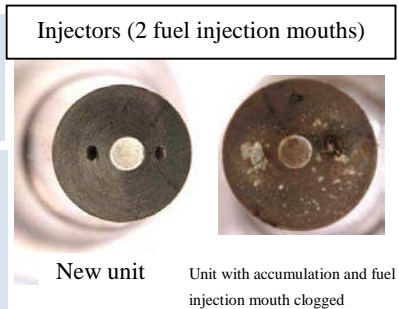
Due to the facts that salt ingredient in the accumulation on the fuel filter and injector was consistent with the ingredients of sea salt and that a trace of viscous sulfur was detected, etc., it is probable that the accumulation in the fuel filter is sea salt and that the accumulation in the injector is fungicide and sea salt.

Due to the facts that the fuel filters are filled with fuel from the fuel tank regardless of fuel pump operation and that fuel that has passed the fuel filters is injected by the injector, it is somewhat likely that sea salt that was mixed with the aircraft's fuel tank flowed with the fuel and accumulated in the fuel filters and injectors.

It is probable that the injectors located in the relatively lower part of the combustion chamber clogged because part of the fuel remaining in the fuel line (fuel that was not returned to the fuel tank) flowed into the injectors located in the relatively lower part of the combustion chamber as the air pressure in the combustion chamber decreased, and sea salt accumulated on the fungicide with increased viscosity by heat near the fuel injection mouth.

Probable causes: It is very likely that in this serious incident, the clogged injectors located relatively lower part of the left engine combustion chamber caused uneven fuel injection and combustion limited in the upper part, lead to a heat concentration to the Upper Structure resulting in engine interior damage. Sea salt accumulation on fungicide with increased viscosity by heat probably clogged the fuel nozzles. Improper use of fungicide is probable. The JTSB could not determine the route of the sea salt penetration.
