## Chapter 2 Aircraft accident and serious incident investigations

### 3 Statistics of investigations of aircraft accidents and serious incidents

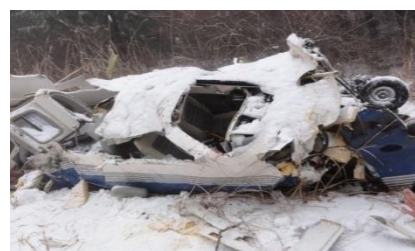
Accident Aircraft  
(At the accident site)

A privately owned Piper PA-46-350P, registered JA701M, took off from Kumamoto Airport at around 17:11 Japan Standard Time for Kitakyushu Airport and went missing on Monday, January 3, 2011. It was found on the south-southeast slope of Mt. Yago, 14 km northeast of the airport next day.

In order to prevent the accidents in in-cloud flight under Visual Flight Routes, Civil Aviation Bureau publicizes again the following contents to the pilot associations and also make them known to a pilot individual using the opportunities of the newly introduced system "Pilot Competency Assessment" (2012 MLIT Ordinance No. 22):

While Japan Civil Aviation Bureau (JCAB) has been calling attention to the items, that are required to be publicized in the recommendation, hither to (Kokukuko No. 86, dated April 20, 2002, Kokukuko No. 359, dated August 2, 2012), JCAB has decided to newly prepare a pamphlet to encourage each pilot to re-acknowledge the hazard in in-cloud VFR flight based on the recent accident cases and to publicize this by distributing the pamphlet to pilots by using the opportunities such as “Pilot Competency Assessment”, etc.

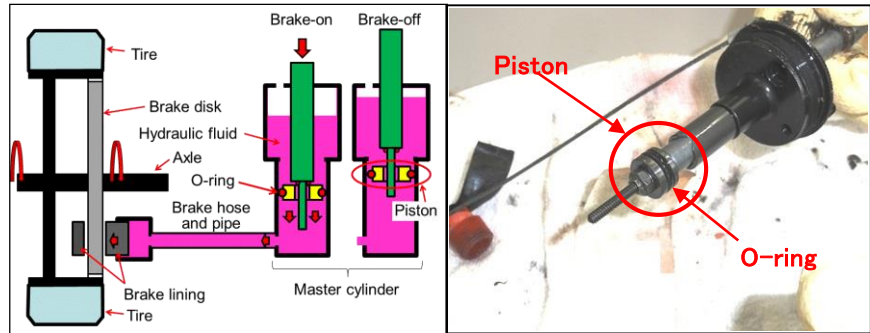
Schematic of brake system

<p>transmit the brake fluid pressure to the brake linings. It is possible that the wear of the O-ring was caused from aging deterioration.</p>		
	Recommendations	<p>Recommendations to Fuji Heavy Industries Ltd. (January 31, 2014)</p> <p>In the Fuji Heavy Industries FA-200 series aircraft, the O-ring of the master cylinder in the brake system is to be replaced if found defective when the master cylinder is disassembled and visually inspected at the 1,000hrs check. However, an O-ring tends to expand when soaked in hydraulic fluid, and in addition, the O-ring becomes hardened when pressured and may have wear or damage which is hard to recognize visually. Therefore, it is recommended to consider that the O-ring should be replaced when the master cylinder is disassembled and usable duration of the O-ring should be established.</p>		
	Report	<p><a href="http://www.mlit.go.jp/jtsb/eng-air_report/JA3689.pdf">http://www.mlit.go.jp/jtsb/eng-air_report/JA3689.pdf</a></p>

Worn O-ring

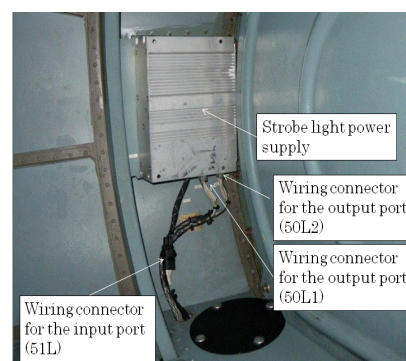
Installation of the strobe light power supply (on the type of helicopter)

This is because the wiring was not designed and structured so that it was fully protected so as to prevent it from being damaged due to the movement of embarkation and preclude a risk of occurring a fire even if it was damaged or destroyed.

It is also possible that since it was not covered with nets to prevent its movement, embarkation in the rear hold damaged the wiring, which was not fully protected from damage due to the movement of the embarkation.

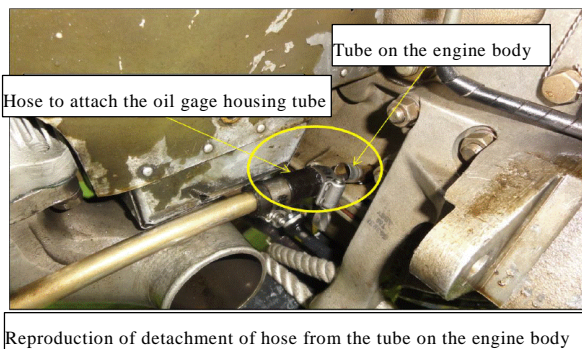
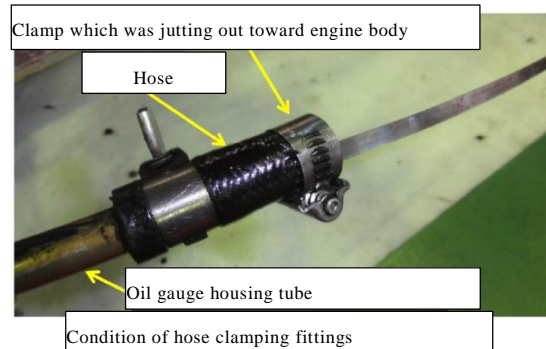
- ① Hose for the oil gauge housing tube, which is part of the oil gauge used to measure the engine oil amount, was detached from the tube on the engine body.
- ② The fitting which clamps the hose connecting the oil gauge housing tube to the tube on the engine body was out of position; therefore, the clamp jutted out toward the engine body, and the hose connection came loose.

- ① In the photo that was taken around the oil gauge housing after the serious incident, traces of oil splattering around the housing were confirmed.
- ② A test run was performed with the oil gauge housing tube detached from an engine of the same model. The results revealed leakage of oil around the housing.

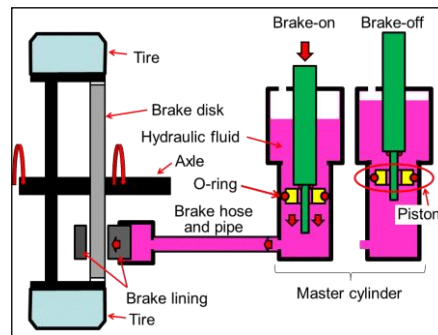
Schematic of brake system

Since the wear of a rubber-made O-ring (mounted on the piston to prevent fluid leaks) in the left master cylinder of the brake system was confirmed, it is highly probable that the left brake system became ineffective because the master cylinder could not maintain sealing capability and brake fluid pressure could not be sufficiently transmitted to the brake linings.

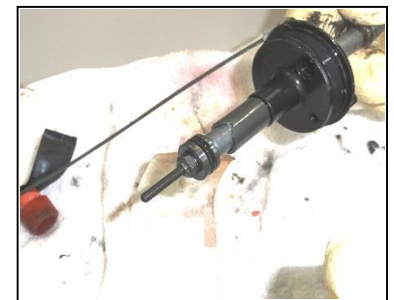
Worn O-ring

In the record of the 1,000hrs check performed on October 2011, the check mark indicating to have carried out the replacement was recorded on the check item which instructs to replace the O-ring as necessary. However, it is highly probable that the O-ring had not been replaced at the time of this check, in consideration of the fact that the O-ring of the left master cylinder was worn out enough to result in the hydraulic fluid leaks although this serious incident occurred after about a year and only about 46 flight hours since the last check, and that there is no requirement in the service manual to replace the O-ring in the case of no defect, and that there was no record of the O-ring name which is to be recorded when replaced. (Total flight time: 3,804hrs. 19min)

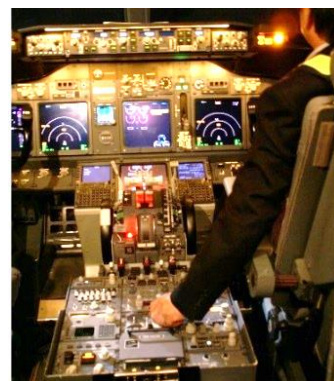
Rudder Trim SW operation

**Probable causes (Excerpt):** It is highly probable that this serious incident occurred in the following circumstances: During the flight, the FO erroneously operated the Rudder Trim SW while having an intention of operating the Door Lock Selector in order to let the PIC reenter the cockpit. The aircraft attitude became unusual beyond a threshold for maintaining the aircraft attitude under the autopilot control. The FO’s recognition of the unusual situation was delayed and his subsequent recovery operations were partially inappropriate or insufficient; therefore, the aircraft attitude became even more unusual, causing the Aircraft to lose its lifting force and went into nosedive. This led to a situation which is equivalent to “a case where aircraft operation is impeded.”

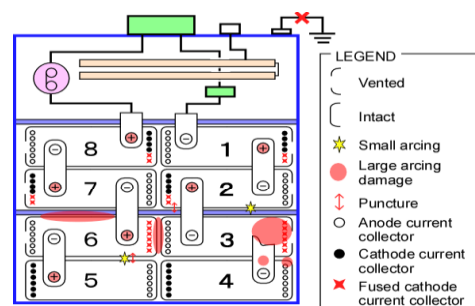
Main battery damage

Cell 6 heat generation was probably caused by internal short circuit; however, the conclusive mechanism thereof was not identified.

In the serious incident, the internal short circuit of a cell developed into cell heat generation, thermal propagation to other cells, and consequently damaged the whole battery. The possible contributing factors to the thermal propagation are that the test conducted during the developmental phase did not appropriately simulate the on-board configuration, and the effects of internal short circuit were underestimated.
