Chapter 3 Railway accident and serious incident investigations

3 Statistics for the investigations of railway accidents and serious incidents

List of published investigation reports on railway accidents (2014)

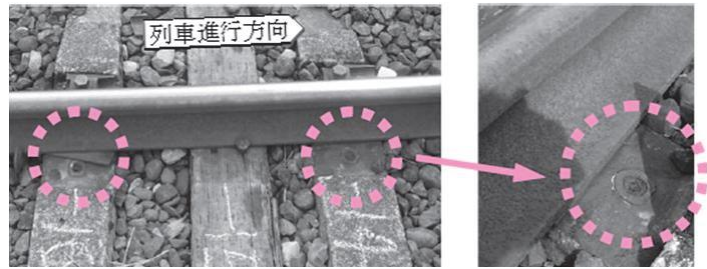
Damage of inserts of rail fasteners on PC

- (1) The looseness of the bolts of the line's rail fastening system, which was caused by repetitive lateral force under running of trains. This had not been re-fastened since the rail had been replaced two months before this accident.
- (2) The excessive shifting of track that had not been maintained. However the track irregularity was larger than allowed under the criteria for maintenance at the time of rail replacement, the rails had been in use with this situation not being addressed. Also, the result of a regular inspection on the shifting of track after the rail replacement had remained unanalyzed.

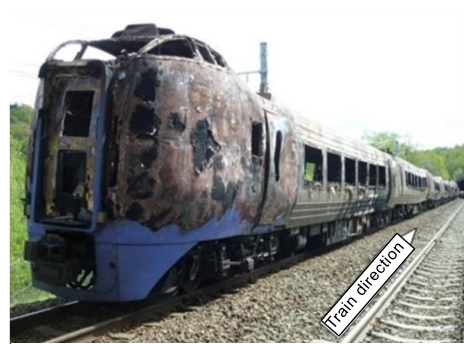
The conductor, in the conductor's compartment of the fourth vehicle of the train, running toward Seifuzan signal station, have heard an abnormal sound and have felt irregular vibration, so he notified those events to the train driver. The train

Status of the burnt cars

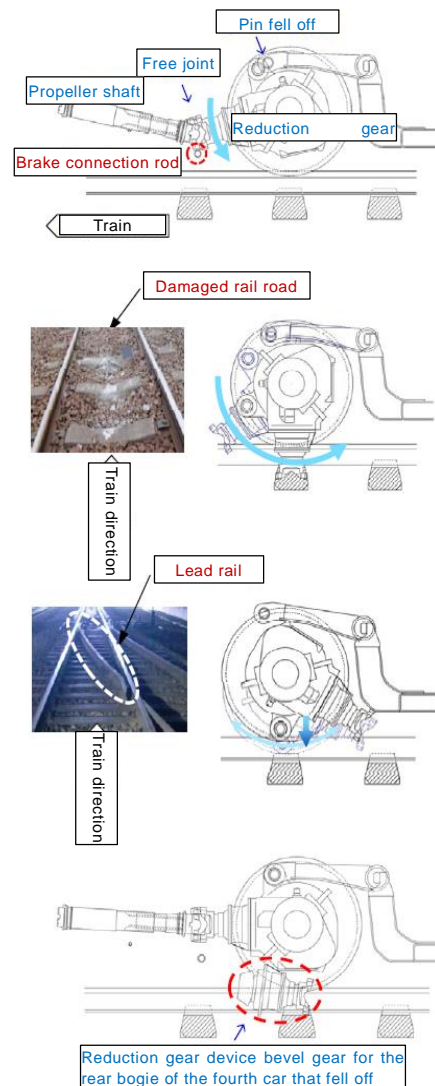
- (1) When the reduction gear device was hung down forward as rotate around the axle, the propeller shaft was also hung down. As a result, the universal joint was broken and finally the reduction gear and the propeller shaft were separated.
- (2) As the separated reduction gear device further rotated, the suspender of the reduction gear device hit the lead rail of the turnout No.12-Ro in the premises of Seifuzan signal station. At this moment, the rear bogie of the fourth vehicle was pushed to the left along the lead rail and the first axle derailed, the second axle of the rear bogie derailed following the first axle. The derailed 2 axles were restored at the turnout No.11-I.
- (3) As the rear bogie of the fifth vehicle hit the bevel gear on the track fallen off from the hanged reduction gear device, the rear bogie was pushed up and the first axle was derailed.

It is probable that the pin suspending the reduction gear device fell down following the process described below. It is also probable that these process were related with huge vibration acting on the rear bogie of the fourth vehicle, due to the circular irregularity of the tread profile of the left wheel in the first axle of the rear bogie of the fourth vehicle.

- (1) There were local wear caused by contacts with other components in the split pin which fixed the grooved hexagonal nut for the suspension pin supporting the reduction gear device, and in the stopper split pin which was inserted at the head of the suspension pin to prevent fallen out.
- (2) As the grooved hexagonal nut was loosened, the split pin inserted in the groove was exposed to the iterative tangential load and finally fell out of the groove of the hexagonal nut.
- (3) The grooved hexagonal nut loosened by missing the split pin and rotated still more until fell out.
- (4) The stopper split pin which was inserted at the head of the suspension pin fell out by the iterative tangential load from the suspension pin.
- (5) After the grooved hexagonal nut and the stopper split pin fell out, the suspension pin dropping out the reduction gear device fell out of the guide.

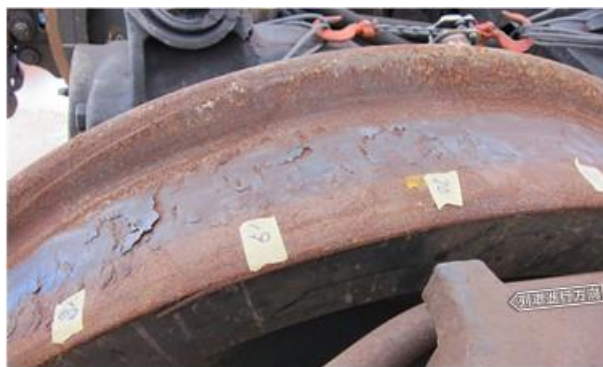
Wheel tread exfoliation condition

1. Measures taken with regard to “Establish a system to constantly check the wheels for states of tread defect and exfoliation. For example, using a procedure to record any discovered tread defects or exfoliations below the regulation value in the inspection book, which should be inspected again in order to understand how much the wheels have deteriorated.”

- (1) The vehicle planning division has made an agreement in October and December of 2013 with field managers, who are involved with car inspections and repair, regarding the promotion of activities to continue monitoring in case they find any wheel whose size of the tread defects or exfoliations is below the regulation value.

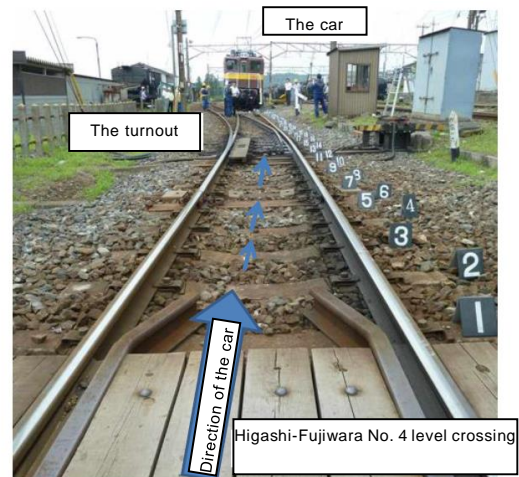
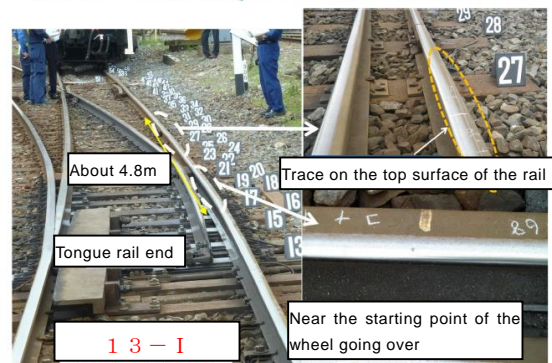
Derailment site

It is probable that the increase in the derailment coefficient is a result of the increase in lateral force, as well as a decrease in the wheel weight. This situation can be deduced from the following factors: the track was deformed in a direction that results in the reduction of the radius; the twist of the track increased so that the train leaned to the front right, and; it is probable that that the train was running with excess of cant, which was due to its low-speed. It is somewhat likely that the shift of the axle load due to the power running at an ascent was also a contributing factor.

It is probable that the decrease in the threshold derailment coefficient results from a shifting of track, which is associated with an excessive reduction of the radius, resulting in an increase in the angle of attack for the first axle of the front bogie.

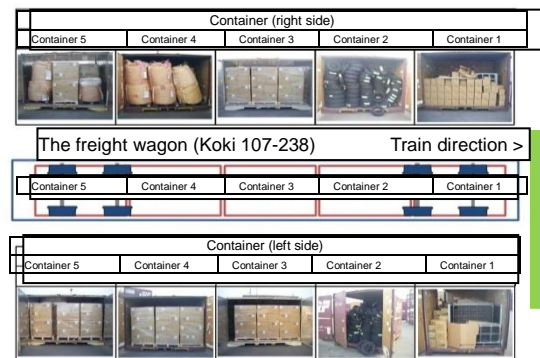
*Left side had heavier loading than the right side's.

Loading situation in container

Due to the fact that there was a relatively large combination of track alignment and cross-level (*1) before the point where the wagon climbed over the rail, it is somewhat likely that the force to roll the wagon increased the decrease of the wheel load of the outside (right) wheel, resulting in a situation in which the wagon was prone to climbing over the right rail.

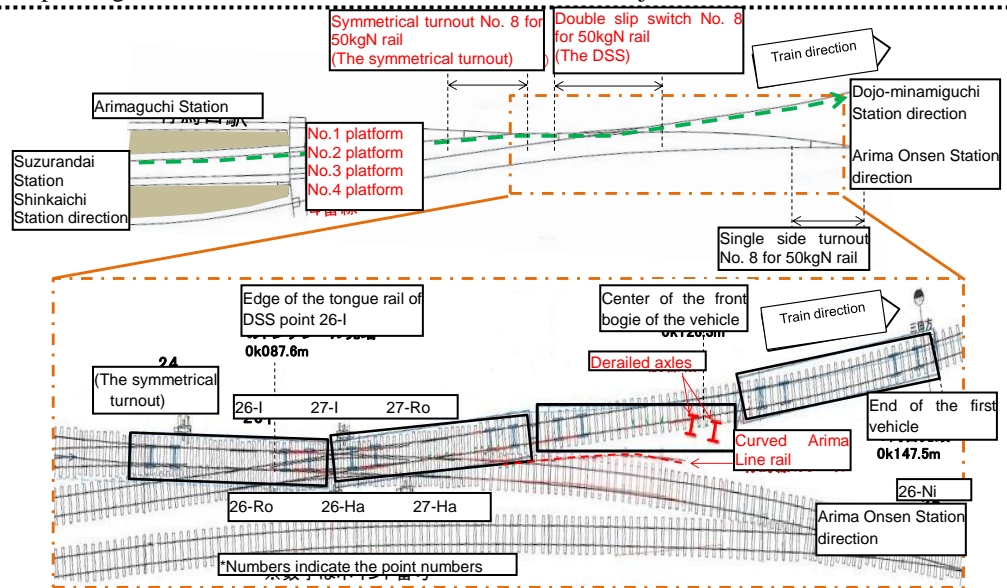
Lines and sketch of the accident site

Lateral force tends to increase on the first axle of the front bogie of the car when a train, which leaves from No.2 platform, travels, compared to when a train, which leaves from No.1 platform, travels. It is probable that the tolerance against derailment was reduced due to the fact that the vehicle was passing the S-shaped track where the shape of curvature changes in the distance between the first axle and the fourth axle, which is shorter than the length of a vehicle.

It is somewhat likely that a relatively large lateral force was easy to occur due to the facts that the double slip switch (*1) had an entrance angle (about 0.38 degrees) in the design near the Point 26-I tongue rail edge and that the track alignment based on the moving average method (*2) including the alignment in the design had changed as to decrease the radius curvature where the wheel is considered to have climbed over the rail.

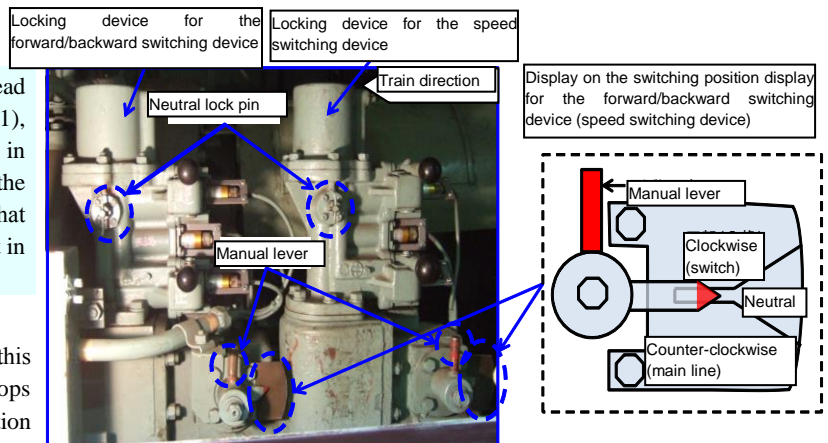
Probable causes (excerpt): It is probable that the remaining converter oil in the torque converter was ignited by the high temperature fragments etc. of the converter which was broken and heated by missing cooling function of the converter because the coolant was drained, and the first stage converter rotated while the deadhead diesel locomotive were running, because the “neutral lock” of the forward/backward switching device was not correctly performed when a diesel locomotive was hauled as the deadhead operation without powering.

The locking device for the forward/backward switching device and the high speed/low speed switching device

Under normal circumstances, the converter is cooled by the coolant that is circulated by the engine. However, the coolant was drained due to the fact that this was in the deadhead operation without powering. Due to this, it is probable that the remaining converter oil (oil used to conduct power) in the torque converter was ignited by the high temperature fragments etc. of the converter which was broken and heated by missing cooling function of the converter.

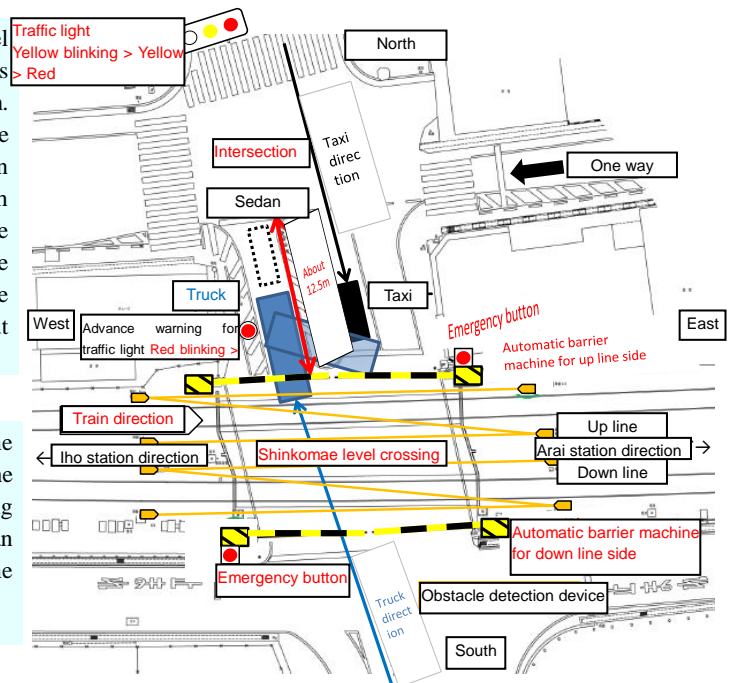
Sketch of the area near the level crossing

It is probable that the truck driver left the rear portion of the truck inside of the level crossing due to the fact that he entered the truck inside of the level crossing without pausing before the level crossing, without thinking that the sedan ahead of his truck might stop at the intersection; because he was not familiar with the road circumstances.

It is probable that the truck driver was trying to move forward with the stretch board lowered in order to avoid colliding with the train. However, it is somewhat likely that the train became derailed because the wheels of the first axle of the front bogie of the train's first car climbed over the stretch board due to the fact that the stretch board was lowered.

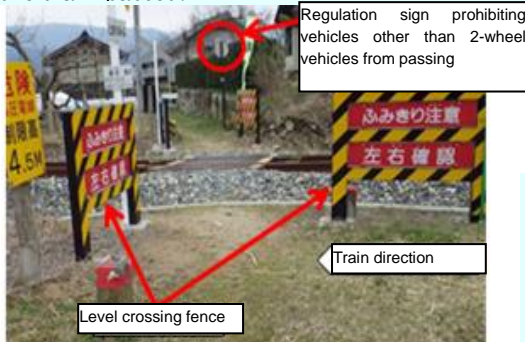
Level crossing from where
the tractor entered

When carts, etc. passed the level crossing, two people were always involved, and one of them checked for approaching trains by using the alarm sound, etc. of the nearby Zakoji level crossing, etc. However, due to the fact that the driver was crossing the level crossing without paying attention to the time when the train passes the level crossing, it is somewhat likely that the driver was not aware of the time when the train passed.

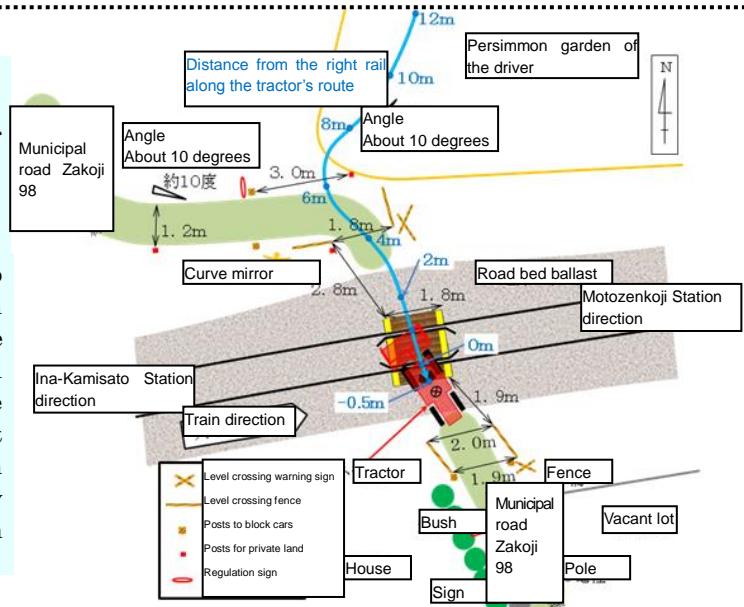
Sketch of the accident site

It is somewhat likely that the driver did not use the road that connected to the level crossing due to the following reasons. The road was an unpaved and narrow (minimum width of about 1.2m) embankment, and it was difficult to drive with the tractor. It was not possible to enter with a truck to transport products, etc. It was also a longer route to the garden on the other side of the track. Due to this, the driver chose the route to pass the level crossing, where he normally passed carts, and passed the level crossing with the tractor.
