ANNUAL REPORT 2015

Japan Transport Safety Board

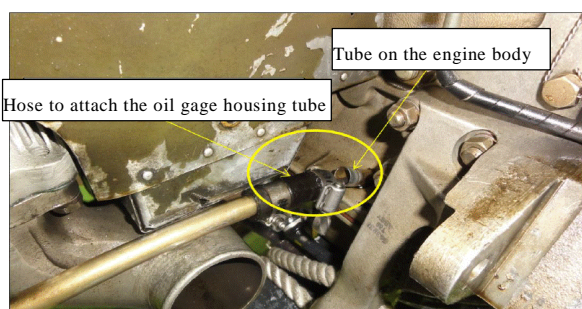
- ① Hose for the oil gauge housing tube, which is part of the oil gauge used to measure the engine oil amount, was detached from the tube on the engine body.
- ② The fitting which clamps the hose connecting the oil gauge housing tube to the tube on the engine body was out of position; therefore, the clamp juttied out toward the engine body, and the hose connection came loose.

Reproduction of detachment of hose from the tube on the engine body

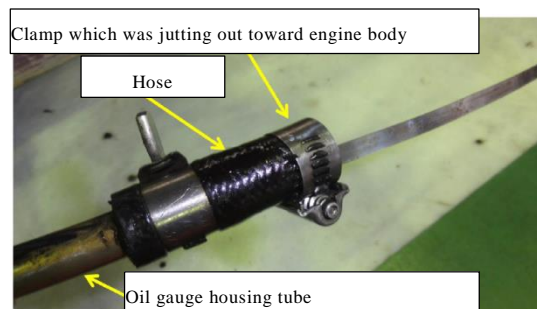
Condition of hose clamping fittings

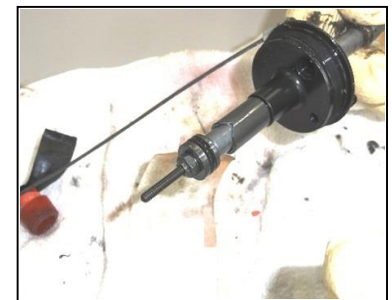
transmit the brake fluid pressure to the brake linings. It is possible that the wear of the O-ring was caused from aging deterioration.		
	Recommendations	Recommendations to Fuji Heavy Industries Ltd. (January 31, 2014) In the Fuji Heavy Industries FA-200 series aircraft, the O-ring of the master cylinder in the brake system is to be replaced if found defective when the master cylinder is disassembled and visually inspected at the 1,000hrs check. However, an O-ring tends to expand when soaked in hydraulic fluid, and in addition, the O-ring becomes hardened when pressured and may have wear or damage which is hard to recognize visually. Therefore, it is recommended to consider that the O-ring should be replaced when the master cylinder is disassembled and usable duration of the O-ring should be established.		
	Report	http://www.mlit.go.jp/jtsb/eng-air_report/JA3689.pdf		
2	Date of publication	Date and location	Operator	Aircraft registration number and aircraft type

Worn O-ring

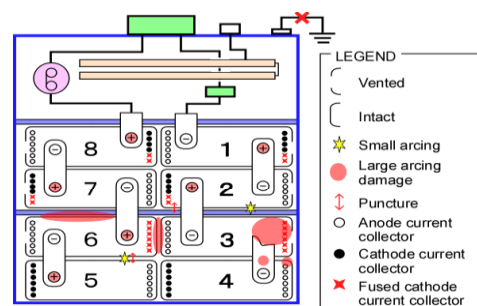
Main battery damage

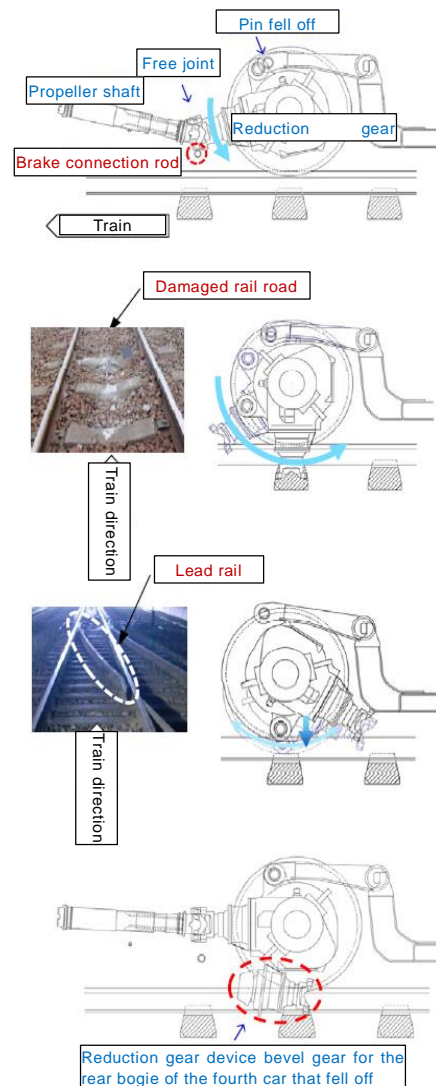
It is probable that the pin suspending the reduction gear device fell down following the process described below. It is also probable that these process were related with huge vibration acting on the rear bogie of the fourth vehicle, due to the circular irregularity of the tread profile of the left wheel in the first axle of the rear bogie of the fourth vehicle.
