## Chapter 5 Marine accident and incident investigations

## 11 Summaries of major marine accident investigation reports (case studies)

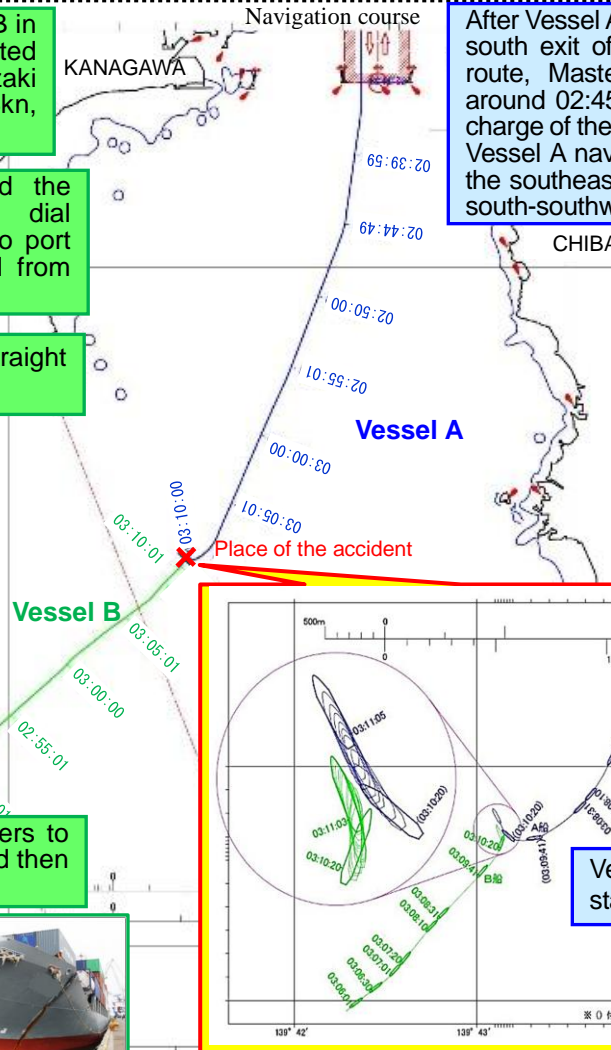
Navigation course

Vessel B, with 2/O B and A/B B in charge of bridge watch, navigated off to the southeast of Tsurugizaki by autopilot at about 13kn, heading northeast.

On Vessel B, 2/O B turned the autopilot course setting dial counterclockwise and turned to port at a distance of about 1.66M from Vessel A at around 03:06:30.

Vessel B was proceeding straight from 03:08:10 to 03:09:31.

On Vessel B, 2/O B noticed that Vessel A, having approached at around 0.5M on the starboard bow, was turning to starboard, so ordered A/B B to turn 20° to port and flashed a daylight signaling light twice to Vessel A, whereupon Vessel B turned to port at a distance of about 0.32M from Vessel A at around 03:09:41.

**Probable Causes:** It is probable that the accident occurred because, when Vessel A was navigating in south-southwest direction and Vessel B was navigating in northeast direction at night and the both ships came closer to each other, Vessel A turned to starboard, Vessel B turned to port and kept proceeding straight, and the both ships collided with each other.

It is probable that Vessel B kept proceeding straight because, after Vessel B turned to port for passing by Vessel A on the starboard side, 2/O B of Vessel B did not conduct look-out properly and hence could not notice that Vessel A in the starboard ahead turned to starboard.

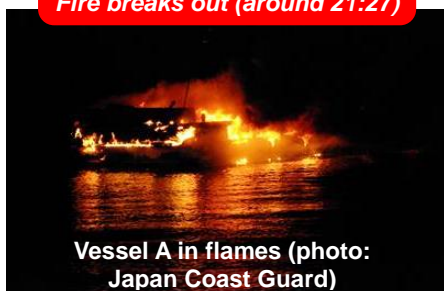
The cabin became filled with white smoke and flames rose up on the outside of the starboard central partition.

Vessel A in flames (photo: Japan Coast Guard)

It is somewhat likely that the fire started as a result of contact between gasoline or similar spurting from pressurized pipes and the exhaust system piping of the starboard main engine, which had grown hot, or of a short circuit, power leakage or other such problem in power cables of the power circuit that were hung near the ceiling of the starboard partition in the engine room. However, the source of the fire on the starboard side of the engine room could not be clarified.

It is somewhat likely that the fire that started in the engine room spread to the rest of the vessel because a ventilator fan was working and fresh air was continuously fed inside the engine room as a result.

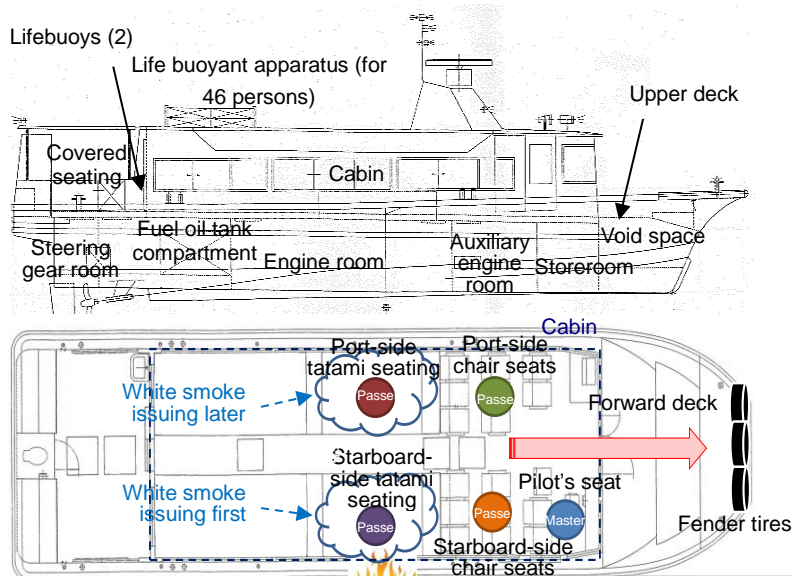
Structures on the upper deck caught fire, and although a Japan Coast Guard patrol boat discharged firefighting water, the fire was not extinguished, and at around 23:55 the vessel sank in the sea off to the southwest of Oge Port.

The skipper and three passengers evacuated to the forward deck and jumped into the sea without putting on life jackets.

The fourth passenger clung on to the chain linking the fender tires at the front of the bow, and awaited rescue while immersed in seawater up to the knee.

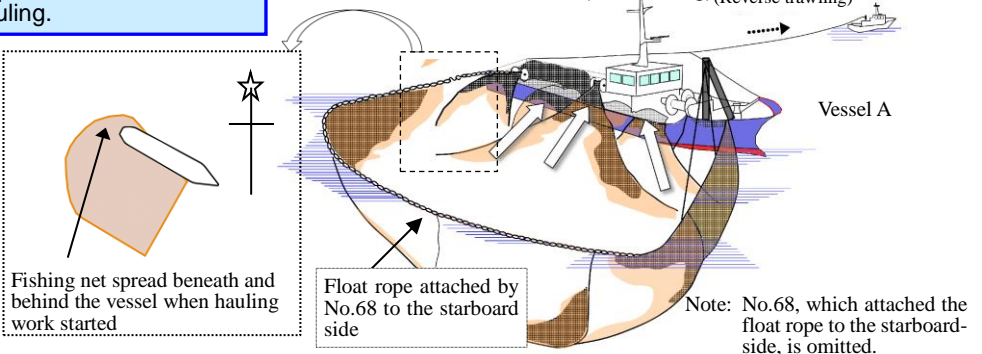
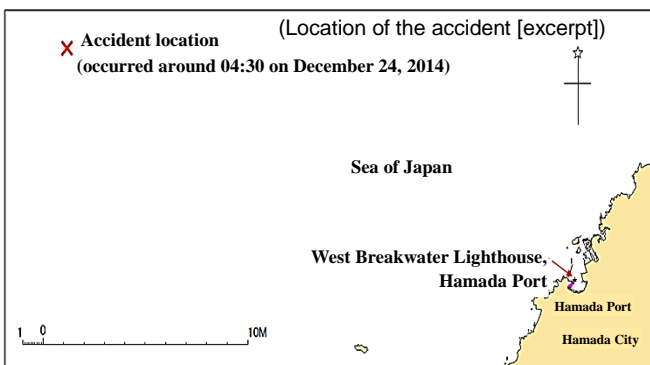
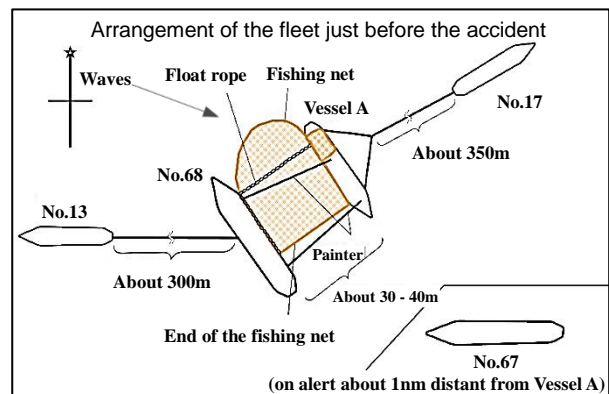
Fishing net spread beneath and behind the vessel when hauling work started

Situation of Vessel A and the fishing net while being hauled from starboard (side-hauling) (Reverse trawling) No.17

- Without filling its port-side ballast tank with seawater, Vessel A took up a position in which it encountered waves from the stern, then started the work of side-hauling while being connected to No.68 by a painter rope on the starboard side with the fishing net in between, and pulled by a rope by No.17 on the port side.

**Probable causes:** It is probable that this accident occurred because, while Vessel A was engaged in the work of hauling in a purse seine fishing net from the starboard side off to the west-northwest of Hamada Port at night under a wave height of about 2.0-2.5m, while being pulled by a rope by a lighting ship on the port side, it fell into a state of diminished stability combined with impact from external heeling moment, causing the starboard list to increase and the vessel to capsize.

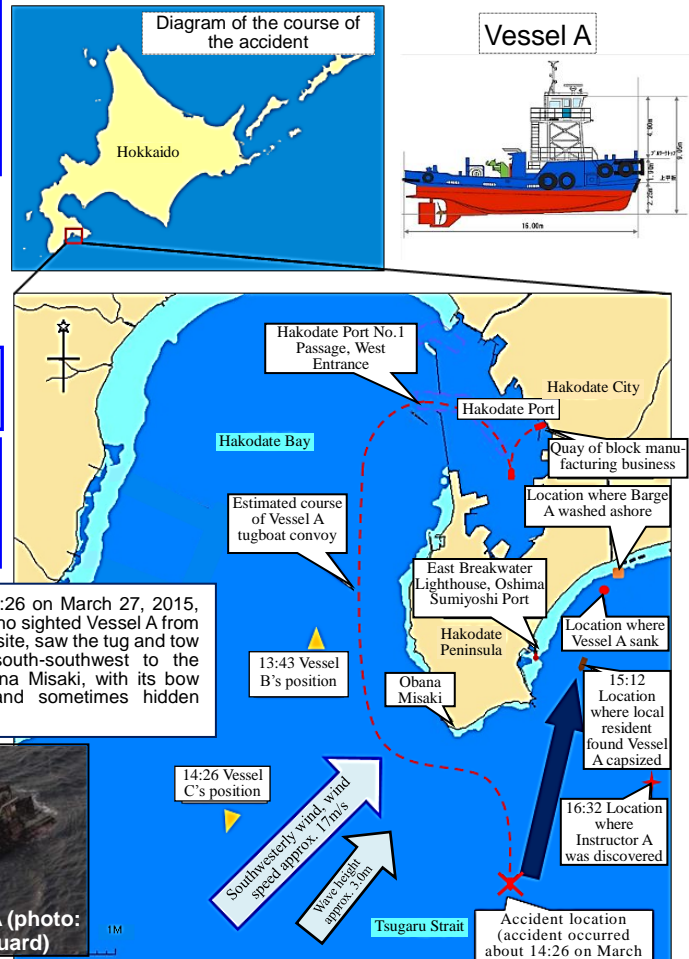
At around 14:18 and 14:26 on March 27, 2015, an officer of Vessel C, who sighted Vessel A from the west of the accident site, saw the tug and tow proceeding south to south-southwest to the south-southeast of Obana Misaki, with its bow covered with waves and sometimes hidden behind waves.

- It is probable that the positional relationship between Vessel A and Barge A would cause a situation of being pulled sideways when in a state of swinging around at ship speeds of 4kn and 5kn.

- In situations where a towed barge causes a swinging motion at a speed of 4kn and wave encounter angle of 20° or a speed of 5kn and an encounter angle of 30°, it is probable that, though not immediately leading to capsizing, the maximum angle of heel to port in Vessel A would be larger than the maximum angle of stability and would exceed the angle of bulwark top immersion of 17.3°, even when taking into account the steady heel angle due to topline tension and wind as well as rolling due to waves.

**Probable causes:** It is somewhat likely that this accident occurred because Vessel A departed from Hakodate Port under conditions in which a gale warning had been issued for the Tsugaru Strait and a gale and high waves advisory for Hakodate City, then formed the tug and tow and started navigating toward Ishinomaki Port, but while it was proceeding south to south-southwest about 1-3M to the south-southeast of Obana Misaki, Vessel A became subjected to compound external force and became pulled sideways, the port-side heel angle became larger than the maximum angle of stability, stability was reduced and the bulwark was submerged in the sea, as a result of which resistance from the bulwark made it difficult to stabilize, the vessel continued to be subjected to waves and capsized to port.

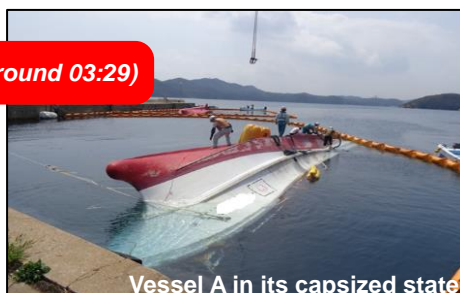
Seawater washing in from the stern of Vessel A flowed in through the sliding door that had been left open for ventilation, pushed through the closed door to the engine room and flowed into the engine room, and at around 03:10 the main engine stopped. Seawater repeatedly washed in, the Vessel A slowly listed to port and the bulwark top was submerged at around 03:20, the stability could not be restored and the vessel capsized.

Vessel A in its capsized state

**Probable causes:** It is probable that this accident occurred because, while Vessel A was drifting on a parachute sea anchor off to the east of Kamijima at night while subject to a south wind blowing at a speed of about 20-30m/s and waves from the east with a height of about 3m, under conditions in which a gale advisory and thunderstorm advisory with the addition of tornadoes had been issued for the Kami-Tsushima and Shimo-Tsushima districts, seawater washing in from the stern flowed into the engine room because the sliding door on the stern side of the galley that served as an entrance to the crew quarters had been left open, the vessel listed to port and the bulwark top was submerged, the vessel lost its stability and capsized.

It is probable that the sliding door on the stern side of the galley that served as an entrance to the crew quarters had been left open because the crew members did not think the weather would deteriorate and were ventilating the crew quarters as usual.
