Chapter 4 Railway accident and serious incident investigations

2 Procedure of railway accident/incident investigation

3 Statistics of investigations of railway accidents and serious incidents

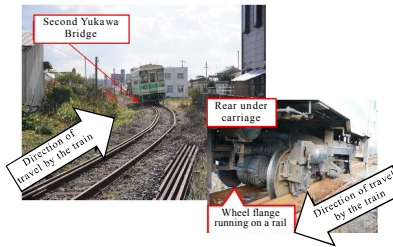
| | Summary | While the train was running approx. 500m ahead from Gobo station, the driver of the train heard abnormal sounds a number of times from under the floor of the vehicle and applied the emergency brake to bring the train to a halt. The driver got off the train and checked, finding all axels in the rear bogie of the vehicle derailed to right. While five passengers and the driver were aboard the train, none of them were injured. | |

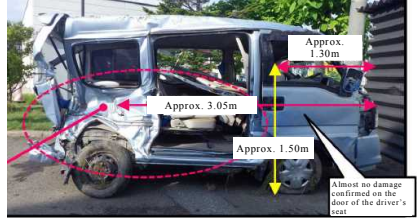
| <p>Summary</p> | <p>While the train was running between Tsugaru-Iizume station and Bishamon station, the driver of the train noticed a light motor vehicle entering to Goshogawara Kiten 6k100m level crossing, class four level crossing, and applied an emergency brake immediately, but the train collided with the light motor vehicle.</p> <p>The driver of the light motor vehicle was dead in the accident.</p> | | | |
| <p>Probable Causes</p> | <p>It is highly probable that the accident had occurred as the train collided with a light motor vehicle, because the light motor vehicle entered to Goshogawara Kiten 6k100m level crossing, class four level crossing, in the situation that the train was approaching.</p> <p>It could not be determined why the light motor vehicle entered to the level crossing in the situation that the train was approaching, because the driver of the light motor vehicle was dead in the accident.</p> <p>However, it is somewhat likely that the poor visibility in the direction of the approaching train due to the copse beside the track was related to obstructing sufficient confirmation of safety in right and left direction by the driver of the light motor vehicle just before the level crossing.</p> <p>Also, it is somewhat likely that the rainy weather when the accident had occurred and the upward steep slope just before the level crossing in right curved road between fields were related to declining attention to the approaching train of the driver of the light motor vehicle.</p> | | | |

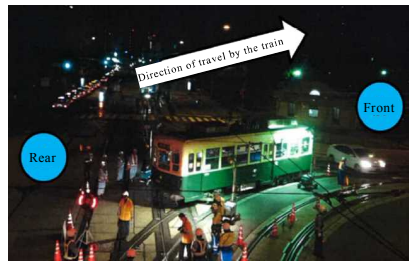
| <p>Summary</p> | <p>While the vehicle was passing the right curved branch line for Nagasaki Eki-Mae tram stop, in the turnout at Kokaido-Mae intersection, the driver of the vehicle felt abnormal situation as if the vehicle was heaved up accompanied with abnormal sound, then the driver applied an emergency brake and stopped the vehicle. The driver got off the vehicle to check the situation, and found that all two axles in the rear bogie were derailed to left of rail.</p> <p>There were a passenger and the driver onboard the vehicle, but there was no casualty. The accident site was in the intersection of the road together with tramway, but the derailed vehicle did not contact nor collide with automobiles, etc., before and after the derailment.</p> | | | |

| | Probable Causes | <p>It is probable that the accident had occurred as the vehicle running right curve in the turnout in the intersection, as the backside of right wheel of the first axle of the rear bogie had been contacting with the side surface of the portion which had the function of guard rail in the diamond crossing, the back side of right wheel climbed up around the tip of the nose rail and started derailment, and after the wheel flange ran on the upper part of the side surface of the portion, the left wheel of the axle ran onto the left rail and the axle derailed to left, then followed the derailments of the second axle in the rear bogie to left.</p> <p>It is probable that the right wheel of the first axle in the rear bogie ran onto the rail and derailed caused by the effects of increased lateral force acting on backside of the wheel due to the abrupt contact of the wheel and the deformed tip of the nose rail, and decreased contact angle between backside of the wheel and the deformed tip of the nose rail.</p> <p>It is probable that the tip of nose rail was deformed by the repeating shocks by backside of right wheels of the front axle of bogies of plural vehicles, acting on the tip of the nose rail in the state of being easily deformed, caused by the effects of the lowered height of the tip of the nose rail by the design modification, in the diamond crossing existed in very small radius curve where wheels always contact with tip of the nose rail structurally.</p> | | |

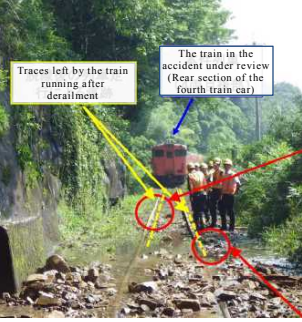
| | <p>Summary</p> | <p>The train departed from Nishi-Miyoshi station on schedule. The driver of the train, while driving the train in powering operation at about 70 km/h, noticed the earth and sand disturbing the front track near the exit of Aoga tunnel, and applied an emergency brake, but the train ran onto the earth and sand containing cluster of rocks, and stopped the train. It was found that the second axle in the front bogie and the second axle in the rear bogie of the first vehicle were derailed to right, by the check implemented after the train had stopped. There were 24 passengers, 2 train crews, i.e., the driver and the conductor, and a facility maintenance staff onboard the train, but there was no casualty.</p> | | |
| | <p>Probable Causes</p> | <p>It is highly probable that the train was derailed because the train hit and ran onto earth and sand containing cluster of rocks flowed into the track, which were transported by the water flowed from swamp in the slope above the longitudinal drain in left side of the track, and overflowed the longitudinal drain, in the accident. It is probable that earth and sand overflowed the longitudinal drain because the inlet of the longitudinal drain was filled up by the earth and sand, that were transformed from the eroded sediments in the riverbed of downstream of the swamp and transported to upper part of the longitudinal drain, when the rain water by the local heavy rain around the accident site flowed downward along the swamp.</p> | | |

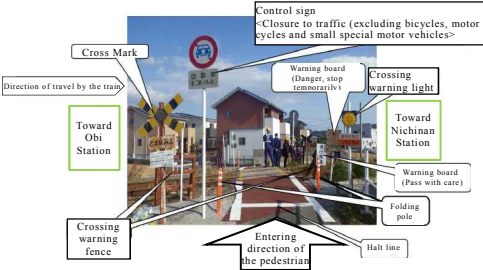
| | <p>Summary</p> | <p>While the train was running between Obi station and Nichinan station, the driver of the train noticed a pedestrian went into Tekkosho level crossing, class four level crossing, then applied an emergency brake immediately, but the train hit the pedestrian. The pedestrian was dead in the accident.</p> | | |
| | <p>Probable Causes</p> | <p>It is highly probable that the accident had occurred as the train hit a pedestrian, because the pedestrian went into Tekkosho level crossing, class four level crossing without automatic barrier machine nor road warning device, in the situation that the train was approaching. It could not be determined why the pedestrian went into the level crossing in the situation that the train was approaching, because the pedestrian was dead in the accident.</p> | | |

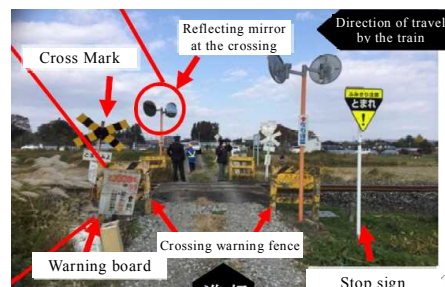
| | Summary | <p>While the train was running between Nakagomi station and Otabe station, the driver of the train noticed a pedestrian staying in Number 2 Shinmachi level crossing, class three level crossing, and then sound a whistle and applied an emergency brake immediately, but the train hit the pedestrian.</p> <p>The pedestrian was dead in the accident.</p> | | |

| | Probable Causes | <p>It is probable that the accident had occurred as the train hit a pedestrian, because the pedestrian went into Number 2 Shinmachi level crossing, class three level crossing equipped with road warning device, in the situation that the road warning device was in warning operation.</p> <p>It is somewhat likely that the pedestrian entered to the level crossing where the road warning device was in warning operation, related with the deterioration of hearing ability of both ears of the pedestrian.</p> <p>In addition, it is somewhat likely that the pedestrian could not recognize red flash lights when the pedestrian went into the level crossing, but it could not be determined the precise situations because the pedestrian was dead in the accident.</p> | | |

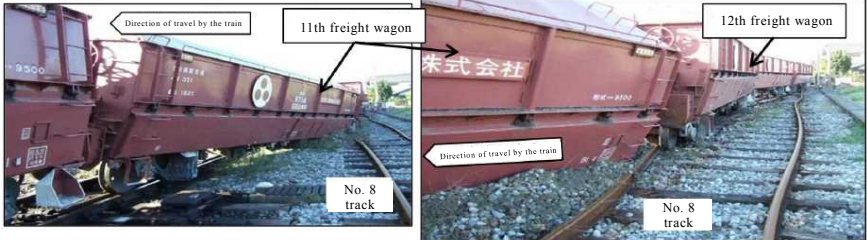
| <p>Summary</p> | <p>The driver of the train, while the train was running before reaching Mino-Akasaka station, felt that the velocity decelerated quickly than as usual, then he checked backward of the train and found that the freight wagons were tilted. The driver applied an emergency brake immediately to stop the train.</p> <p>The driver checked the train and found that freight wagons were derailed, then he communicate with the related staffs such as the station master of Mino-Akasaka station, etc. Station master of Mino-Akasaka station checked the status of the accident site, and found that all 2 axles in the rear bogie of 11th freight wagon and all 4 axles of 12th freight wagon were derailed to left.</p> <p>There were the driver, the station staff and 2 yard guidance staffs onboard the diesel locomotive, but there was no casualty</p> |
| <p>Probable Causes</p> | <p>It is probable that the accident had occurred as the right wheel of the front axle in the front bogie of the 12th freight wagon derailed to inside of track, and after running as widening gauge, left wheel of the axle climbed up left rail and derailed, then the front and rear axles in the rear bogie of the 11th freight wagon and the rear axle in the front bogie and front and rear axles in the rear bogie of the 12th freight wagon were derailed, while the train was running in right curved track of 201 m radius.</p> <p>It is somewhat likely that the right wheel of the front axle in the front bogie of the 12th vehicle derailed inside the track, because the right wheel of the front axle in the front bogie came out of the inside rail, i.e., right rail, and dropped, as the irregularity of gauge was widened by running trains, by the weakened support force of rail due to the deteriorated sleepers and the floated loosed rail spikes existed continuously, in addition to wider irregularity of gauge.</p> <p>It is probable that the larger irregularity of gauge and enlarged irregularity of gauge due to passage of trains were related with the lack of the definite management standard to implement proper maintenance about irregularity of gauge, and understanding of maintained status about rail flow, sleepers, rail spikes etc., and the maintenance based on the understandings were not implemented well.</p> |

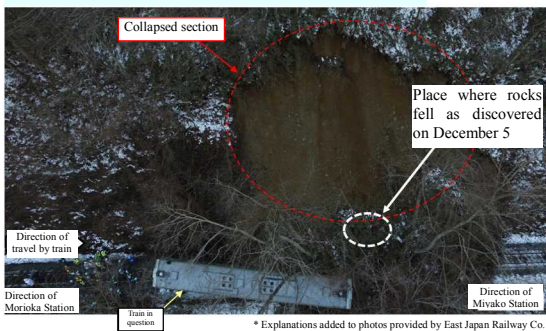
It is somewhat likely that rainwater, etc. permeated into the slope due to stoppage of rainfall and snow melting and made the surface of the slope heavier.

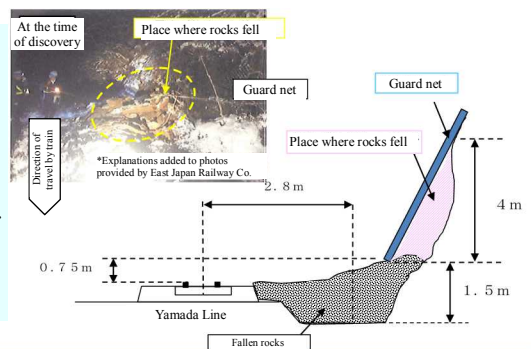
On December 5, 2015, before the accident, rocks used to reinforce the slope fell under the guard net placed over the collapsed section of the slope.

It is somewhat likely that rocks fell in a situation almost identical with the collapse of the slope. It is also somewhat likely that the phenomenon was a predictor of the collapse of the slope.

Probable Causes: It is highly probable that the accident had occurred as the train was derailed by hit and ran onto the fallen trees or earth and sand, etc., flowed into railway track due to the collapse of the slope in track side.

It is somewhat likely that the slope collapsed by the increased weight of the surface layer of the slope due to rainfall and melting snow, where the surface layer of the slope had been unstable by the steep slope and weathering.

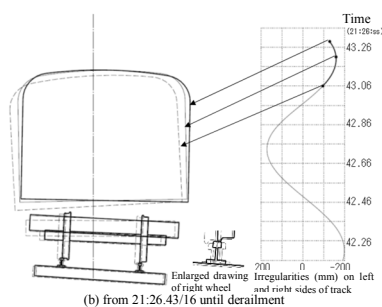
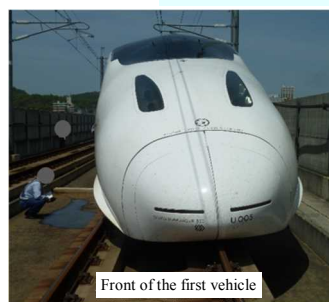
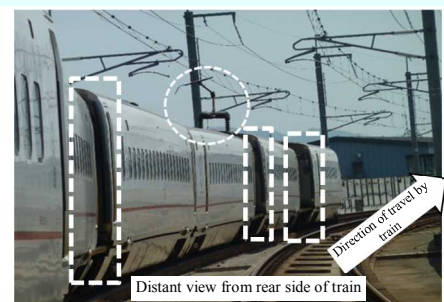
It is probable that vehicles derailed on both the left and right sides of the direction of travel because structural differences in the positions of individual vehicles running on the viaduct at the same time caused moderate differences in the vibrations each vehicle received from the track so that each vehicle showed different movements.

Probable Causes: It is probable that the accident occurred as the train was derailed due to being acted by the ground motion of the earthquake occurred on about 21:26, April 14, 2016, which was one of the 2016 Kumamoto Earthquakes. As for the process to the derailment, it is probable that many axles were derailed almost the same timing, because each vehicle in the train rolled significantly and wheel flanges of left or right wheels jumped on the rail, due to the amplified rolling motion in the frequency range to promote rolling of vehicles acted in the structures, in addition to the violent shakes in lateral direction to the track acted on just under the structure around the accident site, caused by the amplified ground motion.

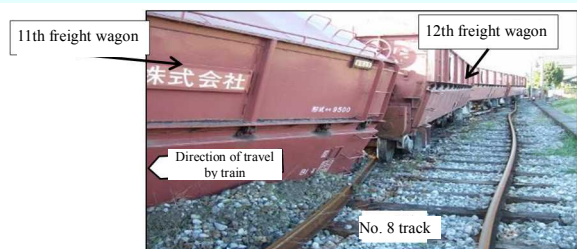
"Flaw" in the circle means "rail flaw."

Probable Causes (excerpt): It is probable that the accident had occurred as the right wheel of the front axle in the front bogie of the 12th freight wagon derailed to inside of track, and after running as widening gauge, left wheel of the axle climbed up left rail and derailed, then the front and rear axles in the rear bogie of the 11th freight wagon and the rear axle in the front bogie and front and rear axles in the rear bogie of the 12th freight wagon were derailed, while the train was running in right curved track of 201 m radius.

It is somewhat likely that the right wheel of the front axle in the front bogie of the 12th vehicle derailed inside the track, because the right wheel of the front axle in the front bogie came out of the inside rail, i.e., right rail, and dropped, as the irregularity of gauge was widened by running trains, by the weakened support force of rail due to the deteriorated sleepers and the floated loosed rail spikes existed continuously, in addition to wider irregularity of gauge.

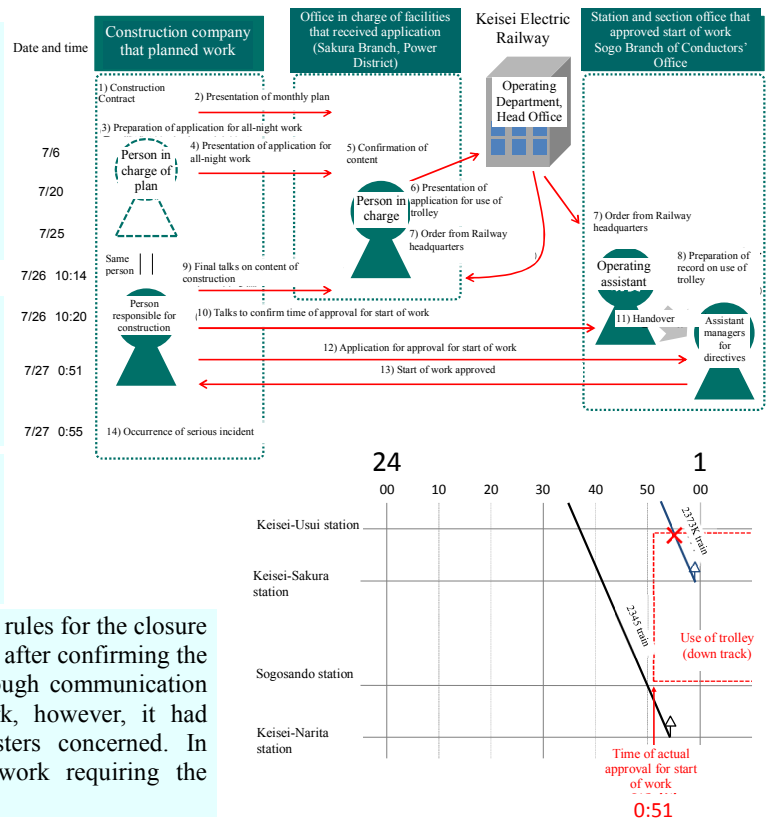
According to Keisei Electric Railway Co., Ltd.'s rules for the closure of tracks, approval for the start of work is issued after confirming the absence of trains in a closed track section through communication with stationmasters concerned. In actual work, however, it had become customary not to inform stationmasters concerned. In addition, there had been little closed-track work requiring the confirmation of multiple trains.

The company has rules banning the entry of any train, etc. into a closed track section. In the implementation of the rules, however, it is highly probable that the ban on entry of any train, etc. into a closed track section was effectuated only by confirming the presence of no train, etc. in the closed section after the end of operations in the section. As judging the end of train services in this method exclusively relies on confirmation by stationmasters concerned, it is highly probable that the entry of a train into a closed section was possible in case of an error in confirmation by any stationmaster. It is probable that this kind of handling by the company was inadequate in preventing any train from entering a closed section.

Probable Causes (excerpt): It is highly probable that the serious incident had occurred as the 2373K train ran into the closed track section after the approval of the track closing work that should be implemented to stop train operation, because the request to start the work was approved without confirmed arrival of the 2373K train at Keisei-Sakura station, the last train bound for Keisei-Sakura station.
