Japan Transport Safety Board

Annual Report

2020

July, 2020

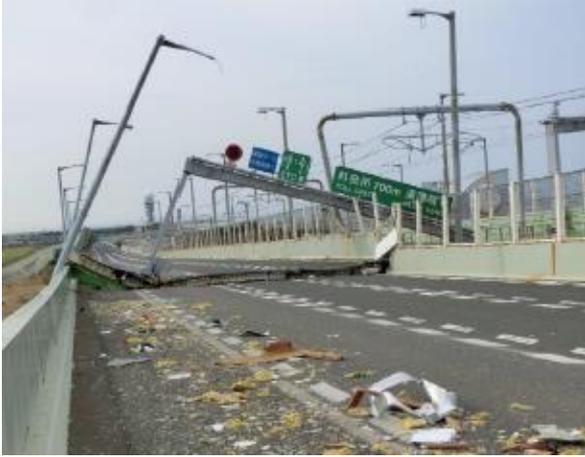
Damage to the bridge at Kansai International Airport Access Bridge

HOUNMARU caused the deck of the starboard bow to be crushed, and Kansai International Airport Access Bridge caused the bridge of the road girder to be bent, broken, scratched, etc., the railway girder to be collapsed, the rail to be warped, the gas pipe to be broken, etc., but there were no casualties among the crew members.

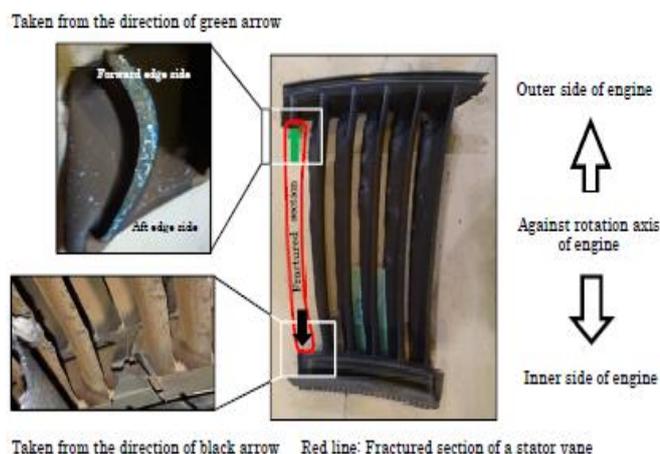
Besides, in the investigation of the serious incident that the engine of a passenger aircraft (Boeing 777-300ER) was damaged (see page 53), which was published in the report on October 31, 2019, the National Institute for Materials Science (NIMS) analyzed the openings generated in the turbine rear frame, which is a structural member for mounting the engine to the airframe. As a result, it was estimated that the cause of the openings was that some of the fragments of the low pressure turbine blades and blades of the engine collided with the turbine rear frame.

2LPT Missing vane in the fifth stage vane segment

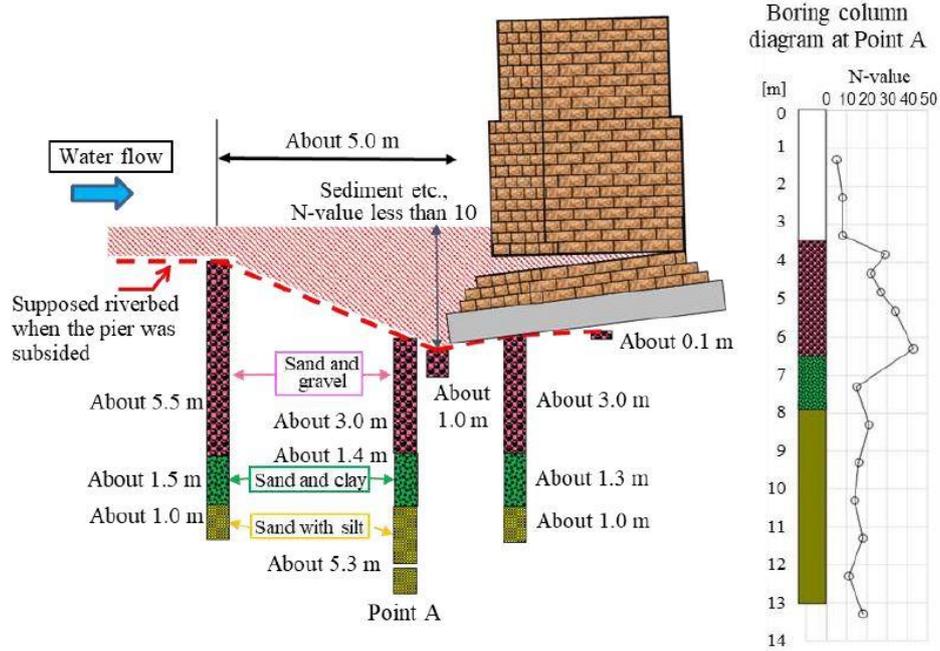
These analyses revealed that, it was probable that the bridge pier sank and tilted because the protective function of the bridge pier against the scour had been weakened since before the occurrence of the accident, the river water increased at the time of the occurrence of the accident caused the scour in a wide area around the bridge pier, and the support base was greatly reduced.

Summary of the results of the boring survey

In addition, based on these analyses, the JTSD discussed necessary measures to prevent recurrence and expressed the opinion to the Minister of Land, Infrastructure, Transport and Tourism (see page 25) on the necessity the Standards for Maintenance and Management of Railway Structures (Structure Section) known to the related railway track operators in order to prevent the same type of scour disaster.

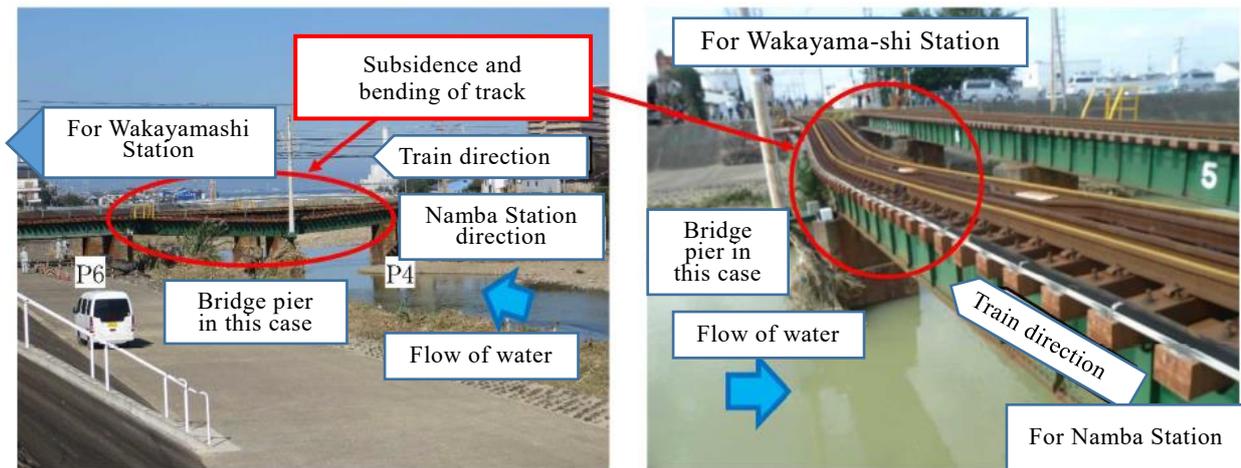
Situation around the accident site

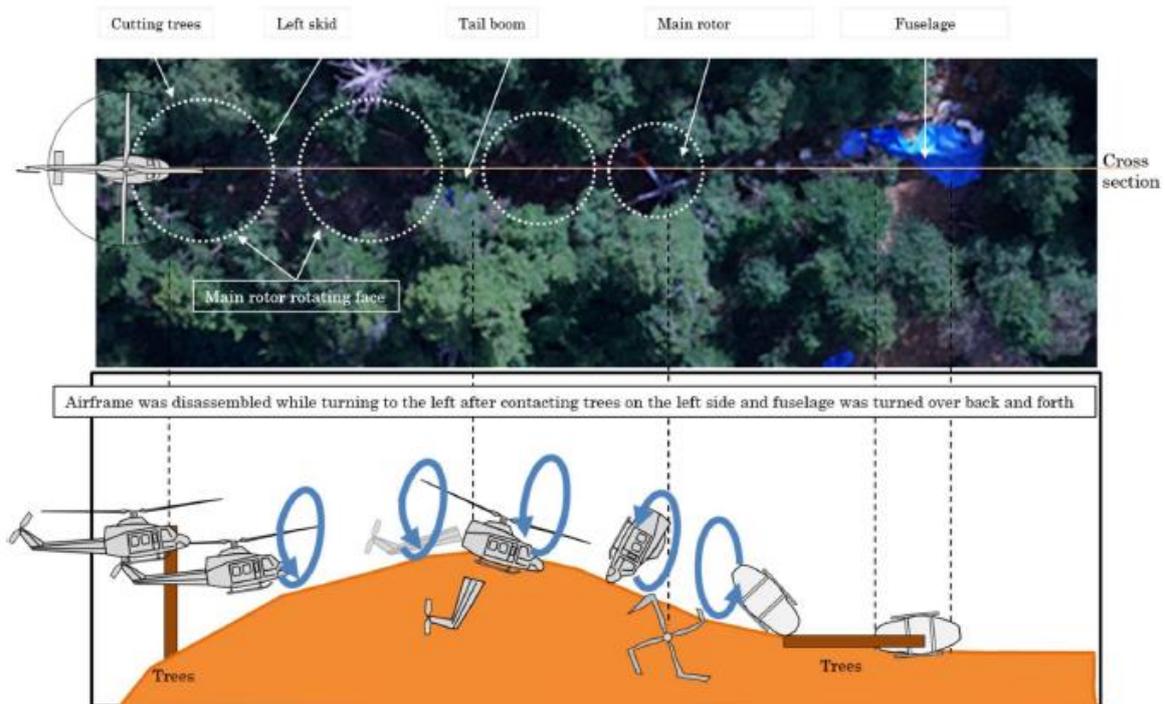
In the investigation of the collision of a helicopter (Bell 412 EP) on a mountain slope in Gunma Prefecture on August 10, 2018, a test on the existence of an error code at the factory of the manufacturer of the digital flight control computer was conducted in the presence of an aircraft accident investigator of the United States of America, the State of Design and Manufacture of the helicopter. As a result of the test, an error code was detected during the test run. However, according to the information from the video camera, there was no video showing the error code during the flight during the flight, and there was no information that a problem had occurred on the aircraft. Therefore, it is considered that there was no abnormality with the aircraft. In this way, steady efforts are made to confirm each piece of information that may be related to the cause of the accident through international cooperation.

Figure showing inverted airframe when crashed

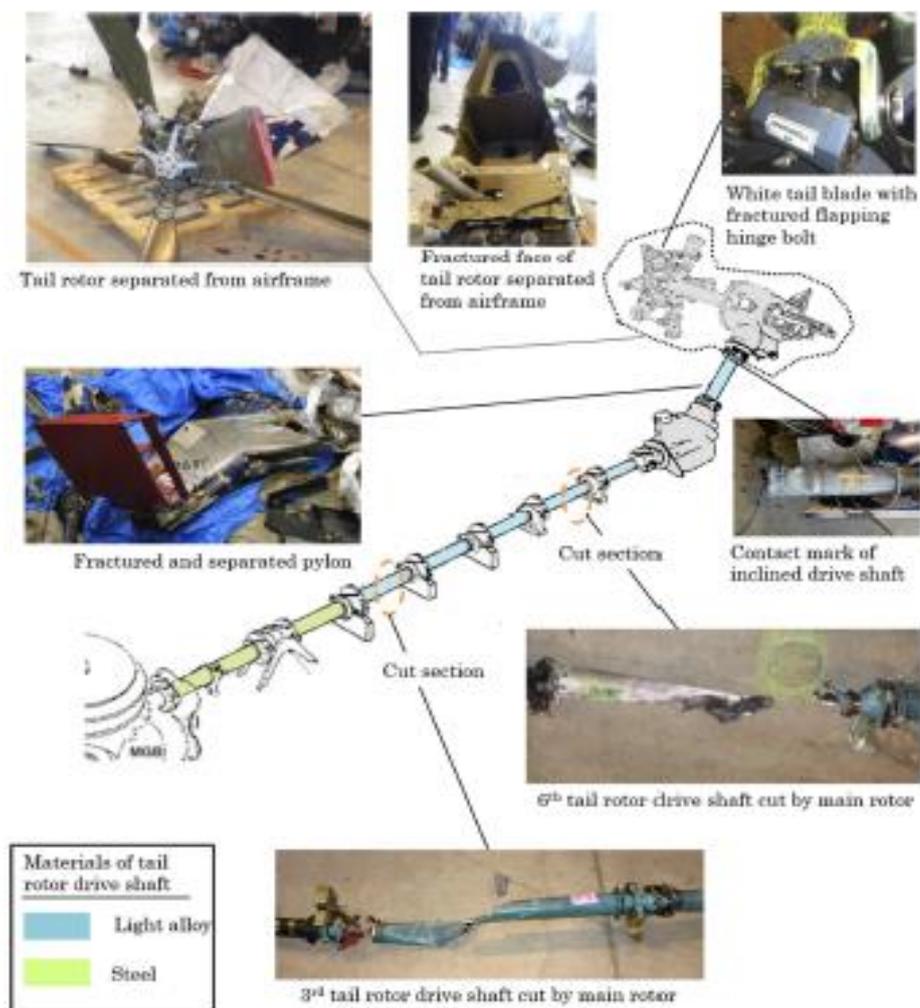
Besides, in the investigation of the uncontrollable crash of a helicopter (Aerospatiale AS332L) that occurred in Gunma Prefecture on November 8, 2017, the French Bureau of Accident Investigation (BEA) participated in the investigation of the tail rotor system at the manufacturer of the helicopter. As a result of detailed examination of many parts supporting the tail rotor, we were able to estimate that the cause of the crash was the tail rotor separated from the airframe during the flight and became uncontrollable.

Tail Rotor drive shafts had contact marks

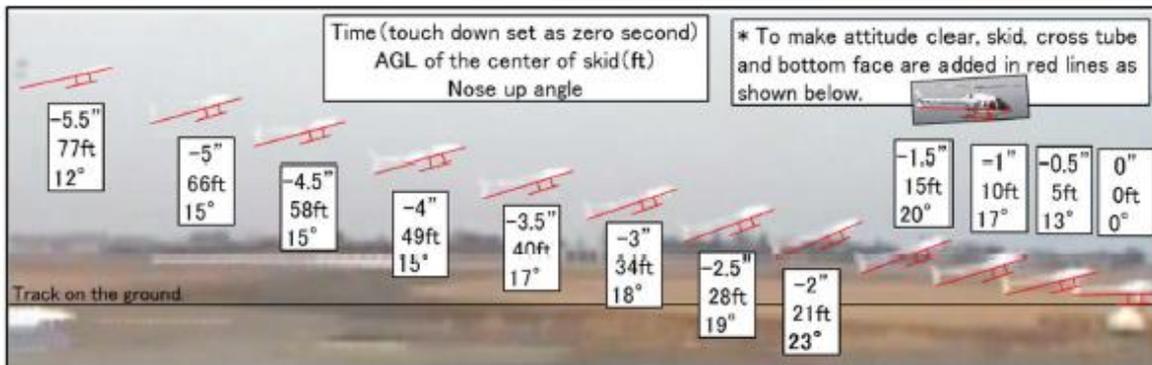
At the same timing, the helicopter touched down accompanied by a strong impact, slid to the left and finally came to a halt slightly pointing to the right.

Damage to Aircraft

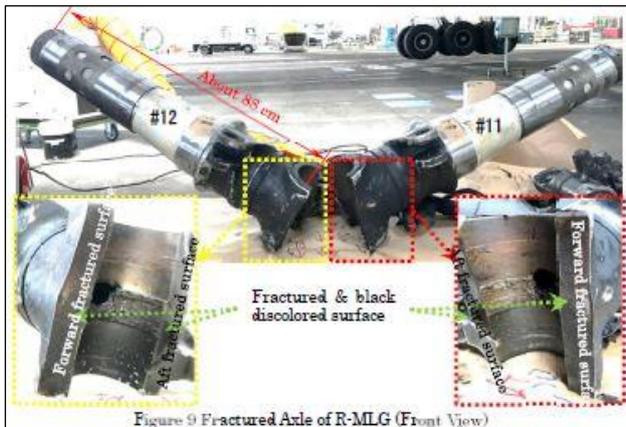
Situation of main damages to aircraft (The R-MLG AFT Axle was fractured)

- The entire fractured surface of the front side of the pivot discolored black due to the corrosion.
- It was confirmed that a partially black-discolored portion due to corrosion and a grey new metal surface were confirmed on the fractured surface of the aft side of the pivot.

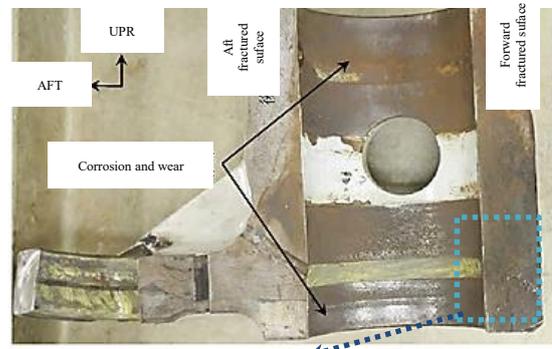
The forward fractured surface had an initiating region of corrosion on the lower side of the pivot bore, then was generating SCC and finally was fractured due to repetitively imposed loads.

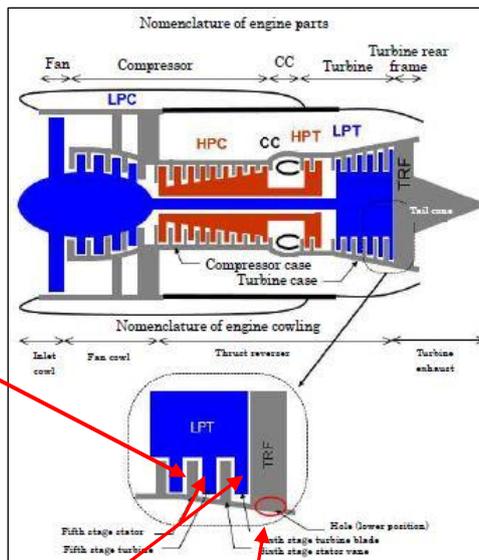
- A hole in size of about 6 cm x about 1 cm, concave deformation (dent) and crack were confirmed on the lower section of TRF attached to the aft flange of the LPT case.

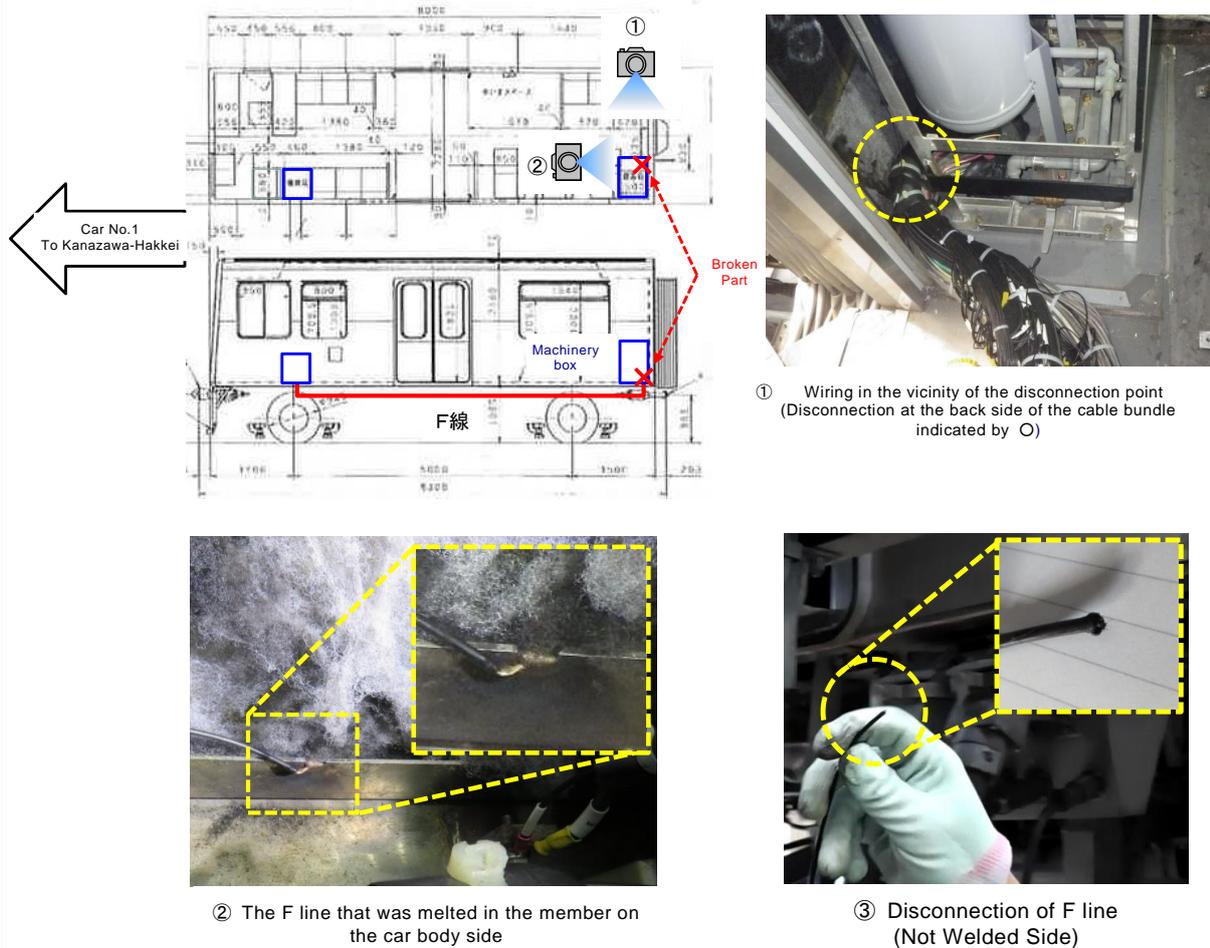
Figure 1 Disconnection of F line

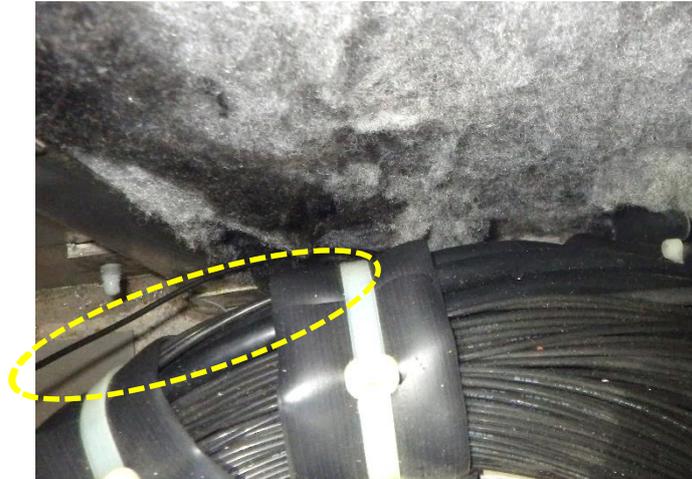
Figure 2 F line out of bundle

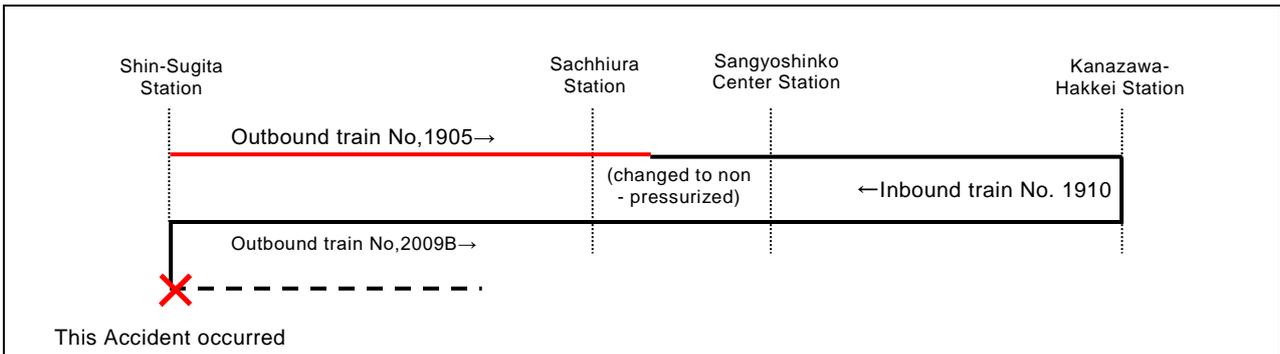
Figure 4 Pressing Condition of F Line (Red Line Indicates Pressing of F Line)

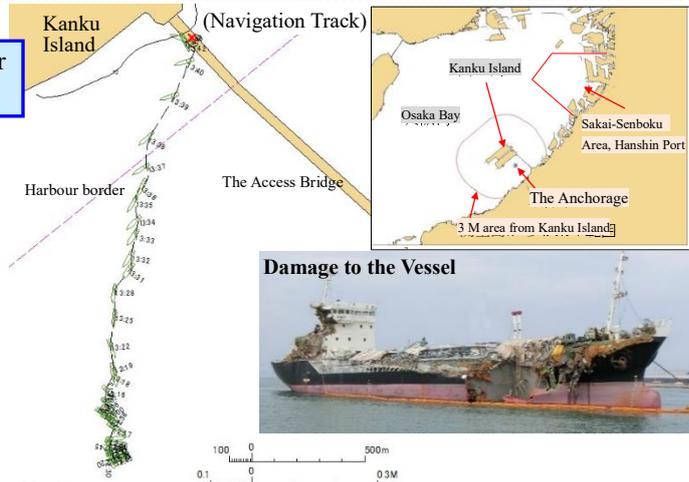
Damage to the Vessel
