Chapter 3 Aircraft accident and serious incident investigations

9 Summaries of major aircraft accident and serious incident investigation reports (case studies)

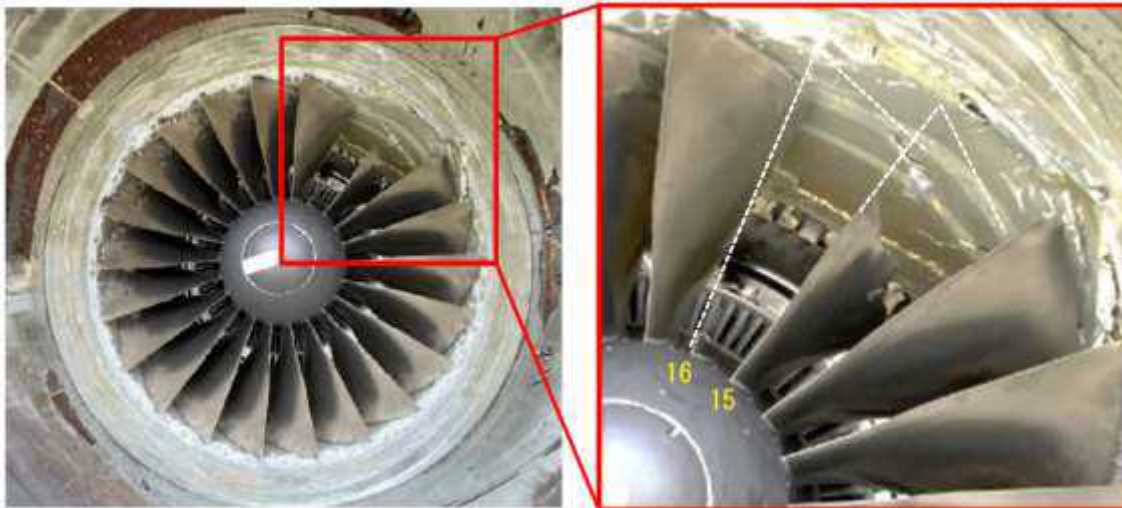
Figure 1. Left engine inlet

- Fan blades of the left engine were damaged.
- Damaged sections of the fan blades and damage to the aircraft are shown in the Appendix below.

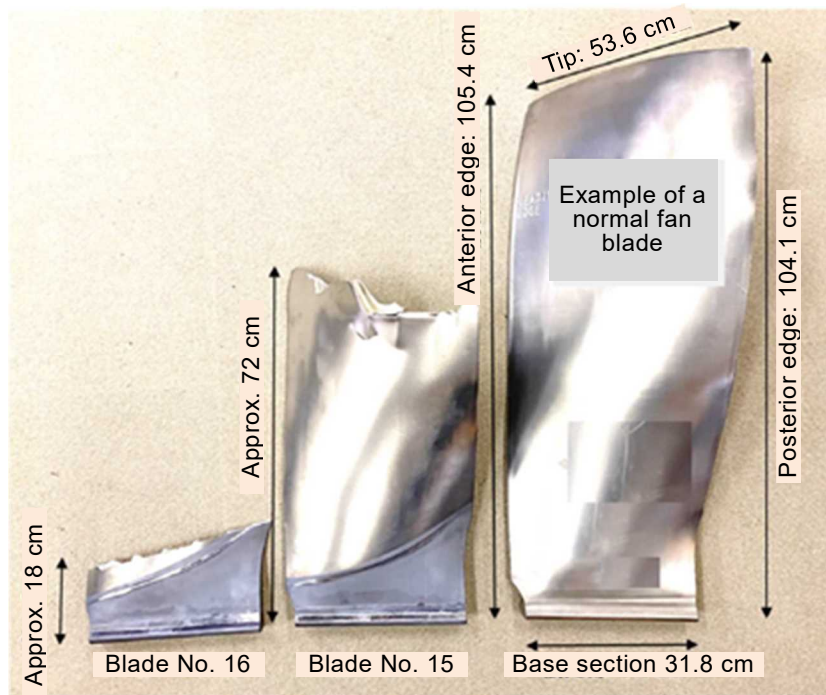
Figure 2. Damaged fan blade

Each engine has 22 fan blades (made of titanium alloy). Blades Nos. 15 and 16 were damaged from the middle and base sections respectively. While a beach mark and a radial mark characteristic of fatigue fracture were observed on the fracture surface of blade No. 16, no such mark was observed on blade No. 15.

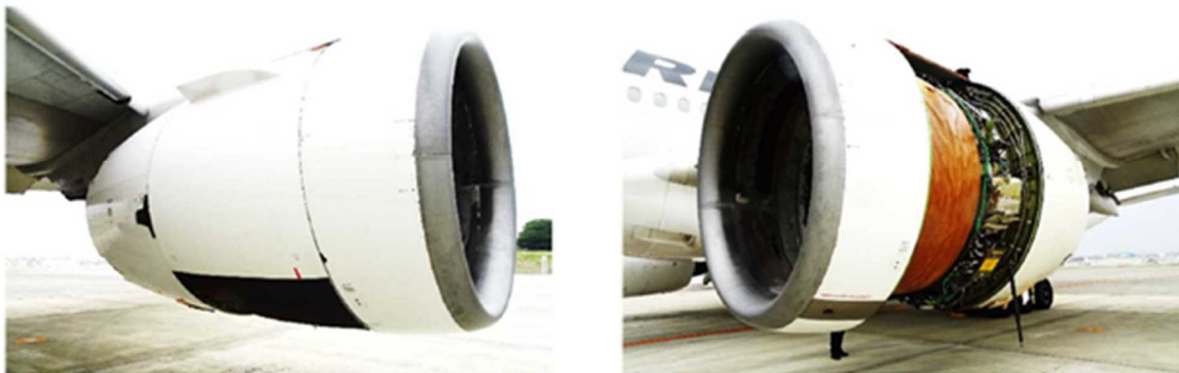
Figure 5. Damaged engine cowl

In addition to the damage to the fan blades, damage to the aircraft body (engine cowl, horizontal stabilizer and fuselage) was found.

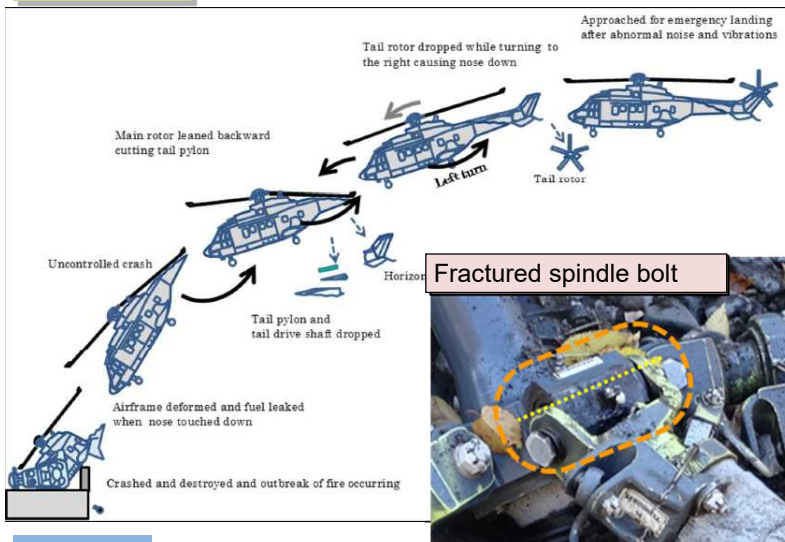
Separation of tail rotor

Probable Causes: In this accident, it is highly probable that, when the Helicopter attempted an emergency landing due to abnormal vibrations occurring in the airframe in flight, the tail rotor was separated leading to loss of control and subsequent crash. It is highly probable that the separation of the tail rotor from the airframe was caused by imbalanced rotation of the tail rotor due to the fracture of the spindle bolt of the flapping hinge of the White Blade, which generated excessive vibrations and damaged the section attached to the tail rotor.

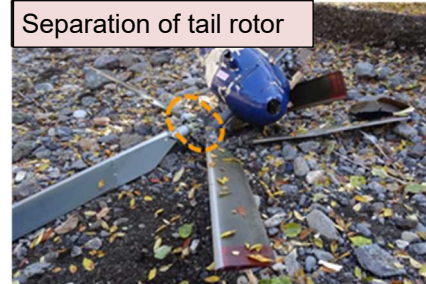
Fractured spindle bolt

- According to the results of a 10-hour inspection and 50-hour inspection carried out from July to August, 2017, it is likely that the inner rings progressively deteriorated and the flapping hinge of the white blade had frozen.
- It is highly probable that the fracture of the spindle bolt was caused by a frozen component inside the outer ring, which accelerated the cracking of the inner ring and exerted a twisting load to the spindle bolt.
- It is probable that the spindle bolt fracture caused an imbalance of the rotational plane of the tail rotor and its subsequent separation.

It is highly probable that the fractured spindle bolt was caused by damaged and stuck bearings of the flapping hinge. Besides, it is highly probable that this resulted from the fact that the damaged condition of the bearings was not grasped in inspections and maintenance work performed on the Helicopter and the appropriate measures were not taken.

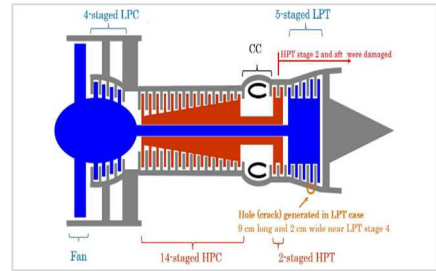
Engine composition and damaged sections (right)

- The 2nd and subsequent stages of No. 1 engine high-pressure turbine (HPT) were damaged (four blades, namely blades Nos. 13, 12, 11 and 10 of the HPT stage 2 were damaged and their remaining portions less so in this order; the fracture surface of blade No. 13 had a trace of low-cycle fatigue originating from the TA section).
- LPT casing: A hole (crack) was observed near the LPT stage 4

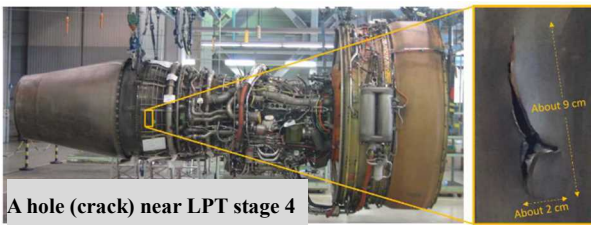
A hole (crack) near LPT stage 4

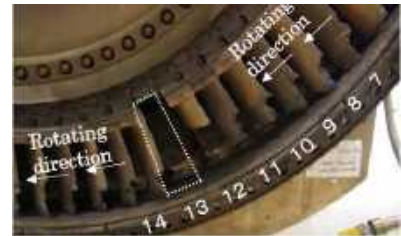
Damaged sections originating from the 2nd stage blade (left) and No. 13 blade (right) of the HPT

Probable Causes: It is highly probable that this serious incident was caused by the fractured blade #13 on HPT (high pressure turbine) stage 2 of No. 1 engine (left side), when the Aircraft was climbing, that damaged blades and stator vanes of aft stages, fragments of which collided with LPT (low pressure turbine) casing and generated a hole (crack). It is highly probable that the fractured blade #13 was caused by cracks that were generated on TA (Turning Around (branching and turning around of cooling air flowing inside blades)) area and progressed thereafter. It is likely that cracks generated on TA area were caused by hot corrosion swelling (blister) generated on the coating layer of the blades and low-cycle fatigue initiating from the cracks.

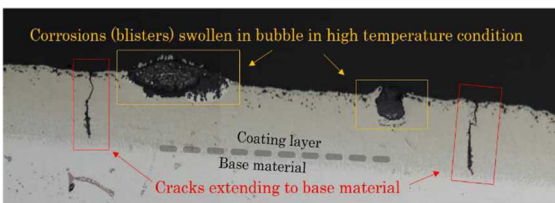
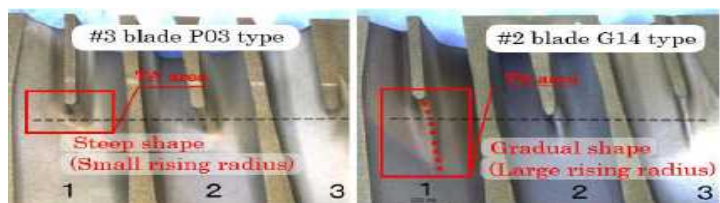
- A possibility of the impact of increased operating cycles
⇒ Coating quality deterioration, base material cracking and its progress
- It is likely that the steep rising shape of the cooling air passage bulkhead became a contributing factor.
⇒ Stress concentration on the section, cracking the base material
- It is likely that the large thickness of the coating layer became a contributing factor.
⇒ A thick coating layer is prone to cracking.

The cross section of the coating layer near the fracture origin (above) and the shape of P03-type TA section (right)
