Chapter 4 Railway accident and serious incident investigations

Railway accident investigation reports published in 2021

Railway serious incident investigation reports published in 2021

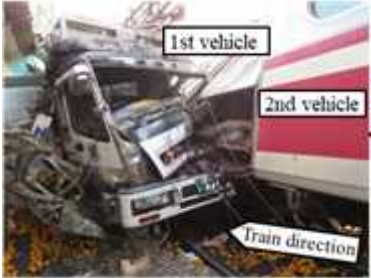
<p>Probable causes</p>	<p>The Japan Transport Safety Board concludes that probable cause of this accident was certain that the standard sized truck entered the Kanagawa-shimmachi No.1 level crossing and hindered the route of the train, and the train could not stop before the level crossing although the obstruction warning signal of the level crossing had been indicating the stop signal, then collided with the truck.</p> <p>It is certain that the truck hindered the route of the train because the road warning device started the warning operation after the truck started to enter the level crossing, and completed the blocking operation before the truck had passed through the level crossing, then the truck stayed in the level crossing.</p> <p>It is likely that the truck stayed in the level crossing because it took long time for the truck to pass through the level crossing due to the narrow width of the road against the size of the truck, when the truck turned right in the intersection and enter the level crossing.</p> <p>As a side note, it is likely that the truck driver, selected the route to the level crossing via the Urashima route 152 to bypass the usual route, related to that the truck could not operate in the usual route. However, it could not be determined why the truck passed the unusual route because the truck driver was dead.</p> <p>The train could not stop before the level crossing, even though the obstruction warning signal of the level crossing had been indicating the stop signal. It is probable that this situation was caused because the driver of the train could not implement the braking operation to stop the train before the level crossing at the position where the indication of the obstruction warning signal of the level crossing became to be sighted from the driver of the train.</p> <p>Concerning that the driver of the train could not implement the braking operation at the place where the driver became able to sight the operation of the obstruction warning device of the level crossing, it is probable that it was difficult for the driver to respond instantaneously to the obstruction warning signal that indicate the stop signal in unanticipated timing. In addition, it is probable that the driver noticed with delay concerned with that there was the scene that the flickering status of the remote obstruction warning device was blocked intermittently by the masts, etc. in spite of the place where the obstruction warning device became to be sighted. As a side note, it is likely that the velocity when the train collided could be reduced if the Driver had operated the emergency stop procedures by the emergency brake when operated the service brake. However, the company stipulated to use the service brake to stop the train as the principle under the rule "when the stop signal was indicated in the obstruction warning device, stop immediately". And the company had entrusted the driver with the judgement to operate the service brake or the emergency brake, considering the status as the velocity, distance, etc. Therefore, it is likely that the above situation was caused as related with that the brake to be used had not been prescribed clearly in the implementing standard of handling operation and the working standard of the driver of electric railcar.</p>

<p>Safety actions</p>	<p>Measures Taken by the Railway Operators after the Accident</p> <p>On September 2019, after this accident, the Company notified the change of the Working Standards of the Driver of Electric Railcar, an internal rule, to "stop immediately" on the handling of the brake when noticed the stop signal of the OWS. After that, the rule was changed as "operate the emergency brake procedures immediately" on November 2019. Furthermore the rule was changed as "when noticed the indication of the flashing light signal, operate the emergency brake immediately and stop the train, provided that the use of the service brake is allowed only when the train can stop certainly in approach of the confirmed flashing light signal, such as the train was operating in low speed as in the slowing down operation or there is enough distance until to the noticed flashing light signal" on February 2020. At the same time, the Company implemented the education and the training for all drivers.</p> <p>On December 2019, the Company reviewed the rules to install the OWS, and decided the installing position where the OWS can be sighted from the place in the distance that the margins are added to the conventional place, i.e., "the place where the OWS can be sighted from the place beyond the distance that train can be stopped by the emergency brake", in order to add the still more margins to brake operation and to improve the visibility of the OWS.</p> <p>Additionally, the Company installed the additional OWS for the Level crossing on December 2019. In addition, the Company implemented the additional measures to install the OWS, for the other level crossings.</p> <p>Measures implemented by the trucking company after the accident</p>

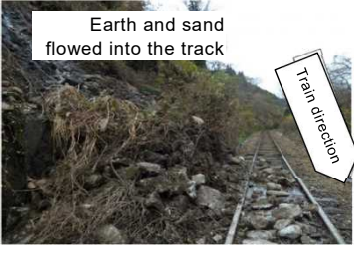
Probable causes	<p>The JTSB concludes that the probable cause of this accident was that the slope in the railway track side collapsed, and the train ran onto the earth and sand flowed into the railway track and derailed in the accident.</p> <p>It is probable that the slope collapsed and earth and sand flowed into the railway track because the strength of the waterway, which had been laid underground of the Fukushima Prefectural Road 347 located in upper part of the collapsed slope, deteriorated over the years, and broken caused the leaking water, that soaked into the collapsed slope, composed of the colluvium layer, and made unstable status due to the increased water content.</p> <p>It is likely that the waterway broke as deteriorated strength due to the deterioration over the years, related by that the management of the waterway had not been conducted properly.</p>		
	Safety actions	<p>Measures taken by the Company</p> <p>(1) Emergency measures taken</p> <ol style="list-style-type: none"> 1. Requested a traffic ban of dump trucks for construction to the Minami-Aizu Construction Office (hereinafter referred to as "the Office") of Fukushima Prefecture that is the administrator of Fukushima prefectural road No. 347 (hereinafter referred to as "the prefectural Road") after the accident occurred. 2. Allocated on-site lookout persons in the vicinity of the collapsed slope from the restarting day on November 30, 2019 (up to December 14 when a wire net was installed), and also regulated the Prefectural Road at a slow speed of 15 km/h during the period for the traffic of dump trucks for construction. 3. Installed lighting equipment in the vicinity of the collapsed slope when restarting the train operation. (Up to September 30, 2020) 4. Reinforced the surrounding area including the collapsed slope using a wire net as a temporary slope treatment. (Installation completed on December 14, 2019) 5. Confirmed with the Office as of June 10, 2020 that the traffic of dump trucks for road construction shall be restarted after the execution of slope protection work, and also confirmed the traffic restrictions (one track operation, very slow speed, and precipitation control, etc. in the area of about 300 m in the vicinity of the route with the collapsed slope). <p>(2) Permanent measures taken</p> <ol style="list-style-type: none"> 1. Executed slope protection work by slope crib (free frame method) on the slope that is likely to impede the train operation around the accident site including the collapsed slope. (See Figure Implementation status of slope protection work) 2. Installed a protection net and a collapse detection sensor, and also reinforced the lower part of the slope that is likely to impede the train operation in the vicinity of the collapsed slope. 3. Confirmed with the Office that the Office shall carry out the joint reinforcement of road gutters, the maintenance and management of road-crossing water conduit and catch basin. <div data-bbox="970 1077 1362 1366" data-label="Image"> </div> <p>Measures taken by Fukushima Prefecture</p> <p>Removed the water conduit buried under the Prefectural Road on December 5, 2019, installed a new water conduit on February 22, 2020, and decided that the Fukushima Prefecture shall manage it.</p>

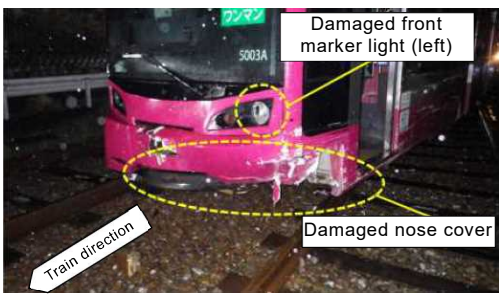
Probable causes	<p>The JTSB concludes that the probable cause of this accident was that the approaching train collided with the compact sedan at the velocity of about 50 km/h, and right wheels of the train ran onto right rail and derailed in this accident, because the compact sedan turned right and entered the level crossing as pushing up the crossing rod in the status that the road warning device was operating and the crossing rod had been lowered, and stopped, and the compact sedan was caught between left side surface of the train and the concrete column for the overhead trolley, etc., and pushed out the vehicle body of the train to right. Besides, it could not be determined why the compact sedan entered the level crossing, because the driver of the compact sedan was dead.</p>

Safety actions	<p>Measures taken by the Company</p> <p>(1) The Company took the following measures.</p> <p>[i] Installed the red colored revolving lights aimed to improve the sighting ability when the level crossing is operated, to the prop of the road warning device of the level crossing, on May 20, 2020.</p> <p>[ii] Let the information on this accident commonly possessing, and conducted the education on the importance of the train protection to all train crews.</p> <p>(2) The company and the road administrator, i.e., Kitakyushu City, discussed on the measures for the safety.</p> <p>Measures taken by Kitakyushu City</p> <p>(3) Responding to the discussion in the above (2), the road administrator, i.e., Kitakyushu City, painted again the blurred stop lines, and installed the light-emitting type road rivets*1 to promote the attention of car drivers, on October 2, 2020.</p> <p>*1 "Light-emitting type road rivet" emits flashing night-light to raise awareness of car drivers, and is installed by embedding them on road surfaces such as stop lines, edge markings, and cross walk.</p>

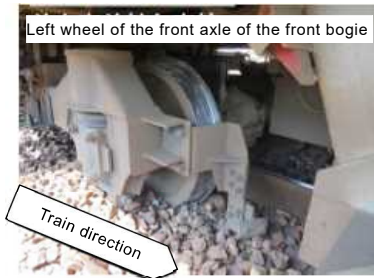
Probable causes	<p>The JTSB concludes that the probable cause of this accident was that, the left wheels of all 2 axles in the front bogie went off to the inside gauge, after that the right wheels of all 2 axles in the front bogie went off to outside gauge in this accident, because the gauge was widened dynamically while the train was passing through left curved track of 300 m radius.</p> <p>It is probable that that the gauge was widened dynamically by the rail tilting and the rail movement caused by the lateral force while the train was passing, because the poor sleepers and the poor rail fastening status had been existed continuously.</p> <p>It is probable that the poor sleepers and the poor rail fastening status existed continuously because the company staff in the work-site division, who was assumed as lacked in the technical abilities, had judged that the status was enough to be observing the progress and had not been implemented the maintenance, in the management of the sleepers and the rail fastening status. In addition, it is probable that the lack of the technical activity was caused by the insufficient education and confirmation for the staffs in the work-site division by the head office.</p>

Safety actions	<p>Measures Taken by the Railway Operator after the Accident</p> <p>(1) Urgent measures</p> <ol style="list-style-type: none"> 1. Exchanged 292 poor sleepers located in the area from the starting point up to about 0 k 470 m, and implemented track maintenance (completed on March 28). 2. Exchanged at least one in three sleepers in the area where continuous failure of sleepers is confirmed and sleepers with ongoing failure (68 sleepers) and installed tie plates in the curve of 400 m radius or less of the whole line (completed on March 28). 3. Implemented running at 40km/h reduced speed from 55 km/h, i.e. at 15 km/h or less as

<p>the speed limit for outbound trains, and at 30km/h reduced speed from 45 km/h, i.e. at 15 km/h or less as the speed limit for inbound trains and monitored the track status by carrying out a daily track inspection for seven days from the restarting day of the train operation (from April 1 to April 7, 2020).</p> <p>(2) Permanent measures</p> <ol style="list-style-type: none"> 1. When inspecting sleepers or conducting an on-foot track patrol, etc., the corrosion status of sleepers shall be checked, and the digging into or displacement of wooden sleepers of the rail bottom or tie plates shall be checked according to the situation especially, the fastening status of the sleepers and the rail fastening device shall be confirmed. In addition, the inspection results of sleepers shall be securely managed using a management ledger for one sleeper, and also appropriate track maintenance shall be carried out (started from March 31, 2020). 2. Inspection documents shall be confirmed by personnel up to the safety manager, and a system shall be established to enable reporting information to superiors urgently without considering costs, etc., if emergency repair, etc. is needed. In addition, it was decided to share information regularly (about once a month) by interviewing each section head (for the building work section, started from November 26, 2020). 3. Since the work did not proceed much due to the small number of workers of the building work section, two new recruits were provided to the building work section (October 1, 2020). In addition, one more recruit was provided in December of the same year. 4. Wooden sleepers in the vicinity from the starting point to 0 k 470 m were replaced with PC sleepers (October 3, 2020). 5. Reference cases with photographs were informed within the building work section for references when evaluating poor sleepers and floating spikes (implemented from October 16, 2020). 6. When inspecting sleepers, if a sleeper, for which replacement is not needed, has a floating spike, although the sleeper management ledger has not described the floating spike, the internal regulations for managing one sleeper shall be changed (to be carried out early) to add D rank to the judgment ranking (a triangle mark shall be given if spare work or hammering is needed due to the floating spike despite of good condition of the sleeper). Moreover, a triangle mark was given using a paint to sleepers with a floating spike, found during the sleeper inspection (completed on November 10, 2020). 7. It was decided to change the number of spikes to be hammered to the number stated in the "track maintenance and management manual" when maintenance is made, such as replacing sleepers in the tie plate installation section (to be implemented every time construction work occurs). 8. Inspection and maintenance of poor bridge sleepers between Mino-Ota station and Seki station (to be replaced in FY 2022). 9. Replacement with PC sleepers for at least one in three sleepers in the curve of 400 m radius or less, excluding the area with switch sleepers (to be implemented by FY 2023).

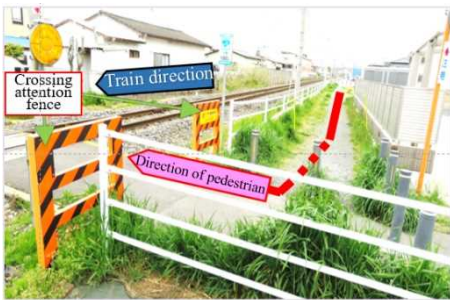
Probable causes	<p>The JTSB concludes that the probable cause of this accident was that the pedestrian entered No.1 Shimoura level crossing, the class 3 level crossing equipped with the road warning device but without the crossing gate, in the status that the road warning device was operating and responded to the approaching train.</p> <p>It could not be determined why the pedestrian entered the level crossing because the pedestrian was dead, although it is likely that the pedestrian did not hear the rumbling sound of the road warning device and that the pedestrian overlooked the red flashing lamps of the road warning device.</p>		
	Safety actions	<p>Proposed a discussion to Higashi-Matsushima City regarding abolition or upgrading the level crossing, given that the accident occurred. However, since the discussion with the city did not progress, the level crossing was constructed for upgrading to class 1 level crossing, considering safety as the first priority.</p> <p>(1) Measures taken by the Company</p> <ol style="list-style-type: none"> 1. Applied yellow paint to the edge end of the level crossing on May 11. 2. Taken the awareness-raising activities regarding level crossing accidents at Higashi-Yamato station and Yamoto station on May 13. (jointly with the cities and Ishinomaki Police Station). 3. Changed the red flashing lamps of the level crossing to omnidirectional red flashing lamps on May 13. 4. Applied a paint to the halt line of the level crossing on May 14. 5. Upgraded the level crossing to class 1 level crossing, and started to operate it from November 21. <p>(2) Measures taken by the City</p> <ol style="list-style-type: none"> 1. Taken public-relations activities at Higashi-Yamato station and Yamoto station on May 13 jointly with Ishimaki Police Station, Ishinomaki district safe driving manager society, the Company, and the traffic safety association, and the disaster prevention section, the general affairs department of Higashi-Matsushima City. 2. Leveled crushed stones as safety measure for pedestrians for non-statutory public properties owned and managed by Higashi-Matsushima City on July 22. 3. Confirming the on-site status such as the paint of the edge ends and halt lines of No.1 Shimoura level crossing once a month by the construction section, the construction department of Higashi-Matsushima City.

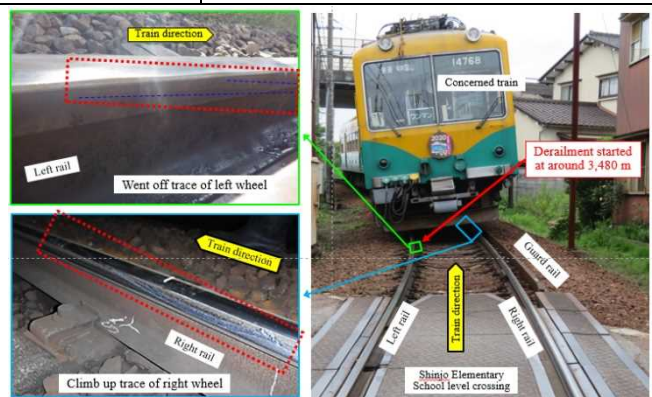
Probable causes	<p>The JTSB concludes that the probable cause of this accident was that the gauge widened significantly while the train was passing in the left curve of 181 m radius, and the left wheel of the 1st axle in the front bogie went off inside gauge.</p> <p>It is probable that the gauge widened significantly because the gauge widened dynamically due to the lateral movement and the tilting of rail caused by the lateral force accompanied by the train running, as the poor rail fastening devices existed continuously in the curved track, where the static irregularity of gauge had been exceeding the maintenance standard value.</p> <p>It is probable that the irregularity of gauge had been exceeded the maintenance standard value because the maintenance was not implemented before the occurrence of this accident as the period from when the gauge exceeded the maintenance standard value to the maintenance had not been stipulated, and there were many places where the gauge exceeded the maintenance standard value and the maintenance of the other places were considered as in higher priority.</p> <p>It is likely that the poor rail fastening devices existed continuously because the management based on the dangerousness against the wide gauge had not been conducted as there was no manual, etc., to enable the proper judgement and measures in the inspection of sleepers and the lack of technical activities for the maintenance management.</p>

Safety actions	<p>Measures taken by the railway operator after the accident</p> <p>(1) Replaced the sleepers and right rail (outer track) in the curve. In addition, removed the guard rail, and installed a derailment prevention rail inside the gauge of the left rail (inner track). In addition, the derailment prevention rail is to be changed to a derailment prevention guard in the future.</p> <p>(2) Applied a reduced train speed of 25 km/h in the curve.</p> <p>(3) Decided to implement an on-foot track patrol once in five days and confirm the rail fastening status by measuring the track irregularities at the same time.</p> <p>(4) Made replacement of all the poor portions and portions with white paint applied for the follow-up purpose of the rail fastening device.</p>		
	Report	<p>https://www.mlit.go.jp/jtsb/railway/rep-acci/RA2021-3-2.pdf (In Japanese only) https://www.mlit.go.jp/jtsb/railway/p-pdf/RA2021-3-2-p.pdf (Explanatory material)</p>

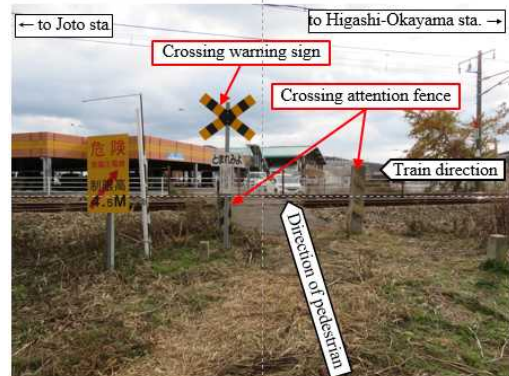
the level crossing.
Probable causes		<p>The JTSB concludes that the probable cause of this accident was that the pedestrian entered Gonotsubo level crossing, the class 4 level crossing, the without crossing gate nor the road warning device, in the status that the train was approaching the level crossing, and collided with the train.</p> <p>It could not be determined the precise reason why the pedestrian entered the level crossing in the status that the train was approaching, because the pedestrian was dead.</p>
Safety actions		JR West Japan and Okayama City abolished the level crossing on September 29, 2021 after discussion.
Report		https://www.mlit.go.jp/jtsb/railway/rep-acci/RA2021-6-1.pdf (In Japanese only) https://www.mlit.go.jp/jtsb/railway/p-pdf/RA2021-6-1-p.pdf (Explanatory material)

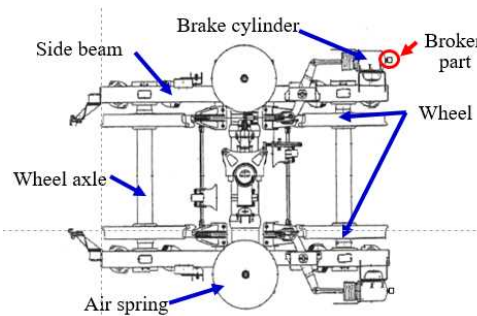
<p>Probable causes</p>	<p>The JTSB concludes that the probable cause of this serious incident was highly probable that the train, that stopped once by the emergency brake in the down grade section, overran in this serious incident, because all brake shoes pushed to each wheel were released and both the service brake and the security brake became not to function, caused as the compressed air, stored in the main air reservoir, the supply air reservoir and the security brake air reservoir, had been lost completely due to the leakage of the compressed air between the main air reservoir and the brake cylinder completely, since the train had collided with the animal invaded to the front part of the rear axle in the front bogie from right side and the pipe connected to the brake cylinder had folded and broken.</p> <p>It is probable that the pipe connected to the brake cylinder had folded and broken as bent in around the root part in the direction opposite to the direction of travel, because the pipe had been overhung in lower side of the brake cylinder in the near place to side surface of the vehicle body and could not prevent the collision with the animal invaded to front part of the rear axle of the front bogie from right side of the track.</p>

<p>Safety actions</p>	<p>1 Measures Implemented by the Company after this Serious Incident</p> <p>(1) Urgent measures</p> <p>The Company decided to implement the following items.</p> <ol style="list-style-type: none"> 1. The Company let all train crews in the Company about this serious incident, and to pay the closest attention to the air leakage from the brake pipe of the cylinder part when implemented the under floor inspection during operation, etc., including the inspection implemented in the train depot. Finished to commonly known this item on October 11, 2020. 2. The Company implemented the measures that the pipe does not folded and broken easily when collided with animals, as fixed the pipe connected to the brake cylinder to the bogie frame in all 16 vehicles of the same kind structure, and completed on October 23, 2020. Here, the Company and the Tango Railway Co., discussed each other on the measures, and the Tango Railway Co., arranged the budget and implemented the measures. 3. The Company and the Tango Railway Co., requested the track side local government on the activities to capture animals, and the track side local government asked their jurisdictional hunting companions and started to capture animals in the places where there were many records of collision along the track side. <p>(2) Permanent measures</p> <p>The Company decided to implement the following items.</p> <ol style="list-style-type: none"> 1. Revised the "Basic procedures when faced abnormality" to make clear the handling when the brake did not work, and prescribed to use the hand brake, on November 1, 2020. 2. The Company and the Tango Railway Co., discussed each other and promote the preparation toward the implementation of changing layout of the pipe connected to the brake cylinder in the all 16 vehicles of the similar structures. <p>2 Measures Implemented by the Ministry of Land, Infrastructure, Transport and Tourism after this Serious Incident</p> <p>The Ministry of Land, Infrastructure, Transport and Tourism took the following actions based on the occurrence of this serious incident.</p> <ol style="list-style-type: none"> (1) On October 5, 2020, implemented the "information provision" to the railway and tramway operators, and instructed the "investigation of causes and implementation of the safety actions" to the Company. (2) On October 6, 2020, instructed the railway and tramway operators to report on the existence of the vehicles with the similar structure, i.e., both the brake pipe and the brake cylinder are laid in the most outside of the bogie frame in the vehicle operated alone. (3) On May 6, 2021, let the railway and tramway operators known well on the contents of the measures described in 1 (1) (ii) and (2) (ii), and instructed the railway and tramway operators who owned the vehicles with the similar structure, to study on the similar measures.

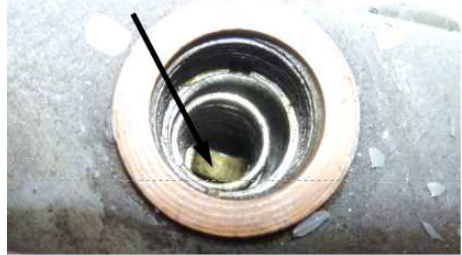
Probable causes	<p>The JTSC concludes that the probable cause of this serious incident was highly probable that the force pushing the slide door had decreased and became smaller than the inertial force caused by the braking operation, because as the valve base frame which was press fitted to the counterbore had come off, in the D valve in the valve cabinet of the door operating equipment, which opened while the train was running, and consequently the compressed air in the closing cylinder of the door operating equipment flew out to the air.</p> <p>It is probable that the valve base frame, which had been press fitted to the counterbore, came off from the counterbore related with the following situations.</p> <ol style="list-style-type: none"> 1. There was the possibility that the upward force by the restoring force of the spring had acted to the switching valve A, and the upward force had also acted to the valve base frame indirectly, when there is no compressed air in the closing cylinder of the door operating equipment. The friction force of the side surface of the counterbore of the D valve and the side surface of the valve base frame was small compared in the status when press fitted as usual, and the valve base frame had been in the status to be risen easily. 2. The valve base frame had been in the status that the unexpected force acted to rise the valve base frame in the undersurface of the valve base frame, while the vehicle was operating and the doors were closed (there was the compressed air in the closing cylinder of the door operating equipment) because there was the space between the undersurface of the valve base frame and bottom surface of the counterbore. 3. There was the possibility that the switching valve A and the valve base frame were strongly pressed and adhered, because the unexpected force had been acted for a long period to the contacted part between the switching valve A and the valve base frame. 4. As the results of the above situations 1 to 3, there was the space that the valve base frame could pass through inside of the spring when the valve base frame was rising in the counterbore, and, at the same time, the valve base frame could rise to the upper edge of the counterbore between the undersurface of the screw cock and the upper edge of the switching valve B. <p>It is likely that the valve base frame settled in the inside of the counterbore in the status as the side surface was in the upside, because the situations of the above 1 to 3 had been repeated for a long period, the undersurface of the valve base frame, which rose gradually inside the counterbore, got over the upper edge of the counterbore when the serious incident occurred, that caused the leakage of the compressed air in the closing cylinder of the door operating equipment, and resulted that the valve base frame fell when from the pressed and adhered valve base frame and the switching valve A were released by the wind pressure of the air stream.</p> <p>Furthermore, it is probable that the chance to prevent the concerned serious incident could not be used in the most, because, although the driver of the train had been noticed that there was the leakage of air from the door before departed from the starting station, and it took a long time to turn on the door pilot lamp compared to as usual, the driver departed the train</p>

Side surface of valve base frame, that came off from the base hole, facing upward

<p>unless to not reporting it to the related sections such as the train dispatcher or the station master, etc., because the doors had closed.</p>
	<p>Safety actions</p>	<p>1 Measures taken by the Company</p> <p>The Company implemented emergency checks and an instructions as shown below after the occurrence of the serious incident.</p> <p>(1) Vehicle depot</p> <p>Checked the existence of the leaked air from the door operating equipment in the door "closed" status by the operation start on January 1, and made the summarized events of the incident and the following details known to relevant sections and persons concerned.</p> <p>Inspection and repair employees</p> <ul style="list-style-type: none"> · Pay particular attention to the status of the door operating equipment and check carefully the existence of the leaked air from the door operating equipment. · If noticing leaked air, promptly report it to relevant employees and deal with the leakage before resuming the operation. <p>Drivers in the premises:</p> <ul style="list-style-type: none"> · Pay attention to check the existence of the leaked air from the door operating equipment when carrying out the inspection before departure from depot or when going through the vehicles to carry out switching work, etc. · If noticing air leak noise, arrange an inspection and repair as currently specified. <p>(2) Crew depot</p> <p>Made the summarized incident and the details stated below known to the crew. Made written notification on January 3, 2021 after raising awareness and giving instructions as a flash report on December 31, 2020.</p> <p>Drivers:</p> <ul style="list-style-type: none"> · Pay attention to check for air leak noise from the vicinity of the doors when checking each door status of vehicles in the inspection before departure from depot. · If noticing the leaked air, communicate to the train dispatcher, the station master, or the shift workers of inspection and repair. If noticing it before driving the train, communicate to the dispatcher or the station master. · If noticing the leaked air or receiving the report of the leaked air, in the middle of driving the train, immediately carry out a stop operation. · If noticing that a lamp to notify the driver (or the door pilot lamp) is turned off, immediately apply the emergency brake, and if there is an adjacent line, trigger the train protection radio. <p>Conductors:</p> <ul style="list-style-type: none"> · If noticing the leaked air from the vicinity of the door, carry out a stop operation of the train. · If noticing that the "fully-closed-door lamp" is turned off during driving a passenger train, carry out an emergency stop operation. <p>2 Measures taken by the Door Operating Equipment Manufacturer</p> <p>The door operating equipment Manufacturer considers that there is no particular need to take urgent measures for the valve cabinet because there had been no air leak after the valve cabinet was modified to be numerically controlled. However, the manufacturer created and established the "TK105 valve cabinet assembly work standard" document as a recurrence prevention measures on May 11 2021.</p> <p>The standard document describes integrated precautions for work on valves D and E that have the same press-fitting process.</p>
