Chapter 3 Aircraft accident and serious incident investigations

Aircraft accident investigation reports published in 2022

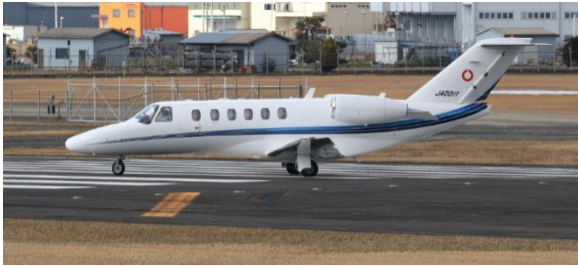
3	Date of publication	Date and location	Operator	Aircraft registration number and aircraft type
	June 30, 2022	April 14, 2021 About 2 nm west of the Yao Airport, at an altitude of about 500 ft	Privately owned	JA001T Cessna 525A (Small aeroplane)
	Summary	During the take-off climb from the airport, the aircraft collided with a bird and sustained damage to the airframe. The captain and six passengers were onboard, and there were no injuries.

Probable causes	It is most likely that the aircraft collided with the bird approximately 2 nm west of Yao Airport at an altitude of approximately 500 ft during the take-off climb from the airport that caused damage to the airframe.		
	Safety Actions	Measures taken by the Yao Airport Office of the Osaka Civil Aviation Bureau to prevent recurrence To clarify bird strike preventive measures in the surroundings of Yao Airport, the Airport Office amended the Yao Airport wild animal collision prevention procedures (dated October 28, 2021), surveyed the ecology of the birds' environment in the surroundings of the airport (situation of lakes

and wildlife sanctuary) and its maintenance program in collaboration with personnel and organizations concerned, on top of that to consider measures to reduce the risk of bird strike.		
	Report	https://www.mlit.go.jp/jtsb/eng-air_report/JA001T.pdf		
4	Date of publication	Date and location	Operator	Aircraft registration number and aircraft type
	June 30, 2022	October 10, 2021 Aso Temporary Airfield, Aso City, Kumamoto Prefecture	Kita-Kyushu Glider Club	JA2189 Alexander Schleicher ASK13 (Glider)
	Summary	<p>When the aircraft with solo trainee onboard for training flight landed at the Aso Temporary Airfield in Aso City, it deviated from the runway, collided with shrub. The aircraft sustained substantial damage, but the pilot was not injured.</p>

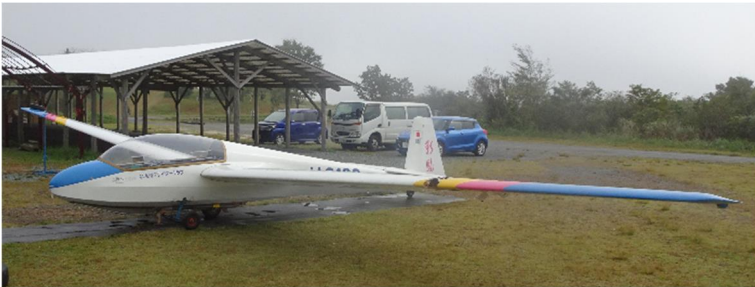
Probable causes	<p>When the aircraft attempted the crosswind landing, the attitude was disturbed due to the wind just before the touchdown, the probable cause of the accident was the trainee could not correct appropriately. Therefore the aircraft touched down with the nose facing the leeward left direction deviated the runway, collided with shrub and sustained damage.</p>

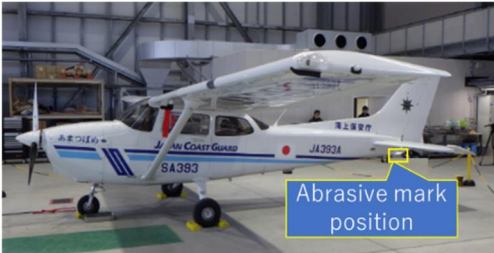
Report	https://www.mlit.go.jp/jtsb/eng-air_report/JA36HK.pdf		
2	Date of publication	Date and location	Operator	Aircraft registration number and aircraft type
	January 20, 2022	February 3, 2021 On the runway of the Kitakyushu Airport	Japan Coast Guard	JA393A Textron Aviation 172S (Small aeroplane)
	Summary	<p>The aircraft executed go-around due to an instable attitude in landing during solo flight training, and the lower part of the aft fuselage contacted on the runway surface at Kitakyushu Airport.</p> <p>A trainee who was alone on board the incident aircraft was not injured.</p>

Probable causes	<p>It is considered highly probable that this serious incident occurred because when the aircraft made a go-around due to its unstable posture at a low altitude during the landing approach, the underside of the aft fuselage touched the runway surface before starting to rise.</p> <p>It is considered probable that the fact that the unstable posture of the aircraft at a low altitude was caused not only the turbulence encountered immediately before touchdown, but also a significant nose-up operation was performed under its influence.</p>		
	Safety Actions	<p>Recurrence prevention measures implemented by the Kitakyushu Aviation Training Center, Miyagi branch school of the Japan Coast Guard School</p> <p>(1) Revision of the Solo flight supervising procedures</p> <p>(i) Reviewing the procedures whether to conduct solo flight or not</p> <p>In the case that forecasted wind direction is between 270° and 280°, crosswind component of the runway is computed by assuming that wind velocity with 20 % increment is a virtual wind velocity. Besides, a monitoring aircraft conducts weather conditions survey (including air current conditions in approach landing) beforehand as needed to decide to conduct training or not.</p> <p>(ii) Modification of the Supervising procedures</p> <p>Instructors supervise overall training at the Center, let a monitoring aircraft with other instructor on board to fly prior to a solo flight aircraft, report weather conditions and aircraft conditions to the Center, and provide necessary advice to the solo flight aircraft. When the monitoring aircraft judged that training is to be suspended due to aggravated weather conditions, etc., it reports the situations to the Center and instructs the solo flight aircraft to return to the airport.</p> <p>(iii) Clarifying response at the time of aggravated weather conditions, etc.</p> <p>When crosswind component of the runway is expected to exceed the Safety Criteria, a solo flight aircraft in approach landing executes go-around and a monitoring aircraft first performs approach landing to determine landing of the solo flight aircraft.</p> <p>When crosswind component of the runway does not exceed the Safety Criteria and approach landing is determined to be practicable, the monitoring aircraft provides necessary advice (confirmation of go-around procedures and air stream conditions, etc.) with the solo flight aircraft.</p> <p>When approach landing is judged to be impracticable, the monitoring aircraft instructs the solo flight aircraft to hold in the air or divert to an alternate aerodrome for landing.</p> <p>(2) Wind direction and wind velocity in takeoff and landing are recorded in the training instruction sheet to grasp educational situations of crosswind takeoff and landing of trainees.</p> <p>(3) Education on landing to all trainees</p> <p>(i) Education on the ground</p> <ul style="list-style-type: none"> • Reeducated situations where go-around is to be executed and attention to be paid in executing go-around. • Reeducated procedures for go-around using a simulator. <p>(ii) Training on board aircraft</p> <ul style="list-style-type: none"> • Additional training (continuous takeoff and landing training) was planned and conducted to evaluate skill for takeoff and landing and go-around. • Takeoff and landing or go-around training was additionally conducted in navigation training after trainees, who had had a blank period, had resumed training although a syllabus of navigation training does not include a takeoff and landing course. <p>(4) Others</p> <p>Reviewing suitable airports as alternatives for the Cross Country Solo Flights, and coordinating familiarization flight training using the same airports with an instructor on board before the Cross Country Solo Flights.</p>

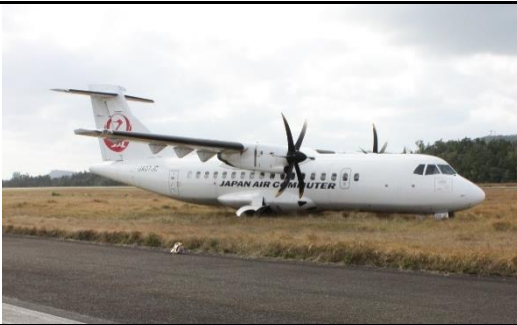
Summary	<p>The aircraft ran off the side of Runway 03 at landing and was disabled to perform taxiing. There were 21 persons on board consisting of the captain, two flight crew members and 18 passengers, and no one was injured.</p>

Probable causes	<p>The JTSB concludes that the probable cause of this serious incident was the delay in correcting the deviation to the left immediately after the touchdown at landing in a crosswind from the left, which resulted in the Aircraft running off the side of the runway, halting in the grass area and being disabled to move on its own.</p>		
	Safety Actions	<p>Recurrence prevention measures taken by the company and the designer/manufacturer</p> <p>(1) The Company</p> <ol style="list-style-type: none"> 1) Revised Manuals <ol style="list-style-type: none"> a. Regarding landing performed when a gust is reported, it is stipulated in Operations Manual (OM) Supplement that judgment, whether to continue approach or halt for a go-around, is made based on the guide that crosswind component of the gust is 1.5 times the maximum crosswind in addition to that the crosswind component of the mean wind velocity satisfies the maximum crosswind stipulated in Airplane Operating Manual (AOM). b. AOM is revised to incorporate the revisions of Flight Crew Operating Manual (FCOM) by the Design and Manufacturer in terms of normal procedures in landing roll. c. "OPERATIONS IN WIND CONDITIONS" is newly incorporated in AOM that reflects what is described in FCOM. d. Descriptions in FTG*1 regarding takeoff and landing in crosswind are revised. 2) Relevant Flight Crew <ol style="list-style-type: none"> a. Captain Ground school training, simulator training, and check and line flight training and check. b. FO Ground school training, simulator training, and line flight training and check. 3) Other Flight Crew Member Holding Type Rating for ATR Aircraft <ol style="list-style-type: none"> a. Conducting ground school training and simulator training to establish knowledge and technique of crosswind landing maneuver recommended by the Design and Manufacturer. b. Conducting ground school training for appropriate operations of Stabilized Approach. <p>(2) The Design and Manufacturer</p> <p>Reviewed the procedures for normal operation in landing roll to revise FCOM.</p> <ol style="list-style-type: none"> 1) Clarified that braking was a primary role in deceleration after touchdown. 2) Clarified to set power levers to ground idle at the time of touchdown of a nosewheel and use the reverse as required. <p>*1 "Flight Technical Guide (FTG)" is to supplement for the AOM regarding basic procedures that the Company aims to standardize actual operations, education, and training.</p> <p>*2 According to OM Supplement and AOM of the Company stipulate, that Stabilized Approach means an aircraft is in the position where it can land safely while conducting an approach normally until starting a flare maneuver since passing 1,000 ft AGL to eliminate any unsafe factors in an approach and a landing and to ensure a safe and stable landing.</p>

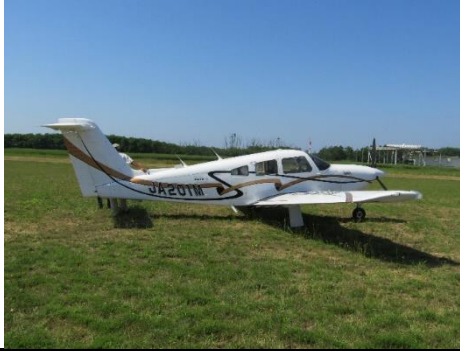
Report	<p>https://www.mlit.go.jp/jtsb/eng-air_report/JA332T.pdf</p>		
5	Date of publication	Date and location	Operator	Aircraft registration number and aircraft type
	March 24, 2022	July 18, 2021 Niigata Airport	Privately owned	JA201M Piper type PA28RT-201T (Small aeroplane)
	Summary	<p>When landing at Niigata Airport, the aircraft halted after deviating to the grassy area on the north side of the runway and was disabled to perform taxiing. The captain and two persons were on board and none of them was injured. The tire of the right main landing gear sustained air leakage. There was no other damage to the airframe.</p>

Probable causes	<p>It is highly probable that the serious incident occurred by the captain's own steering, who recognized that the tire of the right main landing gear had punctured during landing roll, to deviate to the grassy area in the north side of the runway.</p>

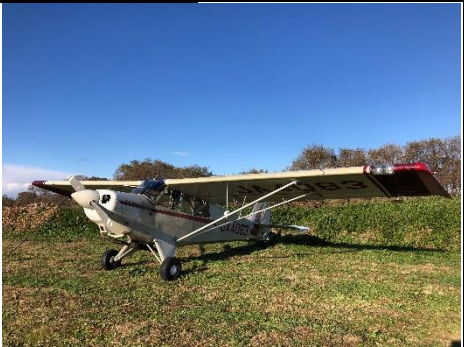
Summary	The airframe leaned to the left during landing roll, and the left wingtip contacted with the ground surface. The pilot alone was onboard, and did not sustain injury.

Probable causes	The probable cause of this serious incident was likely that the aircraft was shaken by the gusty wind from the right direction during landing roll that caused the right wing to float and the aircraft to lean to the left, and the left wingtip contacted with the ground surface.		
	Report	https://www.mlit.go.jp/jtsb/eng-air_report/JA4083.pdf		
8	Date of publication	Date and location	Operator	Aircraft registration number and aircraft type
	June 30, 2022	September 16, 2019 In the sky over near the Komatsu Airfield, at an altitude of about 150 m	Japan Students Aviation League (the League) (Aircraft A)	JA01KY Diamond aircraft HK36TTC Super Dimona (Power glider)
			Japan Students Aviation League (the League) (Aircraft B)	JA2471 Alexander Schleicher ASK21 (Glider)

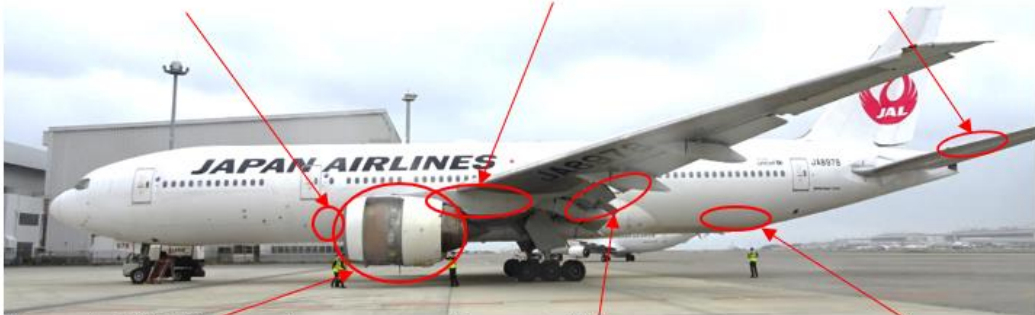
<p>airplane, and the fuselage and horizontal stabilizer were damaged from impact of fragments. There were 189 people onboard, consisting of the captain, 10 crew members, and 178 passengers. There were no injuries.</p> <p>*1 “FL” means a pressure altitude in the standard atmosphere. FL is expressed in the value obtained by dividing the reading on the altimeter (unit: ft) by 100 when the altimeter is set to 29.92 inHg. Flight altitude over 14,000 ft is generally expressed in FL in Japan. For instance, FL170 stands for an altitude of 17,000 ft.</p> <p>Damage to LH FWD fuselage Damage to LH strut and fairings Damage to LH H/STAB L/E</p>

<p>Damage to LH ENG and cowling Damage to LH flaperon Damage to LH AFT fuselage</p>
<p>Probable causes</p>	<p>This was a serious incident certainly caused by the fan blades of the left engine were fractured during take-off climb, resulting in parts and cowlings of the engine were departed, and the airframe was damaged by scattered parts.</p> <p>It is highly probable that the fracture of the fan blade had initiated from the nodule*², which bonded to the internal surface of a hollow structure during the polishing process of manufacturing of the fan blades, and the crack was generated, in addition to this, the Aircraft continued flights without detecting the crack at the subsequent regular inspections led to fatigue fracture.</p> <p>It is probable that the cracks were not detected in the subsequent regular inspections were contributed by method and intervals of the used inspection were insufficient to detect the defect in the fillet region.</p> <p>*2 In this report, “nodule” means a small lump of granular grains adhered to the base material.</p>

<p>Safety Actions</p>	<p>Safety Actions by Pratt&Whitney (P&W)</p> <p>(1) P&W reviewed the inspection method and intervals of the Fan Blade of the similar type of engine, issued Special Instruction (No. 29F-21, No.85F-21 and No.130F-21) and Alert Service Bulletin (ASB) PW4G-112-A72-361, and significantly shortened TAI inspection intervals from every 6,500 FC to every 1,000 FC. Furthermore, UT inspections were set to be conducted every 275 through 550 FC in addition to TAI inspections.</p> <p>(2) The NDIP-1065 Revision G was issued on March 4, 2021 – Revision G incorporates a change in the accept / reject criteria requiring the inspector to refer indications in the high stress area to Team Review instead of being able to accept. Added references to Foreign Material (FM) sample images were added and modified. Flowcharts were updated to reflect G revisions.</p> <p>Safety Actions by Boeing</p> <p>Boeing has developed an interim solution and issued multiple Alert Service Bulletins. The service bulletins include fan cowl inspections and modification to the inlet cowls and thrust reversers to strengthen the integrity of the engine cowling for increased protection for engine fan blade failure events on 777-200 and 777-300 Airplane(s) equipped with Pratt & Whitney PW4000 series engines.</p> <p>(1) Alert Service Bulletin 777-71A0092 issued on January 13, 2022 Fan cowl Fluid Ingression Inspections. This service bulletin provides instructions to inspect fan cowls for possible fluid ingress damage, and do on-condition action(s) to make sure fan cowls are serviceable.</p>

The work scope for the left and right fan cowl panels of Engine 1 and Engine 2 includes detailed inspection of the outer surface top coat, a general visual inspection of the upper edge, and a Thermography Inspection or X-Ray Inspection of the inner surface as well as applicable on condition action(s).

This service bulletin gives instructions to replace affected inlet cowls with changed inlet cowls to strengthen the integrity of the engine inlet cowls for increased protection for engine fan blade failure event. The changed inlet cowls include the following features:

- Inlet aft-bulkhead reinforced with metal plates
- Ballistic shields installed additionally inside of the inlet to prevent fan blade fragments from penetrating the outer barrel.
- Inlet outer barrel panels inspected for fluid ingress and repaired if any defect found.
- Inlet outer barrel panels inspected for prior repairs near aft edge and external metal doublers installed if necessary.
