ANNUAL REPORT 2023

Japan Transport Safety Board
Annual Report 2023
[March 2023]

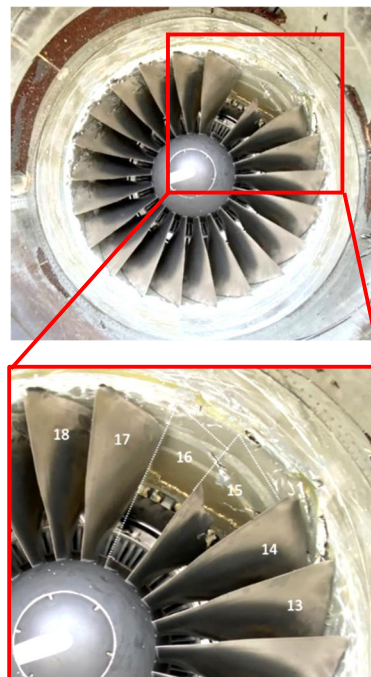
Photo 1 Left engine of the Aircraft

The Aircraft was climbing after take-off from Naha Airport for Tokyo International Airport on December 4, 2020, there occurred an abnormal sound accompanied by shaking of the Aircraft, and the instrument displayed anomaly in the left engine. The captain shut down the engine and landed back at the Airport. In the post-flight inspection, it was confirmed that fan blades of the left engine were fractured, the fan cowl door and other fragments from the nacelle had separated and departed the Aircraft, and the fuselage and horizontal stabilizer were damaged from impact of fragments. (See Photo 1)

It is certain that the fan blades of the left engine were fractured during take-off climb, resulting in parts and cowlings of the engine were departed, and the airframe was damaged by scattered parts.

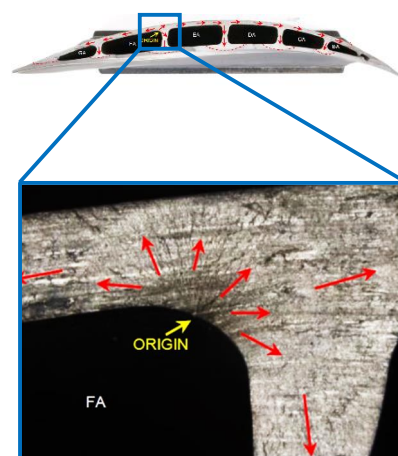
Photo 2 Fractured surface of the fan blade

Since traces of fatigue fracture were found on the fracture surface of the fractured fan blades in the investigation of this serious incident, the Japan Transport Safety Board provided information on the state of the fracture surface of the fan blades to the Civil Aviation Bureau on December 28, 2020 (See Photo 2). In response to this, the Civil Aviation Bureau instructed domestic operators that operate airplanes of the same type to inspect the fan blades, and it was confirmed that there were no abnormalities. However, in the wake of the occurrence of an incident in which the fan blades of an airplane of the same type of another company were fractured in February 2021 in the United States, the Civil Aviation Bureau ordered the suspension of operations of all airplanes of the same type.

In this investigation, with the cooperation of the National Transportation Safety Board (NTSB) of the United States, which designed and manufactured the engine and airframe, an analytical investigation was conducted to determine the cause of the fan blade fracture. As a result, it is highly probable that the fracture of the fan blade had started from the nodule, which bonded to the internal surface of a hollow structure during the polishing process of manufacturing of the fan blades, and the crack occurred, in addition to this, the Aircraft continued flights without detecting the crack at the subsequent regular inspections led to fatigue fracture. It was revealed that the cracks were not detected in the subsequent regular inspections were contributed by method and intervals of the used inspection were insufficient to detect the defect in the fillet region.

Based on the results of these investigations, the engine designers and manufacturers revised the inspection method and inspection intervals of the fan blades, while the airframe designers and manufacturers implemented recurrence prevention measures, such as the strengthening of the protection of the cowlings, etc., in the event of fan blade fracture (see Chapter 3 (page 70) for details).

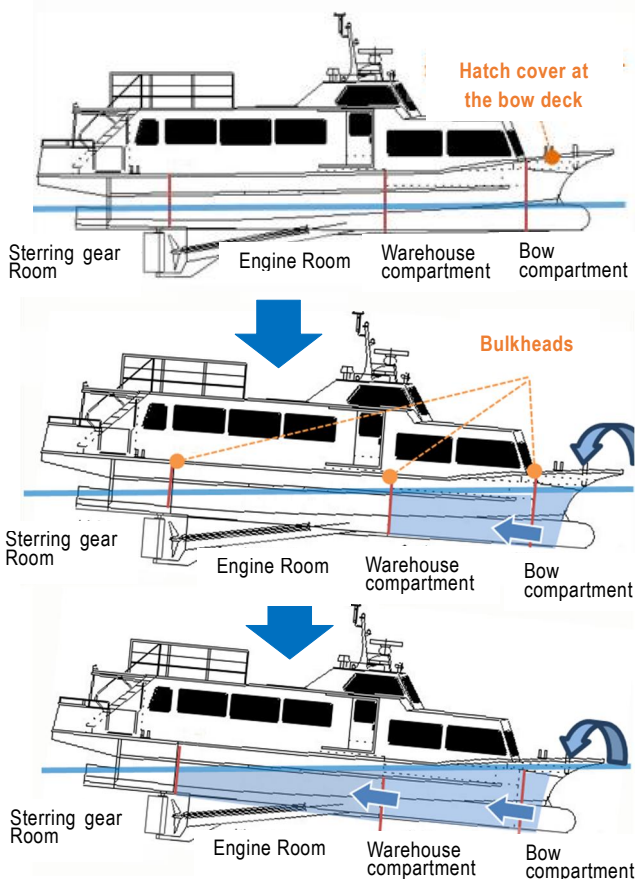
Mechanism from flooding to foundering

In addition, it was found from the results of the investigation of the ship that although the bottom plating was damaged, the damage did not penetrate into its inside, that the hatch cover at the bow deck was missing due to the destruction of the hinge of the mounting part, and that there was an opening in the bulkheads of the ship and the seawater that flooded from the hatch in the bow spread to each compartment under the upper deck.

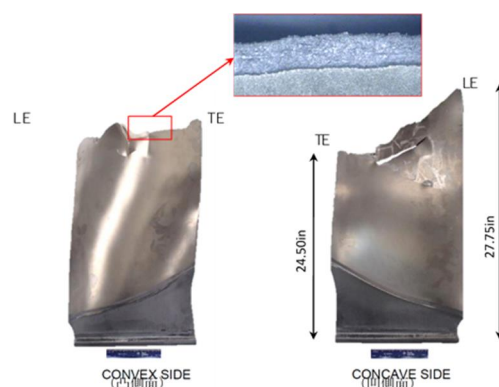
- Serious incident in which the engine of a Boeing 777-200 (large aeroplane), Japan Airlines Co., Ltd. was broken (broken pieces penetrated into the engine) in the sky about 50 km north of Naha Airport (Occurred on December 4, 2020)

The fan blade and the fractured surface of Japan Airlines' aircraft

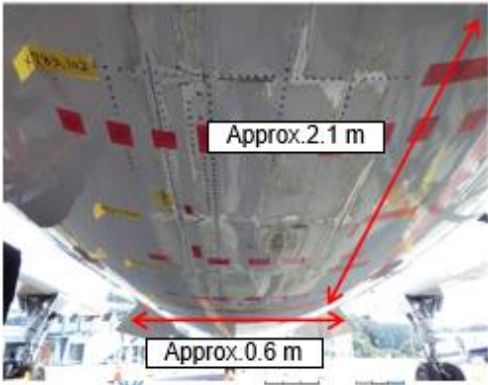
Probable causes	<p>It is probable that the Aircraft was most likely in an excessive nose-up attitude and the lower side of its tail contacted the runway because the captain continued the nose-up operation until moments before the touchdown since the Aircraft did not stop descending due to the airspeed reduction caused by turbulence during the landing flare.</p>

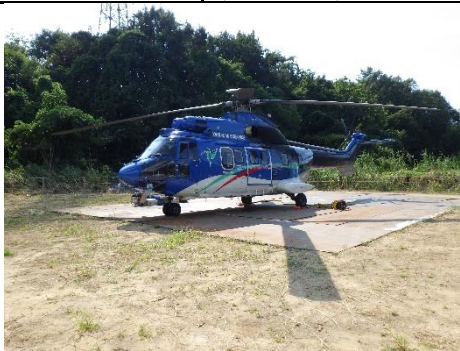
Probable causes	<p>In the serious incident, it is probable that the sling cargo dropped during the external cargo sling operation since the load beam was suddenly unlocked and open. The probable cause of the unlocked load beam could not be determined.</p>		
	Safety Actions	<p>Recurrence prevention measures taken by the Company After the serious incident, the company suspended the use of the subject external cargo sling system, and external cargo sling operations were performed by other existing equipment (manual hook) that was allowed to be equipped to the subject helicopter until improvements in fail-safe of the system operation and enhanced information function to flight crew are implemented.</p>

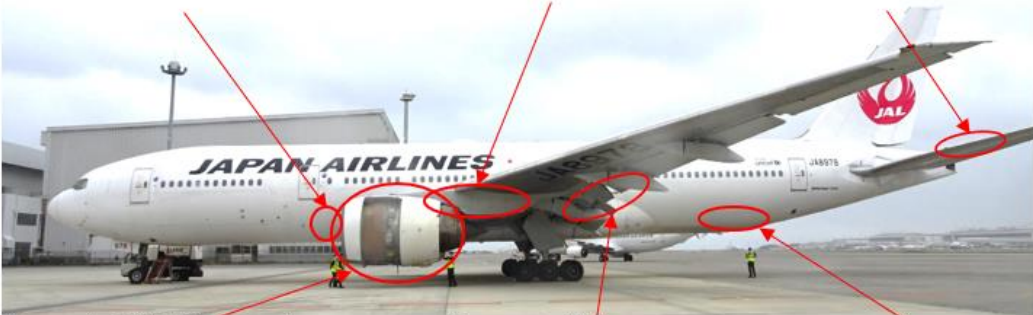
<p>Damage to LH ENG and cowling Damage to LH flap Damage to LH AFT fuselage</p>
<p>Probable causes</p>	<p>This was a serious incident certainly caused by the fan blades of the left engine were fractured during take-off climb, resulting in parts and cowlings of the engine were departed, and the airframe was damaged by scattered parts.</p> <p>It is highly probable that the fracture of the fan blade had initiated from the nodule*², which bonded to the internal surface of a hollow structure during the polishing process of manufacturing of the fan blades, and the crack was generated, in addition to this, the Aircraft continued flights without detecting the crack at the subsequent regular inspections led to fatigue fracture.</p> <p>It is probable that the cracks were not detected in the subsequent regular inspections were contributed by method and intervals of the used inspection were insufficient to detect the defect in the fillet region.</p> <p>*2 In this report, “nodule” means a small lump of granular grains adhered to the base material.</p>

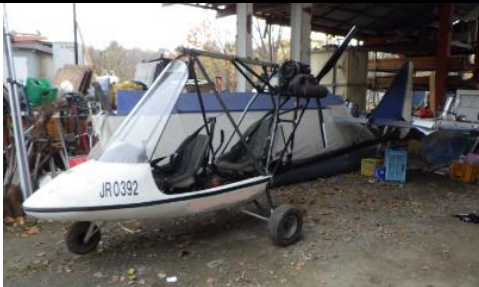
Probable causes	<p>It is probable that since the needle bearing*¹ that connects the connecting rod of the engine No. 2 piston and the crank pin of the aircraft was damaged, the area around the connecting part became hot due to friction and the connecting part between the connecting rod and the crank arm got tied up due to the thermal expansion, causing the engine to stop in flight in this serious incident.</p> <p>It is probable that the reason why the malfunction of the engine was not discovered until it stopped was due to the fact that the maintenance had not been carried out properly based on the maintenance manual.</p> <p>*1 A “needle bearing” is a type of rolling bearing in which an elongated cylindrical roller (needle pin) with a diameter of 5 mm or less and a length of 3 to 10 times the diameter is used as the rolling element. Iron-based bearing steel with excellent wear resistance, such as high-carbon chromium steel, is mainly used.</p>

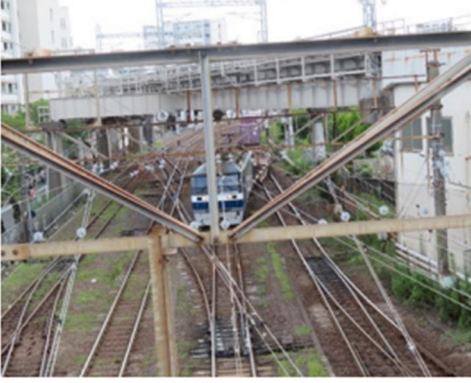
<p>Probable causes</p>	<p>It is probable that the train, coupled with 19 freight wagons, derailed while running by the pushing operation by locomotive, in the concerned accident, because right wheel of the front axle of the front bogie of the third freight wagon climbed up on the guard rail of branch line side at the crossing part of the turnout, after that left wheel entered the wrong track side.</p> <p>It is probable that the back side of the right wheel of the freight wagon climbed up on the branch line side guard rail at the missing part of the turnout, because the lateral force*3 of the front axle of the front bogie increased and the wheel load*4 of the right wheel decreased. It is probable that the vehicle body displaced horizontally and the excessively compressive automatic coupler force*2 was generated in the status that the coupler swing angle of the freight wagon was expanded, while the empty loaded freight wagon was running around the turnout.</p> <p>It is probable that the excessive compressive coupler force had been generated because the operation of the main handle of the mascon*5 had not been implemented obeyed to the prescribed operation, related with that the setting of the weight selecting switch before started the pushing operation by locomotive was not in the prescribed position, and that the driver had been understood that the rule of handling operation in the pushing operation by locomotive did not applied to the concerned train, and the driver's consciousness had been concentrated to velocity and stopping position, although the velocity had not exceeded the limited velocity, just before the front bogie of the third freight wagon was running in around the crossing part of the 192B turnout.</p> <p>It is likely that the education to understand the contents of the works in the pushing operation by locomotive correctly had been insufficient, related with that there was the difference of recognitions for the concerned rule between in the head office, the branch office and the engine division of the JR Freight, as the background of that the driver had been understood that the rule of handling operation in the pushing operation by locomotive was not applied to the concerned train.</p> <p>*2 The “automatic coupler force” means force acting on the coupler between vehicles in the axial direction.</p> <p>*3 The “lateral force” means the horizontal component force acting between the wheel and rail, which is in the plane perpendicular to the longitudinal direction of the rail.</p> <p>*4 The “wheel load” means the vertical component force acting between the wheel and rail, which is in the plane perpendicular to the longitudinal direction of the rail.</p> <p>*5 “Mascon” means “Master Controller”, which is a device operated by the driver to control the acceleration and deceleration of the train.</p>
