## Major activities in the past year

### 1. Publication of the investigation report on the foundering of the passenger ship *KAZU I*

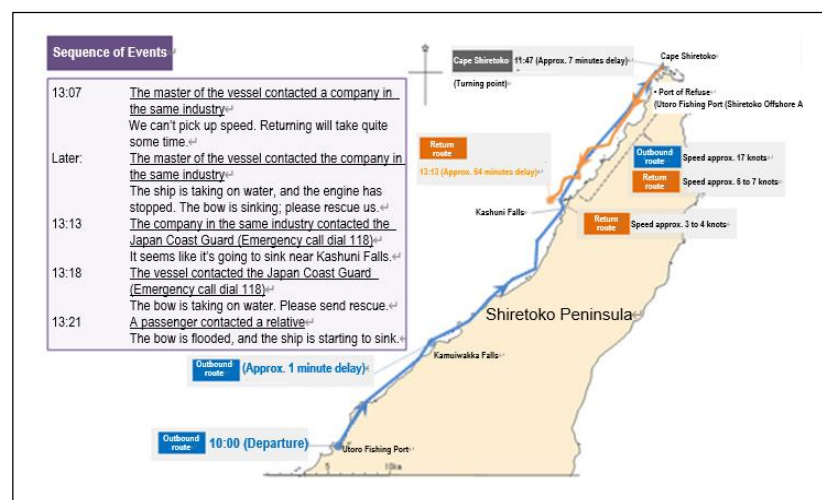
On the day of the accident, the vessel departed from Utoro Fishing Port at around 10 AM for a Shiretoko Cape course, a three-hour round trip to and from Shiretoko Cape. The vessel turned around at the cape at around 11:47 AM. However, due to the passage of a cold front, which caused high waves to spread, the vessel could not make speed on the return trip. Subsequently, the main engine stopped due to flooding, and the vessel began to list. Although a distress call was made, the vessel sank shortly after 1:26 PM on the same day.

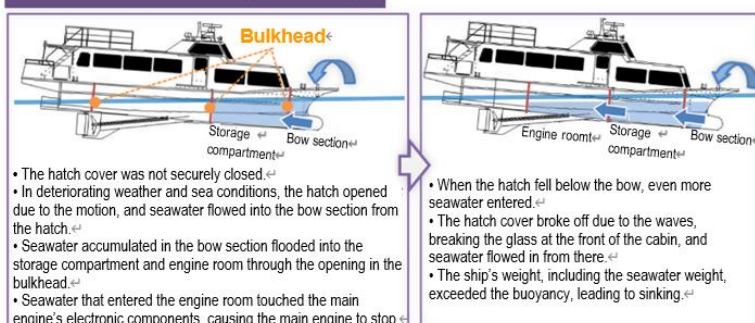
#### Mechanism from Flooding to Sinking

Although it was difficult to obtain direct information on the circumstances leading to the vessel's flooding and foundering in this accident, data from the location information service of a passenger's mobile phone revealed that the vessel turned around at the tip of Shiretoko Cape and did not use the sheltering ports on that day. Furthermore, the hull inspection results indicated that seawater entered through the hatch on the bow deck and spread to various compartments below the upper deck through bulkhead openings.

As a result, by commissioning the Japan Weather Association and the National Maritime Research Institute (NMRI) of the National Institute of Maritime, Port and Aviation Technology, the JTSB clarified the mechanism of the vessel's flooding and foundering through weather analysis and calculation of hull inclination due to flooding.

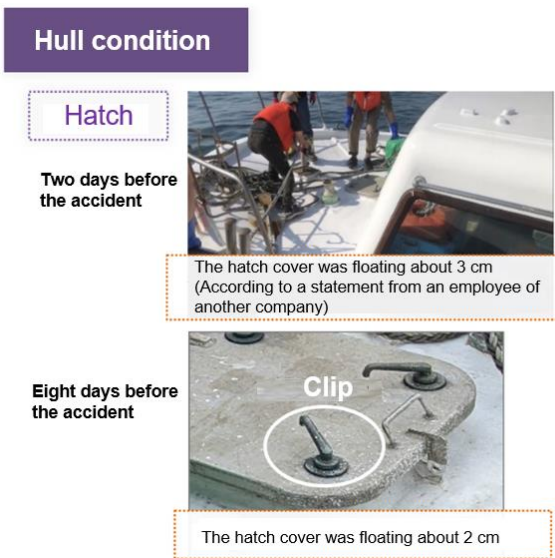
Regarding the hatch on the bow deck, identified in the progress report as the starting point of the flooding route into the vessel, investigations, and analyses were conducted on the possibility of the hatch opening and allowing water ingress.

It was found that the hatch cover had defects that prevented it from being securely fixed, based on the condition of the clips and the floating state of the cover before the accident.

According to the numerical analysis results from NMRI, under the wave conditions on the day of the accident, the hatch cover, which was not secured by clips, could open due to the vessel’s motion, and waves could break over the bow deck.

From these findings, it was analyzed that on the day of the accident, the hatch cover opened early on the return trip from Shiretoko Cape due to the vessel’s motion, and frequent waves broke over the deck under high wave conditions. This led to the progressive loss of buoyancy due to the expanding ingress of water, the main engine’s stoppage, and the vessel’s eventual foundering as the hatch cover, struck by waves, broke the windows of the passenger cabin.

The direct cause was that the vessel departed with the bow deck hatch cover not securely closed despite expected worsening sea conditions and continued navigating without evacuating to a sheltering port. This led to the hatch cover opening due to the vessel's motion, allowing seawater to flow in, expand to compartments below the upper deck, and eventually sink the vessel.

Hardware issues included inadequate maintenance of deteriorating and loose hatch components, JCI's visual-only inspection of the hatch shortly before the accident, and the vessel's structure lacking watertight integrity due to bulkhead openings.

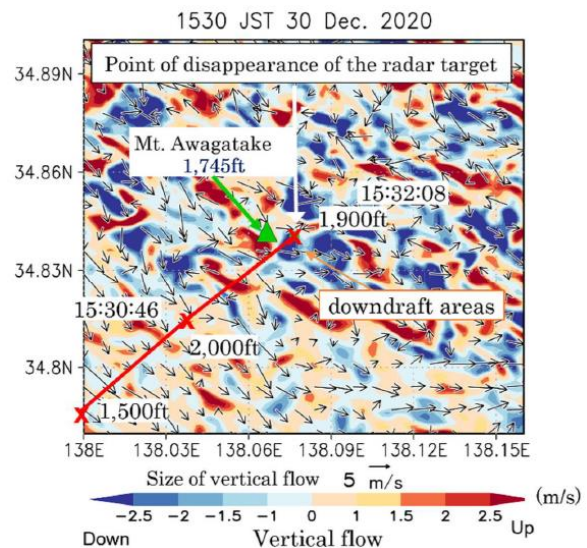
Fig. 1: Vertical flow at 600 m altitude (color) and horizontal wind deviation from the

It is probable that during flight in a mountain region under strong winds, when the helicopter encountered a downdraft caused by a roll-shaped thermal convection and fell into a low-G condition, it is highly probable that the helicopter was resulted in the mast bumping\*<sup>1</sup> and the loss of flight control failure when the aircraft's attitude was not properly controlled, it crashed. The mast bumping occurred leading to the loss of flight control failure was probably because the helicopter continued flying due to encountering turbulence while maintaining airspeed.

In the investigation of this aircraft accident, it was considered that the helicopter experienced sudden attitude changes over the mountainous region, possibly influenced by mountain waves. The Atmosphere and Ocean Research Institute, the University of Tokyo conducted detailed weather simulations to investigate the impact of mountain waves at the time of the accident. The results were compared with information from witnesses and GPS devices to analyze the events leading to the accident.

As a result, the JTSB concluded that while flying at an altitude of approximately 2,000 ft at maximum cruising speed, the aircraft encountered a localized downdraft near the point where the radar target disappeared (Fig. 1). During the low-G flight condition (a state of reduced gravitational forces), the aircraft's attitude was not properly controlled, resulting in mast bumping, where the main rotor blade attachment contacted part of the main rotor drive shaft. This most likely led to a loss of control and a subsequent crash.

Based on the results of this investigation, one measure considered necessary to prevent recurrence is to inform pilots of semi-rigid rotor helicopters<sup>\*2</sup> about precautions to prevent mast bumping, which can lead to loss of control, and to ensure that they obtain necessary weather information before departure. If adverse weather conditions are expected, pilots should either cancel or conduct the flight with a safe flight plan (see Chapter 3, page 44).

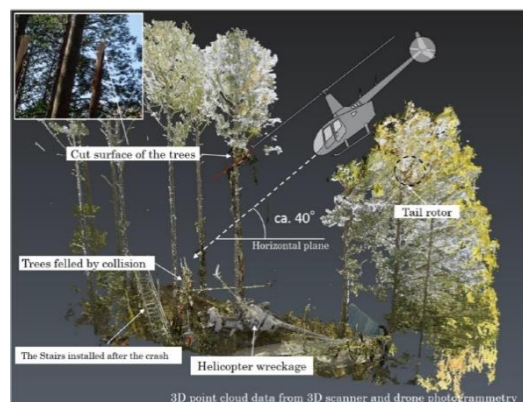
Fig. 2: Estimated approach angle at the time of the crash

In this investigation, to accurately measure the contact position with trees and the wreckage location at the time of the crash, 3D images were taken from above using a drone, and further measurements were made around the wreckage using a 3D laser scanner. By combining these data, the situation near the accident site was

represented as a 3D image (Fig. 2). This investigative method will be used for accident analysis as needed in the future.

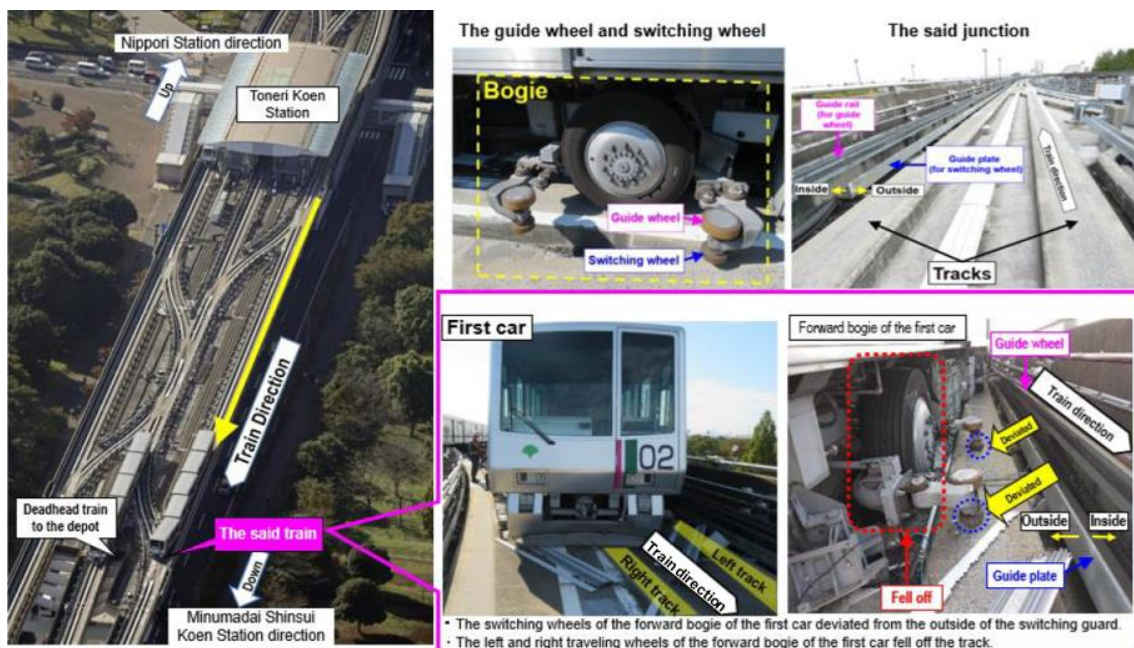
### Situation of the accident site

On October 7, 2021, a train leaving from Nippori Station bound for Minumadai Shinsui Koen Station derailed at a junction within the premises of Toneri Koen Station. An earthquake with a maximum seismic intensity of upper 5 had occurred with an epicenter in the northwestern part of Chiba Prefecture immediately before the accident. Incidentally, eight of 29 passengers were injured in this accident.

It is probable that the train was significantly shaken in the roll direction due to seismic motion, causing the right-side switching wheel of the bogie to ride up onto the guide rail. As a result, the guide rail detached, and the bogie ran towards the right side of the track. Subsequently, the left-side switching wheel of the bogie deviated outside the fixed guide board installed on the left side of the track ahead, resulting in derailment.

- The seismic amplification characteristics of the ground near the accident site may have influenced the occurrence of this accident.
- The natural frequencies of the structures near the accident site in the direction perpendicular to the track and the vehicle's roll direction were around 1.0 Hz, which likely amplified the vehicle's rolling during the earthquake.
- The structures near the accident site exhibited rotational behavior during the earthquake, likely contributing to the vehicle's rolling.

Additionally, during the evacuation of passengers after the accident, re-electrification was conducted without confirming the train's derailment status, resulting in sparks from the overhead wire.

Based on the investigation results, the Tokyo Metropolitan Bureau of Transportation was recommended to take measures to prevent recurrence, such as preventing the guide wheels and switching wheels from riding up onto the guide rail during earthquakes and organizing evacuation guidance methods and procedures that prioritize passenger safety.

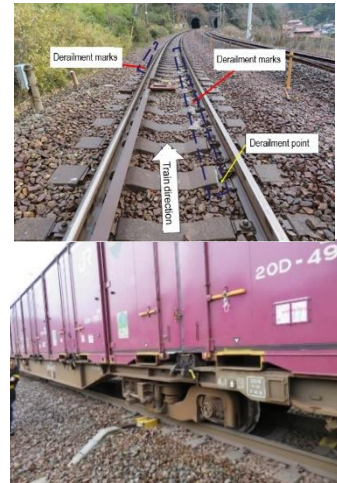
Situation near the accident site

On December 28, 2021, a 25-car freight train traveling from Hiroshima Freight Terminal to Tokyo Freight Terminal, with an additional locomotive connected to the rear due to steep gradients, was traveling at approximately 52 km/h after passing Seno Station when the brakes were applied, and the train came to a stop. When the driver of the front locomotive got off to inspect the train, it was found that all two axles of the front bogie of the 12th car had derailed to the left. There was one driver on the front locomotive and one on the rear auxiliary locomotive, but no injuries occurred.

It is probable that the derailment occurred when the first axle of the front bogie of the freight car experienced a reduction in the wheel load on the outer rail while passing through a right curve with a radius of 300 meters.

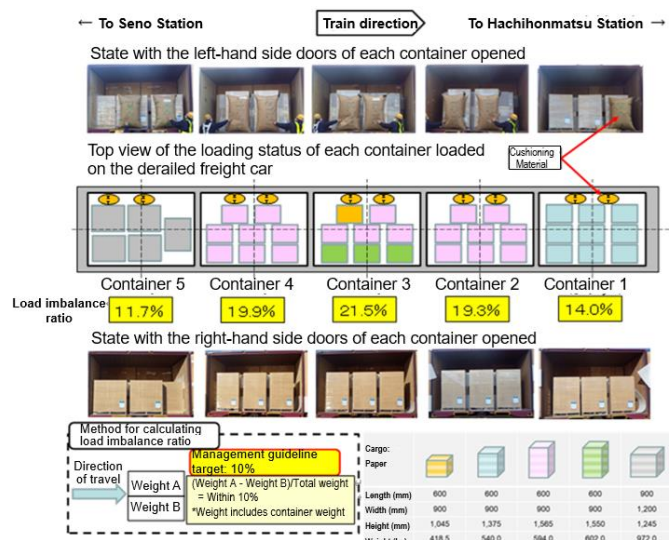
Condition of the cargo in the 12th freight car

The reduction in the wheel load on the outer rail is thought to be due to the imbalance of the wheel load being exacerbated by the cargo in the container being unevenly loaded towards the inner rail side\*.

The uneven loading of the cargo in the container was due to:

(1) Lack of information sharing regarding uneven loading among related companies such as the transport service provider, the shipper, and the loading company.

(2) Inadequate verification system for checking the uneven loading of cargo.

(3) Lack of a mechanism to investigate the cause and take recurrence prevention measures when uneven loading was identified. These factors collectively contributed to the accident.

\*Several containers loaded on the train exceeded the management target guideline of a 10% lateral load imbalance for a single container.

The published accident investigation report includes recommendations for recurrence prevention, such as (1) Ensuring that important information, such as the container loading guidelines, is fully shared and disseminated among companies involved in cargo transportation, (2) Establishing a system to thoroughly understand and address the actual loading practices and prevent uneven loading in advance, (3) Developing a mechanism for investigating the cause and taking recurrence prevention measures in cooperation with related companies, such as transport service providers and loading companies, when uneven loading is identified, and (4) Early enhancement of hardware measures to detect uneven loading effectively.
