# Chapter 5 Marine accident and incident investigations

### Marine serious accident reports published in 2023

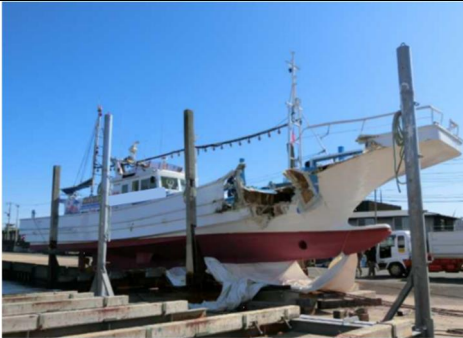
1	Date of publication	Date and location	Vessel type and name, accident type
	January 19, 2023	February 16, 2020 Kashima Port, Ibaraki Prefecture	Recreational fishing vessel No.27 SAKURAIMARU Contact (with breakwater)
	Summary	<p>With the master and one deckhand, one passenger, and 20 anglers on board, the vessel was heading southwest towards Kashima Port, Ibaraki Prefecture, when it contacted with the northern breakwater at the Second Ship Basin of Kashima Port.</p> <p>As a result, 14 anglers, the master, and the deckhand were injured, and the vessel sustained a rupture on the starboard bow. Additionally, the breakwater sustained damage and scuff marks at its tip.</p>

Probable causes	<p>It is probable that this accident occurred when the vessel proceeded southwest at approximately 16 knots towards the Second Ship Basin of Kashima Port. With a blind spot ahead, the master noticed the vessel heading towards the breakwater about 230 meters from the breakwater extending northeast from the opening of the area surrounded by the northern breakwater at the entrance of the Second Ship Basin when the bow of the ship dropped due to the waves and the blind spot disappeared. Upon noticing, he turned the helm to the left to avoid the breakwater, navigating remarkably close to its tip. Due to the influence of the waves, the vessel veered to the right again towards the breakwater, unable to avoid it at a speed of about 16 knots, and collided with the breakwater.</p> <p>The master navigated remarkably close to the breakwater because he usually took a route near it. It is probable that he believed the vessel would clear the breakwater as the heading line on the radar screen pointed to the left, based on his experience.</p>

Safety actions	<p>The following measures are necessary to prevent the recurrence of similar accidents:</p> <ol style="list-style-type: none"> <li>(1) Masters should consider the usual wave conditions in the surrounding sea area and the effects of composite waves generated from reflective waves off nearby structures when navigating past obstacles such as breakwaters, ensuring a safe distance from such obstacles and paying careful attention to the chosen navigation route.</li> <li>(2) Masters should decelerate as much as possible when entering the port, considering the channel's wave conditions.</li> <li>(3) Masters should station deckhands at the bow for lookout duties when entering the port.</li> <li>(4) Masters operating vessels with blind spots should use navigational instruments such as radar and GPS plotters to verify the vessel's position.</li> <li>(5) Shipowners should prioritize visibility from the bow as much as possible in designing and constructing new vessels.</li> </ol>

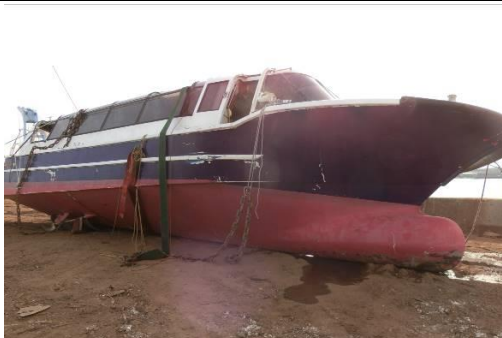
3	Summary	<p>The vessel, which had the master, one deckhand, and 60 passengers on board, ran aground on a drying rock<sup>*1</sup> while navigating off the northwest coast of Wasa Island, Sakaide City, Kagawa Prefecture.</p> <p>The vessel sank, injuring four passengers, after suffering a breach in the outer bottom plate and flooding.</p> <p>*1. The “drying rock” is a rock that submerges at high tide and becomes exposed at low tide.</p>

Probable causes	<p>It is highly probable that this accident occurred off the western coast of Wasa Island when the ship was heading north-northwest towards the Seto Ohashi Bridge. Hearing a passenger teacher explaining the eastern side of Iguro Island to students, the master decided it would be better for the passengers to view the eastern side of Iguro Island. The master checked visually and confirmed that there were no other vessels between the third and fourth bridge piers from the Iguro Island side, concluding that it would be safe to pass between them. However, the master did not notice the presence of a drying rock called Osowai, located to the south of the passage between the piers, approximately 200 cm above the minimum water level, and the ship ran aground on it.</p> <p>It is probable that the master’s failure to notice the drying rock is attributed to the fact that when he glanced at the GPS plotter<sup>*2</sup> screen to confirm the route, he did not enlarge the screen from the 300-meter scale, making the drying rock appear small on display. Additionally, the rock was submerged during the accident and not visible to the naked eye.</p> <p>Despite not usually navigating this area with the vessel, the master had sailed several times a year and believed he was familiar with the rocks and other hazards. Therefore, he did not conduct a waterway survey before departure, contributing to his failure to notice the drying rock.</p> <p>The ship owner had not equipped the vessel with charts marked with standard routes, hazard lines, and other necessary information as specified in the safety management regulations, nor had the safety manager conducted regular safety education on the safety management regulations and related laws. It is probable that this lack of preparation contributed to the master’s failure to conduct a waterway survey before departure.</p> <p>*2. The “GPS plotter” is a device that displays the ship’s position on a map on the screen using information obtained from satellites via the Global Positioning System (GPS) and can plot the ship’s track.</p>

Safety actions	<p>The following measures are necessary to prevent the recurrence of similar accidents:</p> <ol style="list-style-type: none"> <li>(1) Masters should conduct a waterway survey of the planned navigation area using charts, nautical reference maps, fishing facility information, and navigational notices before departure and plan the voyage while identifying obstacles that may hinder navigation.</li> <li>(2) Masters should be aware that in some areas, charts, and the information from electronic navigational reference maps on GPS plotters alone may not provide detailed information on obstacles such as drying rocks or the area’s actual coastline features.</li> <li>(3) If a waterway survey of the planned navigation area has not been conducted in advance, masters should not change the planned route impulsively.</li> <li>(4) Masters should appropriately use detailed displays on GPS plotters and other devices to verify the ship’s position and determine the conditions of the maritime area.</li> <li>(5) Domestic irregular route passenger transport operators must keep charts marked with hazard lines as specified in the reported safety management regulations on board.</li> <li>(6) Safety managers must regularly conduct safety education on safety management regulations and related laws for employees of their company.</li> </ol>

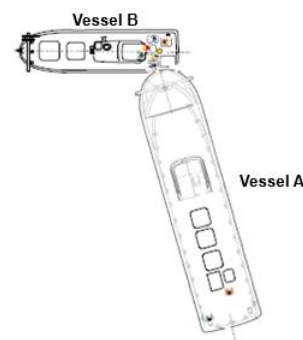
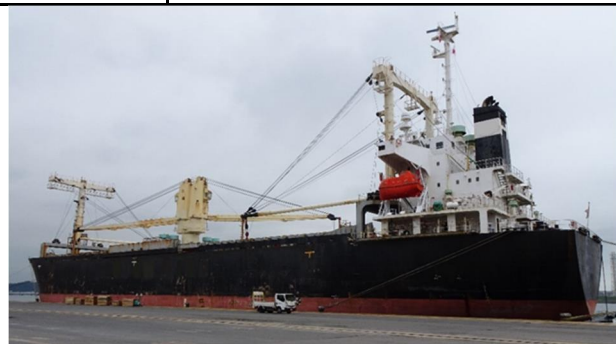
4	Date of publication	Date and location	Vessel type and name, accident type
	March 30, 2023	June 19, 2020 Honmoku Pier A5 Wharf, Yokohama District, Keihin Port	Cargo ship TIMU (Panamanian-flagged) Casualties
	Summary	<p>With a master and 17 crew members, the vessel was moored at Honmoku Pier A5 Wharf. Three stevedores were handling used trucks and other cargo on the second deck of the No. 2 hold, and three welders were attaching D-rings for cargo securing on the same deck. During these operations, two welders were struck by falling used trucks being handled by a crane, resulting in death and injury.</p>	
	Probable causes	<p>It is probable that this accident occurred while the vessel was moored at the pier. Welders were working near the cargo unloading area in the No. 2 hold (hereinafter referred to as “the unloading area”). As the cargo (hereinafter referred to as “the cargo”) approached the</p>

<p>unloading area, the chain sling (hereinafter referred to as “the chain sling”) holding the front gooseneck part of a semi-trailer (hereinafter referred to as “the front part”) broke, causing the trucks to tilt to the port side and fall, hitting two welders.</p> <p>The chain sling in question likely had an insufficient maximum working load*<sup>1</sup> for the maximum working load needed to lift the cargo on the effective side of an asymmetric lift. Additionally, if lateral loads were applied to the chain links on the front part, the links would be subjected to bending stresses exceeding the specified breaking stress for Grade 80 chains under ASTM standards. This could have led to the chain sling breaking under a load smaller than its breaking load*<sup>2</sup>.</p> <p>The stevedoring company did not call the two welders to the pre-operation meeting on the day of the loading/unloading work. They were unaware of the details of the loading/unloading operation. Additionally, the hold supervisor was late in noticing the approaching cargo and failed to communicate this, leading the welders to continue their work facing portside, unaware of the cargo approaching from the starboard side.</p> <p>The work supervisor, finding it difficult to see inside the No. 2 hold surrounded by hatch coaming, believed that loudly communicating the approach of the cargo to the hold supervisor would lead to the evacuation of workers from the unloading area. Despite loudly informing the workers inside the hold, the hold supervisor more likely did not receive the message, and the cargo approached the unloading area.</p> <p>The hold supervisor conversed with the hold workers about tasks, as there was a delay before the cargo would be lifted from the pier. Additionally, he did not hear the loud warning from the work supervisor about the approaching cargo. Consequently, it is probable that the hold supervisor noticed the cargo’s approach late and failed to evacuate workers from the unloading area in time.</p> <p>*1 The “maximum working load” refers to the maximum mass applied to a single chain sling during use. *2 The “breaking load” refers to the maximum load a single chain sling can withstand during a tensile test.</p>

Safety actions	<p>The following measures are suggested to prevent the recurrence of similar accidents:</p> <ul style="list-style-type: none"> <li>• The stevedoring company should select slinging gear with sufficient capacity relative to the weight of the cargo, ensuring that the gear can handle the total weight of the cargo, especially on the effective side in asymmetric lifts.</li> <li>• When using slinging gear to lift cargo with rectangular sections like H-beams by looping under the cargo, the stevedoring company should account for the fact that concentrated loads at the ends of the rectangular sections can cause localized high stress. To distribute the stress, materials such as reinforced fabric rubber pads with adequate elasticity, hardness, tear resistance, and abrasion resistance should be used between the slinging gear and cargo.</li> <li>• Before starting loading/unloading operations, the stevedoring company should hold a meeting with the work supervisors and workers at the worksite to explain the following points:             <ol style="list-style-type: none"> <li>① Work plan (schedule)</li> <li>② Work procedures</li> <li>③ Work methods</li> <li>④ Confirmation of communication methods</li> </ol> </li> <li>• Communication between workers during loading/unloading operations should be ensured using portable radios and visual signals such as hand gestures and flags.</li> <li>• The work supervisor should confirm that there are no workers in the cargo’s path before instructing the crane operator to move the cargo.</li> </ul>

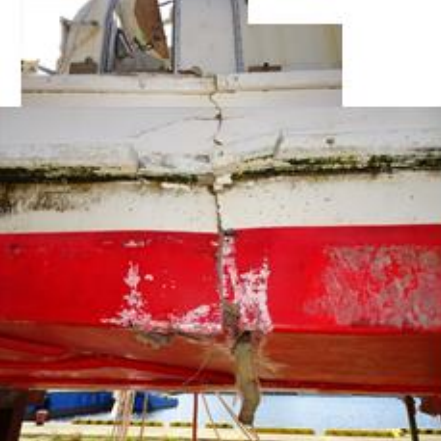
SHINEIMARU (Vessel B) Collision
Summary		<p>With a master and one deckhand on board, Vessel A was heading north towards the fishing grounds off the coast north of Katsumoto Port, Iki City, Nagasaki Prefecture. Meanwhile, Vessel B, with only the master and five anglers on board, was drifting for recreational fishing purposes off the coast north of the same port when the two vessels collided, causing the capsizing of Vessel B.</p> <p>As a result of this collision, two anglers on Vessel B died, and three anglers and the master were injured. Additionally, the portside midsection of Vessel B sustained cracks and other damages (total loss), while Vessel A sustained cracks in the bow's outer plate.</p>	
Probable causes		<p>It is probable that this accident occurred off the coast north of Katsumoto Port, with Vessel A heading north towards the fishing grounds. The deckhand on Vessel A relied on radar for lookout, which was set in a way that could not detect Vessel B due to a blind spot ahead. Meanwhile, Vessel B, drifting with the bow facing west for recreational fishing, had the master focused on the GPS plotter*<sup>1</sup> and considering changes to the return route, believing no other vessels were approaching. This led to both vessels not noticing each other and the subsequent collision.</p> <p>The deckhand on Vessel A relied on radar for lookout because, typically, when detecting radar targets or recognizing multiple vessels outside the blind spot, they would look out of the left and right windows or sway the bow left and right to visually confirm the presence of other vessels within the blind spot. However, it is probable that just before the accident, no radar targets appeared, and no other vessels were seen outside the blind spot, leading the deckhand to believe no vessels obstructed their course and to continue using the radar to supplement the lookout for the blind spot ahead.</p> <p>It is probable that the deckhand on Vessel A could not detect Vessel B on the radar because the left radar, set to a short pulse width, was not adjusted for sensitivity, and the right radar was set to a long pulse width. This configuration made both radars unable to detect Vessel B as the distance decreased to approximately 1.2 miles.</p> <p>It is probable that the master of Vessel B believed no vessels were approaching because, after helping to retrieve fish on the portside midsection of the upper deck, he looked around the starboard side while returning to the wheelhouse and did not notice any approaching vessels.</p> <p>*1. The "GPS plotter" is a device that displays the ship's position on a map on the screen using information obtained from satellites via the Global Positioning System (GPS) and can plot the ship's track.</p>

Safety actions		<p>The following measures should be taken to prevent the recurrence of similar accidents and mitigate damage:</p> <ol style="list-style-type: none"> <li>(1) Navigators should correctly understand their radar's performance, functions, and operation methods and adjust the range, pulse width, sensitivity, rain/snow clutter suppression, and sea clutter suppression levels according to the distance, terrain, weather, and sea conditions.</li> <li>(2) Navigators of vessels with blind spots due to the ship's structure should not rely solely on radar for lookout. They should use visual methods such as swaying the bow left and right to supplement the radar and maintain a proper lookout using all available means, including radar.</li> <li>(3) Shipowners should ensure that the visibility from the bow is maximized as much as possible when designing and constructing new vessels or modifying existing ones.</li> <li>(4) Navigators of drifting vessels should maintain a proper lookout in all directions to detect approaching vessels early. Upon recognizing an approaching vessel, they should issue a warning early and take measures to avoid a collision, such as starting the engine and moving the vessel.</li> <li>(5) Crew members of recreational fishing vessels should, even when they notice that their</li> </ol>

<p>vessel is approaching another vessel and cannot avoid a collision, alert anglers as early as possible using the onboard microphone or other means to ensure they take actions to minimize damage, such as bracing for impact, avoiding injury, or jumping into the water to avoid being trapped inside the vessel in the event of a collision.</p> <p>(6) High-sided vessels with a small crew should equip ladders or other means to rescue anyone who falls overboard effectively.</p>	
	Report	<a href="https://www.mlit.go.jp/jtsb/ship/rep-acci/2023/MA2023-4-2_2020tk0002.pdf">https://www.mlit.go.jp/jtsb/ship/rep-acci/2023/MA2023-4-2_2020tk0002.pdf</a> (Japanese)

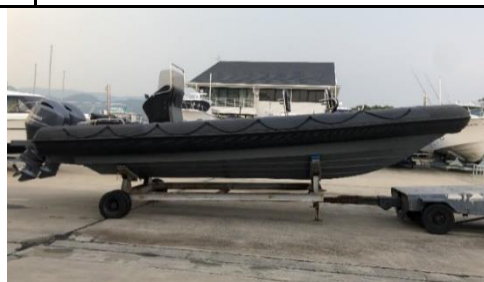
HANABUSAMARU (Vessel B) Collision
	Summary	<p>Vessel A was heading south towards the fishing grounds, and Vessel B was drifting for recreational fishing when the two vessels collided.</p> <p>As a result, one angler on Vessel B died, and the aft deck extension sustained damage, while Vessel A sustained scrapes on the bow's outer plate.</p>	
	Probable causes	<p>It is probable that this accident occurred southeast of Ohara Fishing Port when Vessel A was heading south at approximately 13 knots under autopilot, moving to a different fishing spot. Meanwhile, Vessel B was drifting for recreational fishing. The master of Vessel A, believing no vessels were obstructing his course, continued navigating while organizing fishing gear in the wheelhouse's aft area, failing to notice Vessel B drifting ahead. Meanwhile, the master of Vessel B was focused on the anglers on the starboard deck, the GPS plotter, and the fish finder for vessel position adjustments, delaying his recognition of Vessel A's approach and leading to the collision.</p> <p>The master of Vessel A more likely thought no vessels were obstructing his course and continued navigating while organizing fishing gear in the wheelhouse's aft area because he was more concerned with the positions of four other recreational fishing vessels drifting and fishing from the port beam to the port bow rather than the bow itself, only glancing at the bow momentarily.</p> <p>The master of Vessel B continued drifting without noticing Vessel A's approach. It is probable that he was accustomed to other vessels avoiding his drifting vessel and believed they would do the same during this incident, leading to a decreased awareness of his surroundings.</p>

Safety actions	<p>The following measures should be considered to prevent the recurrence of similar accidents:</p> <ul style="list-style-type: none"> <li>• Masters or other watchkeepers should constantly watch out while navigating and avoid being distracted by specific tasks, focusing on steering.</li> <li>• Masters or other watchkeepers should maintain a constant lookout while drifting and, upon recognizing approaching vessels, should not assume that the navigating vessels will avoid them, taking necessary measures to avoid collisions.</li> <li>• Masters or other watchkeepers should confirm the approach of other vessels by switching radar ranges appropriately in addition to visual observation.</li> </ul>	
	Report	<a href="https://www.mlit.go.jp/jtsb/ship/rep-acci/2023/MA2023-6-1_2021tk0005.pdf">https://www.mlit.go.jp/jtsb/ship/rep-acci/2023/MA2023-6-1_2021tk0005.pdf</a> (Japanese)	 
8	Date of publication	Date and location	Vessel type and name, accident type

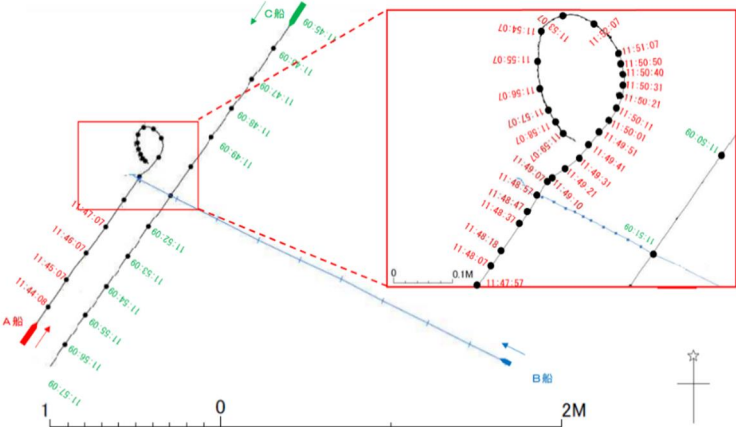
July 27, 2023	February 23, 2021 Off the southeast of Katakai Fishing Port, Kujukuri Town, Chiba Prefecture	Cargo ship ASAHIMARU (Vessel A) Recreational fishing vessel No.3 SHOICHIMARU (Vessel B) Collision
	Summary	<p>With a master and four crew members on board, Vessel A was heading northeast towards Kushiro Port, Hokkaido. Meanwhile, with a master and one crew member on board, Vessel B was heading west-northwest towards Katagai Fishing Port with 12 anglers. The two vessels collided.</p> <p>As a result, the master, crew member, and eight anglers on Vessel B were injured, and the bow was crushed. Vessel A sustained dents and scrapes on the starboard side.</p>	
	Probable causes	<p>It is probable that this accident occurred southeast of Katagai Fishing Port. Vessel A was heading northeast towards Kushiro Port, and Vessel B was heading west-northwest towards Katagai Fishing Port after fishing at the Katagai Trough. Both vessels continued on the same course and speed as their paths intersected almost simultaneously, leading to the collision.</p>

<p>It is probable that Vessel A continued on the same course and speed because the boatswain of Vessel A saw Vessel B on the starboard bow and assumed that fishing vessels and recreational fishing vessels usually avoided Vessel A, believing Vessel B would do the same. Additionally, the presence of an approximately 70-meter-long coastal oil tanker (hereinafter referred to as “Vessel C”) on the starboard-to-starboard meeting situation led him to consider it dangerous to turn starboard to avoid Vessel B.</p> <p>Vessel B continued on the same course and speed because Master B had limited visibility due to spray hitting the front windows of the wheelhouse. When he spotted Vessel A and Vessel C on radar and visually, it is probable that he judged he could safely pass ahead of both vessels. Later, when sea clutter obscured both vessels on the radar screen, he still believed he could safely pass ahead.</p>

Safety actions	<p>The following measures should be considered to prevent the recurrence of similar accidents and mitigate damage:</p> <ul style="list-style-type: none"> <li>• Masters and watchkeepers should continuously monitor the movements of approaching vessels using visual and radar observations without relying solely on their experience. They should also use the radar’s ARPA<sup>*1</sup> functions to maintain a proper lookout.</li> <li>• Masters and watchkeepers should avoid collisions well in advance by changing their course and speed early enough to ensure sufficient time to avoid a collision if there is no</li> </ul>

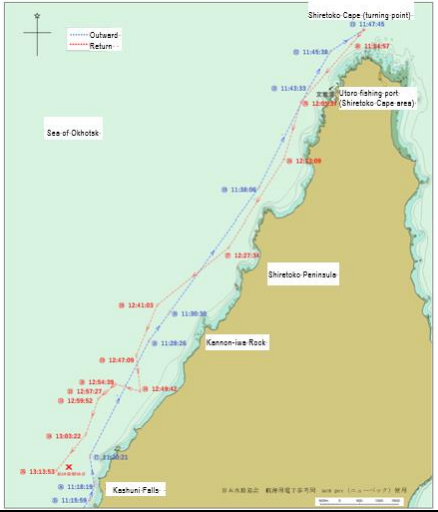
11	Date of publication	Date and location	Vessel type and name, accident type
	September 7, 2023	<p>April 23, 2022</p> <p>Off the western coast of the Shiretoko Peninsula near Kashuni Falls, Hokkaido</p>	<p>Passenger ship KAZU I</p> <p>Foundering</p>
	Summary	<p>With a master and one deckhand, the vessel was navigating the waters off the western coast of the Shiretoko Peninsula with 24 passengers when it began to take on water and sank near Kashuni Falls.</p> <p>As a result of this accident, 18 passengers, the master, and the deckhand died, and six passengers were missing.</p>

Probable causes	<p>(1) Probable causes of the accident</p> <p>① It is probable that the accident occurred because the vessel encountered waves over 1.0 m high while navigating back from Cape Shiretoko under conditions where waves were increasing due to worsening weather with northwesterly winds brought by a cold front passing over the Sea of Okhotsk. These waves hit the bow deck, and the resulting vessel motion caused the bow hatch cover to open, allowing seawater to enter the storage compartment below the upper deck. The water then spread to the storage compartment, engine room, and steering gear room, causing a loss of buoyancy*1 and resulting in the vessel sinking near Kashuni Falls.</p> <p>The bow hatch cover opened under the impact of the waves on the bow deck. The vessel left Utoro Fishing Port*2 despite the expected worsening of sea conditions without ensuring the hatch was securely closed and continued navigation without stopping operations, returning early, or taking refuge in a sheltered port.</p> <p>② It is probable that the bow hatch cover was not securely closed due to inadequate inspection and maintenance of the hatch components, which had deteriorated and loosened over time. The failure of the Japan Craft Inspection Organization (JCI) to conduct an opening and closing test during the inspection just before the accident, relying only on visual checks to judge it in good condition, also contributed to the vessel departing with a faulty hatch.</p> <p>The spread of flooding from the forward compartment to the storage compartment, engine room, and steering gear room was due to the lack of watertight integrity below the upper deck, with bulkhead openings.</p> <p>③ It is probable that the vessel departed contrary to the established operating standards, following the previous method of departing, assuming they would return if weather and sea conditions deteriorated.</p> <p>Moreover, the vessel continued operating without stopping after departure because the master lacked the necessary knowledge and experience regarding the weather and sea</p>

<p>characteristics on the western side of the Shiretoko Peninsula and their impact on the vessel’s handling. Additionally, there was no person in the office of Shiretoko Yuran Co., Ltd. to manage operations and support the master’s decisions. There were no effective means of communication between the vessel and the office. Consequently, the master could not receive information or advice from the office personnel during navigation.</p> <p>The vessel’s lack of effective communication was partly due to the JCI’s<sup>*3</sup> approval of a KDDI Corporation mobile phone with limited coverage on the western side of the Shiretoko Peninsula as the vessel’s communication equipment.</p> <p>④ The significant lack of personnel with the necessary knowledge and experience for safe operation, non-compliance with operating standards, insufficient actual operation management, and inadequate maintenance of physical facilities, such as the hull and communication equipment, at Shiretoko Yuran Co., Ltd. were attributed to the absence of a knowledgeable safety manager. The safety management system was not adequately established, resulting in serious consequences. Furthermore, the Hokkaido District Transport Bureau of the Ministry of Land, Infrastructure, Transport and Tourism failed to identify and address the deficiencies in Shiretoko Yuran Co., Ltd.’s safety management system during the examination of the notification in 2021 when the company’s president was appointed as the safety manager and operations manager, and during the audit of the company. This oversight contributed to the continued operation of the vessel under a weak safety management system.</p> <p>(2) Probable causes of human casualties</p> <p>The vessel’s flooding and sinking resulted in the deaths of 18 passengers, the master, and the deckhand, and six passengers remain missing. The vessel’s lifesaving equipment provided an extremely low chance of rescuing people while they were still alive unless they were rescued immediately after being submerged in seawater with a surface temperature of approximately 4°C. In this accident, the passengers, master, and deckhand were submerged, leading to accidental hypothermia<sup>*4</sup> and the inability to hold their breath, causing them to ingest seawater and die from seawater drowning<sup>*5</sup>. The six missing passengers have not been found, likely due to being swept away in rough sea conditions.</p> <p>*1. “Buoyancy” refers to the force that lifts the vessel upwards when submerged to the upper deck.</p> <p>*2. Utoro Fishing Port is a fishing port located in Shari Town, Shari District, Hokkaido, divided into two districts: the main port in the Utoro area and the branch port in the Shiretoko Cape area. In this report, the main port is referred to as “Utoro Fishing Port,” and the branch port is referred to as “Utoro Fishing Port (Shiretoko Cape Area).”</p> <p>*3. The Japan Craft Inspection Organization (JCI) is a special private corporation established under Chapter 2 of the Ship Safety Act (Act No. 11 of 1933) to ensure the seaworthiness and safety of human life on small vessels. It acts as an agency of the government, handling inspection duties for small vessels.</p> <p>*4. “Accidental hypothermia” refers to a life-threatening condition where the body’s core temperature drops significantly due to exposure to cold.</p> <p>*5. “Seawater drowning” refers to drowning caused by seawater entering the airways.</p>

<p>Safety actions</p>	<p>Based on the causes of this accident, it is necessary to take preventive measures from the perspective of the vessel’s structure and equipment (hatches, bulkheads, communication equipment), the master’s compliance obligations, establishing an operation management system, and the safety management system.</p> <p>(1) Vessel’s structure and equipment</p> <p>① Hatches</p> <p>Shipowners must conduct maintenance to ensure that the hatch closure devices meet the safety standards (weathertight) mandated by the Ship Safety Act and the Small Vessel Safety Regulations. The master must confirm that the hatches are securely closed during pre-departure inspections. The JCI needs to enhance the effectiveness of inspections by regularly checking that hatch clips are functioning correctly and ensuring they meet safety standards.</p> <p>② Bulkheads</p> <p>The Maritime Bureau of the Ministry of Land, Infrastructure, Transport, and Tourism should consider safety standards requiring watertight bulkheads to prevent the spread of</p>

<p>flooding and the vessel’s foundering.</p> <p>③ Communications equipment The JCI must ensure that small passenger vessels have communication devices that allow constant communication on their routes. The inspection methods for radio equipment need to be made effective.</p> <p>(2) Master’s obligations Masters of small passenger vessels must accurately understand and adhere to the operating standards, ensuring they do not depart with the assumption of deciding to return midway if weather and sea conditions deteriorate.</p> <p>(3) Establishment of operation management and safety management systems Operators of small passenger vessels must appoint safety managers, operation managers, and masters with high safety awareness, knowledge of the characteristics of the navigation area, and the ability to make appropriate decisions on whether to depart or continue navigation. They must establish a safety management system that ensures accurate understanding and adherence to safety management regulations and operating standards, enhancing safety awareness, improving the capabilities of all personnel involved in safety, and continuously conducting education, training, and maintenance of the vessel and equipment to maintain and strengthen the safety management system. Collaboration among local operators for mutual safety support is also considered effective.</p> <p>Moreover, the operation management system must function effectively to ensure appropriate operational decisions and land-based support, such as canceling departures, suspending operations, or using refuge ports based on changes in weather and sea conditions. Particularly, operators of small passenger vessels in the Utoro area must accurately understand and comply with the operating standards, ensuring they do not depart with the assumption of deciding to return midway if weather and sea conditions deteriorate.</p> <p>The Maritime Bureau of the Ministry of Land, Infrastructure, Transport, and Tourism needs to enhance the effectiveness of audits conducted by the transport bureau to understand the actual conditions of safety management and operation management by small passenger vessel operators and to take appropriate corrective actions, as necessary. Additionally, it should ensure that small passenger vessel operators accurately understand and comply with operating standards and promote awareness of the importance of identifying and utilizing refuge ports in the navigable areas by including this information in the operating standards.</p> <p>(4) Stricter examination of safety managers and operation managers The Maritime Bureau of the Ministry of Land, Infrastructure, Transport and Tourism will tighten the examination of practical experience, etc., which is a requirement*<sup>6</sup> for Chief Safety Management Officers and Flight Operations Managers. It is also desirable to consider a new system where individuals with experience and knowledge in operation management and safety management, along with high safety awareness, are appointed as safety and operation managers.</p> <p>(5) Lifesaving equipment The Maritime Bureau of the Ministry of Land, Infrastructure, Transport, and Tourism needs to develop lifesaving equipment for small passenger vessels that prevents passengers from coming into direct contact with seawater in case of a foundering. It should also encourage the introduction of such equipment for small passenger vessels operating in areas with low sea surface temperatures.</p> <p>*6. The Enforcement Regulations of the Maritime Transportation Act specify the requirements for safety managers in regular passenger vessel route operations in Article 7-2-2 and for operation managers in Article 7-2-3, and these requirements are applied to irregular passenger route operations as per Article 23-4.</p>

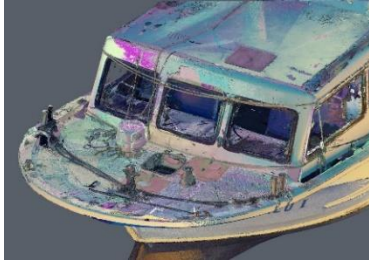
Confirming the shape of the curved deck and the height relationship between the bow hatch and the gunwale

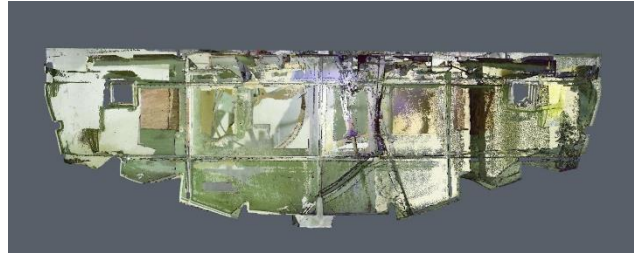
Reproducing interior bulkheads that cannot be photographed entirely due to structures

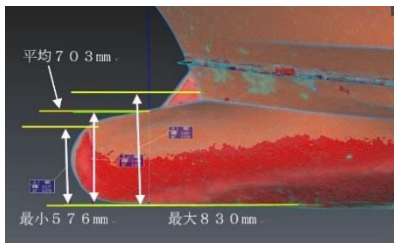
Estimating the draft at the time of the accident
