Major activities in the past year

1 Accident Investigation Regarding a Collision between Aircraft on the Runway at Haneda International Airport in Tokyo

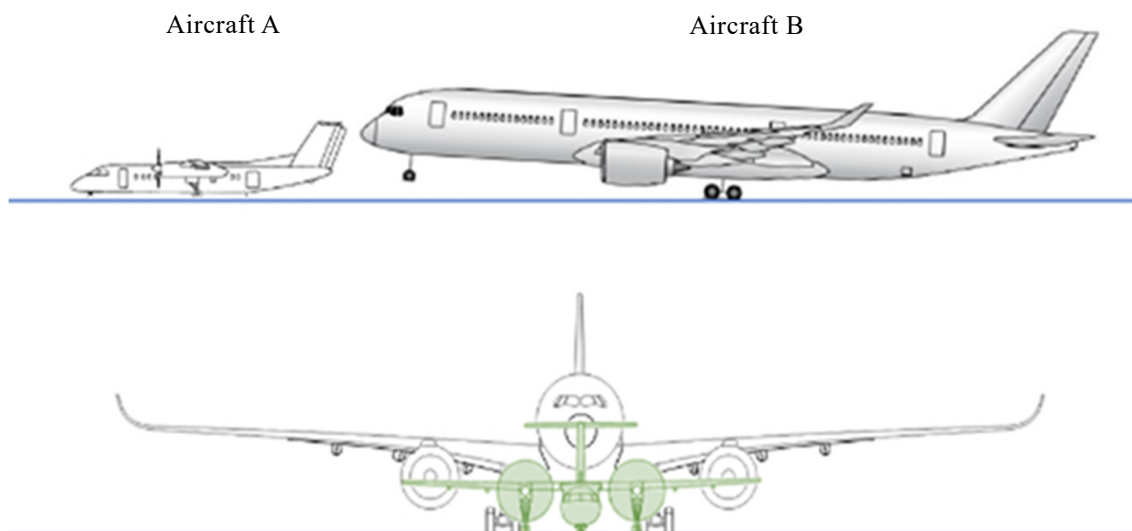
The Situation just before the Collision between Aircraft A and B

The relative positions of the two colliding aircraft were as shown below.

As a result of this collision, it is believed that most of the fuselage of Aircraft A was destroyed. Meanwhile, when Aircraft B collided with Aircraft A, equipment such as the electrical system and control system under the floor of the cockpit was severely damaged. As a result, the wheel brakes that slow down the aircraft did not function, and after taxiing without directional control, Aircraft B continued to roll down the runway and came to a stop in a grassy area.

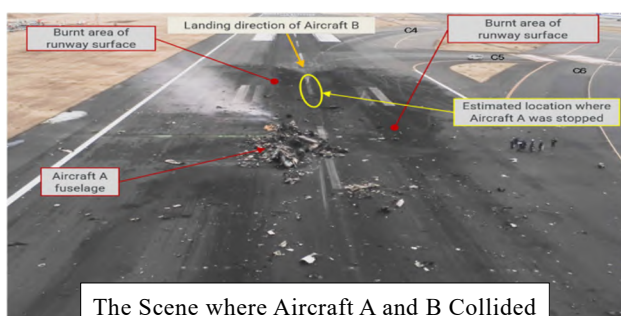
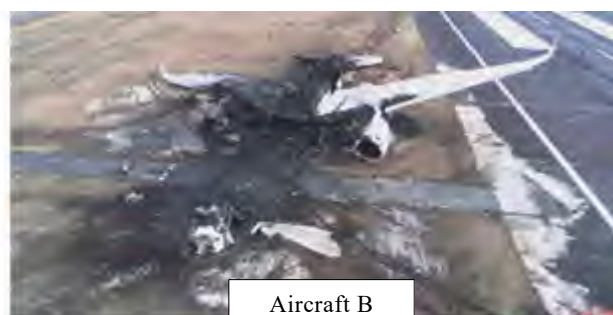
After the collision, the fire that broke out in Aircraft A spread mainly throughout the fuselage. In Aircraft B, the fire burned intensely, primarily in the fuselage, and destroyed most of the aircraft. As shown in the following figure, the fuselages of both aircraft did not retain their original shape.

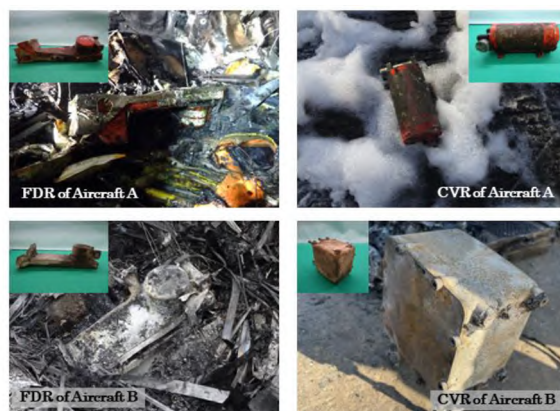
The condition of the flight recorders

In this accident investigation, the Flight Data Recorder records were crucial in clarifying the flight situation and cockpit conditions before the collision. As shown in the figure below, the FDRs of both aircraft were severely damaged by the impact of the collision and the effects of the fire. In particular, the Cockpit Voice Recorder of Aircraft B lost its original shape and took several days to locate. Extracting data from these damaged flight recorders requires special equipment and technology. After repeated trial and error with the cooperation of the relevant states, the JTSC was finally able to extract the recorded data and clarify the situation at the time of the collision.

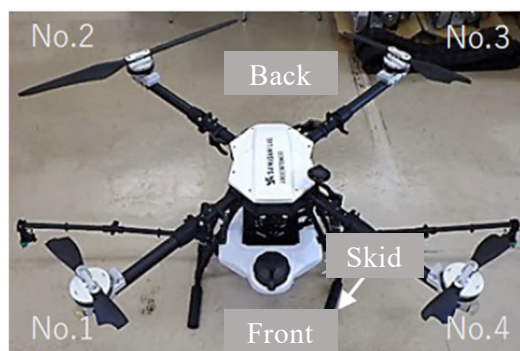
Fig. 1: Accident small UA

On July 14, 2023, a small unmanned aircraft (UA) crashed after colliding with a road sign pillar during pesticide spraying training flight. At that time, the pilot came into contact with the rotating propeller of the small UA, resulting in serious injuries.

In this accident, it is highly probable that the operator was seriously injured because the operator who was approaching the small UA came into contact with the rotating propeller after the small UA collided with a road sign pillar, changed direction toward the operator, and crashed during pesticide spraying training flight.

The reason the operator was approaching the small UA is probable to be that the operator was flying the small UA without being aware of the safe separation distance from the small UA. Additionally, the reason the small UA collided with the pillar is probable to be that the operator was flying the small UA without being aware of the boundaries of the spray area and the safe separation distance from obstacles, and that the operator made an error when interrupting the automatic flight, which made the stopping distance longer than usual.

Based on the results of this investigation, the JTSB indicated that, as one of the safety actions, it is important for those who use small UA for aerial application to assign an assistant to a position according to the flight path and to ensure a safe distance between the small UA and obstacles, the operator, and third parties.

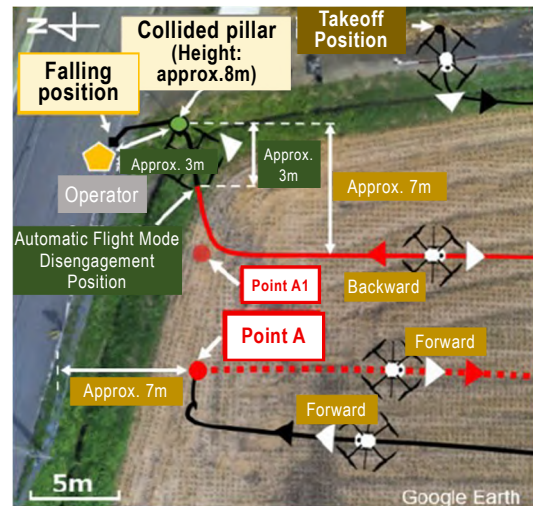
Fig. 2: Flight path at the time of the accident

As a result, it became clear that the operator, who was flying the small UA in automatic flight mode, did not properly switch flight modes when interrupting the automatic flight and stopping the small UA, which resulted in the small UA requiring a longer distance to stop than usual and colliding with the pillar. At that time, it was highly probable that the rotating propeller came into contact with the hand of the operator, who was standing near the pillar, causing the operator's injuries.

In this investigation, to accurately grasp the shape of the rice field and the positional relationship between the utility pole that the small UA collided with and the flight path, photographs were taken from above using a small UA, and the flight path of the small UA near the accident site was depicted by combining the topographic data with the small UA's flight records (see Fig. 2).

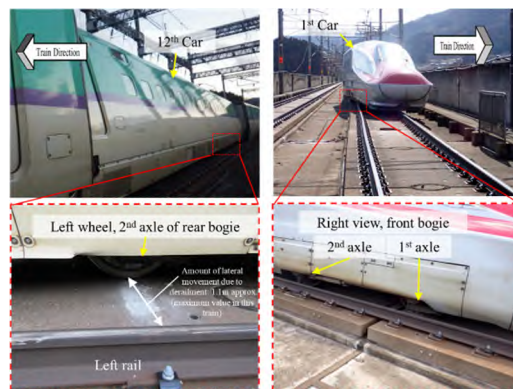
Figure 1 Situation of the Accident Train

On March 16, 2022, the 223B train from Tokyo to Sendai, composed of 17 cars, started from Fukushima station and was derailed between Fukushima station and Shiroishizao station. The 60 of the 68 axles had derailed. In addition, 10 of the 60 derailed axles were in a condition in which the deviation preventing guides, etc. installed on the cars were climbing over the rails. Just before the accident, at around 23:36, an earthquake with an epicenter off the coast of Fukushima Prefecture occurred, with a maximum seismic intensity of 6

It is probable that due to the strong shaking of the track surface caused by the earthquake motion, the rolling of the carbody occurred, then the left or right wheel lifted up, eventually the train derailed after over the rail (rocking derailment).

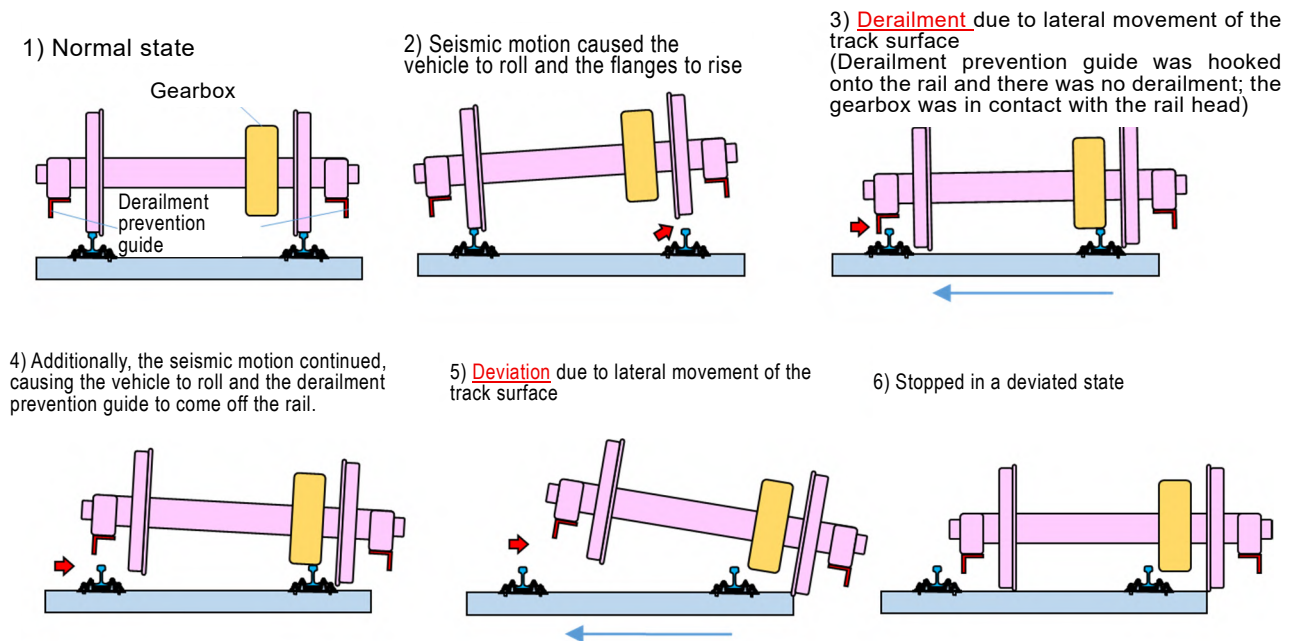
Fig. 2: Image of car behavior during derailment and deviation (example) (The wheel and axle derailed, and deviation prevention guide initially functioned but ultimately deviated.)

The investigation of this accident analyzed the mechanisms of derailment and deviation caused by earthquake ground motion. As a result, the JTSB classified the behavior of each wheel and axle at the time of the accident into eight patterns and found that derailment and deviation occurred in a process such as that shown in Fig. 2 as an example.

Based on the above investigation results, the JTSB has proposed measures to prevent recurrence of accidents, including further enhancing the functionality of derailment and deviation prevention measures for Shinkansen trains.

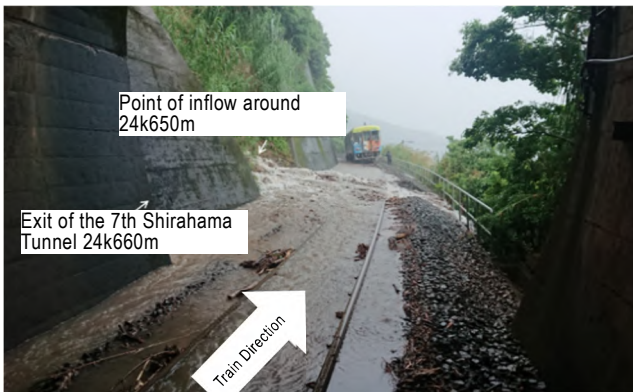
Fig. 1: Situation of the accident site

On June 2, 2023, a single-car train bound for Kubokawa Station from Sukumo Station derailed after running over earth and sand between Ariigawa Station and Tosa-Shirahama Station (see Figs. 1 and 2). There were no passengers on board, only one train driver and one maintenance worker, but no injuries were reported.

It is highly probable that the train departed after rainfall reached the control value at which operation should have been suspended, collided with earth and sand that had accumulated on the tracks, and derailed after running over them.

Based on the above investigation results, the JTSB recommended that Tosa Kuroshio Tetsudo Co., Ltd. establish a system enabling dispatchers who constantly monitor driving conditions to promptly notify train drivers of speed restrictions when the control value for implementing speed restrictions is observed, in order to prevent recurrence of accidents. Additionally, the JTSB recommended the company re-examine its regulations for handling trains during rainfall by comparing them with those of other railway operators, make necessary reviews, and revise its regulations to ensure the safe transportation of trains.

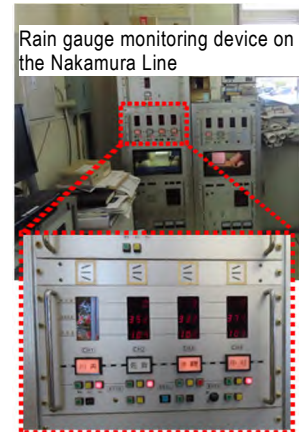
Fig. 3: Rain gauge monitoring device

- On the other hand, the head of facility and rolling stock depot should have been monitoring the rain gauge monitoring device (see Fig. 3), but instead was discussing the operation plan at a distant location and did not pay close attention to the rain gauge monitoring devices.

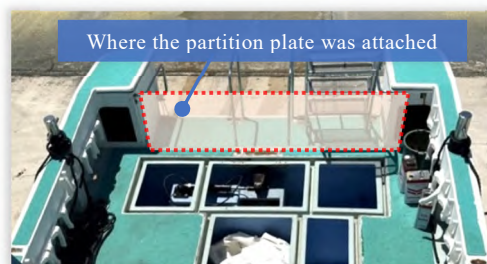
Where the partition plate was attached

This accident occurred when the ship experienced severe wind, rain, and high waves while passengers were diving. Since the ship continued to anchor by letting go anchor from the stern, waves crashed onto the upper deck, seawater and other substances flowed into the engine room from the stern storage, etc. Furthermore, as the Master continued to sail with more passengers on board and the stern lowered, it is probable that the crashing waves caused the ship to flood and capsize.

- By changing the stern shape (removal of the partition plate), the structure became more vulnerable to crashing waves.
- After repairing the hydraulic piping, the penetration was left open without being closed.
- The Master did not obtain information on weather and sea conditions after departure and could not make decisions such as evacuation.
- It was possible that the stern part of the ship sank easily, which affected the deterioration of stability, as approximately 1,000 kg of diving equipment was loaded mainly on the stern deck.
