Chapter 3 Aircraft accident and serious incident investigations

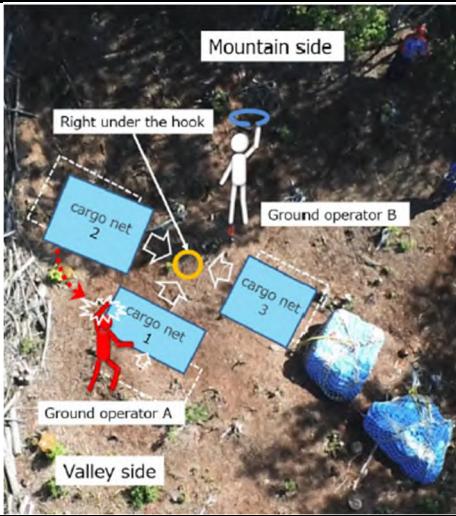
<p>Summary</p> <p>*1“Cargo net” refers to a tool used to wrap and suspend loads by attaching suspension straps to the four corners of the rope woven nets.</p>	<p>When the helicopter lifted the Cargo covered in cargo net^{*1} (hereinafter referred to as “Cargo net”), it came into contact with a ground operator in the mountains in Nantan City, Kyoto Prefecture, and the ground operator was seriously injured.</p>

<p>Safety Actions</p>	<p>It is necessary for the external cargo sling operators to ensure thoroughly that the ground operators shall never approach cargoes without sending a sign to the onboard mechanic, and that when finding the ground operator has not moved to a safe position during the monitoring of ground work, the onboard mechanic shall secure the safety for the ground work in cooperation with the captain. (See “3. ANALYSIS” on the Investigation Report.)</p>		
	<p>Report</p>	<p>https://jtsb.mlit.go.jp/aircraft/rep-acci/AA2024-3-2-JA9678.pdf (Japanese) https://jtsb.mlit.go.jp/eng-air_report/JA9678(3).pdf (English)</p>

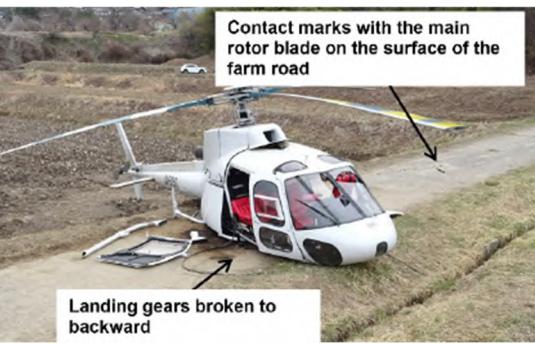
<p>5</p>	<p>Date of publication</p>	<p>Date and location</p>	<p>Operator</p>	<p>Aircraft registration number and aircraft type</p>
		<p>June 27, 2024</p>	<p>March 23, 2021</p>	<p>Privately owned</p>
				<p>JA6050 AÉROSPATIAL AS350B (Rotorcraft)</p>
	<p>Summary</p>	<p>The rotorcraft took off from Tokyo Heliport in Tokyo to transport personnel, and while the helicopter was flying toward Matsukawa Temporary Operation Site, Matsukawa-mura, Kitaazumi-gun, Nagano Prefecture, its engine power decreased over the vicinity of Aoki-mura, Chiiisagata-gun, Nagano Prefecture. Therefore, the helicopter attempted to make a forced landing on a farm road in Ogami, Aoki-mura, resulting in a hard landing, which caused the captain and three passengers to sustain serious injuries, and two passengers to sustain minor injuries. The helicopter was destroyed but no fire broke out.</p>

<p>Probable Causes</p>	<p>The JTSB concludes that the probable cause of this accident was that as the helicopter’s engine power most likely decreased during cruising flight, the helicopter attempted to make a forced landing on a farm road in autorotation^{*1}, and made a hard landing, resulting in injuries to the captain and passengers and the destruction of the helicopter.</p> <p>It is highly probable that the helicopter’s engine power decreased during the flight because the power turbine shaft fractured due to the engine’s power turbine front bearing seizure, however, it was not possible to determine the cause of the power turbine front bearing seizure. And the reason why it became a hard landing at the time of the forced landing was most likely because in autorotation landing, the altitude at flare^{*2}-out became high, and the rate of descent before the touchdown was not sufficiently controlled.</p> <p>*1 "Autorotation" refers to an autorotation flight, and flight condition in which the main rotor blades responsible for the lift are driven only by the aerodynamic force completely at the time of the rotorcraft in motion. (Airworthiness Inspection Manual)</p> <p>*2 "Flare" refers to deceleration operation for landing, which allows the rate of descent to reduce by converting kinetic energy into potential energy.</p>

Safety Actions	<p>(1) As private pilots who fly single-engine helicopters have limited opportunities to take the training of one of emergency procedures taken at the time of engine power loss, it is important for them to fly considering the height velocity-envelope^{*3}, weight, and wind direction / velocity, and it is important to conduct trainings by imaging the landing site, approach direction, and operations at touchdown in case of attempting a forced landing in autorotation in a daily basis.</p> <p>(2) In case of attempting a forced landing in autorotation, in accordance with the emergency operations procedures, it is necessary to maintain NR and airspeed before the start of flare maneuver. Making an autorotation landing on a narrow place requires such advanced skills of touchdown operations by flare, when is unable to bring the helicopter into the wind, or its weight is too heavy, in order to reduce the load at touchdown as much as possible, it is important for a pilot to select the widest possible site and try to land.</p> <p>(3) When the power turbine front bearing of the same type of engine was replaced, it is desirable for the design and manufacturer company collect the replaced parts, examine the deterioration status, and consider additional countermeasures.</p> <p>^{*3} The “height-velocity-envelop, or H/V curve” is a graph charting the height and speed at which a helicopter can safely transition from normal flight to autorotation.</p>

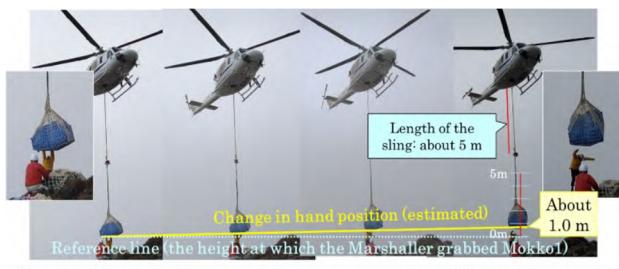
8	Date of publication	Date and location	Operator	Aircraft registration number and aircraft type	
	August 29, 2024	November 28, 2022 Miyakonojo City, Miyazaki Prefecture	Shikoku Air Service Co., Ltd.	JA6977 Bell 412EP (Rotorcraft)	
	Summary	<p>The rotorcraft operated by Shikoku Air Service Co., Ltd., was lifting a cargo during cargo sling operation near the summit of Mt. Ohachi in the Kirishima Mountain Range, Miyakonojo City, Miyazaki Prefecture, the cargo away from the ground came close to a ground operator. Unable to avoid the approaching cargo, the ground operator grabbed it by his hands and his body was lifted along with the cargo. The ground operator left the hands from the cargo immediately after that but was injured when landing on the ground.</p>

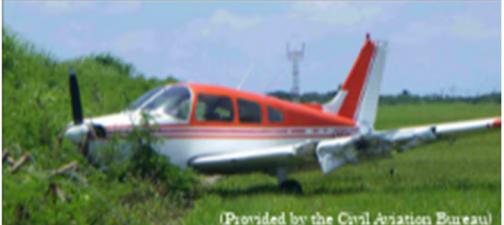
publication			and aircraft type
	September 26, 2024	June 5, 2024 Yoron Airport, Kagoshima prefecture	Privately owned	JA3712 Piper PA-28-151 (Small aeroplane)
	Summary	While the aircraft was landing at Yoron Airport, it deviated from the runway and collided with the airport's perimeter fence, resulting in damage to the leading edges of both wings, and so on.

<small>(Provided by the Civil Aviation Bureau)</small>	
	Probable Causes	The JTSB concludes that the probable cause of this accident was that when the aircraft was on its landing roll and the rudder was used to correct its direction before it had sufficiently slowed down, and the left brake pedal was most likely pressed in the process, which activated the left brake, causing the aircraft to veer to the left, deviate from the runway, enter the grass field, and collide with the perimeter fence, damaging the aircraft.		
	Safety Actions	In the initial training, it is desirable to instruct student pilots to correct heading during the ground run after landing by using the appropriate amount of rudder depending on the speed and to master the appropriate foot position when using the rudder. (See "3. ANALYSIS" on the Investigation Report.)

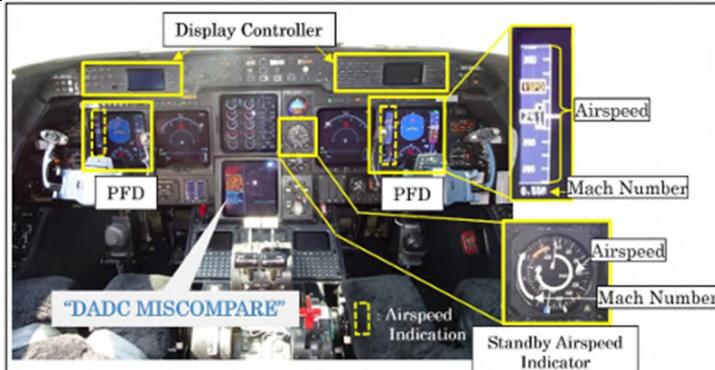
5	<p>Date of publication</p> <p>August 29, 2024</p>	<p>Date and location</p> <p>May 22, 2020 At an altitude of about 13,200m, about 300km southwest of Tokyo International Airport</p>	<p>Operator</p> <p>Prime Jet, LLC</p> <p>Aircraft registration number and aircraft type</p> <p>N146BG GULFSTREAM AEROSPACE G-IV (Large aeroplane)</p>
	<p>Summary</p> <p>The aircraft operated as a positioning flight by Prime Jet, LLC became the airspeed indications unreliable on both primary flight displays *¹ (PFDs) receiving the air-data from a remaining Digital Air Data Computer *² (DADC) when commencing the descent for landing while the flight crew members had deactivated one of the two DADCs, which the flight crew members decided that it had failure during the cruise for the</p>

<p>Tokyo International Airport after the take-off to position the Aircraft from Phnom Penh International Airport. After that, the Aircraft landed at Tokyo International Airport. There were three people on board, including two crew members other than the captain in the Aircraft, no one was injured, and the aircraft had no damage.</p> <p>*¹ “Primary Flight Display” is an integrated instrument that displays information necessary for flight, such as attitude, altitude, and speed.</p> <p>*² “Digital Air Data Computer” is a device that processes outside air information and digitally outputs such as altitude, speed, temperature, and others.</p>		
	Probable Causes	<p>The JTSB concludes that the probable cause of this serious incident is certainly to be determined as falling under the category of multiple malfunctions in one or more systems installed on aircraft impeding the safe flight of aircraft because both airspeed indications became unreliable when the aircraft began the descent in the situation where the flight crew members deactivated No. 2 DADC determined to be faulty as the action for the DADC MISCOMPARE message and the PFDs for both seats use the data from No. 1 DADC.</p> <p>It is possible that the reason that the airspeed indications on the PFDs for both seats, which had been using the data from No. 1 DADC became unreliable was because the aircraft was flying through airspace where ice crystals existed and the No. 1 pitot line was blocked. Regarding the operating status of No. 2 DADC determined to be faulty by the flight crew members, it could not be determined with almost no records on the DFDR except the one during the descent and few objective factual information.</p>

Safety Actions	<p>The design and manufacturing company probably needs to reorganize the descriptions in the QRHs^{*3} related to DADC MISCOMPARE message. (See “3. ANALYSIS” on the Investigation Report.)</p> <p>*³ “QRH” stands for Quick Reference Handbook, which describes the contents of the Airplane Flight Manual regarding emergency operations and performance for quick retrieval and viewing in actual flight operations.</p>		
	Report	<p>(Japanese) (English)</p>

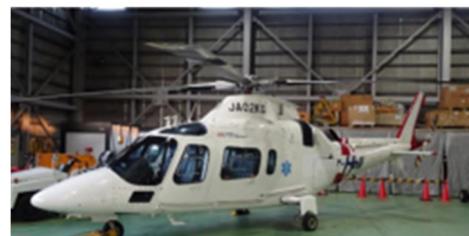
6	Date of publication	Date and location	Operator	Aircraft registration number and aircraft type
	August 29, 2024	June 2, 2022 Kagoshima Airport	Independent Administrative Institution Civil Aviation College	JA74MD Cirrus SR22 (Small aeroplane)
			Kagoshima International Aviation Co., Ltd.	JA02KG Agusta A109E (Rotorcraft),
	Summary	<p>At Kagoshima Airport, while a Cirrus SR22, JA74MD, operated by Independent Administrative Institution Civil Aviation College, stopped on Taxiway T2 in preparation for take-off following the instruction from an air traffic officer, an Agusta A109E, JA02KG, operated by Kagoshima International Aviation Co., Ltd., attempted to approach and land to the take-off and landing position for helicopters (Helipad) established on the taxiway in order to perform a stop-and-go^{*1} being cleared by another air traffic controller.</p> <p>*¹ The “stop and go” means that an aircraft stops once on the runway (on the helipad set on the taxiway in this serious incident) and takes off from that position.</p>

<p>Causes</p> <p>Tower issued a clearance to perform a stop-and-go at the Helipad to Aircraft B, despite the presence of Aircraft A, which was stopped on the taxiway set with the Helipad.</p> <p>It is highly probable that the reason why the Tower cleared Aircraft B to perform a stop-and-go at the helipad was because the Tower had not sufficiently visually confirmed that there were no aircraft and others there that could obstruct a stop-and-go by Aircraft B, and had not recognized the presence of Aircraft A.</p> <p>The failure of the Tower to recognize the presence of Aircraft A was probably due to the fact that the Tower missed the opportunity to recognize the presence of Aircraft A because the Tower did not request prior approval from the Ground responsible for managing the Helipad and because the Ground did not transfer the radio communication for Aircraft A to the Tower. It is possible that a background factor in these incidents was the heavy workload on the Tower due to a temporary increase in traffic.</p>										
	<p>Safety Actions</p> <p>When the air traffic controller in charge of the tower control position issues a clearance for landing or stop-and-go and others, it is the basic actions to ensure sufficient visual confirmation that there would be aircraft and other obstructions in the vicinity. In addition, it is necessary for the control tower to ensure the safety of helicopters landing or performing stop-and-go on the Helipad and aircraft on the taxiway by establishing the specific procedures for approval and permission with regard to the method of operation and use of the Helipad and taxiway set with the Helipad as countermeasures to reduce risk. (See “3. ANALYSIS” on the Investigation Report.)</p>										
	<p>Report</p> <p>https://jtsb.mlit.go.jp/aircraft/rep-inci/AI2024-4-3-JA74MD_JA02KG.pdf (Japanese) https://jtsb.mlit.go.jp/eng-air_report/JA74MD_JA02KG.pdf (English)</p>										
7
