## Chapter 4 Railway accident and serious incident investigations

### 3 Statistics of investigations of railway accidents and serious incidents

### Railway accident investigation reports published in 2024

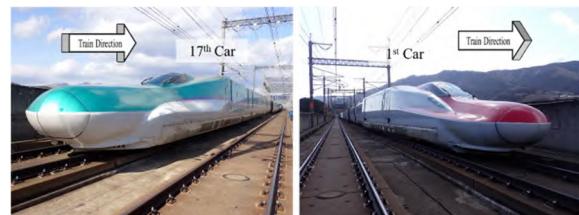
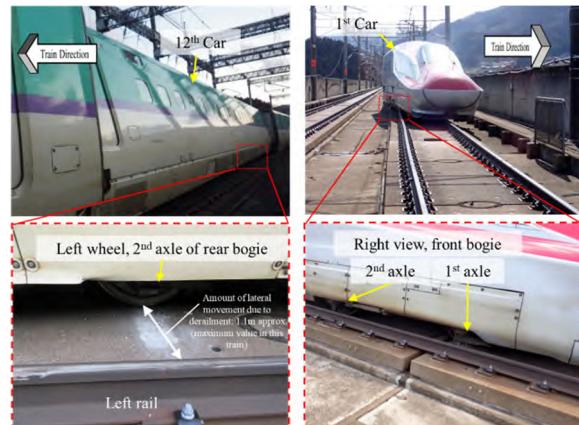
1	Date of publication	Date and accident type	Railway operator	Line section (location)	
	February 26, 2024	March 16, 2022 Train derailment	East Japan Railway Company	Between Fukushima station and Shiroishizao station, Tohoku Shinkansen, Shiroishi City (Miyagi Prefecture)	
Summary		<p>The train started from Fukushima station with 5 minutes late than the scheduled. The train stopped due to the urgent brake automatically triggered by a power failure on the overhead catenary when it was traveling between Fukushima station and Shiroishizao station at a speed of approximately 154 km/h</p> <p>After the train stopped, the driver felt the shaking of a large earthquake, and when he checked the train from inside and outside after the shaking stopped, he found that several cars had derailed.</p> <p>As a result of the subsequent investigation, 60 of the 68 axles had derailed. In addition, 10 of the 60 derailed axles were in a condition in which the deviation preventing guides, etc. installed on the cars were climbing over the rails.</p> <p>There were 75 passengers, one driver and four conductors on board, in which six passengers were injured.</p> <p>At around 23:36:33 on the same day, a magnitude 7.4 earthquake with an epicenter off the coast of Fukushima Prefecture occurred, with a maximum seismic intensity of 6 Upper on the Japanese scale. About two minutes before the quake, a foreshock of magnitude 6.1 occurred, with a maximum seismic intensity of 5-lower on the Japanese scale.</p> <p>*1 "deviation preventing guide" means a guide installed under the journal box of the bogie to contact the rail after derailment to prevent the car from deviating too far from the rail in the event of a derailment of Shinkansen train due to an earthquake or other event. Also referred to as L-shaped car guide, etc.</p>

Probable causes	<p>It is highly probable that this accident, derailments of the train, was caused by the earthquake motion from the earthquake that occurred at 23:36:33 on March 16, 2022, which had its epicenter off the coast of Fukushima Prefecture.</p> <p>It is possible that the process leading to the derailment have been the rolling of the car body caused by the strong shaking of the track surface due to the earthquake motion, which caused the left or right wheel to lift up and over the rail, leading to the derailment (rocking derailment). In addition, the rolling of the car body caused excessive deformation of the air springs, resulting in air spring air loss, it is possible that which have contributed to the derailment.</p> <p>With regard to the deviation preventing guide or the rail guard mounting arm was off and deviated from the rail on some of the wheelsets, it is likely there are following possibilities: Continued seismic motion after the derailment caused the deviation preventing guide, which was preventing the deviation, to climb over the rails and deviate, or the deviation of the deviation preventing guide occurred after the rail guard mounting arm or gear box fell on the rail at the time of derailment.</p> <p>In this accident, it is probable that the earthquake, which occurred approximately 2 minutes before, triggered the system to stop the train early enough, the train had already stopped at the time of derailment, and that the many deviation preventing guides and other devices functioned to prevent the train from deviating too far from the track, thereby preventing the damage from spreading.</p> <p>*2“Rocking derailment” refers to, in case the track vibrates vertically or laterally due to an earthquake etc., a derailment due to the wheel set vibration in the roll direction along with a violent lateral vibration. Specifically, one wheel remains in contact with the rail, while the other wheel lifts off the rail, next the wheel that is in contact with the rail slides along the rail, the wheel set moves laterally, then the flange of the wheel that coming down rides on the rail, or off the rail and derails.</p> <p>*3 The “rail guard mounting arm” here refers to a device installed under the journal box of the bogie for mounting rail guard (a device installed just in front of the wheel at the front end of the train to eliminate obstacles that may interfere with running safety), ceramic jetting device (a device that jets ceramic powder between the wheel and rail as adhesion improvement materials), etc.</p>

Safety actions	<p>As Shinkansen trains are designed to run at high speed, in the event of a derailment and further deviation, it is assumed that significant damage will occur, so safety should be ensured to the maximum extent possible through countermeasures to prevent derailment and deviation, and further upgrading for the countermeasures should be considered and implemented to prevent derailment and deviation of Shinkansen trains in light of the recent accident.</p> <p>In addition, in this accident, although many deviation preventing guides and other devices were functioning to prevent the car from deviating significantly from the track, some of them were not working as expected, and deviations occurred. Particularly, wheel sets with the rail guard mounting arm installed also include leading axles of a train. The leading axle of a train is not restrained by a coupled car, so, if the train derails and deviates while in running, there is a possibility that the deviation will be significant, and the damage will be extensive. Therefore, it is desirable to conduct sufficient deliberations in the future and implement effective countermeasures that minimize deviations.</p> <p>Further, this accident was the train derailment and/or deviation due to the strong shaking of the track surface on the viaduct or other structure, and countermeasures to suppress vibration by improving cars and structures are considered effective, therefore, it is desirable to continue to promote research and technological development in order to implement these measures.</p>

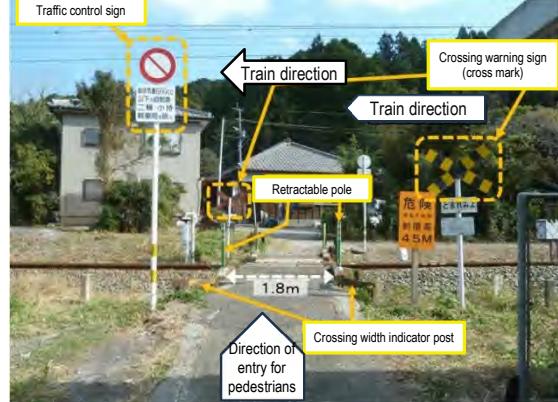
Summary	<p>The driver of the train, while running between Sashiu Station and Kozaki Station, recognized a pedestrian entering from the left side just before Sekita Crossing (Class 4 level crossing) (front, rear, left, and right are based on the train's direction). The driver immediately sounded the horn and initiated an emergency stop, but the train collided with the pedestrian.</p> <p>As a result of this accident, the pedestrian was fatally injured.</p>

Probable causes	<p>It is highly probable that this accident occurred because a pedestrian entered Sekita Crossing (A Class 4 level crossing without a crossing gate or a road warning device) while the train was approaching, resulting in a collision.</p> <p>Regarding why the pedestrian entered the crossing while the train was approaching, it is probable that the pedestrian did not notice the approaching train, but the details could not be clarified as the pedestrian was deceased.</p>

Safety actions	<p>It is desirable to abolish Class 4 level crossings without crossing gates or road warning devices to improve safety. If abolition is impossible, they should be upgraded to Class 1 level crossings. Until abolition or upgrading to Class 1 level crossings is implemented, it is recommended to promote various safety measures for Class 4 level crossings, such as strengthening traffic regulations and installing warning signs. Furthermore, it is desirable that the Company, Oita City, and Oita Higashi Police Station of Oita Prefecture strive to raise safety awareness among pedestrians at the crossing to ensure that safety checks are carried out by stopping temporarily in front of the crossing.</p>	
	Report	<p><a href="https://jtsb.mlit.go.jp/railway/rep-acci/RA2024-3-1.pdf">https://jtsb.mlit.go.jp/railway/rep-acci/RA2024-3-1.pdf</a> (Japanese only)</p>

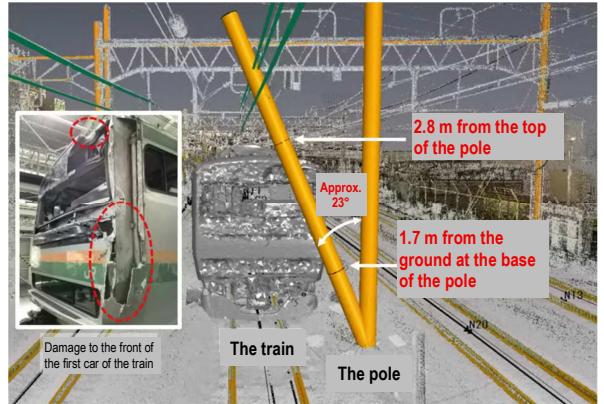
Summary	<p>The train collided with a tilted utility pole while the train was running in the premises of Ofuna Station. The train traveled approximately 205 meters after colliding with the utility pole and then stopped. Afterward, upon inspecting the site, it was found that the front left side of the first car (cars are counted from the front, and front, back, left, and right are based on the train's direction) was severely damaged, the utility pole was broken, and the overhead wire was left hanging.</p> <p>The train had approximately 1,500 passengers, one driver, and two conductors on board, of whom 4 passengers and one driver were injured.</p>

Probable causes	<p>It is highly probable that this accident occurred because a heavily tilted utility pole collided with an approaching train, resulting in shock inside the train and an increase in the internal temperature due to power failure.</p>	<p>The heavily tilted utility pole is believed to have been caused by water entering from horizontal cracks near the ground level of the pole, leading to part of the PC steel bar<sup>*1</sup> corroding and breaking, which rendered the pole unable to withstand the bending moment.</p>

<p>The presence of horizontal cracks in the utility pole is thought to be due to the equipment conditions that subject the pole to relatively large bending moments compared to design values, which, under the influence of temporary bending moments from wind and earthquakes, caused excessive bending moments near the ground level, leading to horizontal cracks, and the continued state of these cracks</p>
