Chapter 5 Marine accident and incident investigations

7 Summaries of serious marine accidents and incidents which occurred in 2024

Marine serious accident reports published in 2024

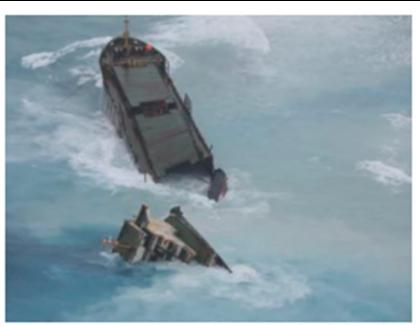
2	Date of publication	Date and location	Vessel type and name, accident type	
	March 28, 2024	January 24, 2023 Off the northwest of Taketomi Island, Taketomi Town, Okinawa Prefecture	The cargo ship XIN HAI ZHOU 2 (Panama) Grounding	
	Summary	<p>The cargo ship was drifting for the purpose of time adjustment off the west of Ishigaki Island, Ishigaki City, Okinawa Prefecture, when she was pushed by the wind and waves. She therefore started her main engine and navigation; however, she continued to be pushed without gaining sufficient propulsion or rudder effect and ran aground on a shallow reef off the northwest of Taketomi Island. The cargo 2's hull subsequently broke in two at her center section.</p>

<p>It is probable that the accident occurred when, under conditions in which a gale warning for the sea south of Okinawa and southern part of the East China Sea as well as a high winds advisory and heavy seas warning for Ishigaki City and Taketomi Town had been issued, the Vessel drifted off the west of Ishigaki Island, where the Shallow Reef exists to the south, received northerly wind and waves from her port side and was pushed south; she continued to drift even after the wind and waves intensified until her distances to the Shallow Reef reached about 3 M; and she subsequently started her main engine and began navigating in an attempt to proceed north but could not gain sufficient propulsion and rudder effect to overcome the external forces, and therefore she continued to be pushed in an uncontrollable state and ran aground on the Shallow Reef.</p> <p>It is somewhat likely the Vessel could not gain sufficient propulsion and rudder effect after she started her main engine because the Master continued to use the main engine at half-ahead revolutions and did not use the maximum available output, resulting in main engine output that was approximately 40% of the MCR.</p> <p>It is probable that the Vessel drifted off the west of Ishigaki Island, where the Shallow Reef existed to the south and where she received wind and waves from the north, without taking refuging steps, such as heaving to^{*1} using the main engine, because the Master thought based solely on weather information he obtained from an overseas weather information website that the weather and sea conditions would not present a problem for navigation if they were as forecasted.</p> <p>It is probable that the Vessel continued to drift even after the wind and waves intensified until her distance to the Shallow Reef reached about 3 M because the Master thought the weather and sea conditions would not present a problem for navigation if they were as forecasted and therefore did not instruct the officer of the watch to monitor and maintain the Vessel's position during drifting and did not specify matters to be reported to the Master concerning changes in weather and sea conditions, etc., or the timing of such reports.</p> <p>^{*1} “Heaving to” is a method of ship maneuvering for keeping a vessel in place by using enough forward propulsion from the main engine to maintain the rudder's effectiveness during stormy weather and catching the wind and waves at slight angle to the bow.</p>

<p>The following measures are possible to prevent recurrence of and mitigate the damage caused by similar accidents:</p> <ul style="list-style-type: none"> • In cases where a passage plan must be changed, the master of a vessel should obtain the latest data and information on the revised destination and weather and sea conditions from the ship management company or local ship's agent. • The master should make weather predictions based on comprehensive judgments from multiple sources of weather information, including forecasts from local weather authorities. When weather and sea conditions are expected to worsen and a safer anchorage is available inside port, the master should coordinate with their ship's agent^{*2} or other concerned party to permit early port entry. If a suitable place to refuge is unavailable, the master should consider moving to safe waters away from the shore and using the main engine to turn the bow to windward or heave to. • When drifting, the master should select a drifting location with no shallow reefs or other such features downwind that is suitable for the forecasted weather and sea conditions as well as geographical conditions. • The master should confirm in advance the possibility of arranging a tugboat in case the vessel's control becomes difficult. When intending to use a tugboat, the master should request it with plenty of time to spare. • When drifting, the master should give clear instructions to the officer of the watch concerning monitoring and maintaining the ship's position and specify the matters to be reported to the master concerning changes in weather and sea conditions, etc., and the timing of such reports, and should have officers of the watch make reports to the master so that moving to a safe area can be completed as soon as possible before the danger of approaching a shallow reef, etc., increases. • The master and officers should, based on a full understanding of the vessel's maneuvering performance and engine performance, handle the main engine within a range that extends to its maximum available output so that sufficient propulsion can be obtained for early movement to a safe area if the vessel encounters stormy weather.

<ul style="list-style-type: none"> The master should share information on the status of ship operations, use of the main engine, and other matters between the bridge and the engine room, and should establish an operating environment that allows him or her to receive advice on the use of the main engine not only from the crew members on the bridge but also from those in the engine room. <p>*2“Ship’s agent” refers to a business operator who, based on a contract, acts as an agent for the shipping company or master of a vessel when the vessel enters or leaves a port. The agent secures the wharf and other facilities, coordinates cargo handling arrangements, completes procedures for entering/leaving port with concerned government agencies, arranges for pilots and tugboats, and handles other necessary matters.</p>	
	Report	https://itsb.mlit.go.jp/ship/rep-acci/2024/MA2024-3-1_2023tk0001.pdf (Japanese) https://itsb.mlit.go.jp/eng-mar_report/2024/2023tk0001e.pdf (English)

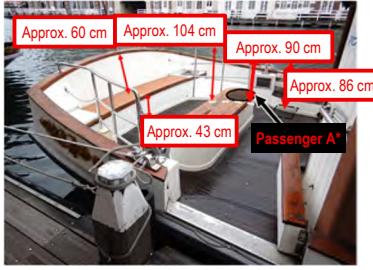
3	Date of publication	Date and location	Vessel type and name, accident type
	April 25, 2024	April 12, 2023 Sasebo City, Nagasaki Prefecture	Passenger ship DELFT Fatality
	Summary	While the passenger ship DELFT, operated by the master alone, with seven passengers on board, was sailing through a canal in a theme park, one passenger fell overboard and died.	
	Probable causes	<p>It is probable that the accident occurred during the night, while the vessel was sailing in the canal in Huis Ten Bosch, Passenger A fell overboard and drowned. It is likely that Passenger A fell overboard from near the gangway of the port side on the stern deck, but as there were no witnesses and no objective information was available, the situation that led to Passenger A falling into the water could not be clarified.</p>

Safety actions	<p>The vessel is an attraction for the theme park as well as a vessel engaged in regular ferry line service for general passengers. It is desirable that the operators, including the company, who operate the vessels in theme parks, take safety measures based on both tangible and intangible elements to reassure passengers.</p> <p>The company suspended the operation of the Canal Cruiser after the accident, but resumed operation on April 18, 2023 after taking the following measures.</p> <ul style="list-style-type: none"> It was decided that passengers on the stern deck should be requested to wear lifejackets, and the company posted that on the stern deck (in four languages (Japanese, English, Korean and Chinese)) as well as informed the passengers (in four languages) through broadcasting before boarding and at the time of departure, and it equipped lifejackets on the stern deck. Safety management regulations were also revised. It was decided that passengers should not move from their seats while the boat was in motion, and the company posted that on the stern deck (in four languages) and informed (in four languages) through broadcasting before boarding and at the time of departure. A camera with a recording function was installed on the stern deck and the rear of the cabin, and a monitor installed in the cockpit was displayed. A message requesting passengers not to lean forward was posted on the stern deck in larger letters than before the accident (in four languages). In addition to the rope on the gangway, a rope was also installed on the inside. The vessel and outboard motor boat were equipped with portable lights to help ensure the safety of passengers at night. <p>In addition, it is probable that the following measures will help mitigate damage in similar accidents in future.</p> <ul style="list-style-type: none"> It is desirable to conduct drills assuming various accident responses that may occur during operation, such as searching for water droppers at night and rescuing unconscious men overboard.

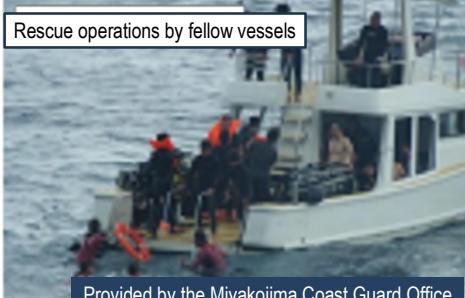
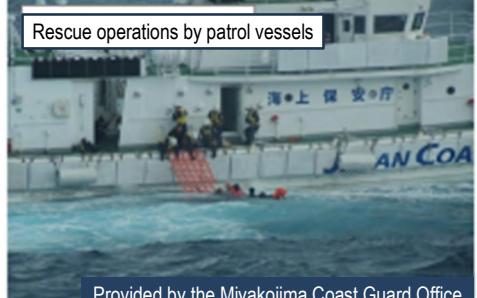
10	Date of publication	<p>Date and location</p> <p>Vessel type and name, accident type</p>
	September 26, 2024	<p>August 16, 2023 Off the Northwest coast of Shimoji Island, Miyakojima City, Okinawa Prefecture</p> <p>Diving vessel CRYSTAL M Capsizing</p>
	Summary	<p>While the vessel, operated by the master alone, with 12 diving passengers and seven instructors, was sailing off the northwest coast of Shimoji Island, it flooded and capsized. The vessel sustained damage such as water damage to the engine room.</p> <div style="display: flex; justify-content: space-around;"> <div style="text-align: center;">

Probable causes	<p>It is probable that this accident occurred off the northwest coast of Shimoji Island, when the wind direction changed from southwest to northwest while passengers were diving heavy winds and rain and high waves caused, the vessel continued to anchor with the open transom*¹ type stern facing northwest, with the anchor in front of the stern, causing waves to crash onto the upper deck from the stern, and seawater, etc. flowing into the engine room from the stern storage, etc., reducing the freeboard. Furthermore, with passengers on board, the vessel continued to navigate with the stern lowered while being hit by waves approximately 2 m high without being able to drain off the water. As a result, water continued to flood the vessel as the upper deck at the stern became submerged, the main engine stopped, the vessel became uncontrollable, and the vessel capsized.</p> <p>It is probable that the waves crashed into the stern because the bulkhead at the stern had been removed, and the weight of the diving equipment on board had reduced the freeboard at the stern. In addition, it is highly probable that seawater, etc., which had entered the storage at the stern, flowed into the engine room because the ship had left the openings and penetrations open without sealing them after the hydraulic piping was repaired.</p> <p>It is probable that the reason the vessel continued to anchor with its stern facing northwest, in the same direction as the wind and waves, was because the master of the vessel recognized that there would be no problem even if waves crashed into the vessel, since any water that entered the upper deck would be discharged overboard without remaining inside the vessel.</p> <p>It is possible that the master of the vessel failed to detect the adverse weather conditions at an</p>

<p>early stage based on the latest meteorological and oceanic information, cloud formation, etc., and was unable to make decisions such as evacuating the area before the weather and sea conditions worsened, which may have contributed to the occurrence of this accident.</p> <p>*1 Wide-open stern section</p>
Safety actions	<p>(1) Response to changes in stern shape</p> <p>The modification to the stern shape by removing the partition plate after the vessel's first regular inspection falls under "changes that may significantly affect stability." However, the vessel's owner did not report this change, and it was not identified during subsequent regular inspections by the Japan Craft Inspection Organization (JCI), therefore, it appears this modification was overlooked.</p> <p>(2) Effect of carrying diving equipment on stability</p> <p>It is probable that on the day of the accident, the vessel was carrying approximately 1,000 kg of diving equipment, mainly on the upper deck at the stern, and the loading of this equipment reduced the freeboard at the stern, which may have contributed to the deterioration of stability, as described in the cause of the accident. It is more likely that in general, diving vessels, like the vessel, navigate with heavy diving equipment loaded on them, meaning that ensuring stability becomes an issue.</p> <p>(3) Involvement of relevant administrative authorities</p> <p>It is probable that Company A carried approximately 4,500 diving passengers (including about 1,000 people on the vessel) in 2022, operating repeatedly under an operating agreement between the operator and the diving company, however, as described in "Guidance by relevant agencies for diving vessels, etc." and "Analysis of guidance provided by relevant authorities, etc.," the initiatives of relevant administrative authorities are currently not necessarily sufficient.</p>

Safety actions	<p>The following matters may well be useful in preventing similar accidents from recurring and mitigating damage in future.</p> <p>Masters of the diving vessels, diving vessel owners, and the operators involved in the operation of diving vessels should take the following measures to prevent similar accidents on diving vessels:</p> <p>(1) Masters</p> <ul style="list-style-type: none"> For open-truss diving vessels with a small stern freeboard, be aware that the structure is prone to wave intrusion from the stern. Especially when at anchor, if wave intrusion is expected, position the anchor at the bow. Understand the drainage capacity and structure of their vessels. If water ingress is detected, immediately confirm the flooded areas and flood volume. If there is a risk to the safety of the hull, take necessary emergency measures such as requesting immediate drainage and rescue. Always collect the latest weather and information on sea conditions. If they detect a deterioration in weather conditions while offshore, such as changes in cloud cover, immediately stop diving and begin evacuation. When there is a risk of capsizing, sinking, etc., work with the instructor on board to guide passengers to safety. In this case, the instructor should assist the master in preventing panic, wearing lifejackets, and contacting rescue services, etc. After diving passengers and crew have evacuated to the sea, the instructor should work to ensure buoyancy, visibility with portable floats, and prevent drifting and dispersion. <p>(2) Diving vessel owners</p> <ul style="list-style-type: none"> If they make any modifications that could significantly affect stability, such as changes to the stern structure, report to the JCI and undergo a special inspection. If there are openings in compartments below the upper deck, water ingress, such as from waves, can spread to other compartments, leading to dangerous conditions like capsizing or sinking, so seal the openings with boards or other materials to prevent the spread of water ingress. It is desirable to install a water ingress alarm system, etc. to detect flooding early. If loading diving equipment significantly changes the draft, etc., report this to the JCI and receive guidance to ensure the stability of the diving vessel. <p>(3) Operators involved in the operation of diving vessels</p> <ul style="list-style-type: none"> Operators who, like Company A, operate diving vessels with a set number of passengers in response to the needs of diving businesses, should clearly define operational standards such as wave height and wind speed in writing, taking full consideration of the seaworthiness of the managed vessels, so that they can make appropriate decisions regarding evacuation, etc. in the event of sudden changes in the weather. Establish a system for communicating with fellow businesses in the area in case of emergencies and sharing information on weather and sea conditions, etc.

Safety actions	<p>(1) Ensuring the effectiveness of stability inspections</p> <p>Changes to the stern structure and the loading of heavy diving equipment affect vessel stability. While vessel owners must naturally exercise caution themselves, in cases where structural changes are clearly visible during inspection or where interviews about the vessel's purpose suggest inadequate stability, the JCI should provide appropriate suggestions and advice to enhance the effectiveness of visual inspections, even when the inspection applicant has not requested approval for structural changes.</p> <p>(2) Initiatives of relevant administrative authorities</p> <p>① Necessity of multi-layered initiatives, etc.</p> <p>To ensure the safe navigation of diving vessels and the safety of the many passengers on board, in addition to the voluntary operational control by operators, we believe that relevant government agencies should also strive to grasp the actual operation of diving vessels, examine the current state of initiatives, and provide multi-layered safety management and guidance regarding safe operation, etc.</p> <p>② Guidance and raising awareness by relevant administrative authorities on site, etc.</p> <p>From the perspective of ensuring the safety of diving vessel operations and diving passengers, it is desirable for the 11th Regional Coast Guard Headquarters and the Okinawa General Bureau of the Cabinet Office to provide guidance and raising awareness for diving vessel operators on how to prevent similar accidents through safety campaigns, etc.</p>

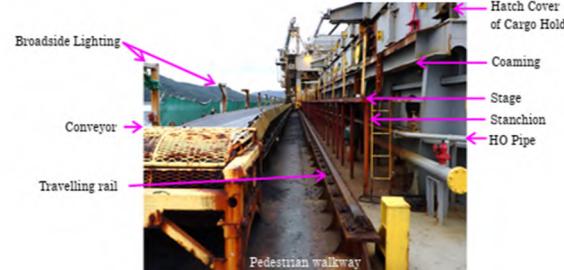
11	Date of publication	<p>Date and location</p> <p>Vessel type and name, accident type</p>
	October 31, 2024	<p>September 21, 2023 K-1 Wharf, No.2 District and Kudamatsu Area, Tokuyama Kudamatsu Port, Yamaguchi Prefecture</p> <p>Coal Carrier ENERGIA CENTAURUS Fatality of a crewmember</p>
	Summary	<p>Coal Carrier “ENERGIA CENTAURUS” was moored and was loading cargo handling operation at K-1 Wharf, No.2 District and Kudamatsu Area, Tokuyama Kudamatsu Port, a boatswain was performing an inspection work on the upper deck, and then, the boatswain was caught between her structure on the upper deck and the cargo unloading device, which had been running, and then was pronounced dead.</p>

Probable causes	<p>The JTSB concludes that the probable cause of this accident was more likely that Boatswain entered around the Travelling Rail in Warning Area for the purpose of HO Pipe Inspection after completing the switching operation of the hatch covers, and subsequently, his body was caught between the SUL Traveler which was travelling to the fore side and the Stanchion, and was injured while the Vessel was moored and was loading cargo handling operation at K-1 Wharf during the night.</p> <p>It is probable that Boatswain entered around the Travelling Rail in Warning Area for the purpose of HO Pipe Inspection because it is more likely he thought HO pipe Inspection would be completed immediately in a short time before beginning to conduct HO Pipe Inspection, and furthermore, he thought it was enough to report the situation after specifying oil leakage point.</p> <p>It is probable that the SUL was travelling to the fore side because the hatch covers of No.2 cargo hold, etc. had been opened and the Stevedores conveyed to CHO Officer, etc. that the un-loading work was going to restart. In addition, Boatswain and Crewmember A did not contact CHO Officer before beginning to conduct HO Pipe Inspection.</p> <p>It is probable that Boatswain continued to conduct HO Pipe Inspection around the Travelling Rail because he was standing and leaning against the Stanchion for observing Crewmember A's state entered under the Stage, etc., and then his visibility was restricted and he did not hear the warning sound during the SUL travelling, and subsequently, he did not notice the SUL approaching.</p> <p>It is certain that the TSS did not detect Boatswain who was at around the Travelling Rail and did not operate emergency stop of the SUL because the SUL was equipped with the TSS on the SUL Traveler, and also the fore side TSS flame of the TSS was narrowed at left and right width and there was a clearance of approximately 400 mm between the end of the TSS flame and the Stanchion.</p>

Safety actions	<p>The following measures are possible to prevent recurrence of and mitigate the damage caused by similar accidents:</p> <ul style="list-style-type: none"> • Master should instruct crewmembers to reconfirm the SMS manual and the arrangements and the procedures, and then repeatedly instruct them not to enter risk areas for conducting inspection work and maintenance work during cargo handling operation. In addition, when crewmembers have necessity for similar inspection work, etc., crewmembers must report the work to responsible persons in charge of cargo handling operation on board and accept permission, and then they must confirm via contact with responsible persons that stevedores are not operating the SULs, and then must conduct the inspection work, etc. by securing safety measures, e.g. assignment of watchmen. • Master and personnel in charge of safety in each department should reinstruct crewmembers to make planning and conduct inspection work and maintenance work and for cargo handling apparatus in appropriate period when they could secure safety. • Master and ship management company, etc. should conduct inspection of safety devices for cargo handling apparatus on a daily basis, and also collect near-miss reports concerning operation of cargo handling apparatus and conduct risk assessment*1 based on the result of the near-miss report, and subsequently take risk mitigation measures, e.g. improvement and modification safety devices. <p>*1 “Risk assessment” means an overall process of risk specification, risk analysis and risk evaluation in some work. Business operator and company were required to decide risk mitigation measures and to take appropriate safety measures based on the result.</p>

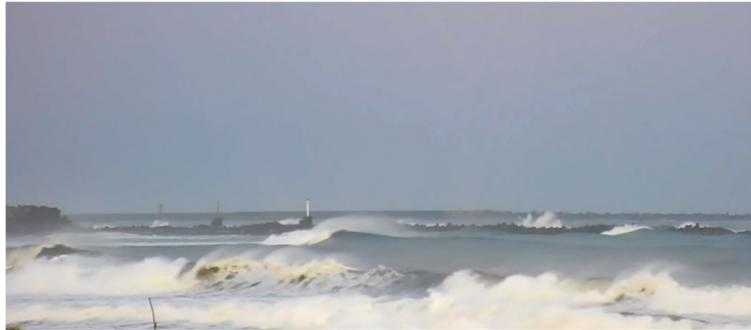
12	Date of publication	Date and location
	November 28, 2024	December 6, 2023 Miyazaki Port, Miyazaki City, Miyazaki Prefecture
	Summary	<p>While the vessel, operated by the master alone, with five anglers on board, was returning to its mooring at Miyazaki Port, it capsized near the entrance to the port's southern channel.</p> <p>As a result, the master and one angler died, four anglers were injured, and the vessel sustained damage to its hull.</p>
	Probable causes	<p>It is probable that this accident occurred when the vessel was attempting to enter the southern channel to return to its mooring at Miyazaki Port. Near the channel entrance at the mouth of the Oyodo River (east of the training walls), there were approximately 2-meter waves with surf and triangular wave patterns. As the master approached at reduced speed with the stern facing the waves, a wave overtook the vessel, lifting the stern on its descending slope and causing the vessel to accelerate. This drove the bow down into the wave ahead, submerging the port bow bulwark and causing the vessel to capsize.</p>

Safety actions	<p>The following matters may well be useful in preventing similar accidents from recurring in future. Masters of small vessels using Miyazaki Port should:</p> <ul style="list-style-type: none"> • Consider the use of the northern sea route and other ports in advance because the southern route is set at the mouth of the Oyodo River which faces the open sea, and waves may increase to dangerous levels or surf may occur due to weather and sea conditions.

<ul style="list-style-type: none">• Gather sufficient weather and sea condition information before setting sail because navigating in high following seas increases the risk of capsizing, and postpone departure, return early, or enter a safe port if they feel that navigation is dangerous based on their vessel's maneuverability. <p>The above details may also be useful for the masters of small vessels navigating the mouth of the Hitotsegawa River, where five capsizing accidents have occurred in the past.</p>
Report	(Japanese only)
