運輸安全委員会
Japan Transport Safety Board

ANNUAL REPORT 2025

[March, 2025]

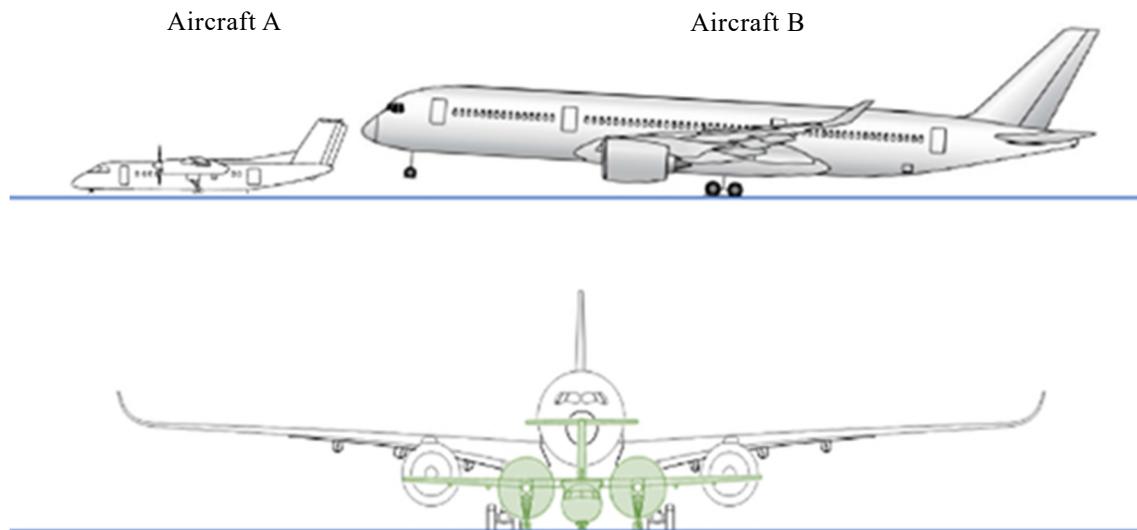
The Situation just before the Collision between Aircraft A and B

The relative positions of the two colliding aircraft were as shown below.

As a result of this collision, it is believed that most of the fuselage of Aircraft A was destroyed. Meanwhile, when Aircraft B collided with Aircraft A, equipment such as the electrical system and control system under the floor of the cockpit was severely damaged. As a result, the wheel brakes that slow down the aircraft did not function, and after taxiing without directional control, Aircraft B continued to roll down the runway and came to a stop in a grassy area.

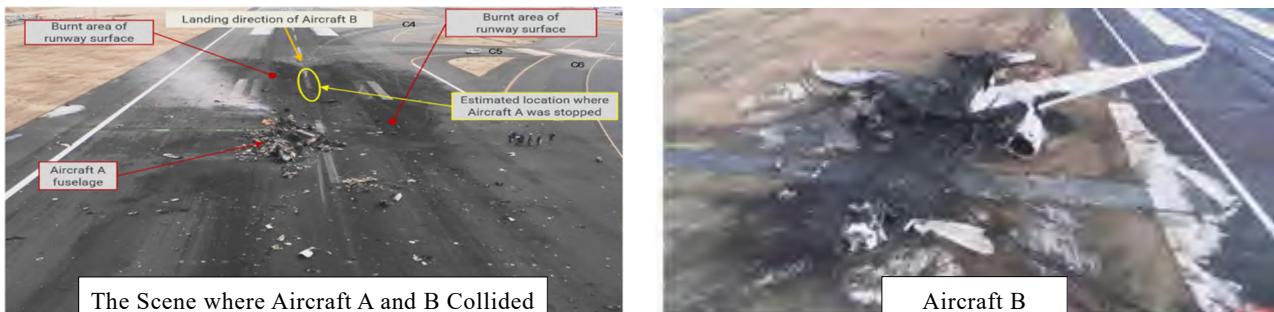
After the collision, the fire that broke out in Aircraft A spread mainly throughout the fuselage. In Aircraft B, the fire burned intensely, primarily in the fuselage, and destroyed most of the aircraft. As shown in the following figure, the fuselages of both aircraft did not retain their original shape.

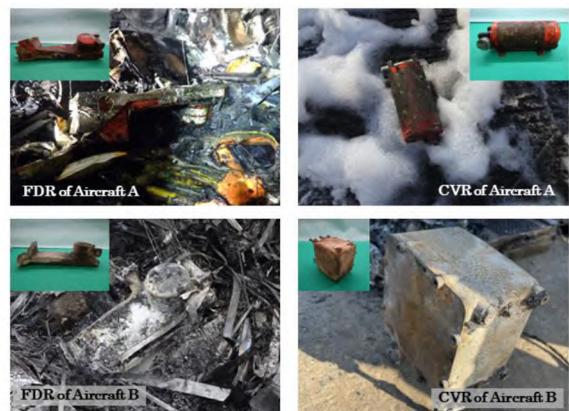
The condition of the flight recorders

In this accident investigation, the Flight Data Recorder records were crucial in clarifying the flight situation and cockpit conditions before the collision. As shown in the figure below, the FDRs of both aircraft were severely damaged by the impact of the collision and the effects of the fire. In particular, the Cockpit Voice Recorder of Aircraft B lost its original shape and took several days to locate. Extracting data from these damaged flight recorders requires special equipment and technology. After repeated trial and error with the cooperation of the relevant states, the JTSB was finally able to extract the recorded data and clarify the situation at the time of the collision.

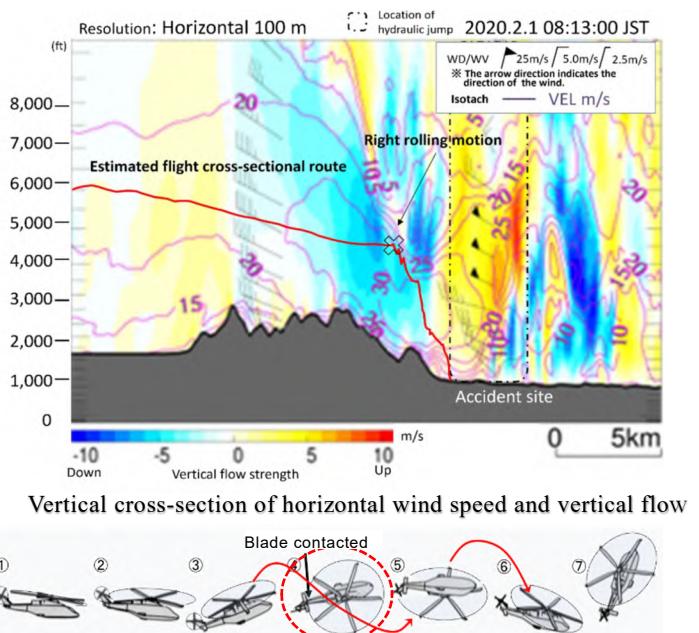
Attitude change at the time of contact with the main rotor blades

It is presumed that the reason why the main rotor blades severed the tail drive shaft while the helicopter was in flight was that, while flying at high speed over a mountainous area in strong winds, the helicopter encountered a strong downdraft, which caused a rapid increase in airspeed, resulting in a right rolling motion exceeding 360°, during which the main rotor blades flapped significantly toward the fuselage.

As a result, when the helicopter encountered a localized strong downdraft and the horizontal wind speed decreased while flying at high speed with a tailwind over the Mountain Range, the airspeed rapidly increased. In response to the attitude change when the airspeed increased, part of the attitude retention function was released and the cyclic stick was moved to the right rear in an

Based on the results of this investigation, the JTSB recommended, as safety actions, that when flying over mountainous regions in strong winds where mountain waves are expected to occur, pilots need to slow down in advance and select appropriate flight control modes to respond to sudden weather changes. The JTSB also recommended that to fully understand and properly use flight control modes during flight, pilots should carefully read the relevant documents and, whenever possible, conduct training using Full Flight Simulator and others corresponding to each aircraft type, including coordination between two pilots to enable quick and calm responses during emergency operations.

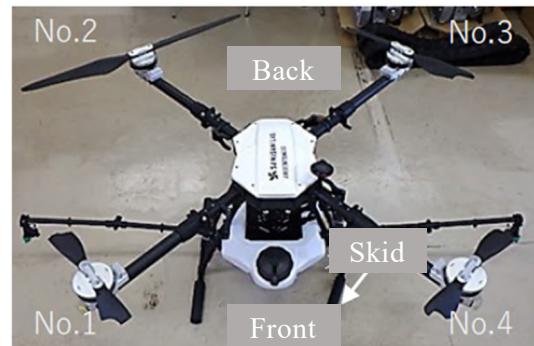
Fig. 1: Accident small UA

In the investigation of this accident, with the cooperation of the small UA manufacturer, flight records of the small UA (see Fig. 1) were obtained and analyzed, and the flight conditions of the small UA were determined from the time it collided with a road sign pillar to the time it came into contact with the operator and crashed. Additionally, to confirm the flight characteristics of the automatic flight mode that was used at the time of the accident, the JTSB reproduced and verified the situation at the time of the accident. These results were compared with the operator's testimony, and the events that occurred were analyzed.

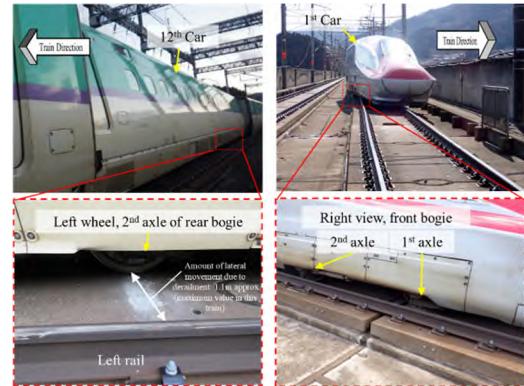
Figure 1 Situation of the Accident Train

On March 16, 2022, the 223B train from Tokyo to Sendai, composed of 17 cars, started from Fukushima station and was derailed between Fukushima station and Shiroishizao station. The 60 of the 68 axles had derailed. In addition, 10 of the 60 derailed axles were in a condition in which the deviation preventing guides, etc. installed on the cars were climbing over the rails. Just before the accident, at around 23:36, an earthquake with an epicenter off the coast of Fukushima Prefecture occurred, with a maximum seismic intensity of 6 Upper on the Japanese scale. About two minutes before the quake, a foreshock with a maximum seismic intensity of 5-lower on the Japanese scale and the train stopped by Earthquake Early Warning System for Shinkansen. There were 75 passengers, one driver and four conductors on board, in which six passengers were injured.

It is probable that due to the strong shaking of the track surface caused by the earthquake motion, the rolling of the carbody occurred, then the left or right wheel lifted up, eventually the train derailed after over the rail (rocking derailment).

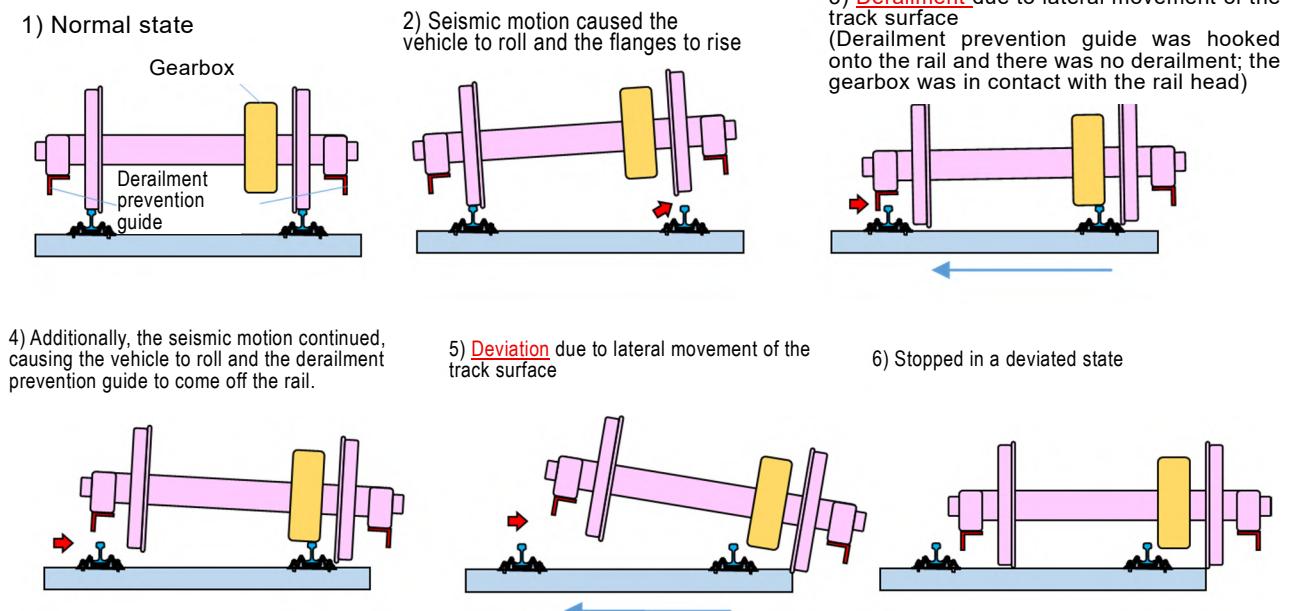
The investigation of this accident analyzed the mechanisms of derailment and deviation caused by earthquake ground motion. As a result, the JTSB classified the behavior of each wheel and axle at the time of the accident into eight patterns and found that derailment and deviation occurred in a process such as that shown in Fig. 2 as an example.

Fig. 2: Image of car behavior during derailment and deviation (example) (The wheel and axle derailed, and deviation prevention guide initially functioned but ultimately deviated.)

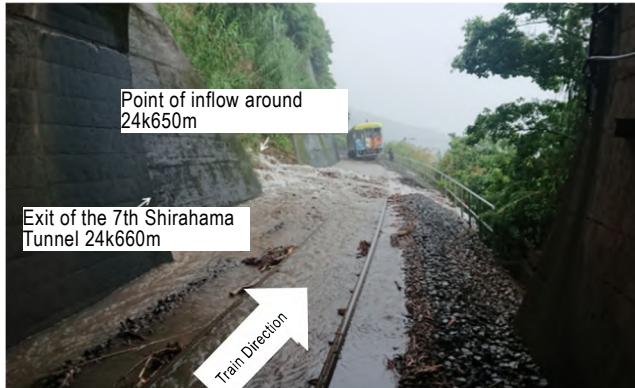
Fig. 1: Situation of the accident site

In the investigation into this accident, the JTSB analyzed the handling of the train, which was allowed to run despite rainfall reaching the control value for the suspension of operations. As a result, the JTSB mainly found the following points:

Based on the above investigation results, the JTSB recommended that Tosa Kuroshio Tetsudo Co., Ltd. establish a system enabling dispatchers who constantly monitor driving conditions to promptly notify train drivers of speed restrictions when the control value for implementing speed restrictions is observed, in order to prevent recurrence of accidents. Additionally, the JTSB recommended the company re-examine its regulations for handling trains during rainfall by comparing them with those of other railway operators, make necessary reviews, and revise its regulations to ensure the safe transportation of trains.

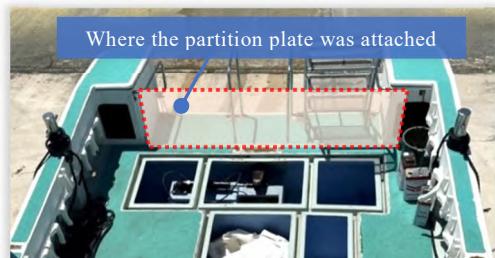
Where the partition plate was attached

This accident occurred when the ship experienced severe wind, rain, and high waves while passengers were diving. Since the ship continued to anchor by letting go anchor from the stern, waves crashed onto the upper deck, seawater and other substances flowed into the engine room from the stern storage, etc. Furthermore, as the Master continued to sail with more passengers on board and the stern lowered, it is probable that the crashing waves caused the ship to flood and capsize.

- By changing the stern shape (removal of the partition plate), the structure became more vulnerable to crashing waves.
- After repairing the hydraulic piping, the penetration was left open without being closed.
- The Master did not obtain information on weather and sea conditions after departure and could not make decisions such as evacuation.
- It was possible that the stern part of the ship sank easily, which affected the deterioration of stability, as approximately 1,000 kg of diving equipment was loaded mainly on the stern deck.

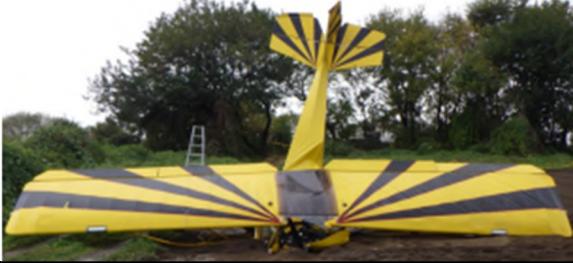
Probable Causes	<p>It is possible that this accident occurred when the ultralight plane made a sharp turn while losing thrust due to engine failure during take-off and ascent, causing the flight speed to slow and the plane to stall due to the larger bank angle, leading to a crash.</p> <p>Regarding the engine failure, the ignition system may have been difficult to ignite, and the fuel system was unable to supply a sufficiently concentrated fuel mixture during ascent.</p>

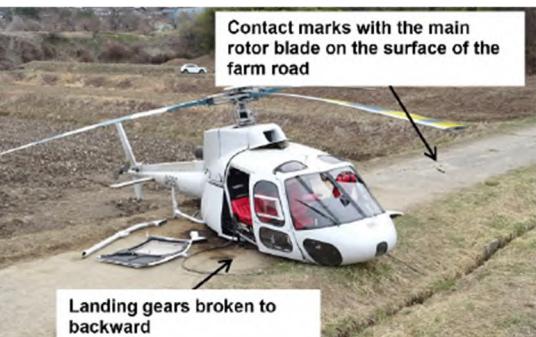
<p>Probable Causes</p>	<p>The JTSB concludes that the probable cause of this accident was that as the helicopter’s engine power most likely decreased during cruising flight, the helicopter attempted to make a forced landing on a farm road in autorotation^{*1}, and made a hard landing, resulting in injuries to the captain and passengers and the destruction of the helicopter.</p> <p>It is highly probable that the helicopter’s engine power decreased during the flight because the power turbine shaft fractured due to the engine’s power turbine front bearing seizure, however, it was not possible to determine the cause of the power turbine front bearing seizure. And the reason why it became a hard landing at the time of the forced landing was most likely because in autorotation landing, the altitude at flare^{*2}-out became high, and the rate of descent before the touchdown was not sufficiently controlled.</p> <p>*1 "Autorotation" refers to an autorotation flight, and flight condition in which the main rotor blades responsible for the lift are driven only by the aerodynamic force completely at the time of the rotorcraft in motion. (Airworthiness Inspection Manual)</p> <p>*2 "Flare" refers to deceleration operation for landing, which allows the rate of descent to reduce by converting kinetic energy into potential energy.</p>

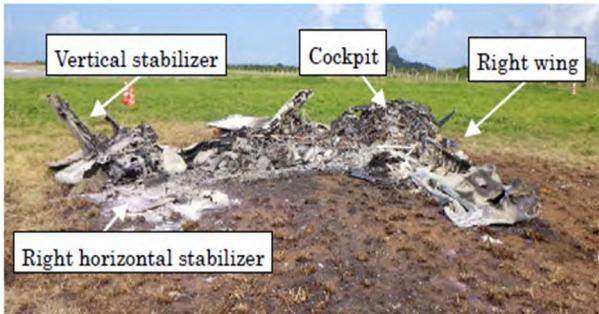
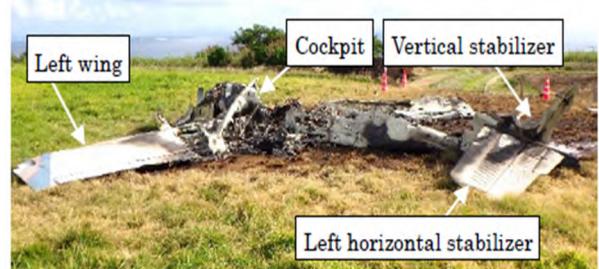
<p>Probable Causes</p> <p>The JTSB concludes that the probable cause of this accident was likely that the aircraft collided with the fence and its posts, and slopes in the airport because it failed to correct its lowered approach path when approaching Runway 04 at Iejima Airport. After that, it is more likely that the aircraft bounced, crashed into the grassy area short of the runway, and the aircraft was destroyed and went up in flames.</p> <p>Regarding the reason the aircraft failed to correct its lowered approach path, it was not possible to determine because the aircraft was not equipped with a flight data recorder and others, the only records available to verify the flight conditions were radar wake records, the persons onboard member were fatally injured, and the aircraft was severely damaged.</p>	Safety Actions	<p>It is desirable that the NPO should consider the necessity to enhance the system that would allow them to sufficiently manage not only training but also daily operation and maintenance in order to maintain safe operations, which is a prerequisite for their activities. (See “3. ANALYSIS” on the Investigation Report.)</p>

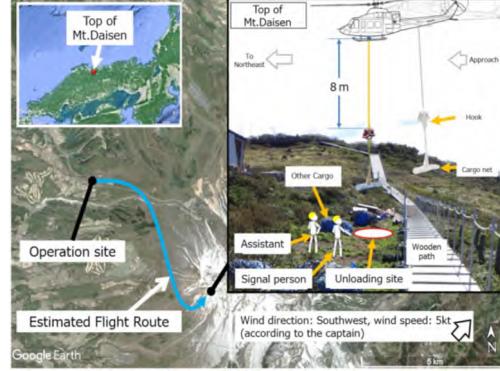
Probable Causes	<p>The JTSB concludes that in this accident, it is certain that the signal person was injured because while the helicopter was unloading, the Cargo net swung and hit the left leg of the signal person who had moved to the side of the wooden path thinking that assistance work might be required.</p> <p>It is highly probable that the Cargo net hit the signal person because during unloading, the signal person was in the range where the Cargo net could swing and reach. Distracted by the assistant moving between the Cargo net and other cargo, the signal person took the eyes off from the Cargo net, which also more likely contributed to.</p>

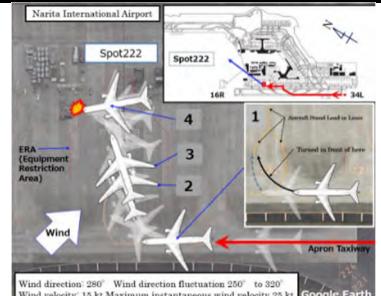
Probable Causes	<p>The JTSB concludes that it is certain that the probable cause of this accident was that while turning toward the Spot, the aircraft slid on the icy surface on the Spot and the PIC became unable to control the taxiing of the aircraft, thus the aircraft collided with a ground service equipment parking around the Spot, resulting in damage to the airframe.</p> <p>The aircraft slid on the icy surface probably because the surface conditions on the Spot had not been fully improved for the taxiing of the aircraft, and its taxiing speed was not the one to cope with the surface conditions on the Spot.</p> <p>The surface conditions on the Spot had not been fully improved because the spray range and amount of the anti-icing agents were inappropriate, which probably contributed to it. In addition, the aircraft's taxiing speed was not the one to cope with the surface conditions on the Spot probably because the information that would affect the taxiing of aircraft was not provided to the flight crewmembers of the aircraft from the ground.</p>

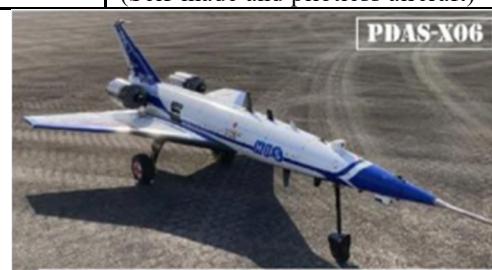
Probable Causes	<p>The probable cause of this accident was that the self-made and pilotless aircraft was about to deviate from the pre-set test flight airspace during the test flight, triggering the FTS mode (a function to prevent deviation from the test flight area), which automatically controlled the aircraft to land on the sea surface, resulting in a total loss due to the impact at landing.</p> <p>It is probable that the self-made and pilotless aircraft was about to deviate from the pre-set test flight airspace due to the following factors:</p> <ul style="list-style-type: none"> • The loss of communication with the pilot led to a switch to autopilot. • An unintended altitude drop occurred while flying on autopilot, causing the aircraft to switch to RTH Climb mode, with priority given to regaining altitude.

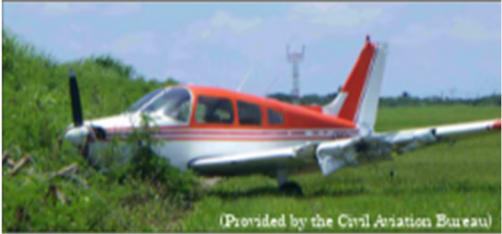
<small>(Provided by the Civil Aviation Bureau)</small>	
	Probable Causes	The JTSB concludes that the probable cause of this accident was that when the aircraft was on its landing roll and the rudder was used to correct its direction before it had sufficiently slowed down, and the left brake pedal was most likely pressed in the process, which activated the left brake, causing the aircraft to veer to the left, deviate from the runway, enter the grass field, and collide with the perimeter fence, damaging the aircraft.		
	Safety Actions	In the initial training, it is desirable to instruct student pilots to correct heading during the ground run after landing by using the appropriate amount of rudder depending on the speed and to master the appropriate foot position when using the rudder. (See "3. ANALYSIS" on the Investigation Report.)

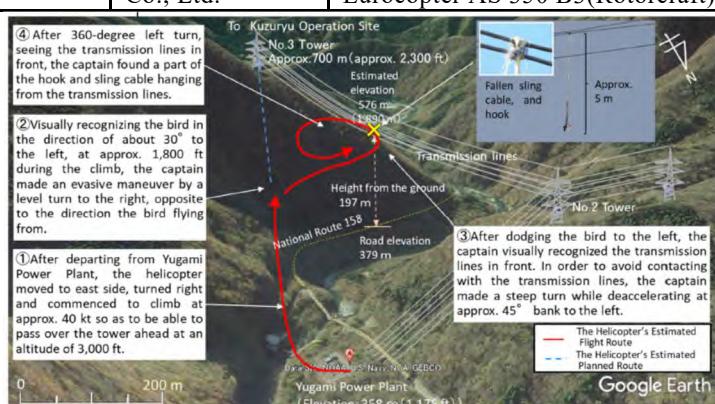
helicopter nor to the personnel inside and outside the helicopter.		
	Probable Causes	<p>The JTSB concludes that the probable cause of this serious incident was that it is highly probable that while the helicopter was making an evasive from transmission lines maneuver by a steep turn, the underslung sling cable contacted with the two transmission lines, and the contact areas on the sling cable were burnt out and severed, then a part of the sling cable and the hook fell onto the transmission line.</p> <p>The reason why the sling cable contacted with the transmission lines was because when the helicopter made a steep turn to avoid a bird strike after a big bird was spotted during the climb, the attention to the transmission lines was diminished, and a level turn was made at the same altitude as the transmission lines, which most likely brought the sling cable to an altitude in which the sling cable would come into contact with the transmission lines and did not allow sufficient clearance.</p>

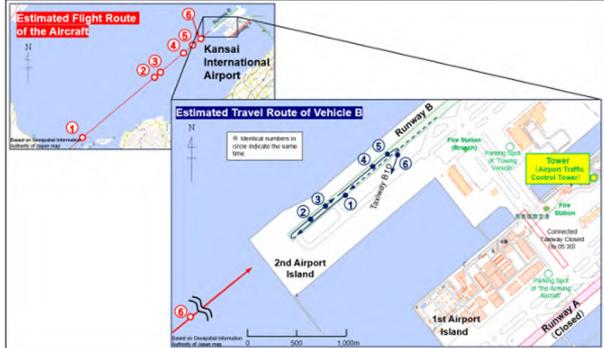
Probable Causes	<p>The JTSB concludes that the probable cause of this serious incident was certainly that when Vehicle B was conducting a scheduled inspection on Runway B with the entry permission, the Tower cleared the aircraft to land on the runway, therefore, the aircraft attempted to land.</p> <p>The reason why the Tower cleared the aircraft to land on Runway B despite the existence of Vehicle B on the runway was most likely because as the Tower received the incorrect information that the runway was clear from the Ground who was in charge of radio communications with Vehicle A and Vehicle B, and the Tower did not visually recognize Vehicle B on the runway, therefore, judged that Vehicle B had vacated the runway, thus there would be no obstacles and others on the runway.</p> <p>It is highly probable that the Ground informed the Tower of incorrect information that the runway was clear was because the Ground mistook the report of vacating the runway from Vehicle A for that from Vehicle B.</p>

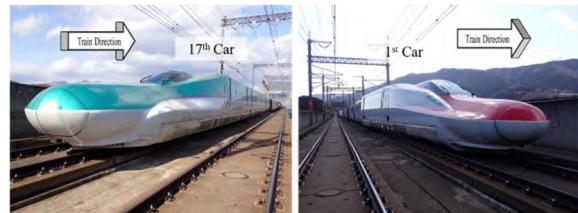
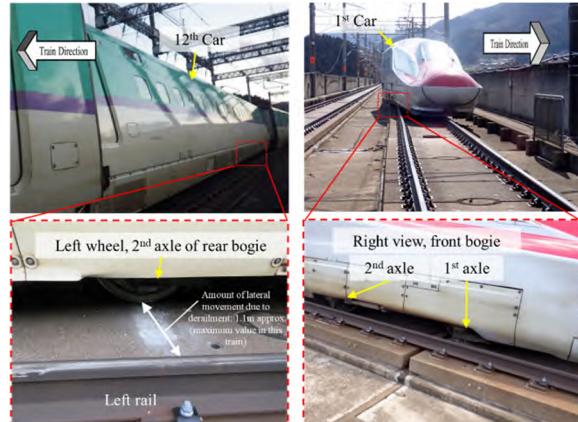
Probable causes	<p>It is highly probable that this accident, derailments of the train, was caused by the earthquake motion from the earthquake that occurred at 23:36:33 on March 16, 2022, which had its epicenter off the coast of Fukushima Prefecture.</p> <p>It is possible that the process leading to the derailment have been the rolling of the car body caused by the strong shaking of the track surface due to the earthquake motion, which caused the left or right wheel to lift up and over the rail, leading to the derailment (rocking derailment). In addition, the rolling of the car body caused excessive deformation of the air springs, resulting in air spring air loss, it is possible that which have contributed to the derailment.</p> <p>With regard to the deviation preventing guide or the rail guard mounting arm was off and deviated from the rail on some of the wheelsets, it is likely there are following possibilities: Continued seismic motion after the derailment caused the deviation preventing guide, which was preventing the deviation, to climb over the rails and deviate, or the deviation of the deviation preventing guide occurred after the rail guard mounting arm or gear box fell on the rail at the time of derailment.</p> <p>In this accident, it is probable that the earthquake, which occurred approximately 2 minutes before, triggered the system to stop the train early enough, the train had already stopped at the time of derailment, and that the many deviation preventing guides and other devices functioned to prevent the train from deviating too far from the track, thereby preventing the damage from spreading.</p> <p>*2“Rocking derailment” refers to, in case the track vibrates vertically or laterally due to an earthquake etc., a derailment due to the wheel set vibration in the roll direction along with a violent lateral vibration. Specifically, one wheel remains in contact with the rail, while the other wheel lifts off the rail, next the wheel that is in contact with the rail slides along the rail, the wheel set moves laterally, then the flange of the wheel that coming down rides on the rail, or off the rail and derails.</p> <p>*3 The “rail guard mounting arm” here refers to a device installed under the journal box of the bogie for mounting rail guard (a device installed just in front of the wheel at the front end of the train to eliminate obstacles that may interfere with running safety), ceramic jetting device (a device that jets ceramic powder between the wheel and rail as adhesion improvement materials), etc.</p>

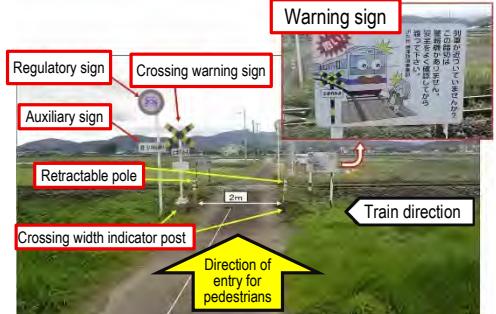
<p>Probable causes</p> <p>It is highly probable that this accident occurred because a pedestrian entered the Niju-no-Tsubo Crossing, a Class 4 level crossing that does not have a crossing gate or a road warning device, while the train was approaching, resulting in a collision.</p> <p>The pedestrian probably entered the crossing while the train was approaching because he did not notice the approaching train. However, the details could not be clarified as the pedestrian was deceased.</p>

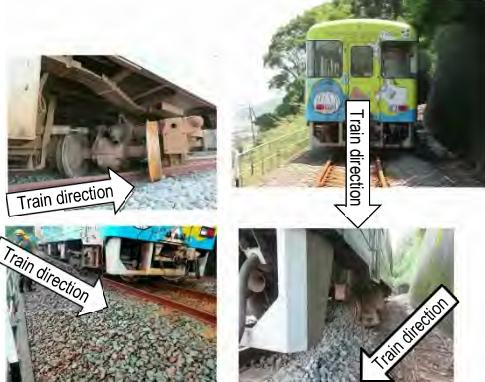
Probable causes	<p>It is highly probable that this accident occurred when the train derailed after colliding with the sand and other materials that had flowed onto the tracks due to slope collapse, which occurred after the train had departed when the rainfall had reached the level of train operation prohibition.</p> <p>The probable cause of the train departing under conditions when the rainfall had reached the level of train operation prohibition is that the train dispatcher did not give the driver notice of operation prohibition and allowed the train to depart from Nakamura Station.</p> <p>The reason why the train dispatcher did not give the notice of the operation prohibition to the driver is probably because, when the rain gauge reached the regulation value, the train dispatcher did not promptly carry out operation control based on his own judgment, but instead carried out operation control after receiving instructions from the head of facility and rolling stock depot, which was contrary to the regulations.</p> <p>With regard to the fact that the head of facility and rolling stock depot did not give instructions to the dispatcher to stop the train when the rainfall reached the level for prohibiting train operation, it is highly probable that it had become the norm to wait and see what would happen without immediately taking operational control when the rain gauge reached the regulated level, and that there was a low level of awareness of the need to ensure the safety of train operation during rainfall, which may have been due to a lack of understanding of the dangers of rainfall when it reached the regulated level.</p>

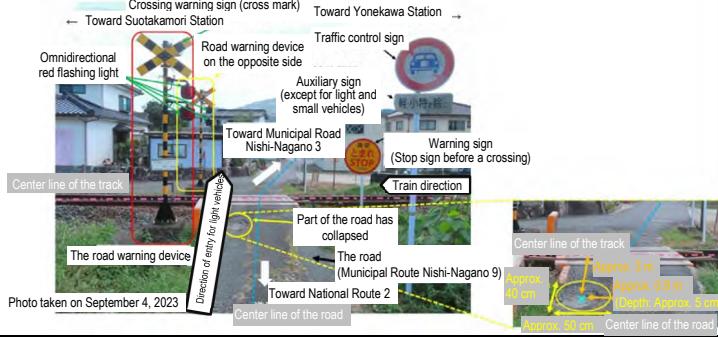
<p>Probable causes</p> <p>It is highly probable that this accident occurred because a light vehicle entered Nakahara Crossing, a Class 3 level crossing equipped with a road warning device, while the train was approaching and the warning device was active, resulting in a collision.</p> <p>Regarding the reason why the light vehicle entered the crossing while the train was approaching, it is possible that the driver did not notice the approach of the train, but it could not be clarified as the driver of the light vehicle was deceased.</p>						
	<p>Safety actions</p> <p>It is desirable to abolish Class 3 level crossings without crossing gates to improve safety. If abolition is impossible, crossing gates should be installed to upgrade them to Class 1 level crossings.</p> <p>In addition, until abolition or upgrading to Class 1 level crossings is implemented, it is advisable for the Company and Iwakuni City to cooperate with the Iwakuni Police Station in Yamaguchi Prefecture and others to encourage pedestrians at similar level crossings to stop temporarily and check for safety before crossing by carrying out awareness-raising activities and installing warning signs, etc.</p> <p>Additionally, since the Company and the City have Class 3 and Class 4 level crossings in addition to this level crossing, it is desirable that the Company and the local authorities continue to discuss the abolition or upgrading to Class 1 level crossings of these crossings as part of efforts to reach a consensus.</p>

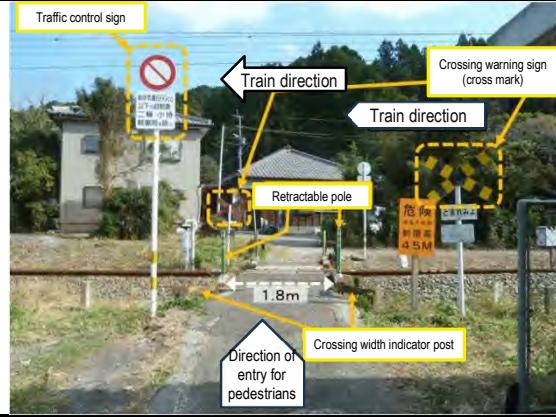
<p>Probable causes</p> <p>Regarding why the pedestrian entered the crossing while the train was approaching, it is probable that the pedestrian did not notice the approaching train, but the details could not be clarified as the pedestrian was deceased.</p>		
	<p>Safety actions</p> <p>It is desirable to abolish Class 4 level crossings without crossing gates or road warning devices to improve safety. If abolition is impossible, they should be upgraded to Class 1 level crossings. Until abolition or upgrading to Class 1 level crossings is implemented, it is recommended to promote various safety measures for Class 4 level crossings, such as strengthening traffic regulations and installing warning signs. Furthermore, it is desirable that the Company, Oita City, and Oita Higashi Police Station of Oita Prefecture strive to raise safety awareness among pedestrians at the crossing to ensure that safety checks are carried out by stopping temporarily in front of the crossing.</p>

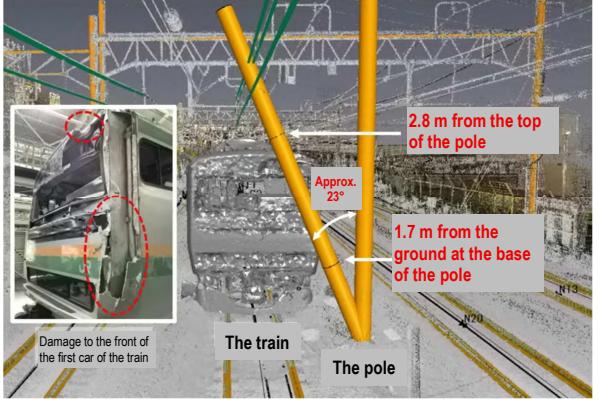
<p>Probable causes</p> <p>It is highly probable that this accident occurred because a heavily tilted utility pole collided with an approaching train, resulting in shock inside the train and an increase in the internal temperature due to power failure.</p> <p>The heavily tilted utility pole is believed to have been caused by water entering from horizontal cracks near the ground level of the pole, leading to part of the PC steel bar^{*1} corroding and breaking, which rendered the pole unable to withstand the bending moment.</p> <p>The presence of horizontal cracks in the utility pole is thought to be due to the equipment conditions that subject the pole to relatively large bending moments compared to design values, which, under the influence of temporary bending moments from wind and earthquakes, caused excessive bending moments near the ground level, leading to horizontal cracks, and the continued state of these cracks</p>

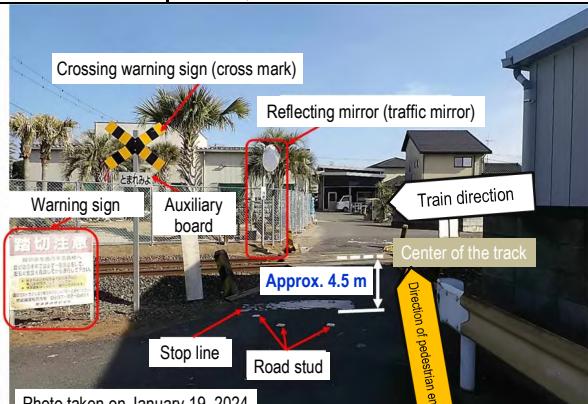
Probable causes	<p>It is highly probable that this accident occurred because a pedestrian riding the bicycle entered Heinai 2 Crossing, Class 4 level crossing without a crossing gate or a road warning device, while a train was approaching, and collided with the train.</p> <p>The reason why the pedestrian entered the crossing while the train was approaching is likely because the pedestrian did not notice the approaching train, but the details could not be clarified as the driver was deceased.</p>

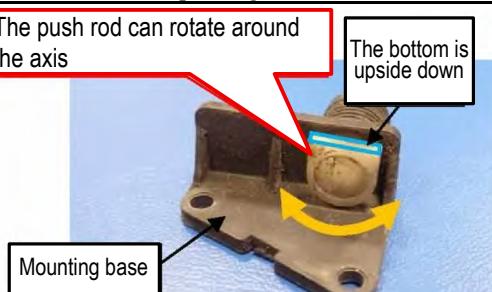
<p>(a) For the middle door</p> <p>The push rod does not rotate around the center of the axis</p>

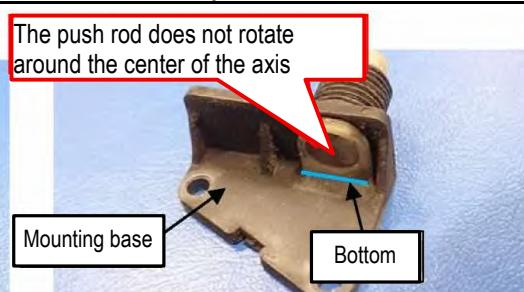
<p>(b) Normal</p>		
		<p>It is certain that this accident occurred because the driver of the train departed without closing the middle door while the circuit to prevent the vehicle power running with the door open was not functioning properly.</p> <p>The reason the circuit was not functioning properly is probably due to the fact that the push rod of the door open/close detection switch, which is pressed down when the door is closed, was installed in the opposite direction from its original mounting position. Accordingly, the switch was pressed even when the door was open, leading to the door being detected as closed.</p> <p>Regarding the driver departing without closing the door, it is probable that the driver assumed the door was already closed and did not perform the door-closing operation, and did not recheck that the door was closed with an interior mirror before departure, and the door indicator light was on because the push rod for the open/close detection switch was held in a pressed state.</p>

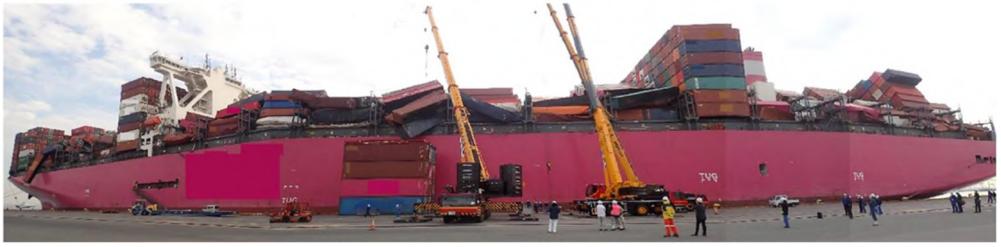
Probable causes	<p>It is probable that the cause of the Accident was that, at night when the vessel was proceeding east-southeast off the west-northwest coast of Niihau Island in the Hawaiian Islands, when the ship was experiencing swells of approximately 5 to 6 m from the northwest and north-northwest directions on the port side and stern, and the master attempted to reduce the rolling. As the ship was sailing on a course of approximately 140°, the direction of the swell was close to the danger zone where the ship received waves from 30° to 60° to port stern, resulting in a roll angle of over 20° and the first cargo collapse.</p> <p>After that, the master felt the rolling become even more intense, changed the course to approximately 120° and continued sailing, causing the direction of the swell to shift from the stern of the ship to 30° to 60° to port.</p> <p>It is thought that this caused the cargo to enter the danger zone, resulting in a roll angle of 25 ° or more, and the second collapse of the cargo occurred.</p> <p>It is probable that the cargo on the ship collapsed, causing the loaded containers to collapse and damage to container hatch cover and other equipment on deck leading to this accident. The master set the course at approximately 140° and the direction of the swell was close to the danger zone, probably due to the fact that he could not properly assess the sea conditions at night.</p> <p>The vessel is considered to have proceeded under conditions that were prone to parametric rolling*1 from about 21:40 on November 30, when the rolling began, to about 00:59 on December 1, when the ship changed course significantly.</p> <p>*1 Parametric roll is a resonance phenomenon in which the roll of a ship is rapidly amplified when the roll period of the ship and the encounter period of waves are in a certain relationship.</p>

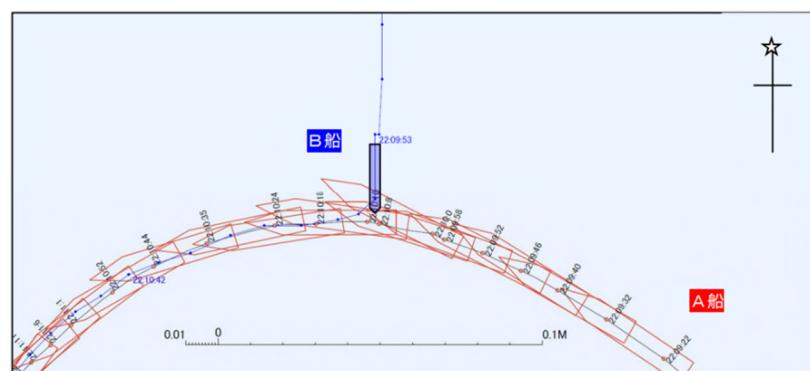
Probable causes	<p>The JTSB concludes that the probable cause of this accident was that, when Vessel A was heading north toward the Republic of Korea and Vessel B was heading south toward Hachinohe Port after fishing operation at off the east coast of Nakayamazaki Rokkasho Village, during night, since Vessel A turned to starboard and sailing the course which was east side of extended course of Vessel B and Vessel A approached around 0.6M to Vessel C which was forward sailing toward south of east side of vessel B, Vessel A turned to port exponentially and sailing toward north-west under same speed and Vessel B was also sailing same course and speed continuously. Therefore, it is probable that two vessels were collided.</p> <p>It is probable that Vessel A turned to port exponentially and sailing toward north-west under same speed after heading to the east of the extended course of Vessel B in order to avoid to collider with Vessel C. However, since the Officer A2 who was navigational watch on duty of Vessel A was disappearance, it could not be determined why especially the cause to turn to port exponentially.</p> <p>When Chief fisherman B saw two lights of which were red light (port side light) and masthead light, he seemed that Vessel A sailed around 020° on the course. Since he believed that Vessel A could pass in forward of the Vessel B safely and Vessel A could pass port to port with Vessel C, Chief Fisherman B was watching the fish finder continuously and he could not find to be approach from Vessel A. Therefore, it is probable that Vessel B was sailing continuously under same speed and same course.</p>

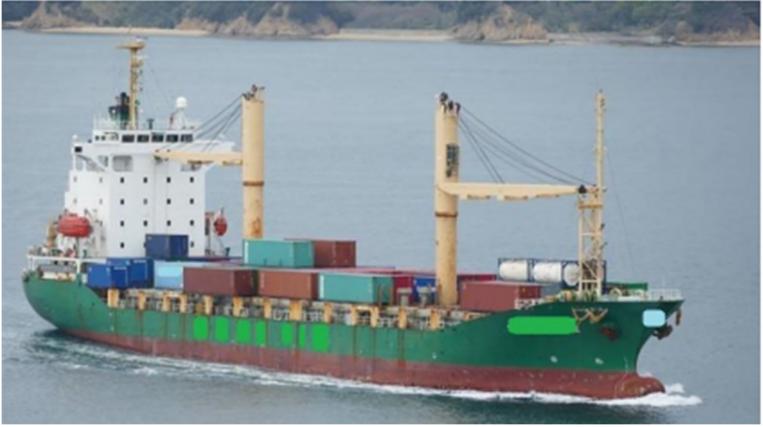
Probable causes		<p>Under the subject vessel was berthing operation at Komatsushima District, Tokushima Komatsushima Port, Tokushima Prefecture, when this spring line caught on the underside of this fender and receiving the tension, the linesman A looked diagonally downward from near upper edge of the berth located this fender in order to confirm the status of this spring line. When this spring line came off from underside of this fender and bounced up, since linesman A's head was entered in the area that this spring line was bounced up and this spring line hit to his head, it is probably that this accident had occurred.</p>

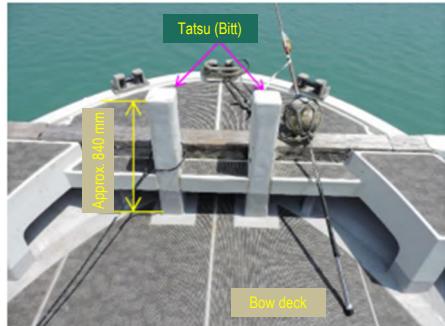
Probable causes	<p>It is probable that this accident occurred because under conditions of swell and waves from the south, while proceeding south-southeast at a speed of about 9 knots off the south coast of Kudakashima Island, the master thought that the speed of the main engine had been lowered sufficiently and continued to navigate with the anglers on the bow deck. Therefore, when the bow was struck by waves about 2.0 m high at the bow and the bow rolled violently up and down, Angler A suffered injury to the buttocks and back when colliding with the bow deck and the left face of Angler B collided with the bow, injuring him.</p>
	Safety actions	<p>The following matters, which may be useful for preventing any similar accidents from recurring and mitigating damage in future should be heeded.</p> <ul style="list-style-type: none"> • Masters and other responsible parties of recreational fishing vessels, etc. should comply with the departure cancellation standards stipulated in the operational guidelines, obtain the latest weather and sea conditions information in advance, and determine whether or not to depart. • Masters and other responsible parties of recreational fishing vessels, etc. should ensure that users observe the precautions before boarding the vessel, such as the risk of the bow rolling up and down violently due to the vessel's motion, which may pose an injury risk and that they wear lifejackets except in the cabin while on board the vessel. • Masters and other responsible parties of recreational fishing vessels, etc. should pay attention to the height and direction of the waves during navigation, and when the vessels are rolling due to the impact of waves, taking the rolling characteristics during navigation, etc. into consideration, should comply with accident prevention provisions for users due to rolling in the operational guidelines, in accordance with the contents of the opinions expressed by the JTSB to the Director-General of the Fisheries Agency on February 16, 2023, e.g. by reducing rolling by changing the course to the waves and reducing to a sufficiently safe speed, and instructing users from the central part to the rear of the hull. • It is desirable that the masters of recreational fishing vessels and recreational fishing vessel operators take measures to ensure that precautions, etc. are communicated to foreign users by, for

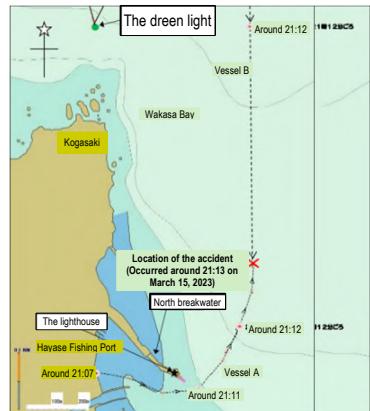
Probable causes	<p>It is probable that the accident occurred, while Vessel A was proceeding north off the northeast coast of Hayase Fishing Port at night, while Vessel B was proceeding south after completing recreational fishing, Master A, who was distracted by a conversation with a fellow shipmate on the mobile phone, continued to navigate while watching the Green Light on the port bow, which is the course target, and did not keep a proper lookout on the right ahead. In addition, Master B thought that there were no other vessels at about 1 M from Hayase Fishing Port that would interfere with the navigation, continued to navigate with a blind spot created by the bow lift, and did not keep a proper lookout to compensate for the blind spot on the bow. Accordingly, the two vessels approached each other unawares and collided.</p>

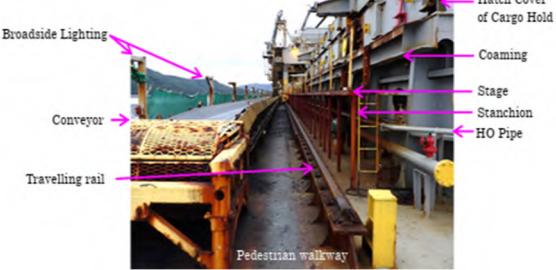
Probable causes	<p>The JTSB concludes that the probable cause of this accident was more likely that Boatswain entered around the Travelling Rail in Warning Area for the purpose of HO Pipe Inspection after completing the switching operation of the hatch covers, and subsequently, his body was caught between the SUL Traveler which was travelling to the fore side and the Stanchion, and was injured while the Vessel was moored and was loading cargo handling operation at K-1 Wharf during the night.</p> <p>It is probable that Boatswain entered around the Travelling Rail in Warning Area for the purpose of HO Pipe Inspection because it is more likely he thought HO pipe Inspection would be completed immediately in a short time before beginning to conduct HO Pipe Inspection, and furthermore, he thought it was enough to report the situation after specifying oil leakage point.</p> <p>It is probable that the SUL was travelling to the fore side because the hatch covers of No.2 cargo hold, etc. had been opened and the Stevedores conveyed to CHO Officer, etc. that the un-loading work was going to restart. In addition, Boatswain and Crewmember A did not contact CHO Officer before beginning to conduct HO Pipe Inspection.</p> <p>It is probable that Boatswain continued to conduct HO Pipe Inspection around the Travelling Rail because he was standing and leaning against the Stanchion for observing Crewmember A's state entered under the Stage, etc., and then his visibility was restricted and he did not hear the warning sound during the SUL travelling, and subsequently, he did not notice the SUL approaching.</p> <p>It is certain that the TSS did not detect Boatswain who was at around the Travelling Rail and did not operate emergency stop of the SUL because the SUL was equipped with the TSS on the SUL Traveler, and also the fore side TSS flame of the TSS was narrowed at left and right width and there was a clearance of approximately 400 mm between the end of the TSS flame and the Stanchion.</p>
