# JTSTB Digests

JTSTB (Japan Transport Safety Board)

(Issued in April, 2014)

## Digest of Aircraft Accident Analyses For Prevention of Helicopter Accidents

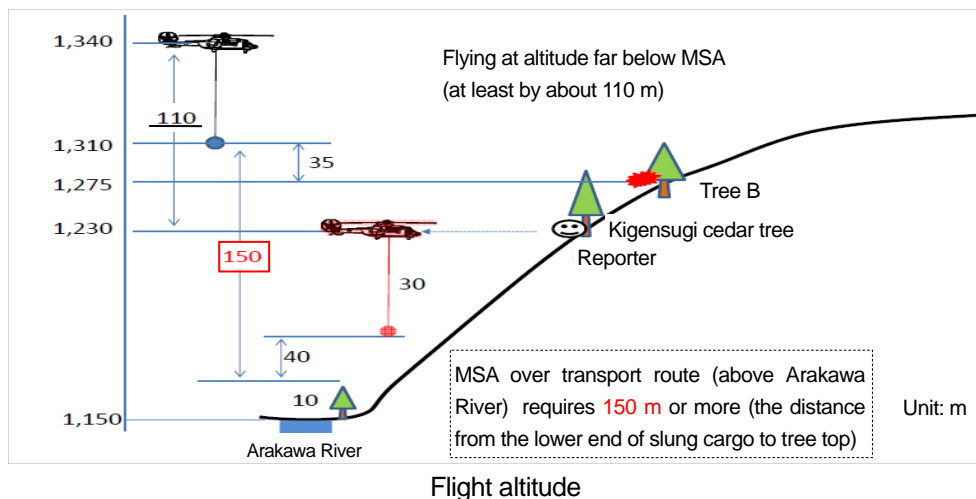
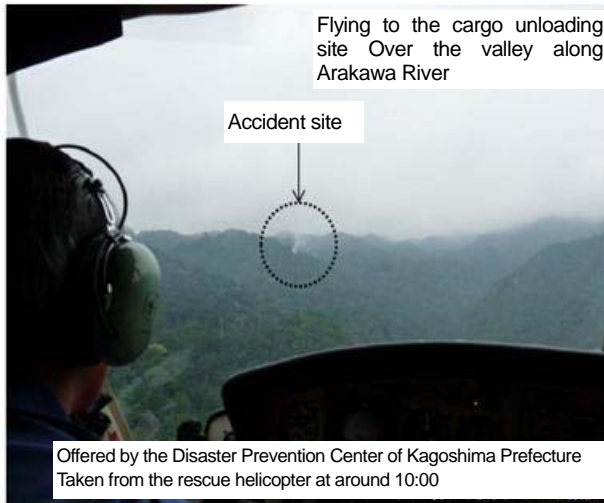
Accident Site Taken From Afar During Rescue Operation

## Reasons for Unavoidable Collision with the Trees

It is probable that the pilot selected the easier maneuver of the left turn than OGE hovering (\*1) above the Arakawa River, although the latter was possible if he accepted a large control input. His selection resulted in the proximity to the slope in the valley causing the underslung cargo being caught in the branches of Tree B or Rock A. Reason for his selection are as follows:

- ▶ It is highly probable that the helicopter was flying over the route for the cargo transport far below the Minimum Safety Altitude (MSA).
- ▶ The pilot possibly reduced the climb rate to avoid in-cloud situation during the turn, as the opening between the flying altitude and the cloud base was small, although it had enough climbing power to avoid the collision with trees.
- ▶ The pilot possibly failed to judge the cargo clearance from the tree top because it was the left turn—his right seat position hampered his look-out, with the cargo slung with 30 m long slings.

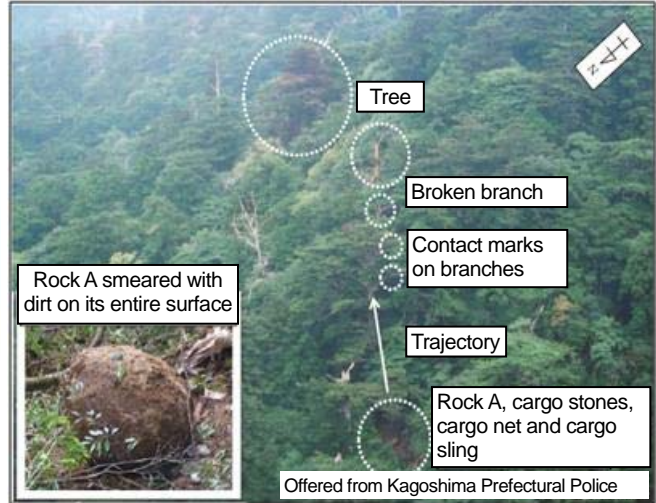
Aerial Photo of Accident Site

**Probable Cause:** In this accident, it is probable that the helicopter, while flying in the mountain valley with underslung external cargo, made a left turn to return back, crashed after nearing the slope with its underslung cargo caught in ground objects such as trees or rocks during maneuver. The post-crash fire consumed the helicopter and the pilot and the loadmaster suffered fatal injuries. The followings are possible reasons why the helicopter came close to the slope during the left turn, and the underslung cargo came to be caught in ground objects such as trees or rocks: capable OGE hovering for turn-back was not carried out; en route altitude was well below MSA; the climbing was restrained during the left turn as the opening under the cloud base was small; and the failure of judging underslung cargo clearance from the trees.

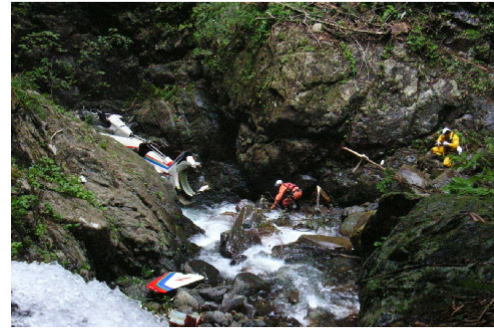
The aircraft lost horizontal stability due to spinning and moved to north-westward slashing tree branches and crashed into the left bank cliff from the nose.

Just After the Occurrence of the Accident  
(This picture was taken by a member of the gorge climbing party)

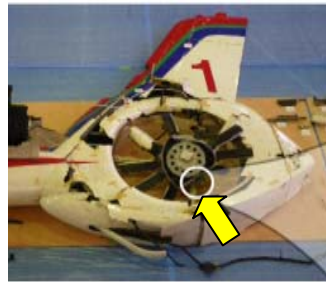
Fenestron

Tree branches were sucked into the Fenestron, and the aircraft lost its yaw control due to the damaged tail rotor, started to spin to the left, and its main rotors contacted with trees located left aft side of the aircraft.

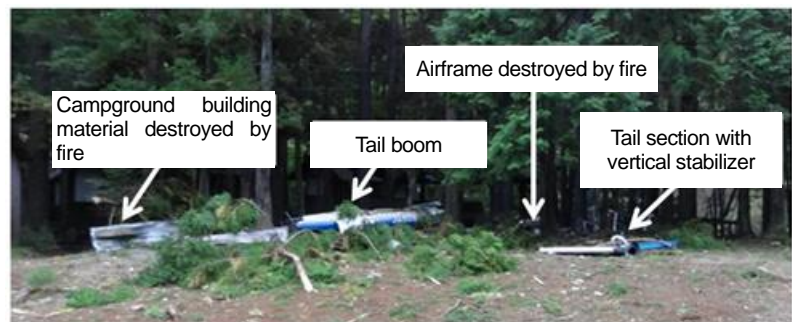
Accident Site

**Around 12:17** The helicopter crashed into Choja-yashiki Campground

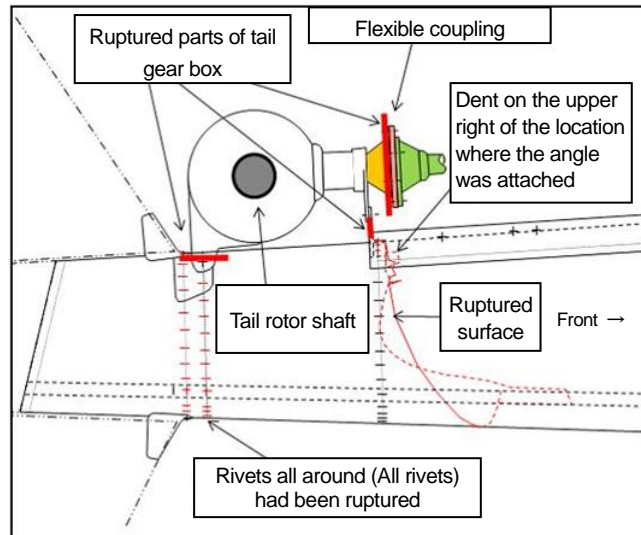
Ruptured Tail Boom

The mount of the tail gear box was broken by the impact of the contact of sling cable with the tail rotor causing the tail rotor shaft to tilt backward.

The flexible coupling with no support swung wildly, with the protruding portion colliding with and damaging the surrounding structure, and the damage to the tail section was exacerbated while searching for an emergency landing site.

It is probable that the helicopter became uncontrollable and crashed as a result of the rupture of the tail section including the vertical stabilizer.

- ▶ If damage to the airframe may be anticipated to expand, which can result in increased difficulty in operating the helicopter, pilots should make an emergency landing as soon as possible.

- (1) Amendment to Flight Procedures: Flying with a light-weighted hook alone slung beneath the helicopter is prohibited and the descending airspeed of a helicopter with a sling cable shorter than 10 m must be  $V_y$  or lower.
- (2) Special training on emergency procedures for tail rotor failure and procedures for selecting emergency landing site was provided to all pilots. Periodic assessment of the flying skill of pilots engaged in cargo transportation carrying a load slung beneath the helicopter will be made.
- (3) Safety Management Department was established to confirm that no problem related to laws and regulations exist, as well as to confirm safety prior to issuing work instructions.
- (4) The technical information communication system was amended to widely disseminate to all departments involved the technical information from manufacturing companies or other relevant sources.

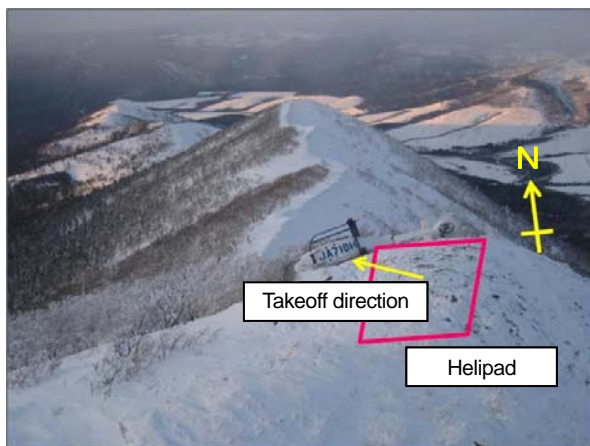
Accident site (on the day of the accident)

It is highly probable that obstacles, possibly branches of creeping pines (\*1) covered with snow, restrained the right and left skids, and it continued the lift-off sequence with the right skid sill restrained. As a result, abrupt right roll started and the roll angle exceeded the critical roll-over angle. The aircraft rolled over to the right in a state of dynamic roll-over, and sustained damaged.

(2) When an assistant is on board, he/she should make sure before takeoff that skid skis or snowshoes (\*3) are clear of obstacles (such as railroad ties) and check the condition of a ski rack.

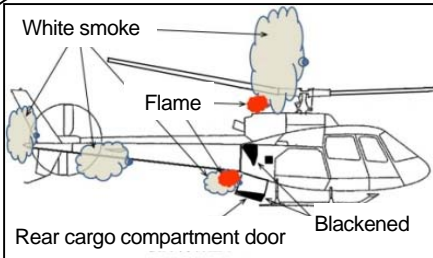
The left door of the rear hold was open and dangling, and the hold was emitting white smoke upward with flames sometimes seen to come out. White smoke was blowing out from also the horizontal stabilizer and the back end of the tail boom. Part of the rear hold door also became black.

Based on **situation immediately after landing** and **condition of the fire during flight**, it is highly probable that the fire occurred at around the rear hold of the helicopter.

Condition just before landing (depicted based on a video image by an eyewitness)

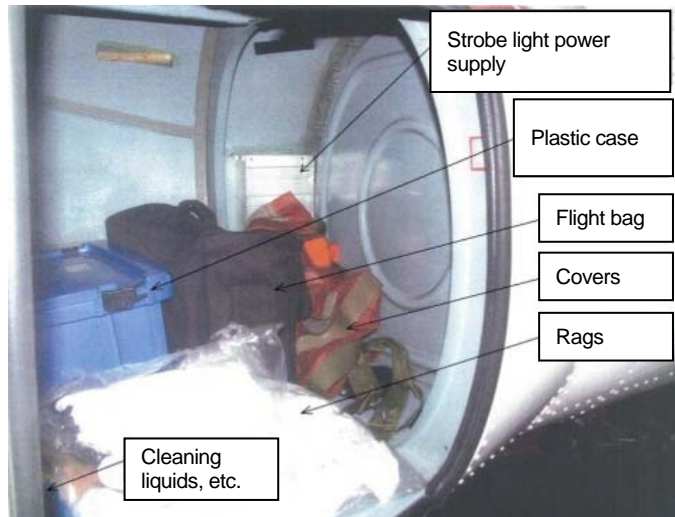
The rear hold was filled with so many inflammable items such as extra oils, plastic cases, documents, flight bag, covers, rags and cleaning liquids that are almost no room to stand, and they were not covered with a floor tie-down net to prevent them from moving. However, it was confirmed no abnormality by the flight mechanics during the preflight inspection.

Condition of embarkation in the rear hold (Reproduced based on the mechanic's memory using the type of helicopter)
