Case 3

After a collision between Vessel A and Vessel B caused by a failure to keep a lookout, Vessel A collided again with Vessel C while Vessel A was turning to starboard due to her residual momentum

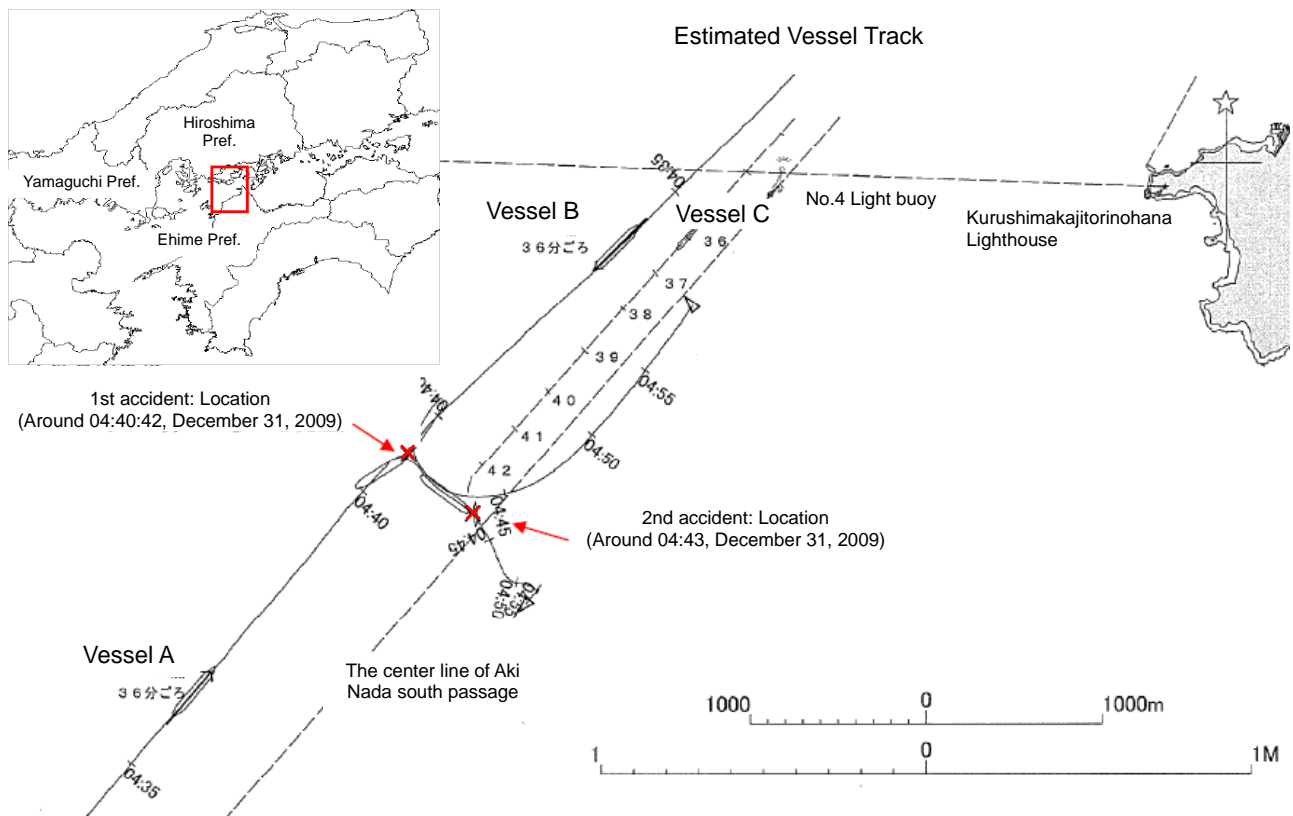
Summary (1st accident): The Vessel A, manned with the Master A and 19 crew members, was proceeding northeastward off the southwest of Kajitorino Hana and the Vessel B, manned with the Master B and 18 crew members, was proceeding southeastward in the same area. The two vessels collided with each other at around 04:40:42, December 31, 2009.

The port bow of the Vessel A was breached and port stern was dented. The bow of the Vessel B was cracked and dented and the starboard stern was dented. But no fatality or injury was caused on both vessels.

Summary (2nd accident): The Vessel A was proceeding southeastward after colliding with the Vessel B around the location of the 1st accident and the Vessel C, manned with the Master C and 3 crew members, was proceeding southwestward behind the port side of the Vessel B. The two vessels collided with each other at around 04:43.

The Vessel A sustained damage in the bow, and the Vessel C sustained the dent damage in her starboard mid-section. But no fatality or injury was caused on both vessels.

- > Vessels sailing along the recommended route should sail on the right side of the center line of the route.
- > Keep a proper lookout by sight and using radar and other available means.
