## Case 4

# Serious injuries suffered by passengers from the shaking of the aircraft encountering severe atmospheric disturbance

Summary : On Tuesday August 21, 2012, an Airbus A330-300, operated by Company A, took off from Honolulu International Airport (the United States of America) for Incheon International Airport (the Republic of Korea), as a scheduled flight. While flying at approximately 40,000 ft over Matsue City, Shimane Prefecture, around 15:17 Japan Standard Time (JST: UTC+9hr, unless otherwise stated, all times are indicated in JST on a 24-hour clock), the aircraft was shaken. Two passengers were seriously injured and one passenger was slightly injured.

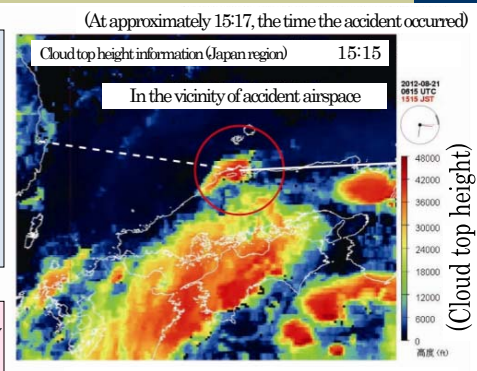
**Effect of Cumulonimbus**  
Cumulonimbus were generated rapidly in the vicinity of the accident airspace from approximately one hour before the accident occurred, with a cloud top height exceeding the Aircraft's flight altitude of 40,000 ft. Moreover, it was recorded in the Cockpit Voice Recorder that immediately before the accident occurred, JEC was out of service due to a lightning strike and that other aircraft flying around the Aircraft had been communicating with the Tokyo ACC to avoid significant weather conditions.

It is highly probable that cumulonimbus to which the PIC and the Route Captain should pay attention existed in the vicinity of the accident airspace.

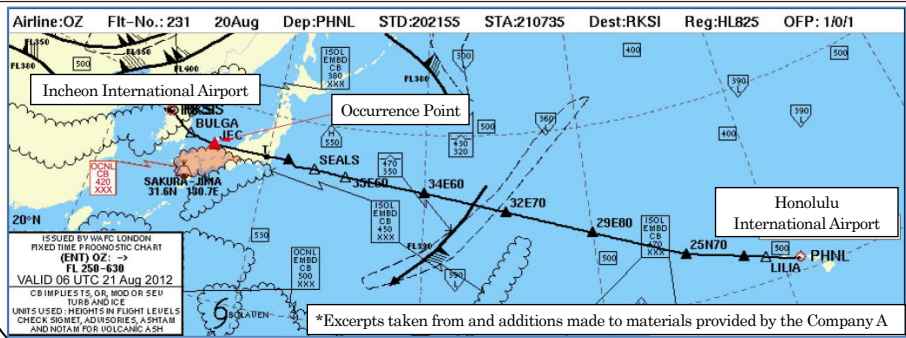
According to the statements of the PIC, although it was forecast in the pre-flight weather briefing that there would be a cloud top height of 42,000ft around the flight route, no significant weather conditions such as clouds was forecast on the flight route including the accident point; however there was a possibility that the nearby clouds expanded to the site of the accident.

The Significant Weather Prognostic Chart for International Aviation issued by the London WAFC and confirmed by the PIC in the pre-flight briefing.

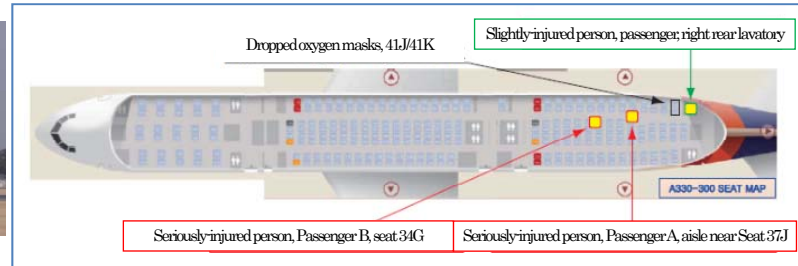
At the initial shaking, Passenger A was thrown into the air and fell forcefully to the floor.

When Passenger B took off her seat belt to assist Passenger A, Passenger B was thrown into the air and fell as the aircraft shook once again.

Position of injured persons at the time of the accident

**Probable Causes** : It is highly probable that in this accident, serious injury was sustained by a passenger walking in the rear aisle due to the severe shaking of the Aircraft, and that serious injury was sustained by another passenger seated nearby when the passenger removed the seat belt in order to help the injured passenger, the Aircraft shook severely again at that moment.
