3. Case of close call incidents, aircraft accidents, etc. (related to wake turbulence and wrong approach to a runway, etc.)

Case 1 of wake turbulence (aircraft accident)

The aircraft encountered strong wake turbulence from the preceding aircraft when descending, and two cabin attendants who were in the aft galley fell over

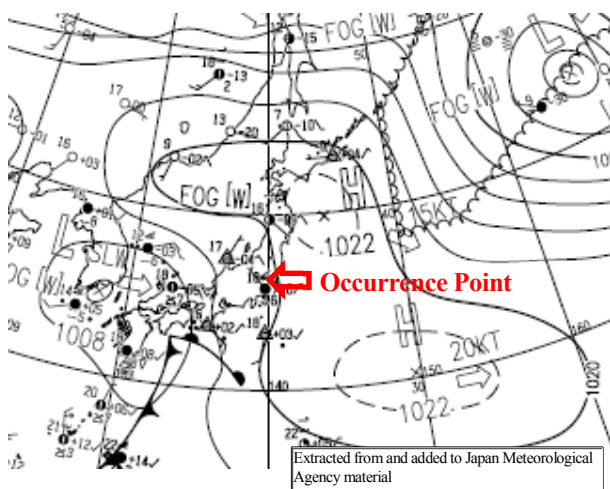
Asia Surface Synoptic Chart (09:00 on April 29)

According to the Asia Surface Synoptic Chart at 09:00 and the Regional Significant Weather Prognostic Chart (Kanto) at 10:00 on the day of the accident, the airspace where the accident occurred was at the edge of a high atmospheric pressure area moving eastward at 20 kt, with no effects of a low atmospheric pressure approaching from the south coast of Shikoku island, and no bad weather was observed.

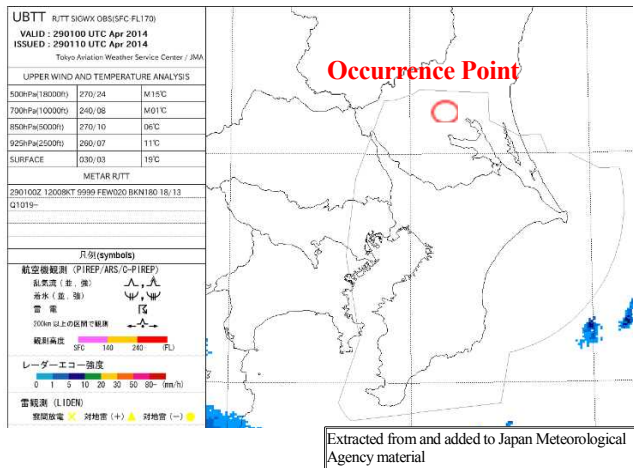
Regional Significant Weather Prognostic Chart (Kanto) (10:00 on April 29)

In addition, according to the Hourly Atmospheric Analysis Charts* at 09:00 and 10:00, the wind was blowing at a low speed about 5 kt in the airspace where the accident occurred, and no vertical wind shear was observed. The temperature was stable at approximately minus two degrees. *See the investigation report
