# JTSTB Digests

JTSTB (Japan Transport Safety Board) DIGESTS

(Issued in May,2016)

### Close call incidents in the field of aviation

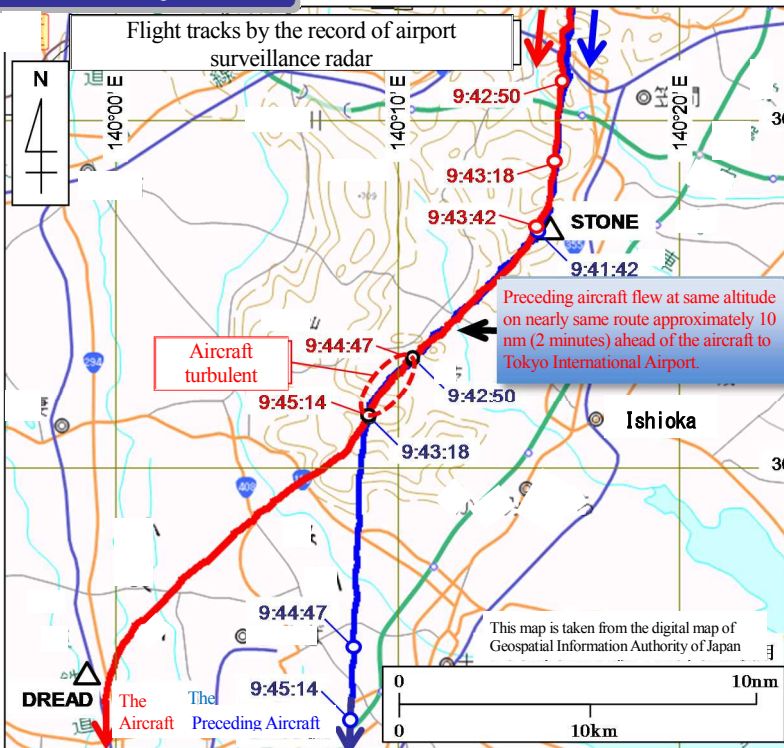
#### Estimated Flight Route

Summary: On Tuesday, April 29, 2014, at 09:16 Japan Standard Time (JST: unless otherwise stated, all times are indicated in JST, UTC+9h), an Embraer ERJ170-100STD, operated by Company A. took off from Yamagata Airport as the scheduled flight 1252 of code sharing with Company B. At around 09:45 when the aircraft was descending toward Tokyo International Airport, it encountered turbulence at an altitude of approximately 10,600 ft over Ishioka City, Ibaraki Prefecture. Two cabin attendants were injured who were in the aft galley.

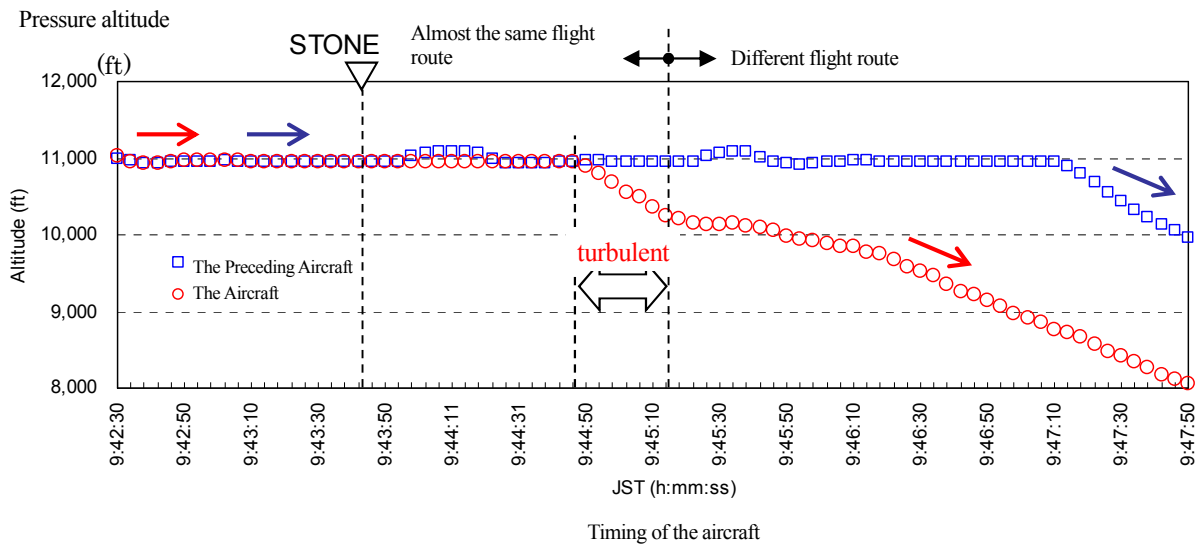
### Illustration of assumed flight altitude

According to the records of the flight recorder and the radar track records of Tokyo radar approach control facility, the vertical acceleration of the aircraft started to fluctuate little by little at around 09:44:47 when it began to fly approximately 200 ft below the preceding aircraft on the same flight route as the preceding aircraft, and after the large fluctuation began at around 09:44:57, when it was flying approximately 600 ft below the preceding aircraft. After that the fluctuation almost stopped at around 09:45:15 when the aircraft began to fly on a different route from the preceding aircraft after its left turn.

The Aircraft started to descend upon receiving an instruction from the Tokyo radar approach control facility, and as the vertical acceleration of the Aircraft started to fluctuate little by little at an altitude of approximately 10,800 ft around 09:44:47, it is probable that the Aircraft started to be affected by the wake turbulence from the Preceding Aircraft around that time.

This big shake continued until it recorded the vertical acceleration of approximately 1.64G at 09:45:07, and then turned toward convergence. Therefore it is probable that the Aircraft encountered the strong wake turbulence from around 09:44:57 until around 09:45:07 while it was descending from an altitude of approximately 10,600 ft to approximately 10,400 ft.

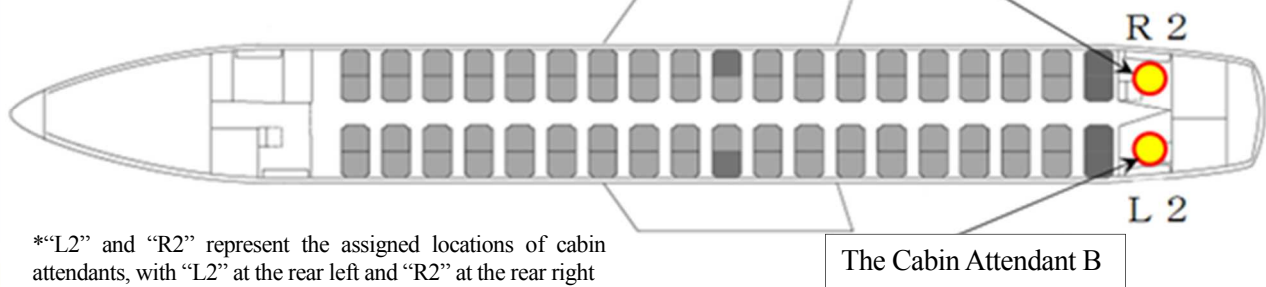
### Locations of the Injured when the Accident Occurred.

When the Cabin Attendant A entered the aft galley from the front side after cabin safety check, she took the R2 handset and monitored the call. After receiving the information on the estimate time of passing an altitude of 10,000 ft and instruction to carry out cabin safety checks the cockpit, and when she tried to place back the handset, the aircraft was strongly shaken and she collided with the R2 door; subsequently, collided with the Cabin Attendant B who was strongly flung from the L2 side, and fell down.

Immediately after the Cabin Attendant B received the notification from the cockpit with the L2 handset about the estimate time of passing an altitude of 10,000 ft, and when she was about to make an announcement to the passengers, the aircraft was strongly shaken and her body was strongly flung to the R2 side, and then collided with the Cabin Attendant A who was at R2.

**Probable Causes :** It is probable that this accident was caused by the shaking of the Aircraft which encountered the strong wake turbulence from the Preceding Aircraft while the Aircraft was descending; accordingly, two cabin attendants in the aft galley fell down and one of them was seriously injured.

➤It is probable that it would be beneficial for pilots to keep in mind the content described in guidance\* in the event wake turbulence is encountered, and review the operation continuously to appropriately recover the fuselage attitude in case of unexpected encountering with a wake turbulence.

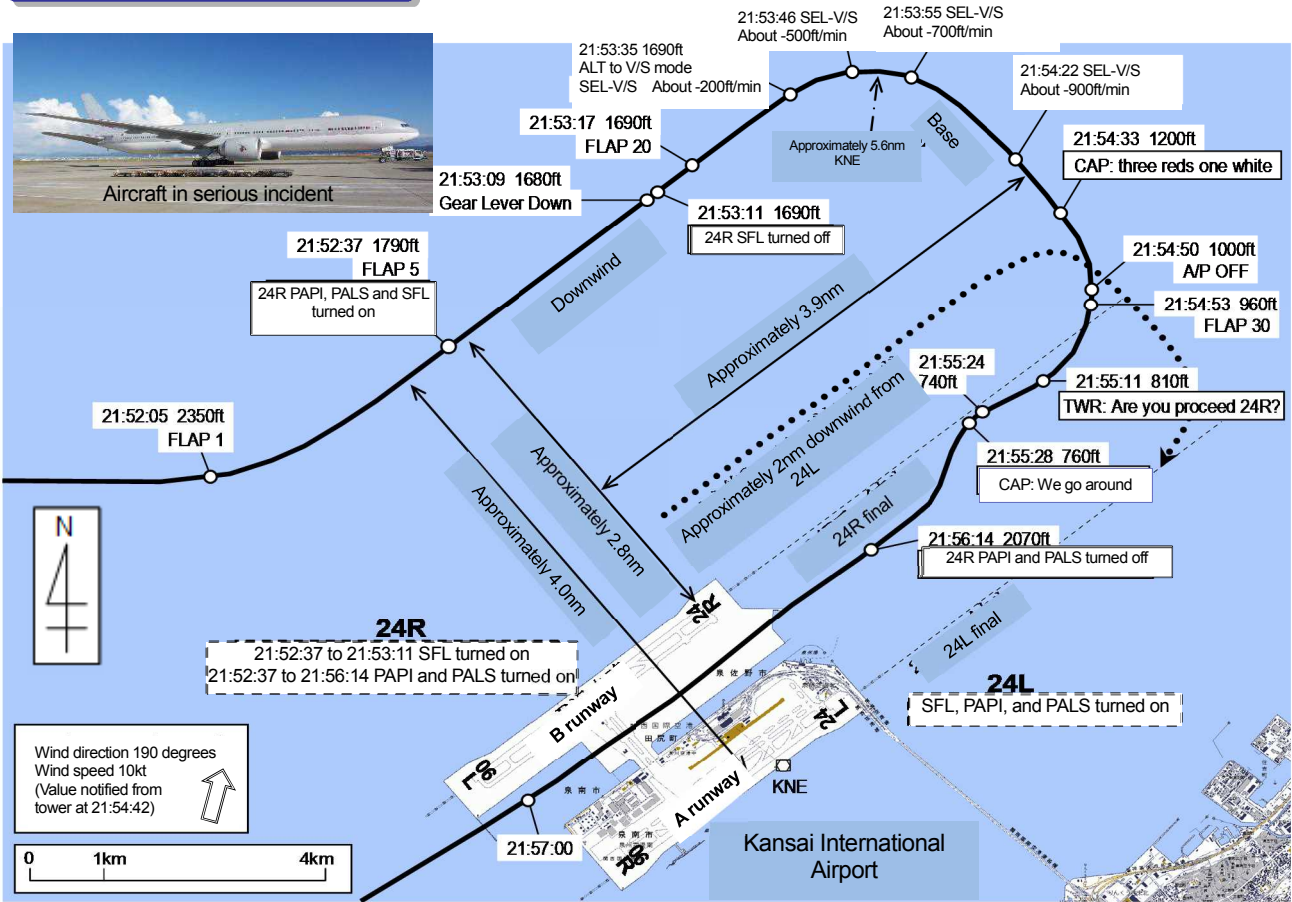
## Estimated Flight Route

Summary : On August 30 (Monday), 2010, a Boeing 777-300, operated by Company A, took off from Narita International Airport at 20:59 Japan Standard Time (JST: UTC+ 9hr, unless otherwise stated all times are indicated in JST using a 24-hour clock). At about 21:55, when the aircraft was approaching Kansai International Airport, it attempted to land on runway 24R, which was closed. Thereafter, the aircraft made a go-around and touched down on runway 24L at 22:07. There were 124 people on board, including the captain, 16 crewmembers, and 107 passengers but no one was injured.

**PROBABLE CAUSES :** It is considered highly probable that this serious incident occurred because while the aircraft was conducting visual approach to the airport the Captain and the First Officer assumed 24R to be 24L, and approached 24R by mistake after the aircraft received a landing clearance to 24L.

And it was the first visual approach to the Airport at night for both the Captain and the First Officer. It would have been desirable for them to or make an ILS approach as originally planned instead of the visual approach.

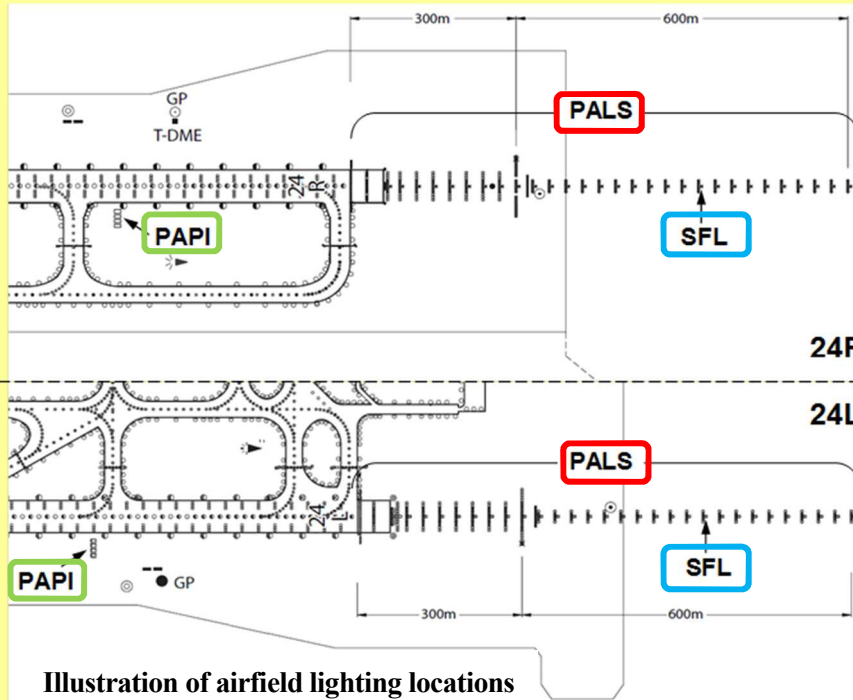
Illustration of airfield lighting locations

The precision approach lighting system (PALS), the sequenced flashing lights (SFL), and the precision approach path indicator (PAPI) of runway 24R were turned on.  
\*The explanation of each lights are the next page.

The SFL of 24R was turned off.

The PALS and PAPI on 24R were turned off.
