### 3. Case Studies of Accidents

#### Case 1 Due to unexpected circumstances (Unable to maintain altitude due to a downdraft and failure to start the engine)

After being released from the towing aircraft, the motor Glider greatly lost height due to failure to start the engine, and finally crashed. (Captain: Age 44, Total flight time: 1,195 hours)

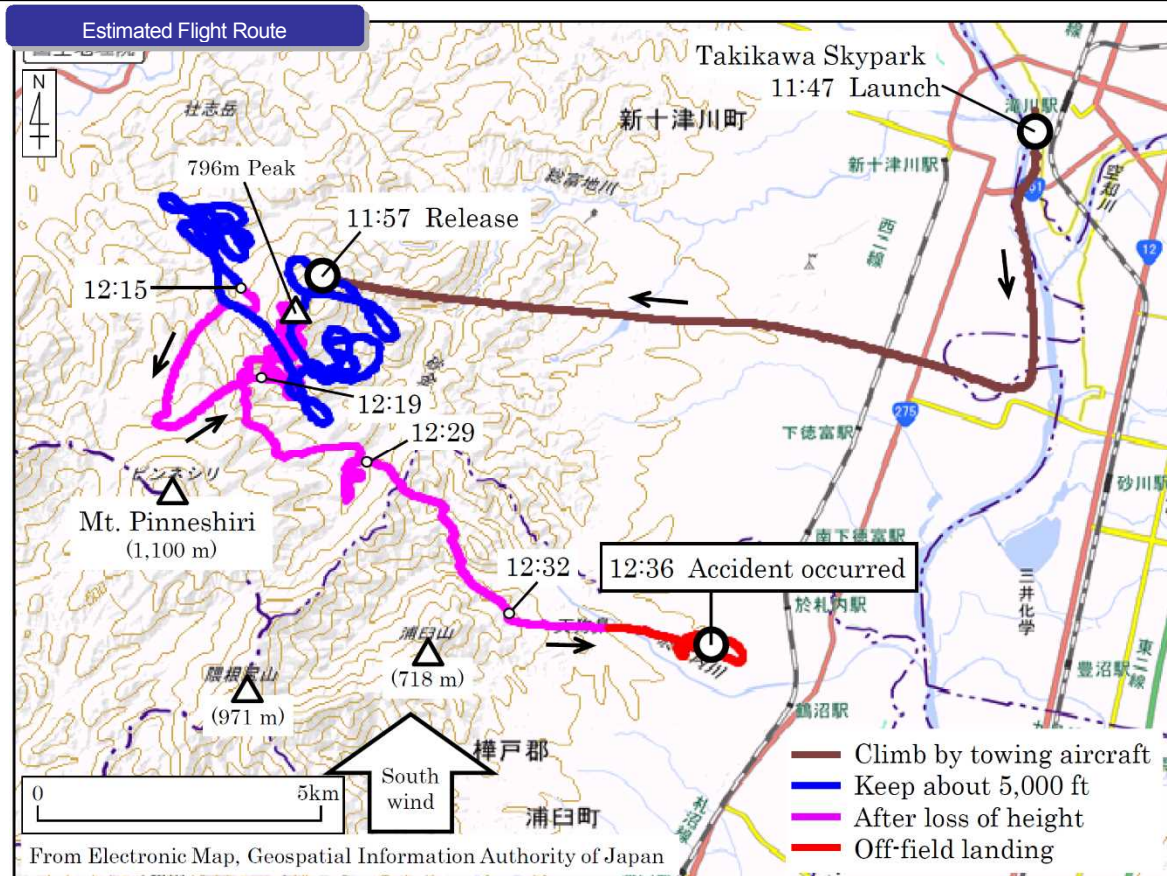
**Summary:** On Saturday May 30, 2015, a privately owned Schempp-Hirth Discus bT, launched by aerotow from Takikawa Skypark for navigation training and was released from the towing aircraft in a point about 13 km west-southwest of Takikawa Skypark at an altitude of about 5,300 ft. At 12:36 Japan Standard Time (JST: UTC+9 hr: unless otherwise stated all times are indicated in JST), the glider crashed into the grassland about 11 km southwest of Takikawa Skypark at an elevation of about 85 m. Only the captain was on board and fatally injured. The glider was destroyed but there was no outbreak of fire.

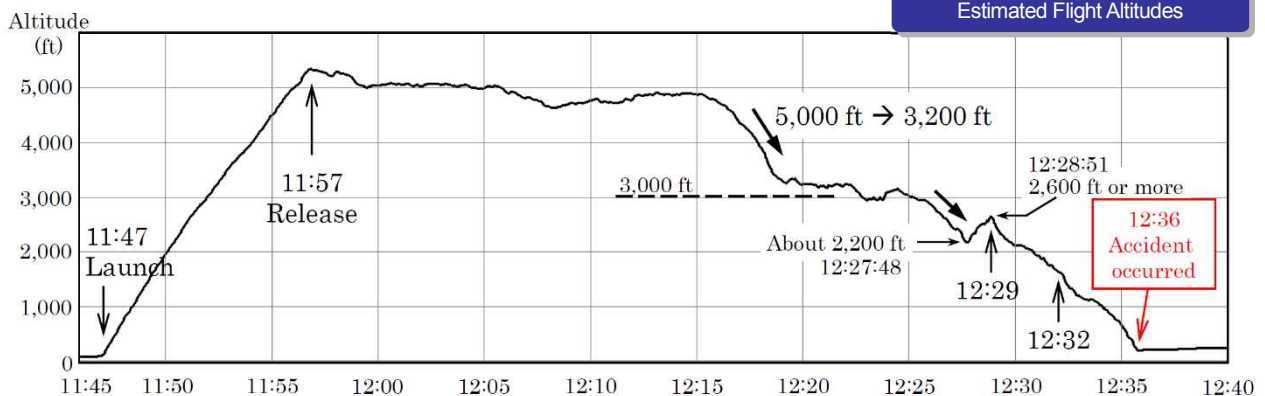
### Situations Leading to the Accident

The Glider went south towards Mt. Pinneshiri from around 12:15 and turned to the left on the way to get away from it, during which it largely descended to an altitude of about 3,200 ft.

It is highly probable that the large descent was caused by entry into the downdraft zone (sinking zone) which occurred in the north of Mt. Pinneshiri.

The fuel quantity in the fuel tank was less than the non-usable fuel; therefore, it is highly probable that the engine did not start due to the fuel exhaustion.

The engine of the Glider remained extended; therefore, it is probable that the glide performance was decreased, the loss of height was large, and no sufficient altitude was left; and consequently, it was difficult for the captain to keep the airspeed necessary to continue the flight.
