Case 3 Due to miss judgment of altitude, etc. (Flight training at a low altitude)

Training was continued below the required altitude, causing the Glider to make a hard landing and become damaged. (Instructor (captain): Age 75, Total flight time: 1,279 hours; Trainee: Age 59, Total flight time: 305 hours)

Summary: A Scheibe SF34B, owned by Association A, was damaged during a landing practice on Runway 14 at Nirasaki Gliding Field in Tatsuoka-machi, Nirasaki City, Yamanashi.

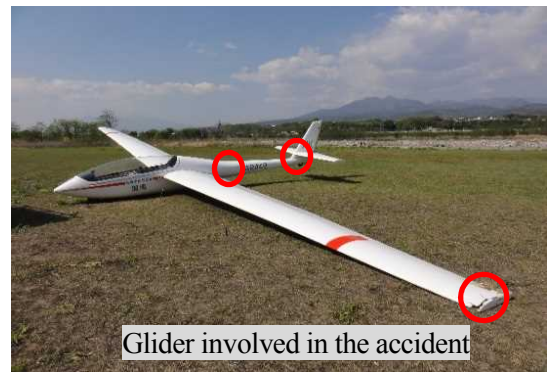
The Glider continued to turn to the left, it could not directly face the Runway and the left main wing tip was brought in contact with the ground in front of the Runway. After bouncing once, the Glider slightly veered the nose to the right, crossed the Runway while skidding sideways, and stopped with the nose directed to the west.

- Extent of damage: Substantially damaged
- Fuselage: Severe distortion, Paint peeling and others
 - Left main wing: Wing Tip breakage, Cracks and others
 - Tail wheel: Recessed into the fuselage

After the left main wing tip was brought in contact with the ground in front of the Runway, the tail wheel and main wheel touched down on the ground towards the center line.

- It is probable that sink rate was large in the touchdown of the fuselage.
- It is probable that the front wheel touched down to the ground, veering the nose slightly to the right after the fuselage bounced in its reaction, the Glider crossed the Runway while skidding sideways with the front wheel and main wheel, and it was stopped in the western edge of the Runway with the nose directed to the west.
