Serious Accident : Case 2

While in docking operation for a container ship, a mooring rope attached onto a bitt on the berth broke, and snapped back, hitting mooring workers, and took their lives

Outline: the container ship (the Ship) was docking at Port Island Container-Berth 18 at about 0736 hrs, May 20, 2009, when a mooring rope attached onto a bitt on the berth broke, snapped back and hit two workmen engaged in mooring work. Both of them died.

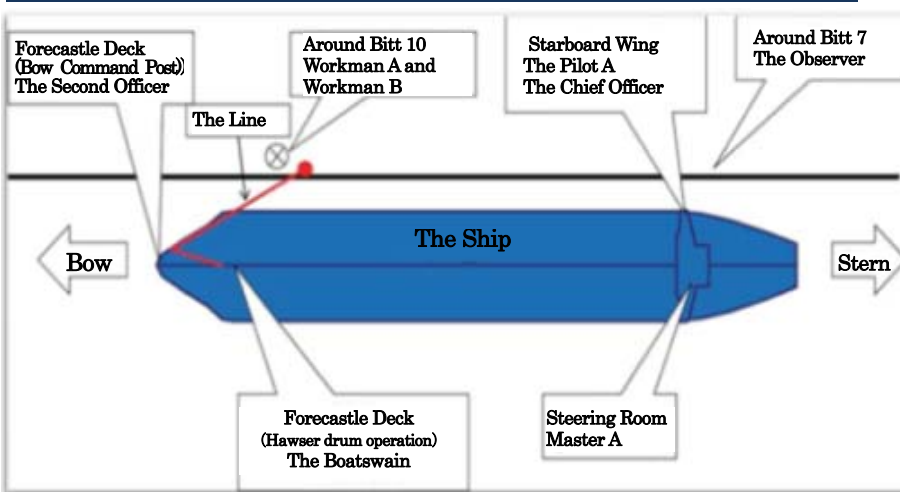
Positions of the workman and the crew when the Accident

- ① It is considered probable that part-time workmen, Workman A and Workman B were winding-in the second spring line, standing about 10m from Bitt 10 toward Bitt 13, in order to prevent the Line from getting in under the fender.
- ② It is considered highly probable that the Line, upon breaking, hit the left side of Workman A's face, and the right side of Workman B's face and the his neck.

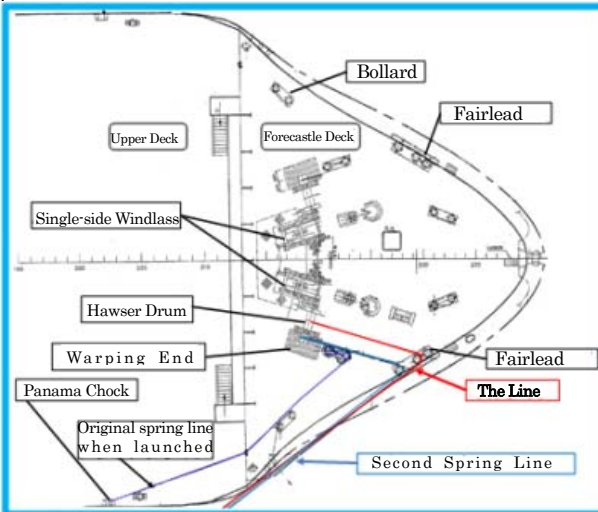
The route of a forward spring line

At the time of launching, a forward spring line was to run from the bollard on the forecastle deck to the panama chock on the upper deck, and to run to a bitt on a berth.

It is considered probable that the Line, wound on the hawser drum, was used as a forward spring line for operational efficiency.

It is considered probable that the Line had been repeatedly used for the forward spring line, and therefore, it is considered probable that the Line's strength had degraded upon damage caused by repetitive touching the Bend Point, such as yarns sticking-out and breaks and fluff in the portion of 20m–34m from the end of the eye.

Therefore, it is recommended to clearly state and require to pay attention to the route of mooring ropes and the bits to moor the ropes onto in order to prevent mooring ropes from touching corners such as the Bend Point to the extent possible and obtain safe and effective mooring forces, and to place a person in charge to take command of operations in such a position from where the person can acquire the knowledge of the overall conditions of mooring ropes. At the same time, it is recommended to make all the ships under management comply with such requirements.

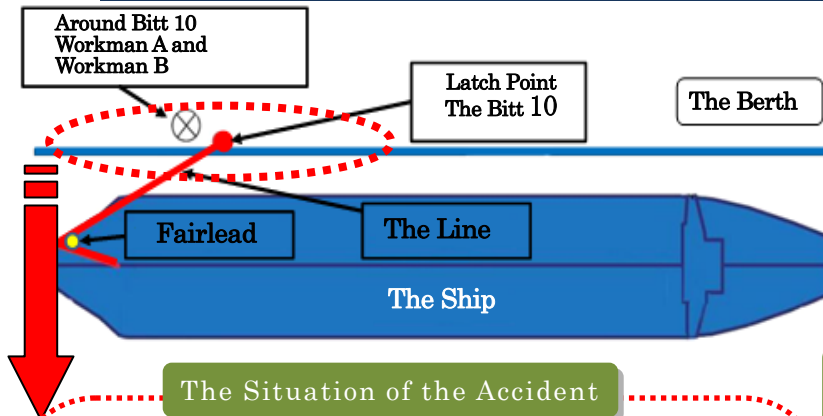
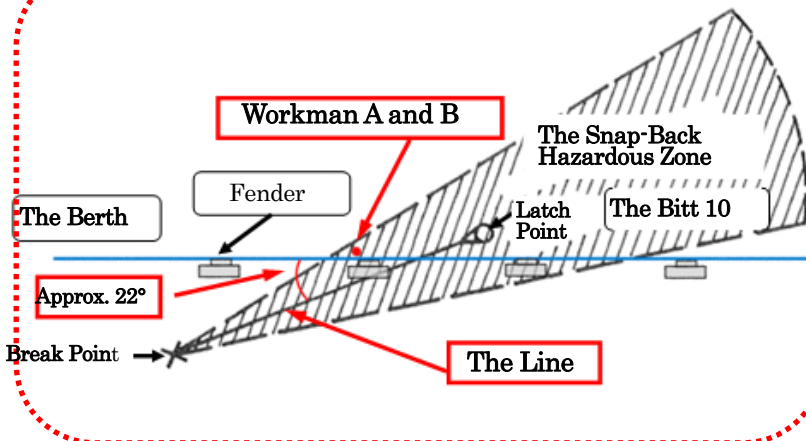
The Situation of the Accident and the Snap-Back Hazardous Zone

* The chart for the situation of the accident shows a snap-back hazardous zone when a break point is between a latch point and a fairlead. In the case of the Ship, as in the reference chart, the mooring line was bent at the fairlead, although a snap-back hazardous zone will extend further if a break point is between a fairlead and a latch point.

It is desirable that line handling service providers provide their mooring workers with information on extension of the snap-back hazardous zones of ropes when broken under tension, and give them instructions such as to avoid working inside the zone unless necessary and to complete the work swiftly and leave from the snap-back hazardous zones as promptly as possible.
