Serious Accident : Case 3

While hoisting cargo with a deck crane, the wire rope broke and the cargo fell into the hold of the barge

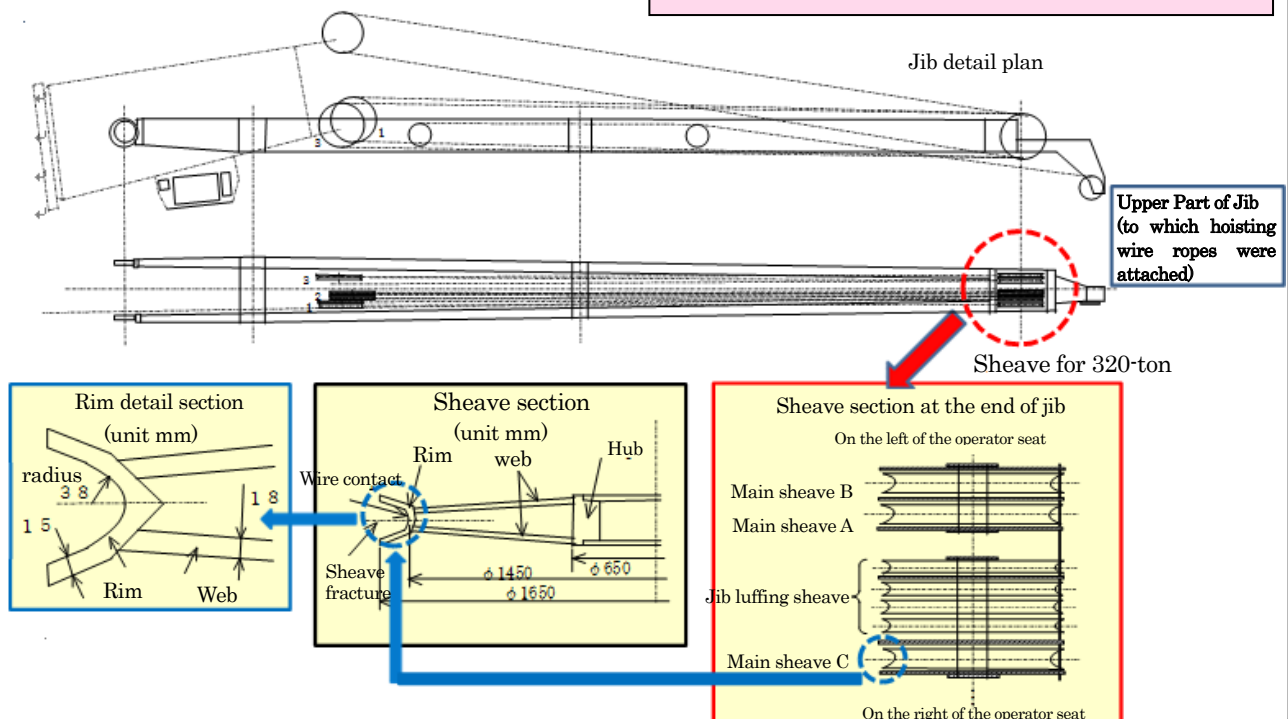
Jib and Sheave

It is considered probable that tension on the Main Wire was sharply reduced due to the fracture of the entire circumference of the rim of the Main Sheave C (*2), and then the Main Wire dropped into the gap caused by the fracture and came to a stop on the hub, when a jolting overload larger than its break load was inflicted on the wire, leading to a break.

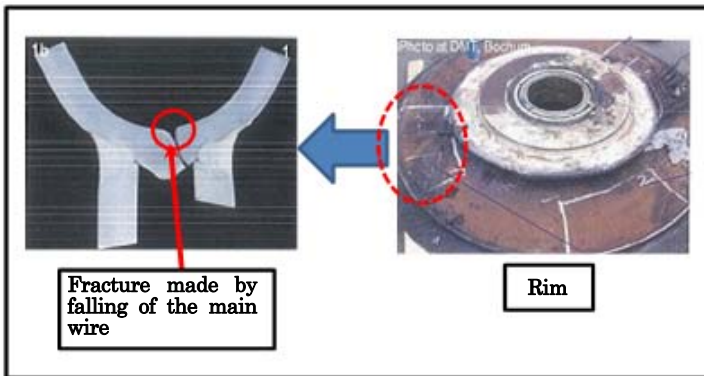
State of Rim Fracture

It is considered probable that: the rim of the Main Sheave C had small cracks in its backside portion of the wire guide surface and its surface was hardened due to the cold forming used in its manufacture, resulting in ductility reduction. In addition, residual stress was not completely removed from the rim. As a heavy cargo weighing approximately as much as the Safe Working Load was hoisted, conditions that allow brittle fracture were created inside the rim while Crane No.3 was in operation, thus finally resulting in the break.

It is considered probable that, through bending and shaping the material by cold forming and the elongation and narrowing down process during the rim production, the surface of the rim underwent substantial hardening, and caused significant ductility reduction.

This accident occurred in spite of the fact that Crane No.3 had passed a load test three weeks earlier, and a later investigation revealed the occurrence of a brittle fracture on the fractured surface of Main Sheave C, and various sized cracks were observed on Main Sheave E's surface.

In the face of these findings, crane manufacturers should, when they produce a rim that requires strong bending and shaping processes as a part of a weld construction sheave, perform proper control of manufacturing processes, including the selection of materials.

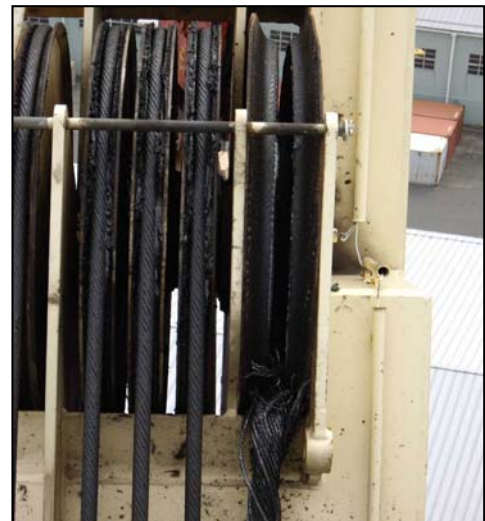
Sheaves at the end of Jib (Crane No. 3)

Jib luffing sheave Main Sheave C
