JTSB Digests

JTSB (Japan Transport Safety Board)

Digest of Marine Accident Analyses

For prevention of “Fatal and Injury Accidents Related to On-Board Works”

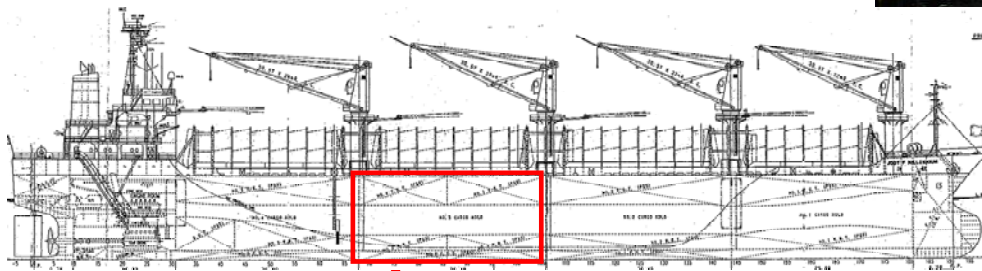
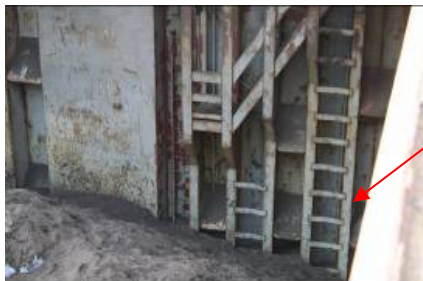
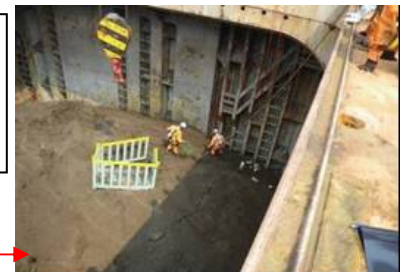
cargo hold No. 3
Above: general arrangement”(excerpt)
Left: approach to cargo hold
Right: rescue operation

While the ship was berthed at the wharf of port of Saganoseki, and Driver B entered cargo hold No. 3 and was descending toward the bottom, he inhaled oxygen-deficient air (*4), developed anoxia and died.

During the voyage, the copper concentrate loaded in cargo hold No.3 oxidized, and the oxygen in the airtight hold was consumed. The atmosphere (*2) in cargo hold No. 3 became oxygen-deficient, and at the same time, odorous hazardous gases, which were heavier than air, were generated by the floatation reagents (*3) adhering to the copper concentrate and accumulated in the cargo hold.

- ▶ Casual factors leading to oxygen-deficiency in cargo hold No.3
 - the copper concentrate loaded in cargo hold No. 3 had oxidized during transportation from Port Moresby Harbour to port of Saganoseki, and the oxygen in airtight cargo hold No.3 had been consumed, creating an oxygen-deficient environment

- (3) To request the MSDS (*5) of floatation reagents from shippers.
- (4) To inform all employees who have the possibility of being engaged in cargo operation that depending on the floatation reagent adhering to copper sulfide concentrate, it may generate toxic gas, and since the generated toxic gas is heavier than air, it stagnates in cargo hold, hence, there is a danger of not being replaced by air.

- (5) To make the risks of oxygen-deficient conditions and anoxia known to all personnel who have the possibility of being engaged in cargo operation and to familiarize them with appropriate coping behavior in case of fatal accidents occurring in cargo holds loading copper sulfide concentrate.

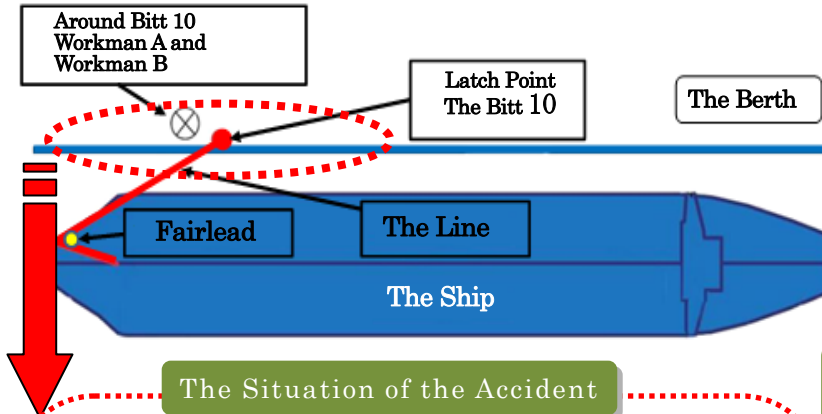
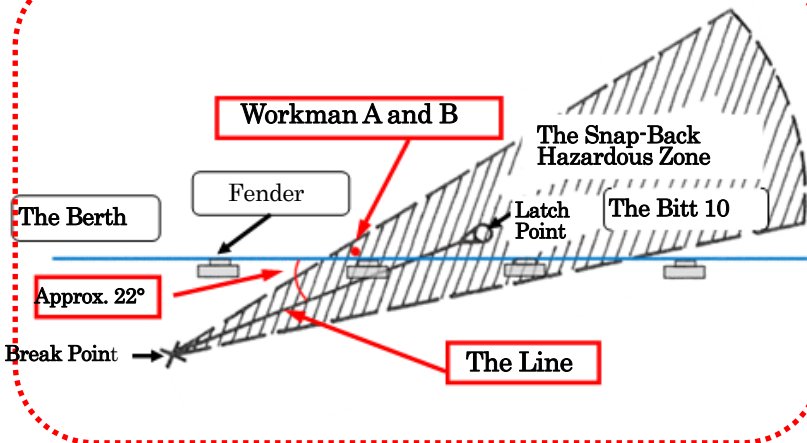
The Situation of the Accident and the Snap-Back Hazardous Zone

* The chart for the situation of the accident shows a snap-back hazardous zone when a break point is between a latch point and a fairlead.
In the case of the Ship, as in the reference chart, the mooring line was bent at the fairlead, although a snap-back hazardous zone will extend further if a break point is between a fairlead and a latch point.

It is desirable that line handling service providers provide their mooring workers with information on extension of the snap-back hazardous zones of ropes when broken under tension, and give them instructions such as to avoid working inside the zone unless necessary and to complete the work swiftly and leave from the snap-back hazardous zones as promptly as possible.

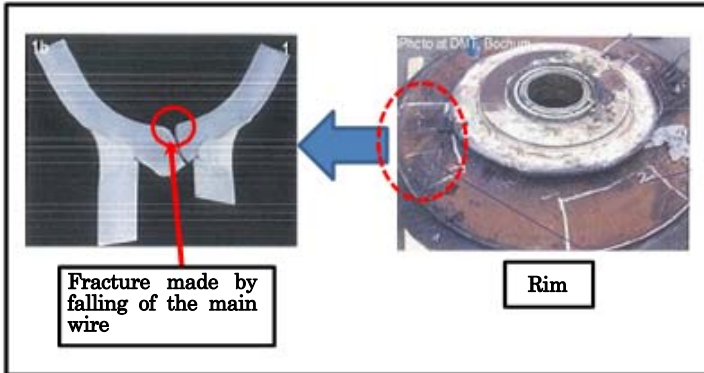
State of Rim Fracture

It is considered probable that: the rim of the Main Sheave C had small cracks in its backside portion of the wire guide surface and its surface was hardened due to the cold forming used in its manufacture, resulting in ductility reduction. In addition, residual stress was not completely removed from the rim. As a heavy cargo weighing approximately as much as the Safe Working Load was hoisted, conditions that allow brittle fracture were created inside the rim while Crane No.3 was in operation, thus finally resulting in the break.

It is considered probable that, through bending and shaping the material by cold forming and the elongation and narrowing down process during the rim production, the surface of the rim underwent substantial hardening, and caused significant ductility reduction.

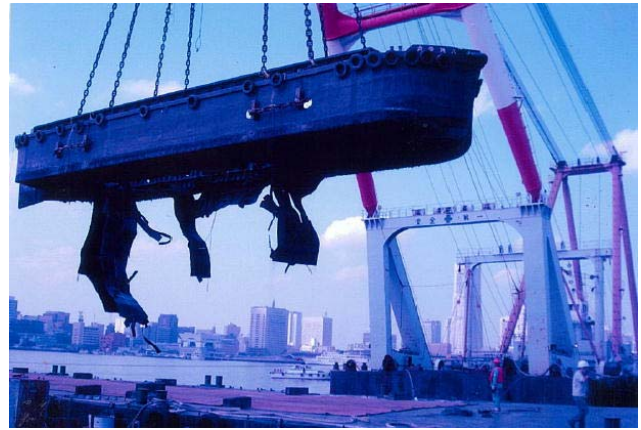
Vessel B which Sustained a Fracture at the Bottom

Vessel B sustained a fracture at the bottom of the hold because of the cargo, and sank.
