Case 3: Lack of Knowledge, Skill, and Experience

Date and Time of Occurrence: Around 09:33, August 1, 2020

Type: New Wings MAX-R447/MAW (Weight transfer controlled ultralight plane)

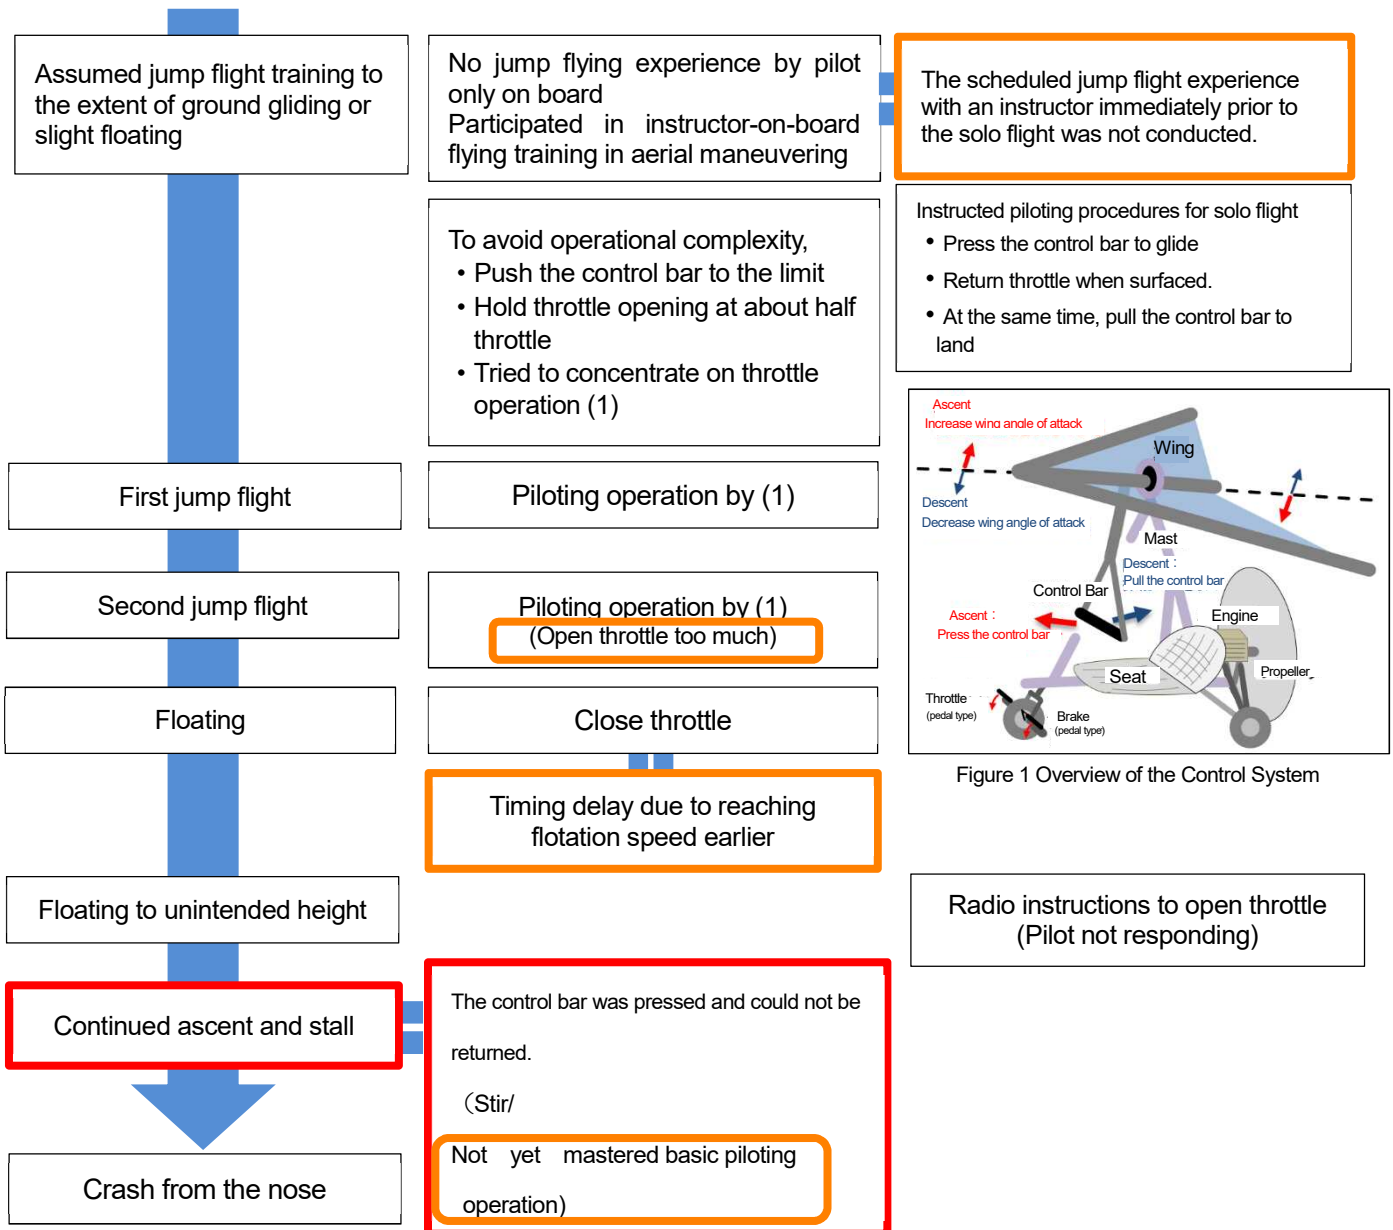
Figure 1 Overview of the Control System

Radio instructions to open throttle (Pilot not responding)

【Probable Causes: Improper Piloting】
It is probable that the pilot did not operate the control bar and throttle properly during the training of jump flight, resulting in the aircraft ascending to a height unintended by the pilot after floating, and then continuing to ascend and losing speed afterwards, causing the aircraft to crash from the nose.

【Factors: Lack of Knowledge, Skills, and Experience】
Probable reasons why the piloting maneuver was not performed properly are as follows:

- Operational training on the ground prior to the jump flight and flight training with a flight instructor on board were not sufficiently conducted.
- The pilot did not master the basic piloting operation.
