2. Situations where accidents occurred due to pitching, etc.

2.1 Sea conditions and navigational conditions at the time of accident

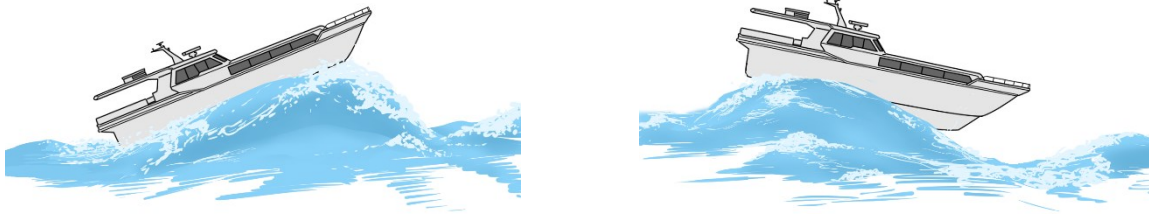
This type of accidents is caused by **pitching of the ship's body**. When the ship's body pitched up and down and the bow is lifted, bodies of the anglers were lifted up and fell.
