### 3. Cases of accidents due to pitching, etc.

#### Case 1: 2 anglers suffered from vertebral fractures who sit on the starboard front when the starboard bow pitched and rolled due to heavy surges

## Case 2: 3 anglers on the forward deck suffered from vertebral fractures, etc. when the ship pitched

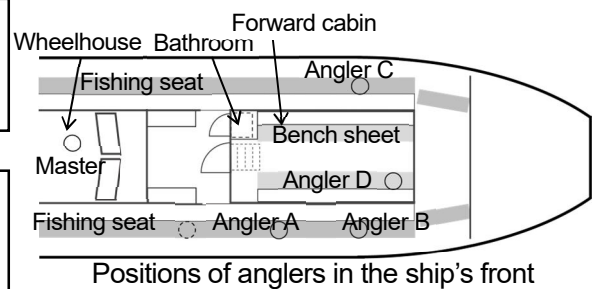
Angler A, Angler B, and Angler D hit their buttocks due to pitching and rolling approximately 5 minutes after the announcement prior to the arrival.

- Even after heavy surges were observed, the master **made an announcement prior to the arrival as usual** and allowed anglers to choose a waiting position, because the wave height was low and **heavy pitching and rolling were not felt after reducing the speed**.
- The master **could not feel heavy pitching and rolling at the bow** when the anglers were injured, because the master navigated the Vessel in the wheelhouse near the midship area and did not see how Angler A and Angler B on the starboard front.

**Cause:** In this accident, it is supposed that Angler A and Angler B who sit on the fishing seat on the starboard front were lifted up and then fell and their buttocks hit the fishing seat, because the starboard bow of the Vessel, while heading toward south-southeast at the speed of approximately 15 knots, pitched due to heavy surges.

- The masters and operators of recreational fishing vessels must **set standards for moving anglers to the stern side from the midship such as wind direction, wind speed, wave direction, and wave height (with respect to the vessel speed)**.

- If the standards are exceeded while sailing, the masters and operators of recreational fishing vessels must **ensure safety by stopping to sail or reducing the speed sufficiently and then move anglers to the stern side from the midship**.

- The masters and operators of recreational fishing vessels must obtain information on winds and waves of sea areas where they plan to sail. If the standards are exceeded, the masters and operators of recreational fishing vessels must **set sail after verifying that anglers have moved to the stern side from the midship**.

- The masters of recreational fishing vessels, etc. must **comply with the operational rules (regulations on prevention of accidents involving injuries due to pitching and rolling)**.
