Chapter 3 Case studies and analysis of aircraft turbulence-related accidents

1. Introduction of accident cases

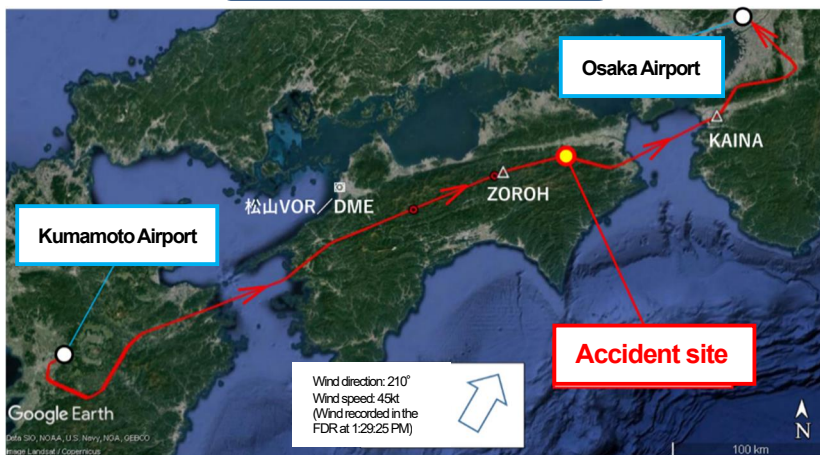
Estimated flight path diagram

The FDR records show that between 1:29:08 PM and approximately 12 seconds later, the vertical acceleration fluctuated between +0.2 G and +2.1 G. During this time, the aircraft was likely flying near developed convective clouds, encountering turbulence caused by these clouds, which resulted in significant aircraft movement.

The flight crew probably kept the seatbelt sign off until the aircraft encountered significant vertical turbulence, as they believed they could avoid the echo by altering course and considered passenger needs. Regarding seatbelt sign operation, it is advisable for flight crews to take a more safety-conscious approach when there is a possibility of aircraft turbulence.

Probable Cause: This accident most likely has been occurred when the aircraft encountered turbulence caused by convective clouds while the seatbelt sign was off, resulting in severe aircraft movement, then a cabin crew member, who was crouching and working in the galley at the rear of the aircraft, was lifted off the floor, lost balance, and fell, sustaining injuries. The aircraft's encounter with turbulence from convective clouds was likely due to insufficient evasive maneuvers based on onboard weather radar displays of convective clouds. Additionally, the presence of developing convective clouds, which were difficult to detect on the onboard weather radar, likely have contributed to the inability to maintain an appropriate distance from the turbulence.

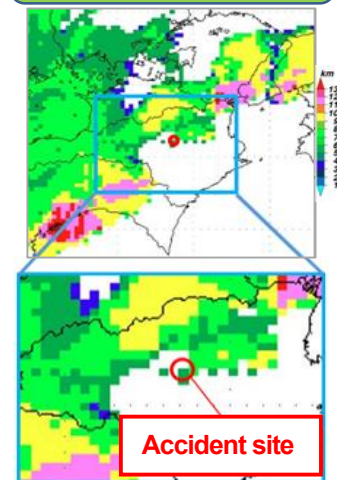
Rader composite images (echo top altitude)

Based on radar composite images (echo top altitude), it is highly probable that convective clouds had developed near the accident site, reaching altitudes between 5 km (16,403 ft) and 6 km (19,685 ft).

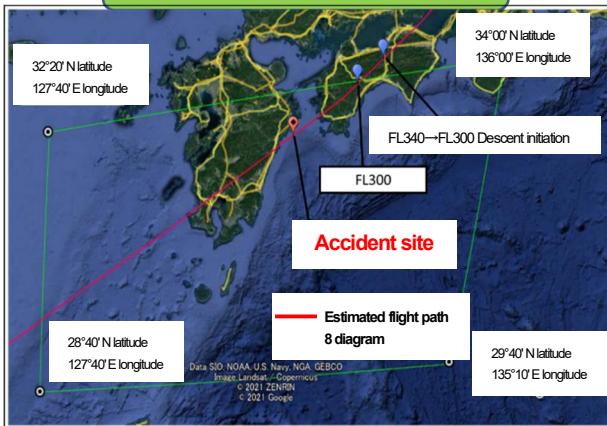
Estimated flight path diagram

Probable Cause: This accident most likely has been occurred when the aircraft encountered wind shear near the jet stream, causing significant turbulence, which led to a cabin crew member falling while moving through the aisle and sustaining a serious injury.

It is most likely that a strong wind shear existed along the jet stream near the accident site, as a transverse line of upper clouds and a vertical shear zone were observed. The aircraft most likely have experienced significant turbulence due to this wind shear. As a result of this turbulence, the senior cabin crew member, who was moving through the aisle to return from the rear of the cabin to the front jump seat, highly probably fell and fractured their right ankle.

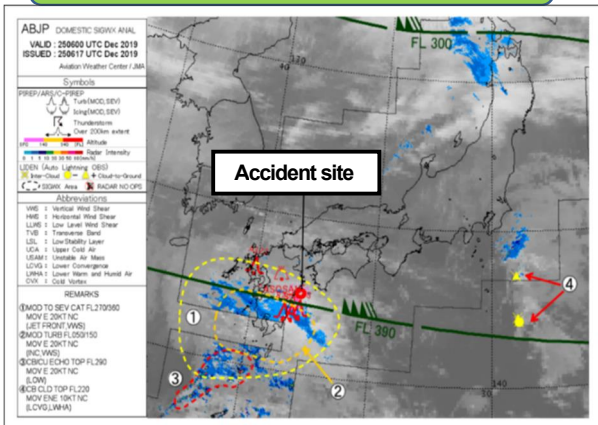
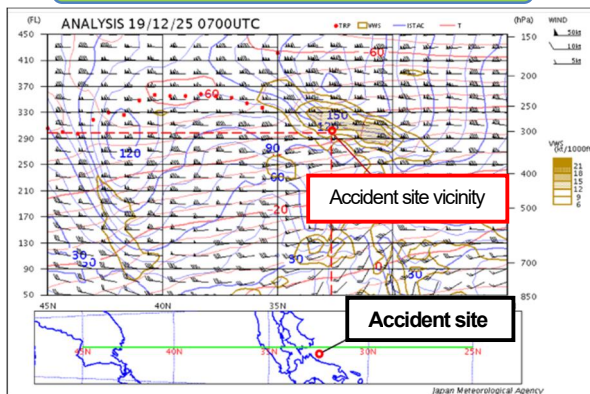
The flight crew, based on the weather data reviewed before the flight, the onboard weather radar display, and pilot reports, more likely expected some turbulence but did not anticipate encountering turbulence of such severity. However, if they had obtained the SIGMET information issued by the Japan Meteorological Agency at 2:00 PM, it probably has been useful for the flight crew to proactively assess the need for altitude and route changes, seatbelt enforcement, and the timing of safety information dissemination to the cabin.

The Operation Control Center (OCC) more likely have not obtained the SIGMET information issued by the Japan Meteorological Agency at 2:00 PM. Since SIGMET information provides critical updates on significant weather changes affecting flight safety, it probably be beneficial for OCC to acquire such information in a timely manner and appropriately relay it to the flight crew to help prevent similar accidents.

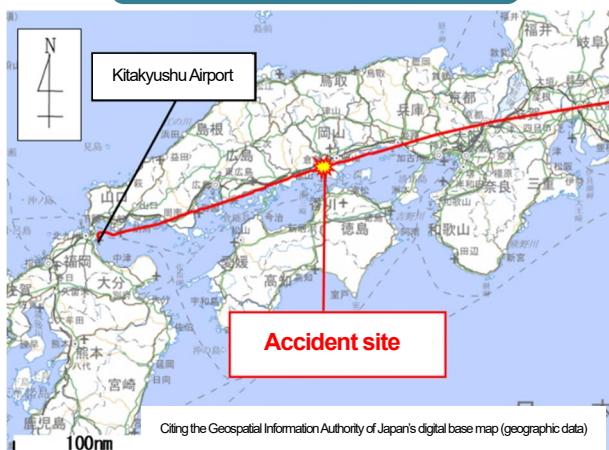
Estimated flight path diagram

Although no cloud echoes were observed near the accident site, it is probable that clear-air turbulence caused by the jet stream was present. At the time of the accident, PIREP reports indicated that clear-air turbulence had occurred around 7:48 PM at FL300, approximately 14 nm northwest of the accident site.

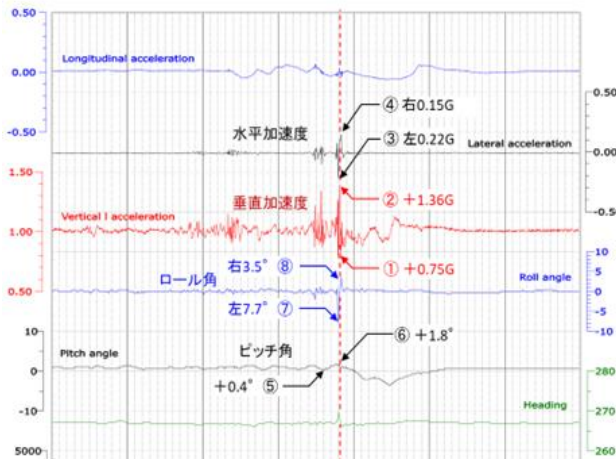
QAR records

The vertical acceleration fluctuated between +0.75G and +1.36G, while the horizontal acceleration ranged from 0.22G to the left to 0.15G to the right. Given the presence of a vertical shear zone on the hourly atmospheric analysis chart and the absence of clouds, it is probable that the turbulence was caused by clear-air turbulence resulting from the influence of the jet stream.
