4. Case studies of the accident

1. Case of grounding and sinking due to unawareness of reef locations in the operational areas

2. Case of capsizing and sinking due to unique oceanographic conditions in the operating areas

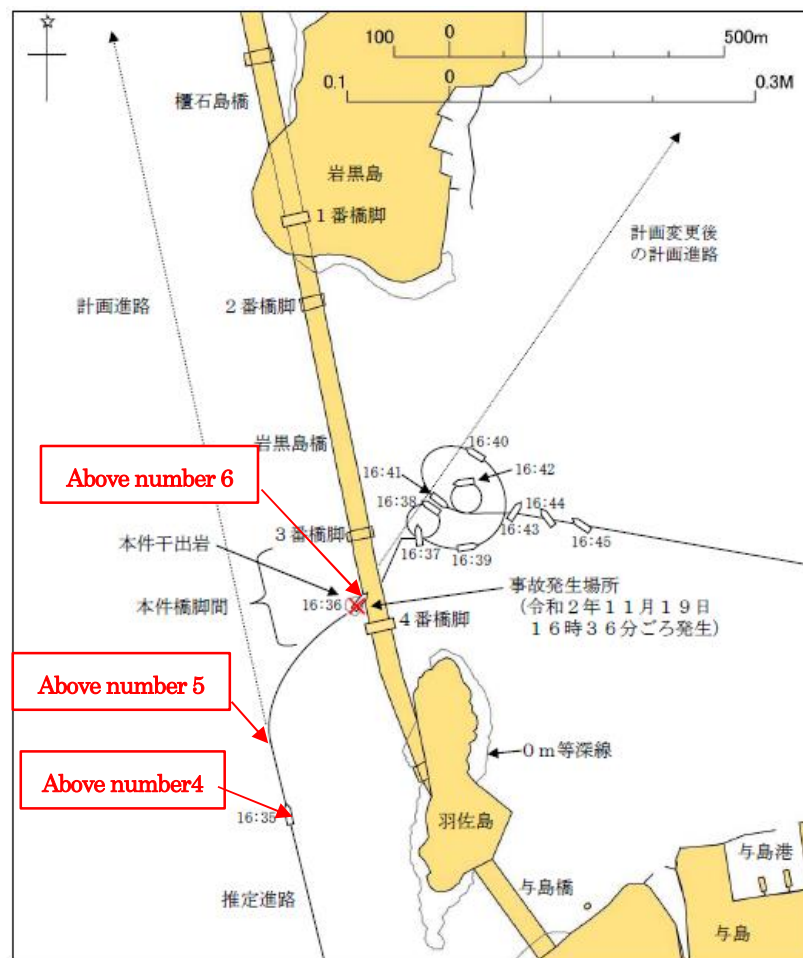
Figure 18- Around the accident area

4. At around 4:35 PM on the same day, while navigating west of Wasa Island, north of Yoshima, a supervising teacher was explaining Iwakuro Island, visible off the starboard bow, to the students. Based on his/her own judgment, the master decided to **alter the original voyage plan** and pass under the Seto Ohashi Bridge (Iwakuro Island Bridge) to head east of Iwakuro Island.

5. The master was aware that the usual passage towards the east of Iwakuro Island was between the second and third bridge piers. However, having seen fishing boats pass between the third and fourth bridge piers two to three times in the past, he/she decided to take a **direct course** toward the east of Iwakuro Island by passing between the third and fourth piers.

6. To take a direct course east of Iwakuro Island, the master turned starboard and navigated northeast near the fourth bridge pier. However, Passenger Ship A was **pushed by an eastward current of approximately 1.7 knots** and, at around 4:36 PM, **ran aground on the rock which covers and uncovers (commonly known as "Osowai"), which had a water surface height of approximately 2.0 meters.**

For reference, **the key events (4–6) in the accident area are marked by numbers** on the map below.

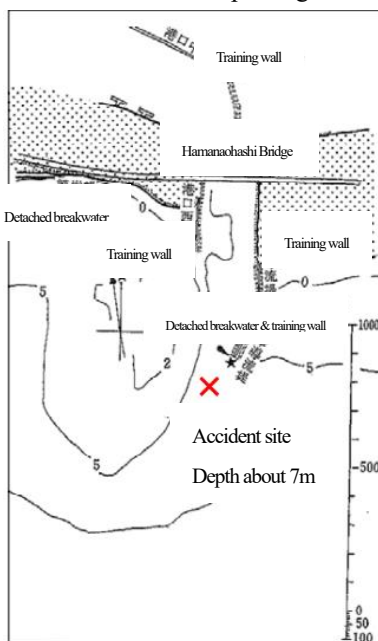
Figure 20-Overview of Imagireguchi

Imagireguchi in Lake Hamana is a 200m-wide inlet connecting to the Enshunada Sea. As the offshore water depth gradually decreases from 10m to 2m near the inlet, incoming waves undergo a transformation. When these regular offshore waves reach the shallow waters, their wavelength shortens while their height increases, often resulting in steep **breaking waves (surf waves)** due to the abrupt change in wave shape.

According to testimony from local fisheries cooperative officials interviewed during the investigation, when **the outgoing tide flows** southward from Imagireguchi, it can **collide with large offshore swells, wind waves, or the Enshunada current, generating extremely high waves**—sometimes reaching up to 5 meters. Notably, on the day of the accident, no local fishing boats were operating.

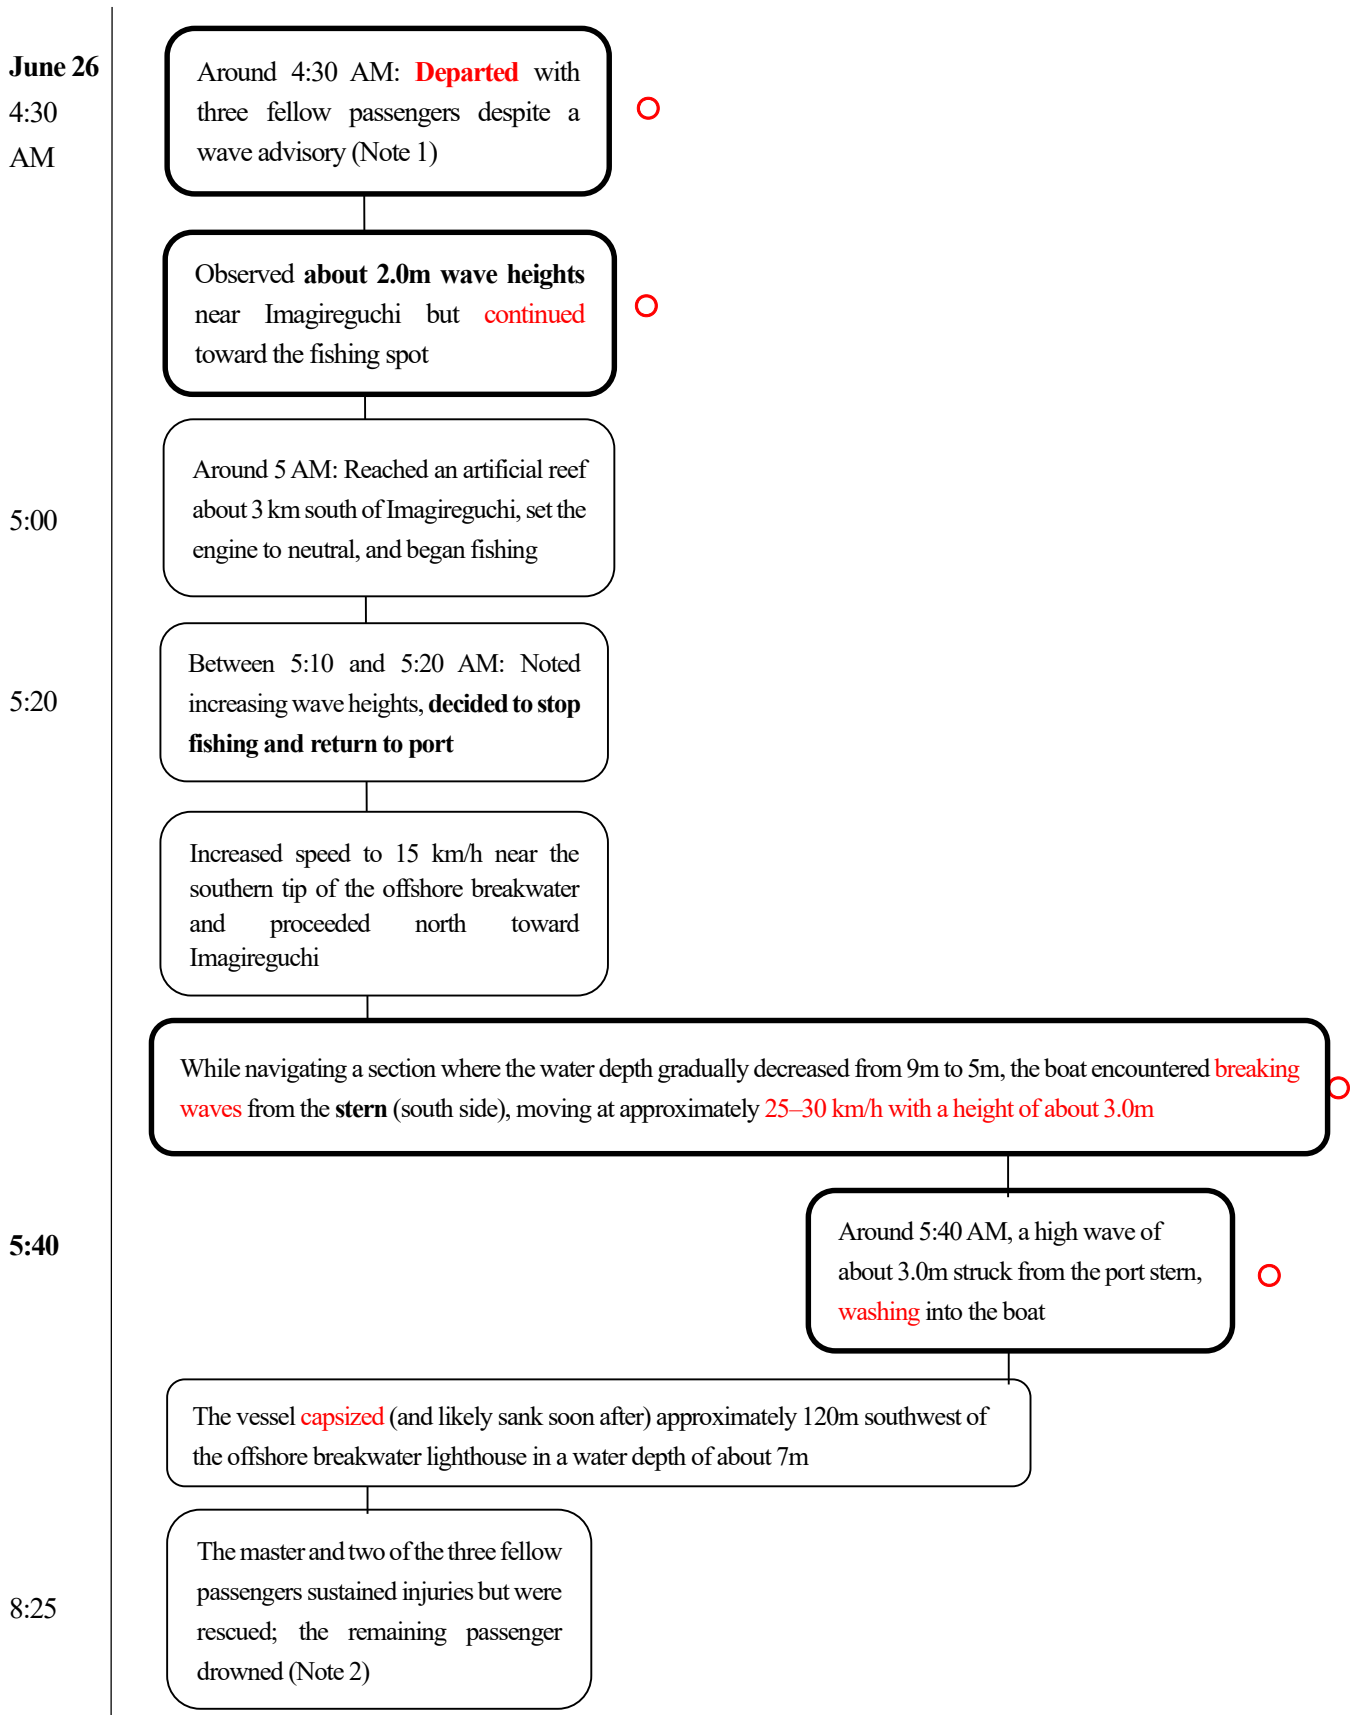
Note 1 : Wave Advisory issued by the Shizuoka Meteorological Observatory at 2:42 AM on June 26, 2011, for southern Hamamatsu (Enshu South). It warned of 3.0m wind waves and swells persisting into the early hours of June 27.

Note 2 : The fellow passengers who drowned was on the exposed deck at the time of capsizing and was not wearing a life jacket.

In VTA, bold-framed boxes represent "**variation factors**", indicating deviations from normal **judgment, actions, or events** related to the accident. In this case, the identified variation factors include: 1)**Judgment**: Departing despite the issuance of a wave advisory, 2)**Action**: Continuing navigation after observing 2m waves near Imagireguchi, 3)**Action**: Navigating while being hit by breaking waves (3.0m) from the stern at 25–30 km/h, 4)**Event**: A high wave striking from the port stern, leading to water ingress.

Additionally, a "**○ (red circle)**" next to a box represents an "**exclusion node**," emphasizing that the accident would not have occurred if the factor had been eliminated. Since exclusion nodes are equivalent to direct causes or underlying factors, they typically overlap with variation factor boxes.
