Japan Transport Safety Board DIGESTS

Number 45 (issued on April, 2024)

Maritime Accident Analysis Report

Preventing major accidents involving small passenger ships

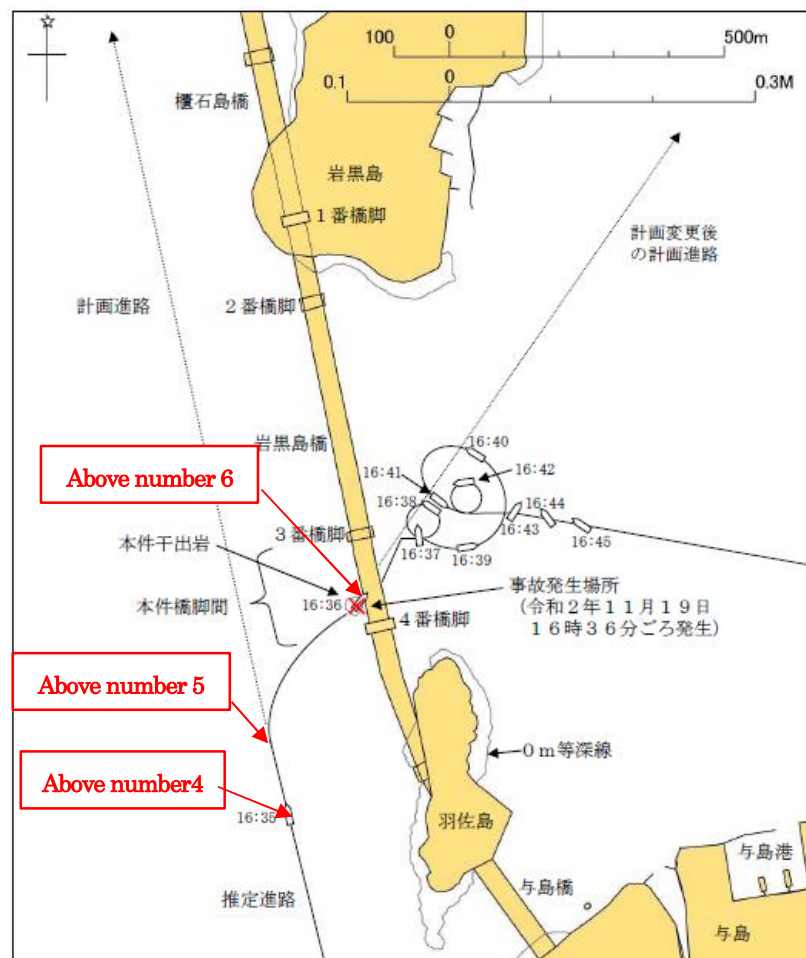
Figure 18- Around the accident area

For reference, **the key events (4–6) in the accident area are marked by numbers** on the map below.

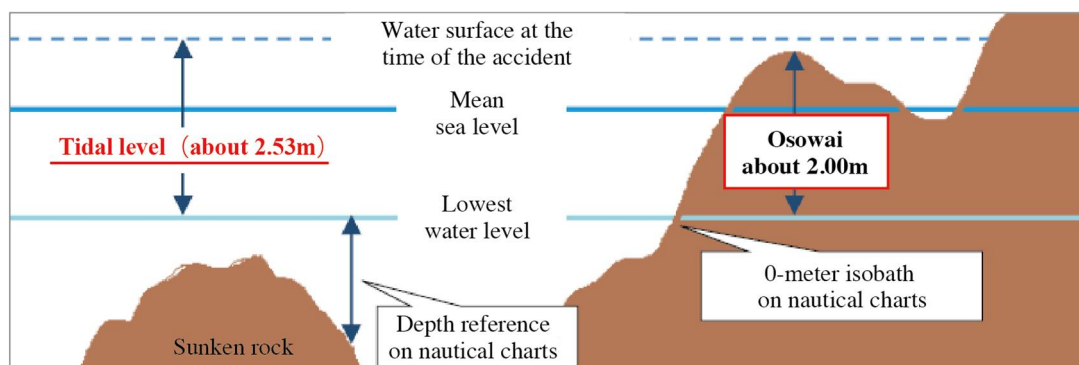
Figure 19-Tidal conditions at the time of the grounding

At the time of the accident, **the tide level was approximately 2.53 meters** above the lowest water level, which serves as the depth reference on nautical charts. Since Osowai protrudes about 2.00 meters above the lowest water level, it was submerged at this tide level. As a result, the depth from **the water surface to the top of Osowai was about 0.5 meters**.

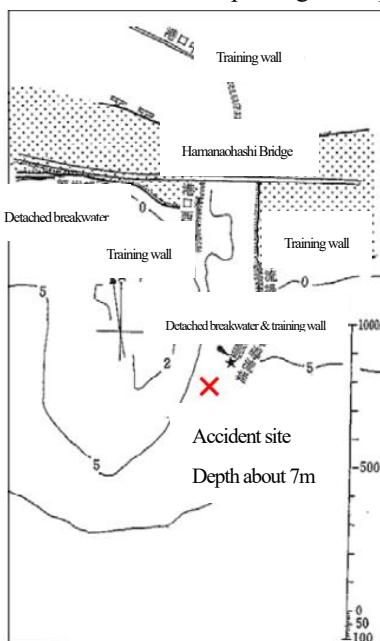
Figure 20-Overview of Imagireguchi

This accident occurred despite calm weather conditions near Lake Hamana. However, swells propagated due to the influence of Typhoon No. 5 moving northward in the East China Sea had become breaking waves offshore from Imagireguchi. These breaking waves combined with the ebb tide, resulting in high waves that struck the port stern, ultimately causing the vessel to capsize.

1. Check tidal currents and weather conditions and if high waves are expected south of Imagireguchi, the small vessels should avoid departing from Lake Hamana due to the risk of capsizing.

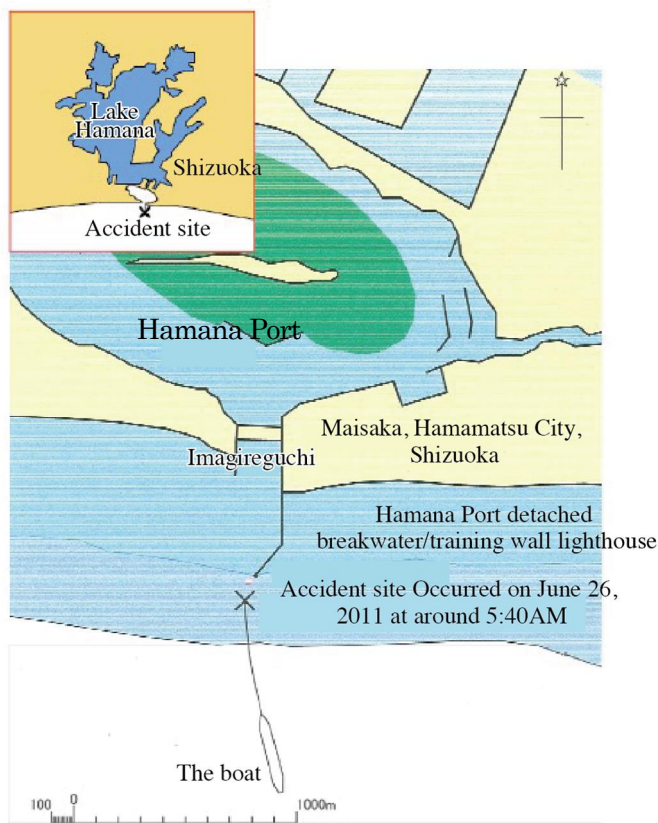
Figure 21 - Estimated navigation route

- The vessel departed despite the issuance of a **wave warning** predicting continuous swells and wave heights of approximately 3.0m.
- Although **weather conditions** around Lake Hamana were **calm**, swells propagating from the open sea broke near Imagireguchi, where they collided with the ebb tide, **creating high waves**.
