Railway Accident Analysis Report

Preventing railway accidents caused by snow

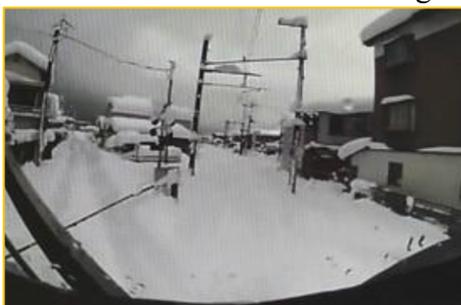
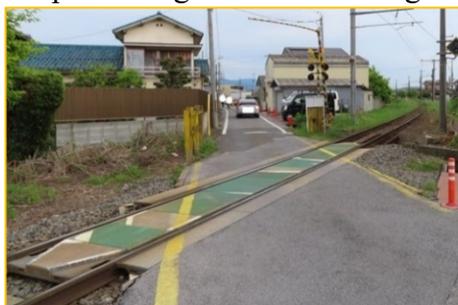
The left photo shows an unplowed track (level crossing) as seen from a train. Ruts where vehicles have passed through the snow on the road can be seen from the left toward the center of the photo. (From a railway accident investigation report)

The right photo shows the same level crossing without snow as seen from the road.

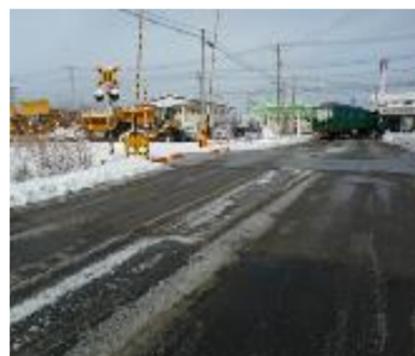
Figure 8: Example overall view of a location where a level crossing snow-melting device has been installed. There is little snow on the road near the level crossing. (From the East Japan Railway Company website)

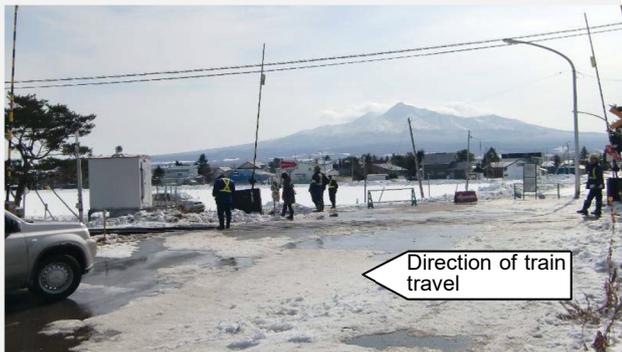
Figure 13: Condition of the level crossing where the accident occurred and the southeast direction from it (the day after the accident)

Probable causes: The JTSB concludes that it is probable that the accident was caused as the train climbed up onto compacted snow formed in the flangeways and on the rail surfaces at the level crossing and then moved to the left, resulting in a derailment.

As for the occurrence of the accident, it is possible that the rapid formation of compacted snow due to a combination of the following factors was involved: strong winds from the direction unobstructed near the accident site caused a snowdrift to grow quickly at the level crossing, which, together with snowfall earlier in the period before the accident, led to snow accumulating enough to bury the rails at the crossing; and many heavy vehicles passed over the crossing and compacted the accumulated snow in a short time.

- (1) On level crossings on line sections with low train frequency where compacted snow may form in the flangeways because of frequent passing of heavy vehicles, the following measures have been implemented in weather conditions where snowdrifts may be formed by wet snow:
 - Snow removal at the crossing and removal of snowdrifts at the crossing ends before the first train
 - During time periods with long intervals between trains, repeated checks on snowdrift formation and the monitoring of flangeways by patrolling, and snow removal when necessary
- (2) A camera was installed at the level crossing where the accident had occurred to monitor the condition of the crossing according to weather conditions.

- (3) Efforts were continuously made to appropriately ascertain snowfall and accumulation conditions, and snow removal was carried out. In addition, for level crossings equipped with filler rubber, visual inspections and checks using a hammer, for example, were conducted to investigate whether soil and sand had accumulated in the hollow sections of the filler rubber. The operator has decided to check the conditions of filler rubber, remove soil and sand when necessary, and take measures to prevent the ingress of soil and sand before the winter season and, for locations where ingress is observed, to further strengthen the monitoring system.

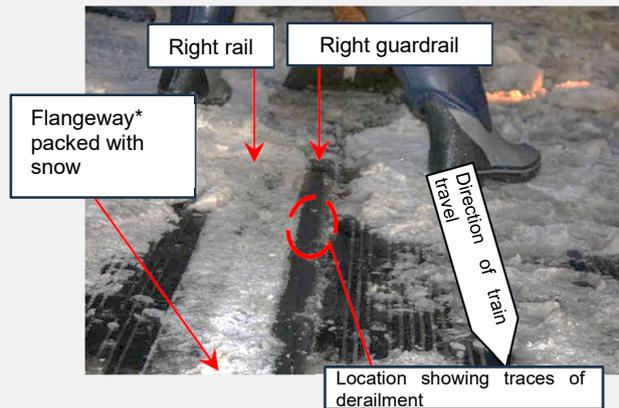
Figure 14: Condition of the level crossing where the accident occurred (photographed after removing snow at the location on the evening of the day of the accident)

* At the level crossing, although there is filler rubber at the bottom, it is not visible.

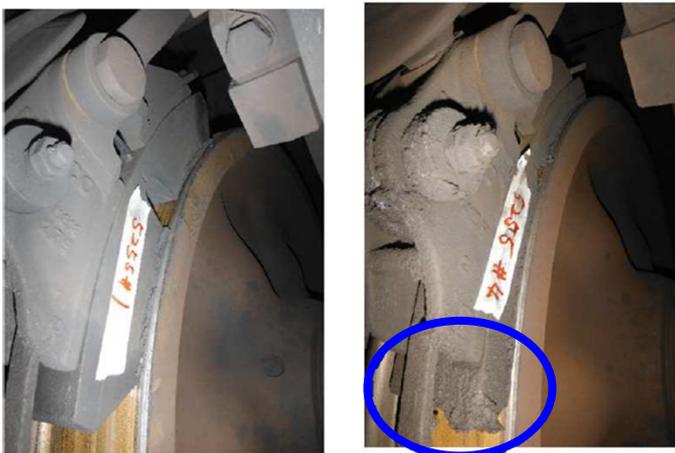
Figure 17: Brake shoes of the train
Left: example with little deposit.
Right: example showing accumulated deposits (in the blue circle)

Probable causes: The JTSB concludes that the probable cause of the accident was, when the following train that was running on snowy track received an instruction from the operation control center to stop immediately for the overrun handling of the preceding train at B Station and attempted to stop using the emergency brake, the train could not produce required braking force and consequently collided with the preceding train that was stopped.

- ii) Clarify operation controls (speed restrictions, cancellation of operations).
 - Implementation of speed restrictions:
 - Operate at a speed of 60 km/h or less when further snowfall is expected under any of the following conditions: hourly snowfall is 2 cm or more or equivalent, or snow depth is 8 cm or more, or when the driver, etc., recognizes insufficient braking force by early brake application.

- Operate at a speed of 40 km/h or less (25 km/h or less on E Line, another route of the same operator) when further snowfall is expected under any of the following conditions: hourly snowfall is 3 cm or more or equivalent, or snow depth is 11 cm or more, or when the driver, etc., recognizes insufficient braking force even during the above speed restriction of 60 km/h or less.

- iii) Clarify the timing of use of snow brakes.
 - The driver on duty shall use snow brakes when snow accumulation on the track is observed. However, the head of the operation control center shall instruct all trains to use snow brakes even before snow accumulates, if a driver reports that braking force is insufficient during snowfall.

- iv) Re-emphasize early brake application during snowfall and snow accumulation.
 - Re-emphasize that drivers must start brake application further before the application start point for rainy conditions to ascertain the condition of braking force if snow accumulation on the track is observed.

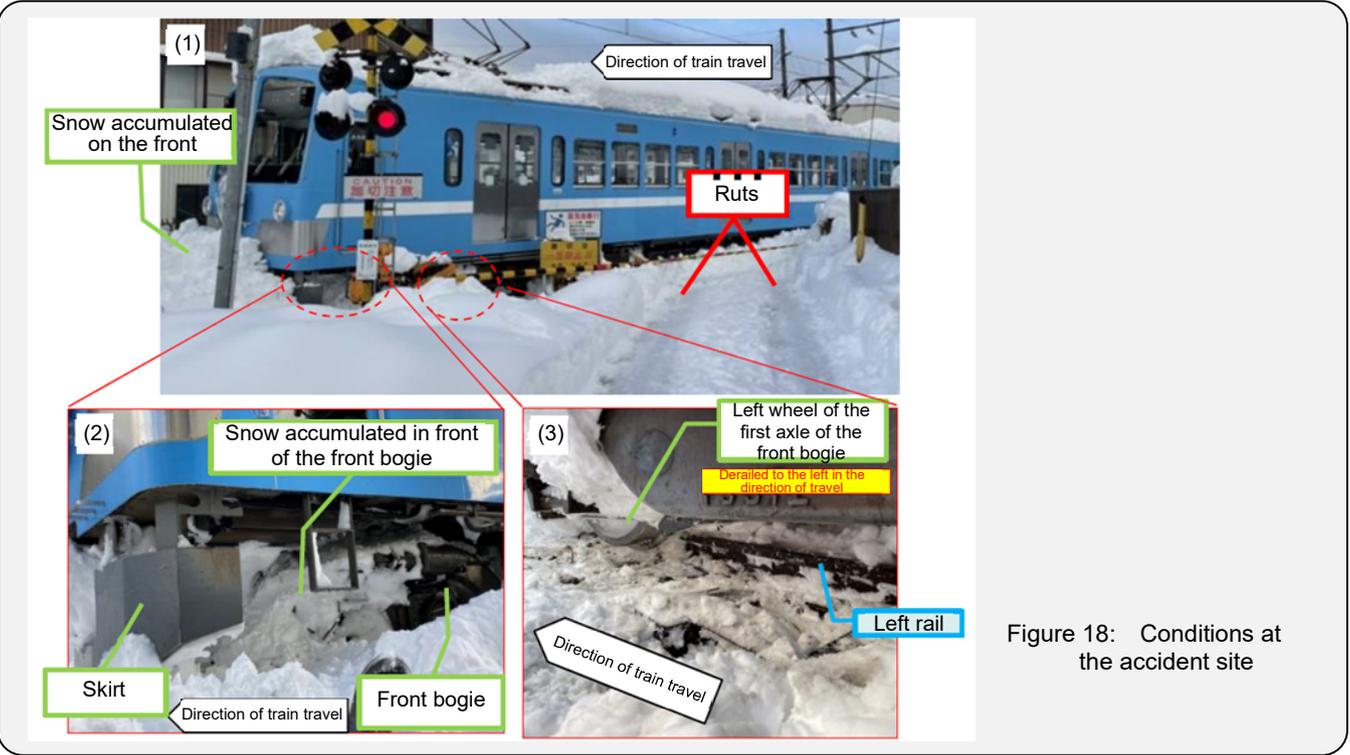
Figure 18: Conditions at the accident site

The train was operated, after thinking that the condition was the same as on the previous day when snow had accumulated, and derailed.

Probable causes: The JTSB concludes that it is possible that the accident occurred because the wheel load of the front bogie of the leading car decreased, and while the train was running with that bogie turned to the left, the first axle of the bogie climbed up onto compacted snow that was on the rails and in the flangeways at the level crossing, causing a derailment.

As for the presence of a large amount of snow on the track, it is possible that under conditions of low temperature and heavy snowfall, in addition to the snow that was on the track when the last train passed the level crossing on the previous day, much of the snow that fell before the train ran had not melted and therefore remained.

As for the operation of the train that did not use cars equipped with a snow plow without performing snow removal, it is probable that, although the conditions of snow accumulated on the track and compacted snow at the level crossing were presumed to differ between the previous day when trains were operated and the day of the accident, the chief safety management officer thought that the conditions of snow accumulated on the track and compacted snow at the crossing on the previous day were the same as those on the day of the accident, and finally determined the necessity of snow removal and the possibility of operations based on the past instance in which trains ran without problems. Furthermore, it is possible that the following factors were involved: the operator's internal regulations, etc., contained no objective standards and conditions that enable the determination of the necessity of snow removal, the use of cars with a snow plow, and the possibility of operations based on the conditions of snow accumulation and compacted snow, for example; and information gathering for determining the necessity of snow removal and the possibility of operations was insufficient because the operator had not checked the condition of compacted snow at the level crossing.

- (1) Setting of operation controls corresponding to the amount of snow
It was stipulated that train operations are to be canceled when snow accumulation at a height of 25 cm or more above the top of the rail or 40 cm or more above the top of the sleepers is observed.

- (3) Setting of conditions for carrying out snow removal
It was stipulated that snow removal on tracks is to be carried out by running an inspection vehicle equipped with a snow plow after removing snow from the rails and flangeways at level crossings that are the target of snow removal. The inspection vehicle is to be operated when snowfall of 20 cm or more above the rail head is observed during the period from the last train to the first train, or where train operations are canceled, and will not be operated if snowfall exceeds 35 cm above the rail head and 50 cm above the top of the sleepers. In addition, when operating an inspection vehicle, the track will be closed.

- (4) Setting of conditions for lifting the cancellation of operations
It was stipulated that the operation control center will make a comprehensive assessment of the situation and issue instructions to resume operations when an inspection vehicle has been operated and the electrical, track maintenance, and train depot staff have confirmed that there are no abnormalities.
