JTSB (Japan Transport Safety Board)

(Issued in April, 2013)

Digest of Aircraft Accident Analyses For Prevention of Small Aeroplane Accidents

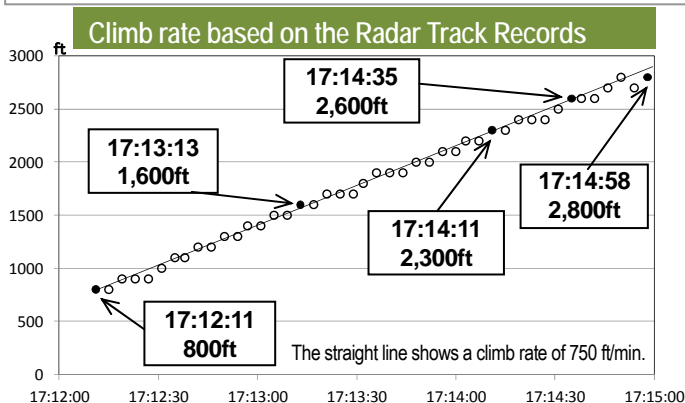
The PIC's possible intention was to take the course which would enable him to fly over mountains of moderate height at 6,500 ft, without flying over mountains of comparably high height and reach Kitakyushu Airport by turning to the left during its after-takeoff climb and flying directly to WP positioned on the extension of the Aircraft's flight path, as shown in the Estimated Flight Route.

It is possible that the low climb rate after taking off from Kumamoto Airport suggests that the PIC expected icing conditions and kept the climb rate low in order to maintain climb speed activating the ice protection.

It is possible that as he was not sufficiently familiar with mountain terrain features near Kumamoto Airport, he shifted into a straight ascent with a low climb rate, giving priority to a climb speed.

- (1) Commence flying only when VMC is maintained all across the en-route based on the latest weather information.**
- (2) Prepare alternative plans in case where deteriorating weather while collecting weather information on en-route.**
- (3) Decide well in advance on returning to the departed airport or landing at a proper place.**

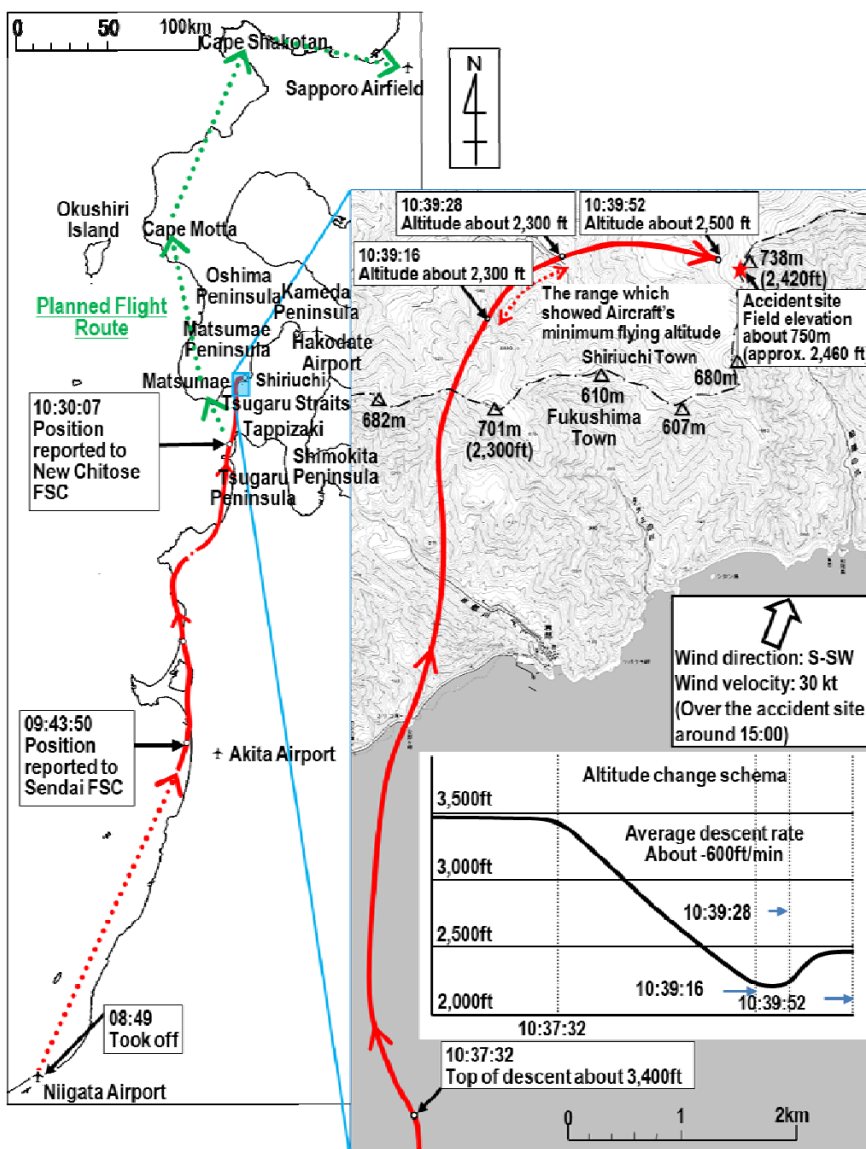
Estimated Flight Route

The aircraft was flying over the Tsugaru Strait and then, it was flying at a low altitude for a period of 2 minutes 20 second from its start of descent to the time when its target disappeared from the ATC radar display. It is probable that the PIC, without changing flight rules from VFR to IFR by climbing, continued to fly VFR at low altitude and without requesting for a radar vector by an ATC facility and the aircraft consequently crashed into the tree top near the ridge.

The PIC tried to continue north-bound flight over the mountainous area; however, low hanging clouds prohibited his visual recognition of mountain features over the wide area. The PIC judged that his attempt would be difficult and he decided to turn to the right to fly over the sea. His trial was done under low visibility condition with degraded visual recognition of mountain ridges. The belated decision making lead to a flight into a tree top on the mountain ridge.

- A PIC should make the final decision that the weather in the airspace he is going to fly is appropriate for a flight in a cautious manner based on the weather forecasts and meteorological observations.
- When a pilot flying under VFR expects to encounter bad weather conditions, the pilot do not try too hard operation and needs to make a decision to turn back without delay.
- When a pilot, who has a valid instrument flight certificate, flies an aircraft authorized for IFR flight and expects to encounter bad weather conditions during its VFR flight, the pilot should bear in mind that he/she has an option of changing the flight rule to IFR at an appropriate time upon considering the onboard equipment and airplane performance, and requesting for radar vector by an ATC facility.

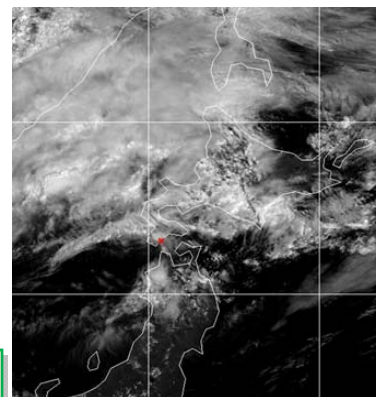
Meteorological Satellite Japan Area
Visible Imagery (at 10:30 on July 28)

It is possible that the PIC probably judged before departure that weather in the Hokkaido region would worsen as time goes by.

It is possible that judging from the meteorological conditions on the day of the accident, the PIC should not have decided to have a VFR flight for Sapporo Airfield.

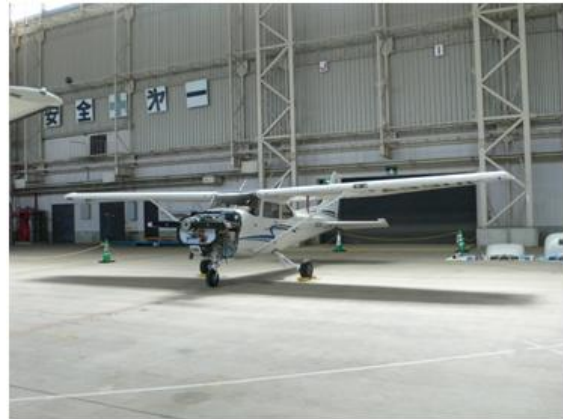
The aircraft

He set the flaps at FULL DOWN on the mid-final at about 75 kt. The runway threshold airspeed was about 71 kt.

It is possible that he established faster final speed - approx. 75kt against 70 kt, and threshold speed - approx. 71 kt against 65 kt, as the flight instructor in charge had pointed out premature airspeed reduction deriving from the student pilot's tendency to rotate more than necessary during roundout.

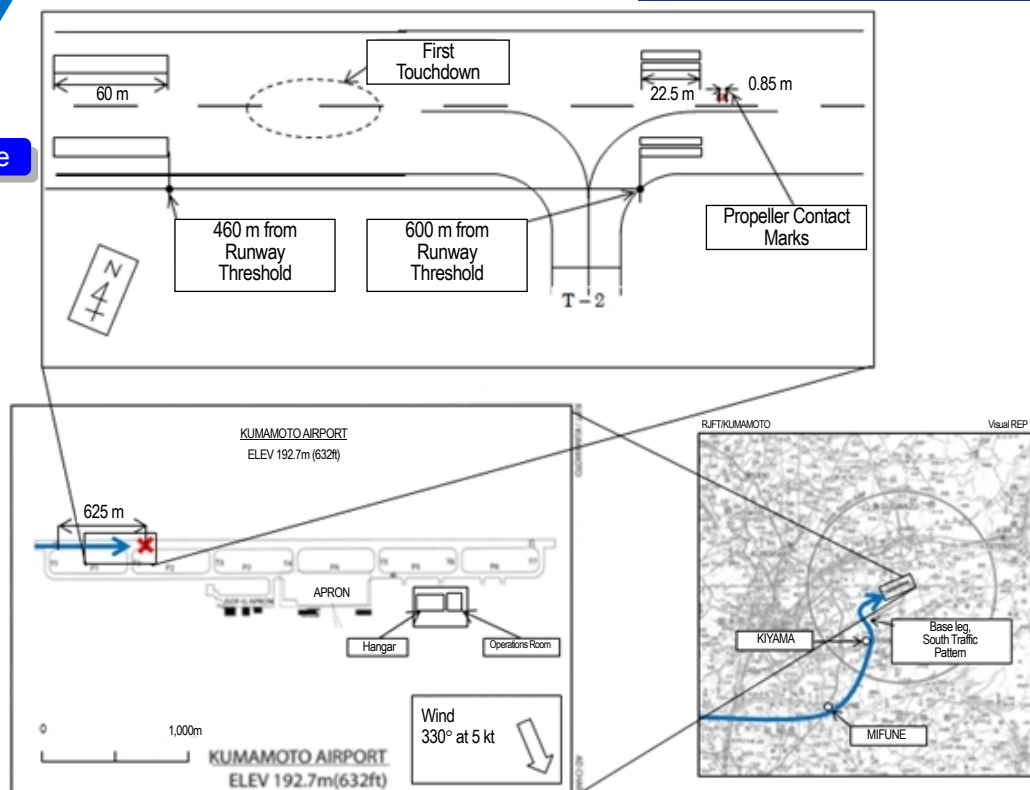
Estimated Flight Route

The student pilot retarded the throttle to IDLE for touchdown, but the aircraft sank suddenly immediately before the touchdown, landed harder and bounced high.

It is very likely that the aircraft bounced upon landing, followed by a nose-low hard contact with the runway, resulting in damage of propeller blades and fuselage structure.

The aircraft bounced again, this time higher. He executed a go around to avoid follow-on nose low attitude.

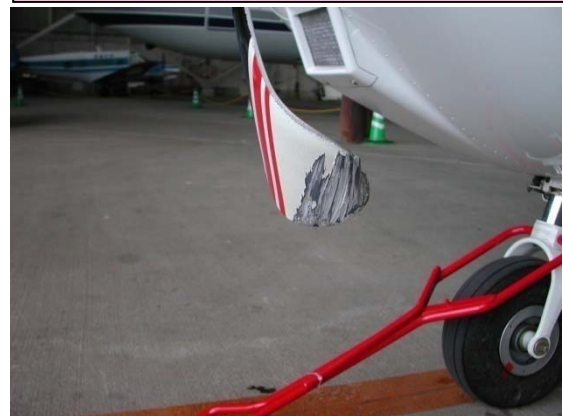
Damage of the propeller blades

He had possibly pushed the control wheel or failed to apply back elevator pressure to hold the pitch down attitude, resulting in the nose-low contact with the runway. It is highly probable that hard strikes of propeller blades very likely lead to the damage of fuselage structure.

- It is necessary to develop teaching techniques to have student pilots acquire proper flare height and touch-down attitude, and share them among instructors.
- As it is possible that student pilots in early phase may not have sufficient landing techniques, granting them solo flight needs to be done with further caution considering weather conditions and their preparedness.
- Appropriate training including in-flight training should be given to student pilots so that they could execute a go-around without hesitation in order to address the unexpected sink after passing over the runway threshold or bouncing after the touchdown.
