AI2011-9

**AIRCRAFT SERIOUS INCIDENT
INVESTIGATION REPORT**

Japan Transport Safety Board

**QATAR AIRWAYS
BOEING 777-300, A7BAE
ABOUT AN ALTITUDE OF 1,000 FT, 3.8 NM NORTHEAST OF
RUNWAY 24R, KANSAI INTERNATIONAL AIRPORT, JAPAN
AT ABOUT 21:55 JST, AUGUST 30, 2010**

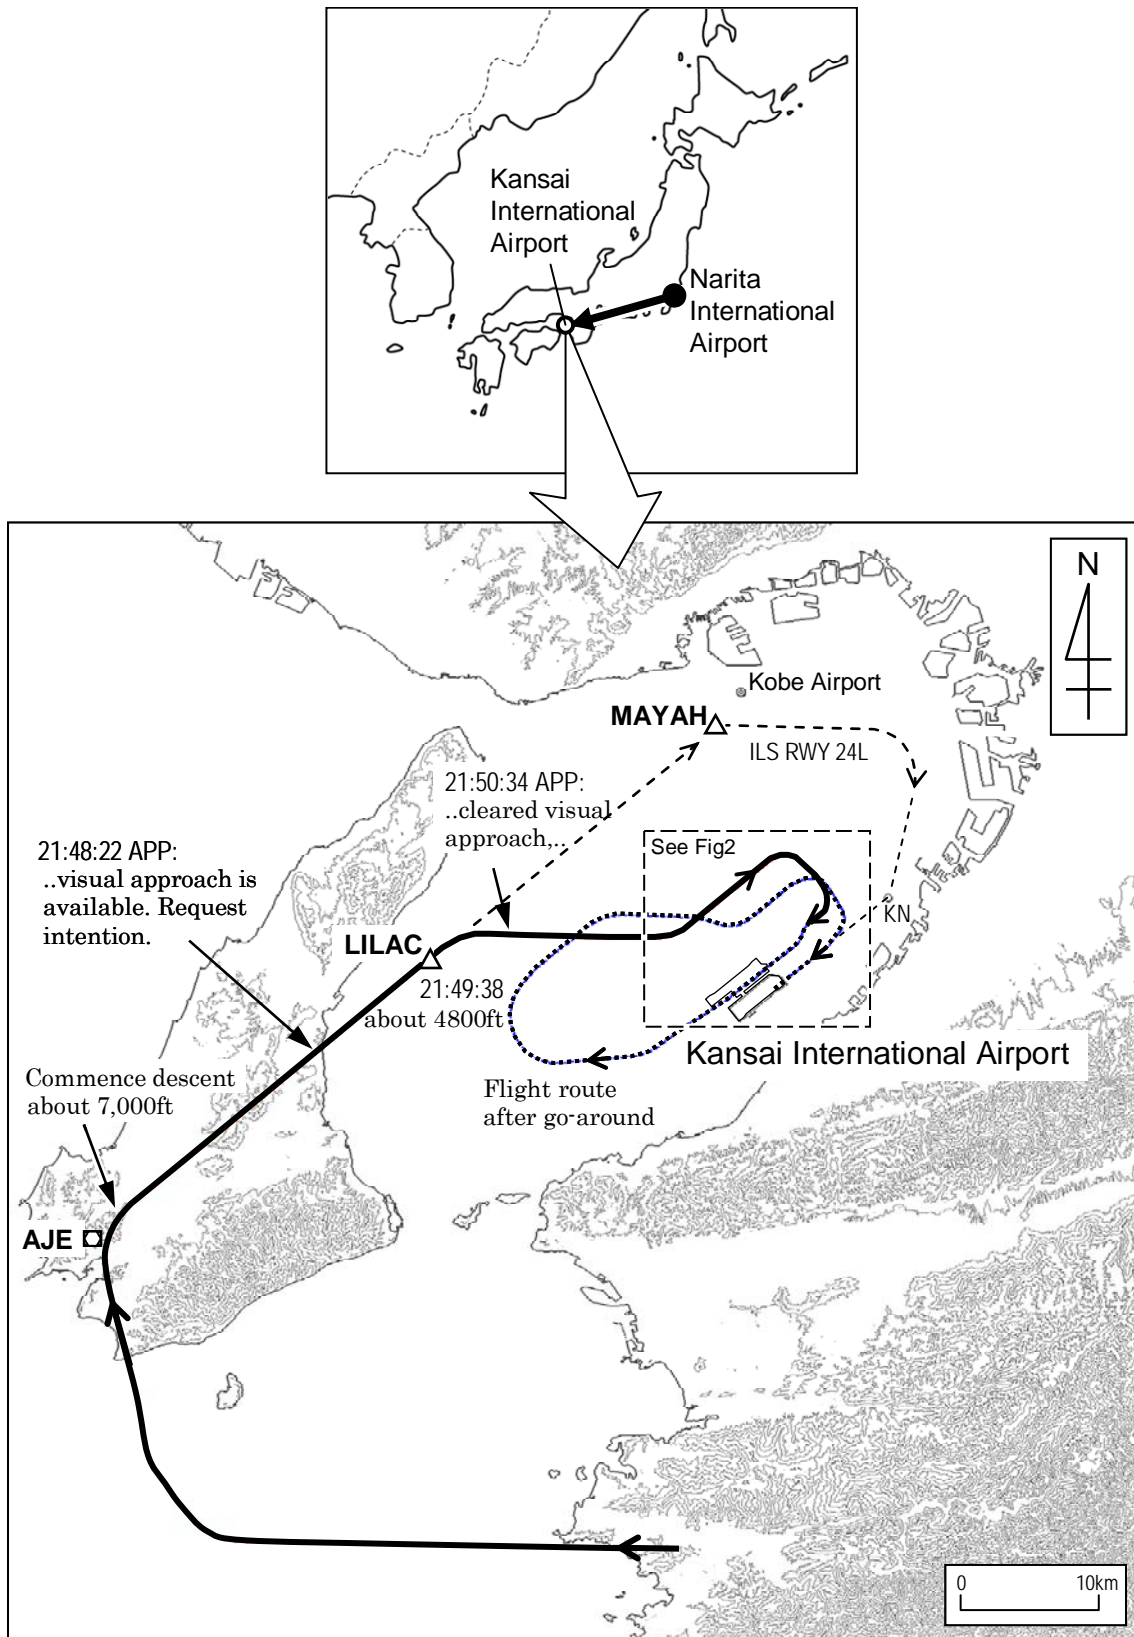
Figure 1 Estimated Flight Route -1

This serious incident occurred at an altitude of approximately 1,000 ft, approximately 3.8 nm northeast of the approach end of 24R at Kansai International Airport at around 21:55.

- (5) The First Officer took the traffic pattern wider than the standard width specified in 2.9.4 (2) in order to have leeway to fly. It is considered probable that this was not the direct cause of the false recognition of the runway. However, the traffic pattern was made above the sea, the visual approach was made at night with limited visual reference objects visible, and the downwind leg was close to the standard traffic pattern for 24R. Therefore, it is considered probable that, after the runway once became invisible in the downwind leg, when the Aircraft made the base turn, the First Officer saw a runway and a PAPI close to the position where they were normally seen, assumed it was the right runway, and entered 24R mistakenly.

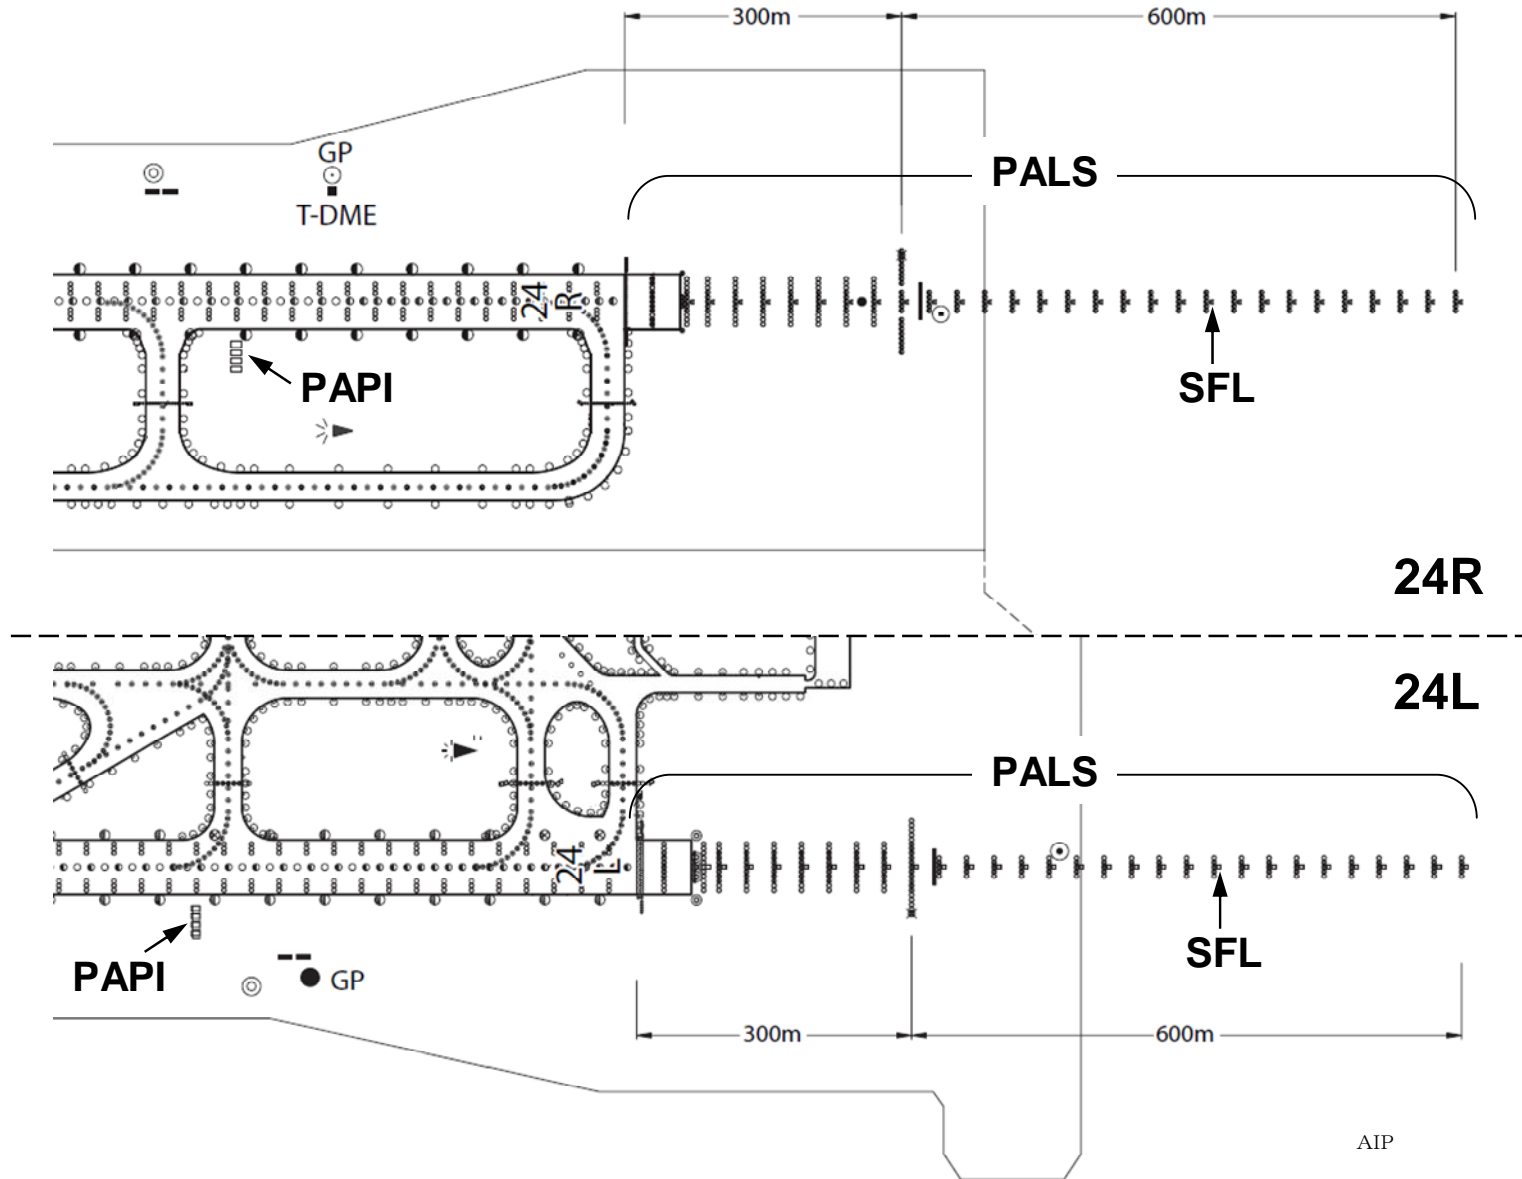
Figure 3 Lighting Arrangements

The SFL was lit between 21:52 and 21:53 and the PALS and PAPI were lit between 21:52 and 21:56.

The runway edge lights and runway touchdown zone lights were turned on in order to secure safety for the maintenance work but the runway centerline lights were turned off.

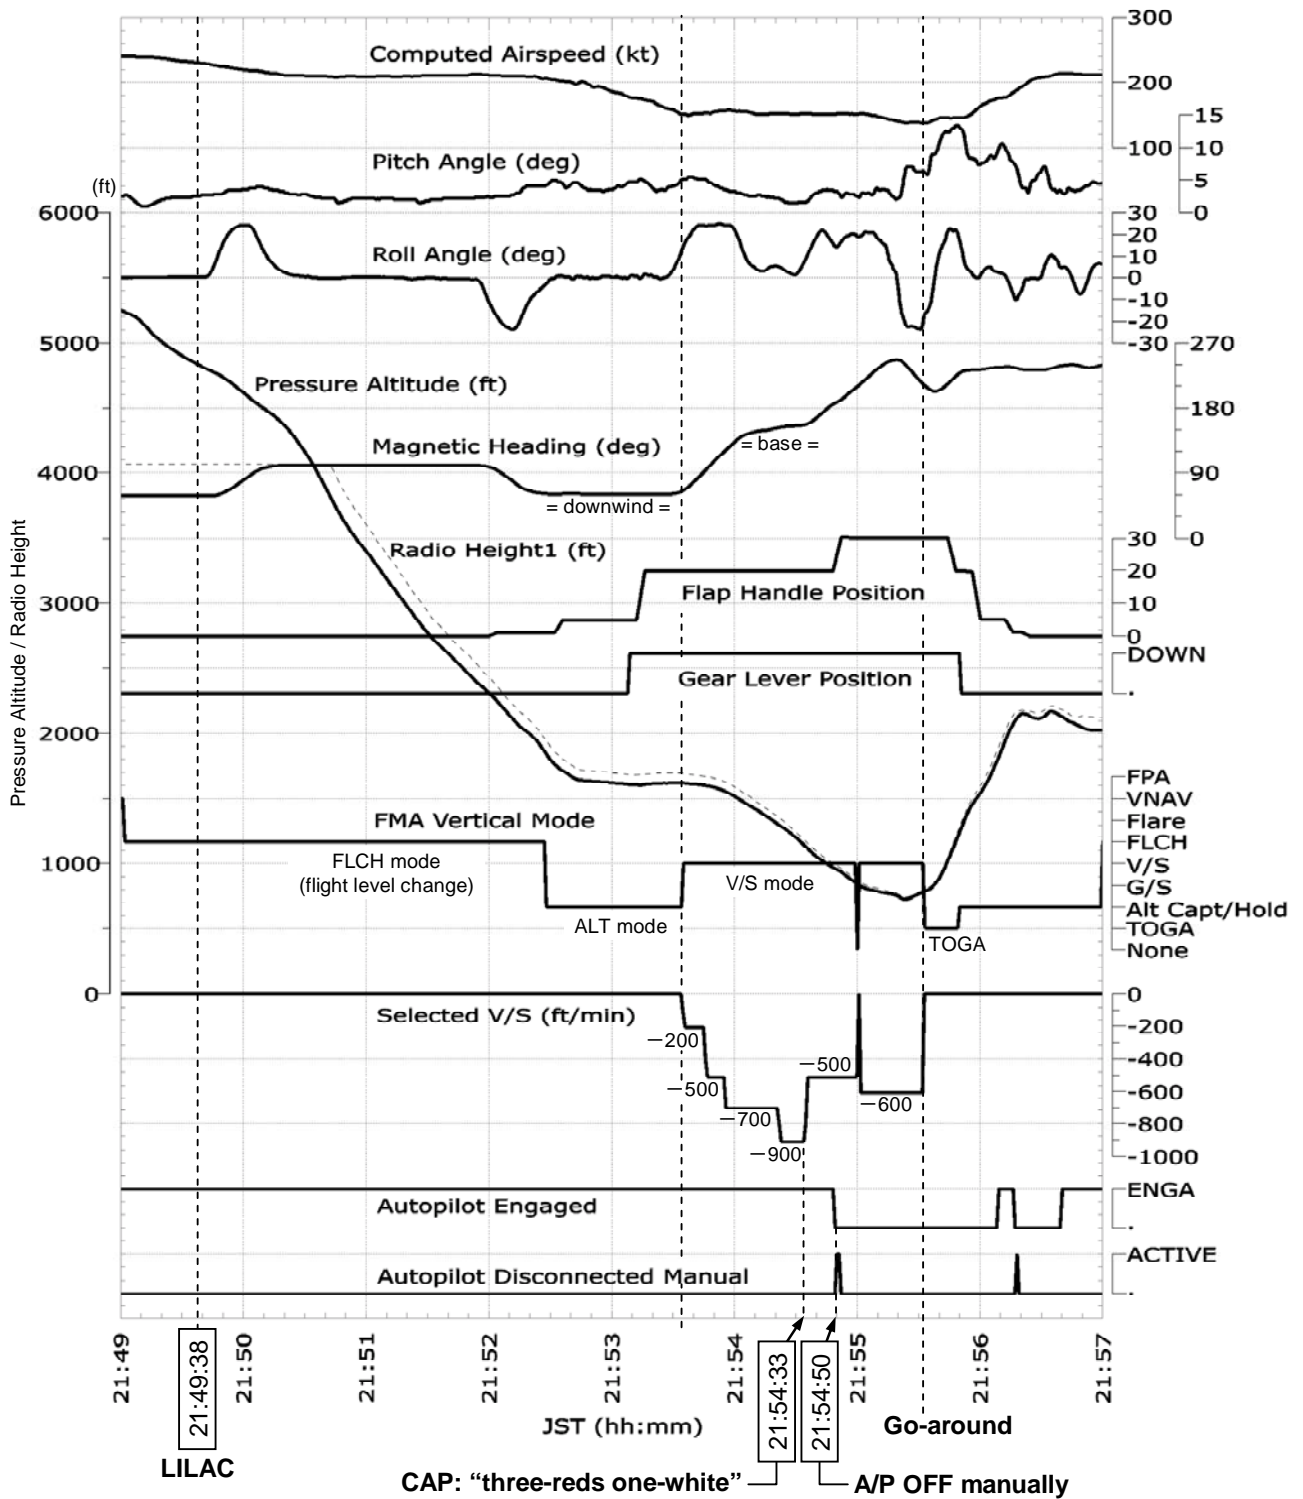
Figure 5 DFDR Records

- 21:53:11: The SFL of 24R was turned off.
- 21:53:35: The autopilot of the Aircraft was set to vertical speed (V/S) mode with a descent rate of 200 ft/min (hereinafter referred to as “fpm”) selected.

- 21:53:46: A descent rate of 500 fpm was selected for the Aircraft.
- 21:53:55: A descent rate of 700 fpm was selected for the Aircraft.
- 21:54:22: A descent rate of 900 fpm was selected for the Aircraft.

According to the DFDR records, an ILS frequency of 24L was selected at the time of the serious incident.
