**AIRCRAFT SERIOUS INCIDENT
INVESTIGATION REPORT**

**Privately owned
B – 3 2 0 3**

MULTIPLE MALFUNCTIONS IMPEDING

EMBRAER ERJ190-100ECJ, B-3203

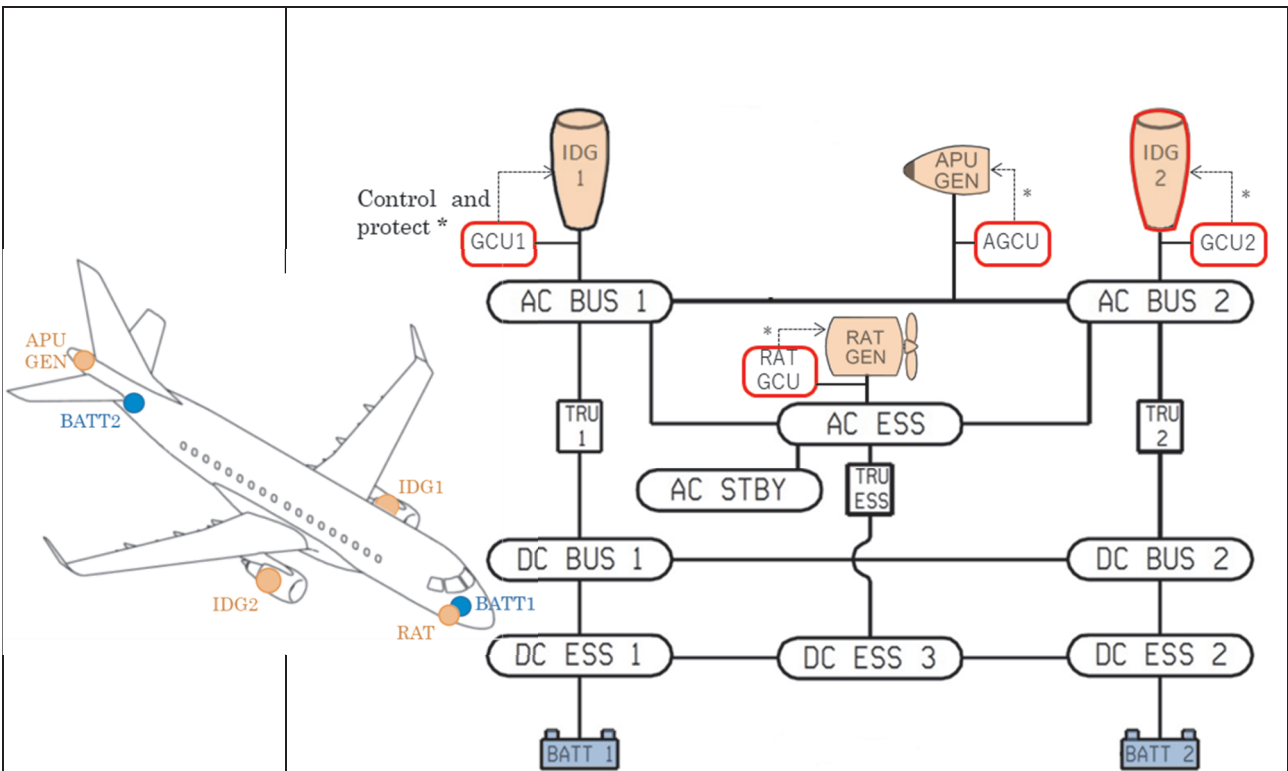
Figure 3: Power supply systems

*Equipment in red box was investigated in detail (See 2.7(5))

- ① Due to the detection of an Overfrequency condition, the GCU2 had tripped the IDG2 off from the No.2 power supply system, but it was a false detection, which was not caused by an IDG2 fault but by an internal fault with the GCU2.
- ② Due to the detection of an Undervoltage, the GCU1 had tripped off the IDG1 from the No.1 power supply system, but it was a false detection, which was not caused by an IDG1 fault but by an internal fault with the GCU1.
