AIRCRAFT SERIOUS INCIDENT INVESTIGATION REPORT

ATTEMPT OF LANDING ON A RUNWAY
BEING USED BY OTHER AIRCRAFT ETC.

CHINA POSTAL AIRLINES LLC

BOEING 737-800, B-5156

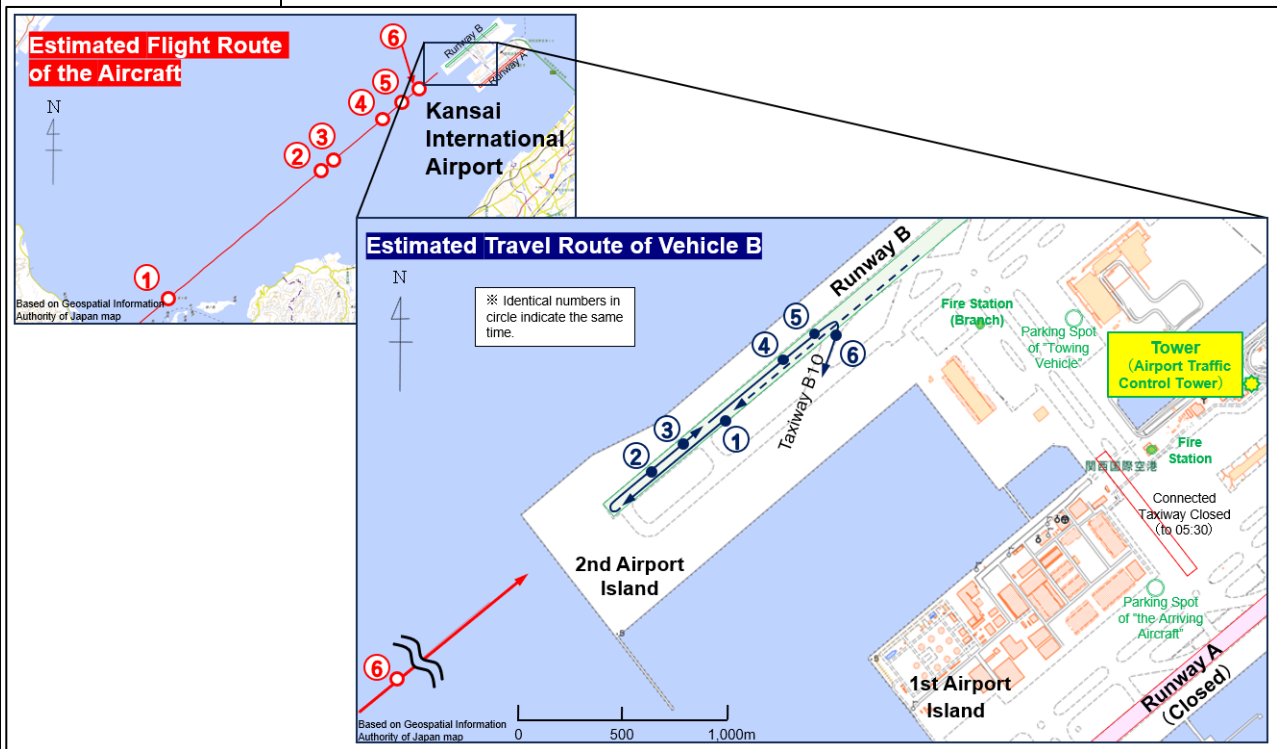
Figure 4: Situation at the Time of Occurrence of the Serious Incident

At 05:31:00, the aircraft established communication with the Tower (at Position ① in the upper left of Figure 4). As Vehicle B was still inspecting the runway, the Tower did not issue a landing clearance to the aircraft and instructed it to continue the approach. At this time, the Tower visually confirmed that Vehicle B was about to approach the southwest end of Runway B and decided to have Vehicle B vacate from the runway at the timing of its completion of the inspection in the going direction.

- (3) At 05:33:30, Vehicle A called the Ground with its own radio call sign (Operation 3) (at Time ② in Figure 4). Despite responding to Vehicle A, “Operation 3, go ahead”, when hearing the word “Operation”, the Ground thought reflexively that Vehicle B (Operation 4) had called, thus looked toward Runway B side. Confirming the position of the aircraft, the Ground found the aircraft approaching Runway B than expected. Vehicle A reported to the Ground, saying “Vacated Runway A” with its current position. As thinking that Vehicle B vacated Runway B as completing the runway inspection, the Ground read back only saying "Roger, vacated runway". When looking back toward the Ground in order to make coordination for Vehicle B to vacate the runway, the Tower heard

Actually, the Ground received the report about vacating the runway from Vehicle A and read it back to Vehicle A, but as believing that the Ground was communicating with Vehicle B, the Ground immediately informed the Tower that Runway B was clear. Upon receiving the information, although the Tower was unable to visually recognize Vehicle B that would have vacated Runway B, as not visually recognizing Vehicle B on the runway including the area near the runway's southwest end where the Tower had last saw it, the Tower issued a landing clearance to the aircraft at 05:33:43 (at Position ③ in the upper left of Figure 4).

(4) When the Tower issued the landing clearance to the aircraft, Vehicle B was conducting the inspection in the returning direction and was proceeding in the same direction as the aircraft approach direction. Also feeling strange when hearing the Ground's holding instruction to Vehicle A, the driver of Vehicle B confirmed the situation of aircraft in the vicinity with a mobile device. Noticing that an arriving aircraft was approaching the runway its own vehicle was inspecting, the driver of Vehicle B opened the window to visually confirm the location of the arriving aircraft. Thinking that it would be enough time to vacate the runway even after confirming the situation with the Ground, thus at 05:34:41, the driver of Vehicle B confirmed with the Ground to see whether Vehicle B should vacate from "the runway" where it was running for the inspection (at Position ④ in the lower right of Figure 4). The Ground thought this confirmation call was made by Vehicle A, and informed Vehicle A that it did not need to vacate the runway. In respond, Vehicle B once again asked the Ground if it would be allowed to vacate "Runway B" where it was running for the inspection. As noticing the confirmation call was from Vehicle B, therefore, the Ground instructed Vehicle B to vacate the runway at 05:35:00 (at Position ⑤ in the lower right of Figure 4). Upon receiving the instruction, Vehicle B was heading toward the nearest Taxiway B10 as fast as possible. At 05:35:18, Vehicle B vacated Runway B (at Position ⑥ in the lower right of Figure 4).

<p>Immediately after instructing Vehicle B to vacate the runway, the Ground informed the Tower that Vehicle B might be still on the runway. Upon receiving the information, the Tower checked on Runway B again, and saw Vehicle B being about to vacate the runway toward Taxiway B10. Shortly afterwards, the Tower visually confirmed the position of the aircraft as well. As judging that there would be still time for the aircraft to land and Vehicle B was also about to vacate the runway, the Tower thought there was no need to instruct the aircraft to execute a go-around or others.</p> <p>At 05:35:53, the aircraft landed on Runway B. The captain and the co-pilot did not visually recognize Vehicle B on the runway.</p>

The JTSB concludes that the closest distance between the aircraft and Vehicle B before Vehicle B vacated the runway was most likely approximately 3,480 m (approximately 1.88 nm).
