AIRCRAFT ACCIDENT INVESTIGATION REPORT

China Airlines
Airbus Industrie A300B4-622R, B1816
Nagoya Airport
April 26, 1994

July 19, 1996

Aircraft Accident Investigation Commission
Ministry of Transport

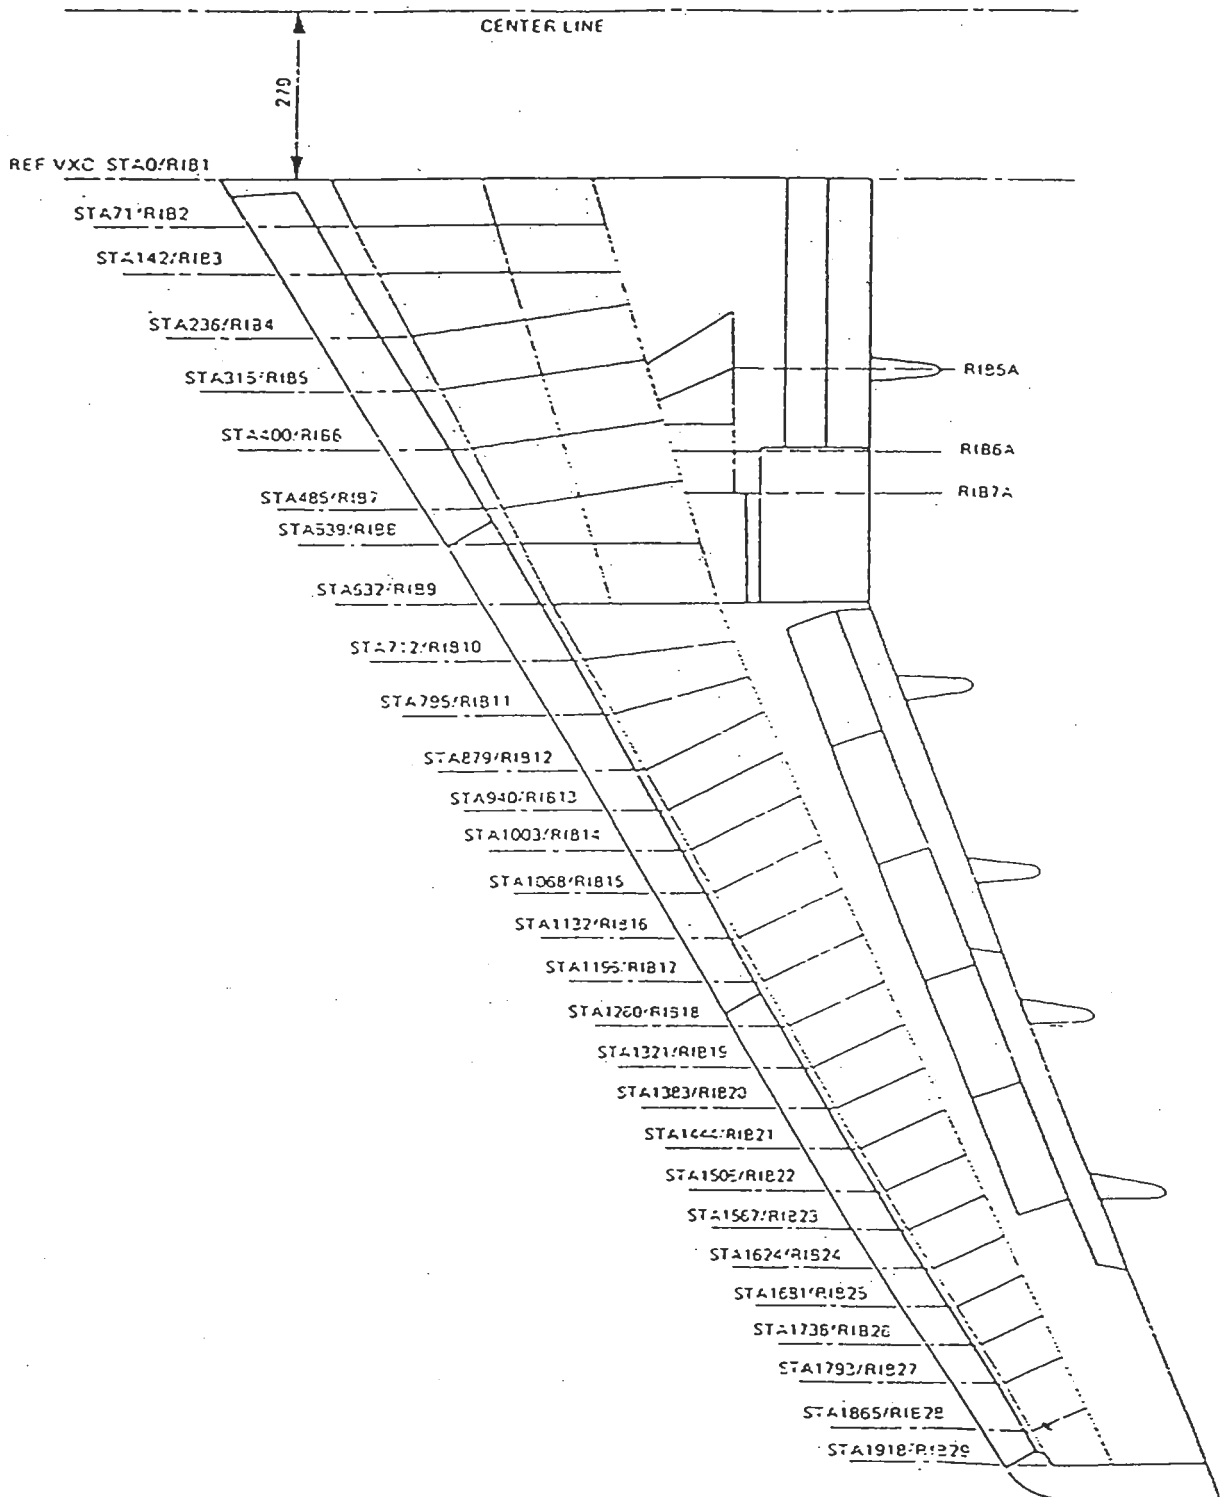
Attached Figure 19 Wing Stations

- ③ Center box section
 - The center box section was burnt.
 - Almost all thrust work ribs of the center-box lower structure had buckled and fractured by an upward force (see attached Figure 19).

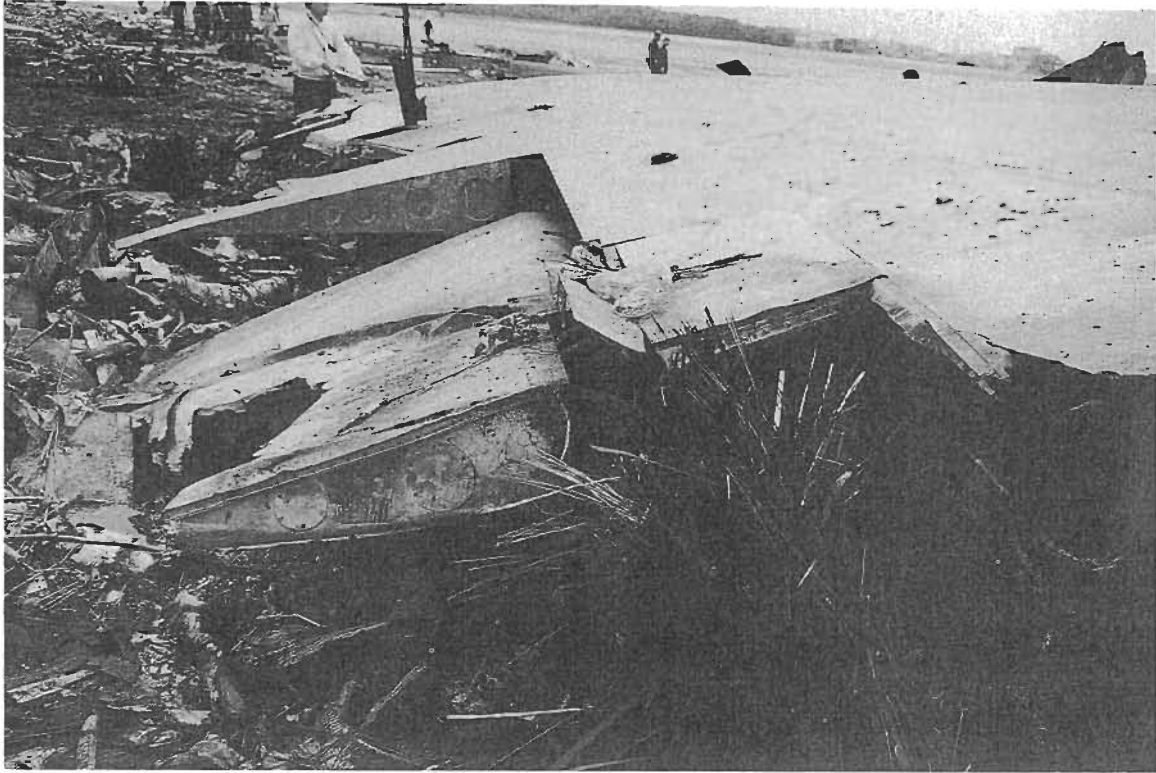
Photo.5 Left Aileron

Both the RH and LH ailerons were in their down positions and were burnt.
(See attached Photographs 5 and 6)

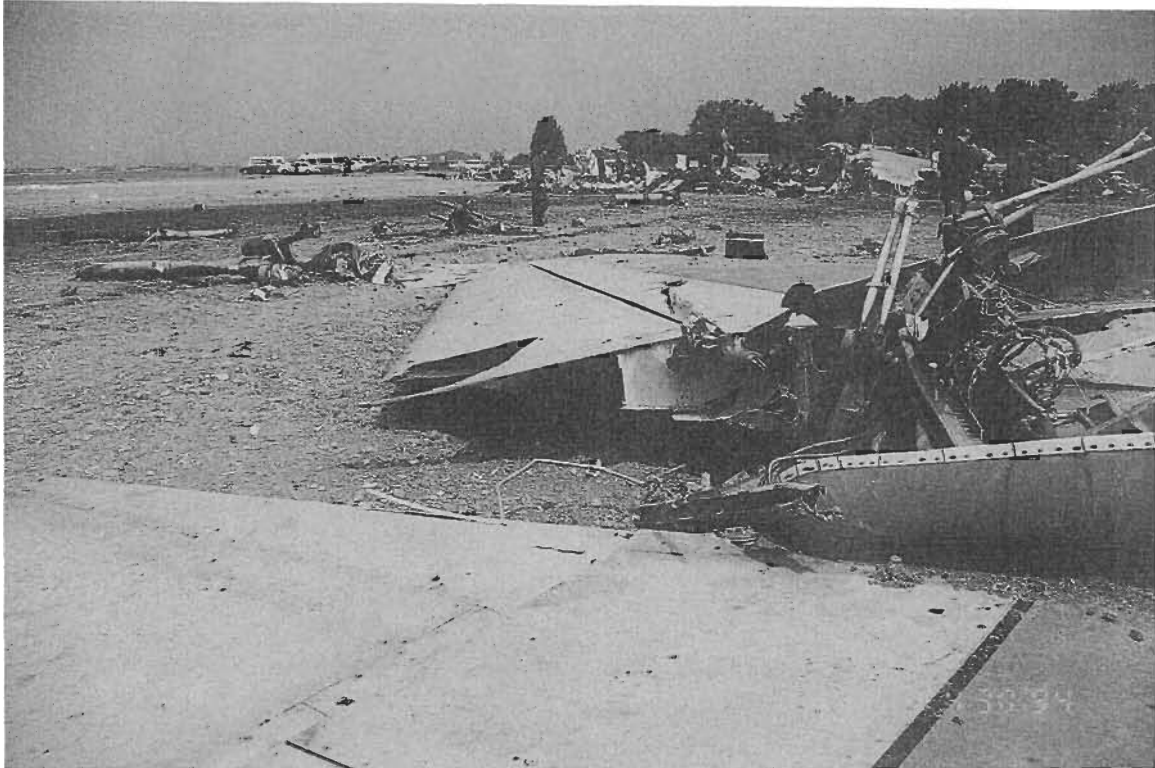
Photo.9 Left Elevator

- The elevators remained attached to the THS, but were damaged.
- Both the RH and LH elevators had scratches on their leading edge lower surfaces, but none on the trailing edge lower surface.

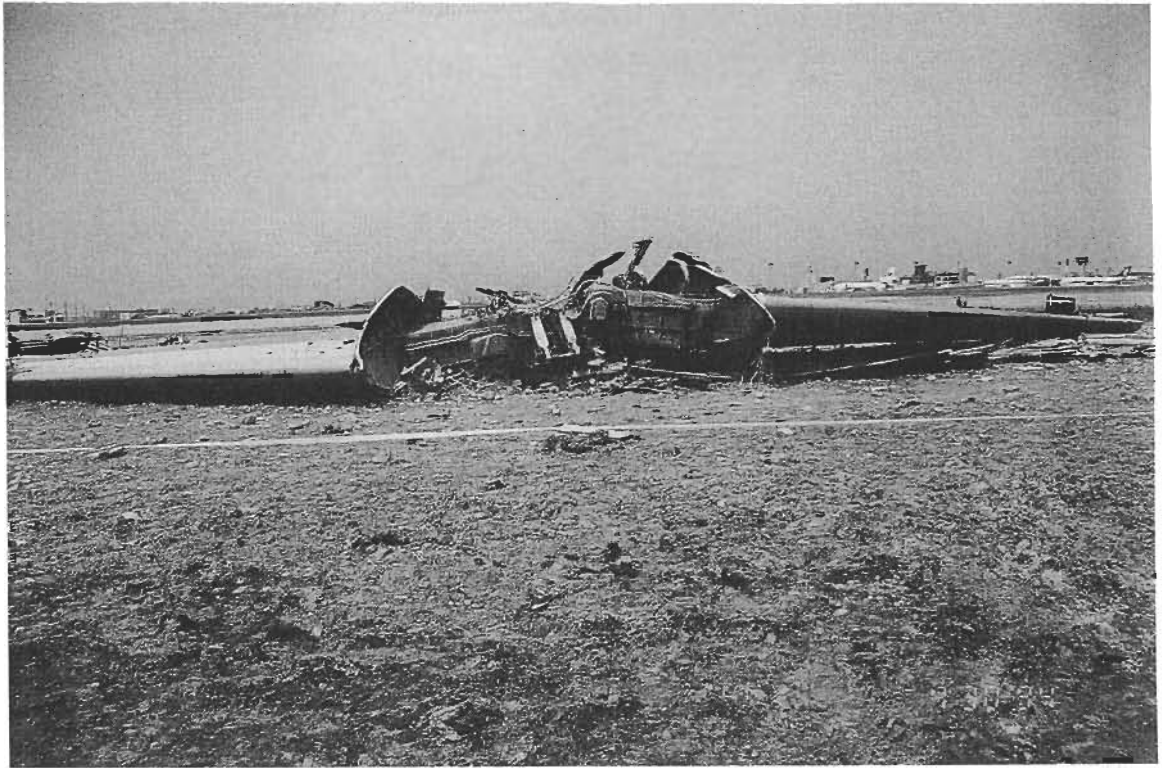
Photo.11 THS

- The THS had separated at its joint to the fuselage, and was fractured at its central section.
- The screw jack was fractured and had torn off at the screw shaft section near the actuator's bottom end; it was bent near the nut.

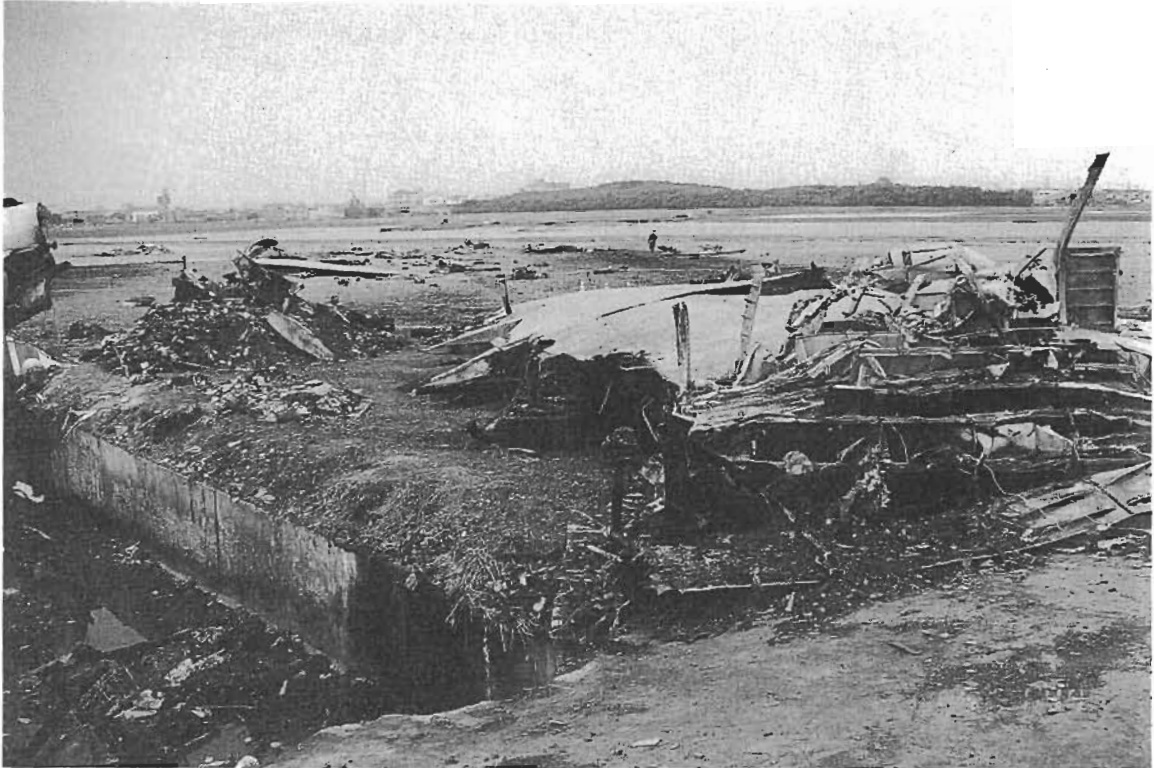
Photo.19 Left Wing

- ① LH wing
 - The main spar and upper skin in the upper section of the pylon (between W.STA 400 and 485) were fractured.
 - The skin in the rear part of the aft main spar, on the inboard side of the aileron, was destroyed by fire.
 - The lower skin had been exposed to flames and was burnt.
 - The upper skin between W.STA 940/RIB 13 and W.STA 1567/ RIB 23 had melted.
 - The wing tip was fractured near W.STA 1567/RIB 23, and had separated from the main wing and burnt.
 - The tip fence was fractured and burnt, and had separated with its lower part deformed. (See attached Photograph 19)

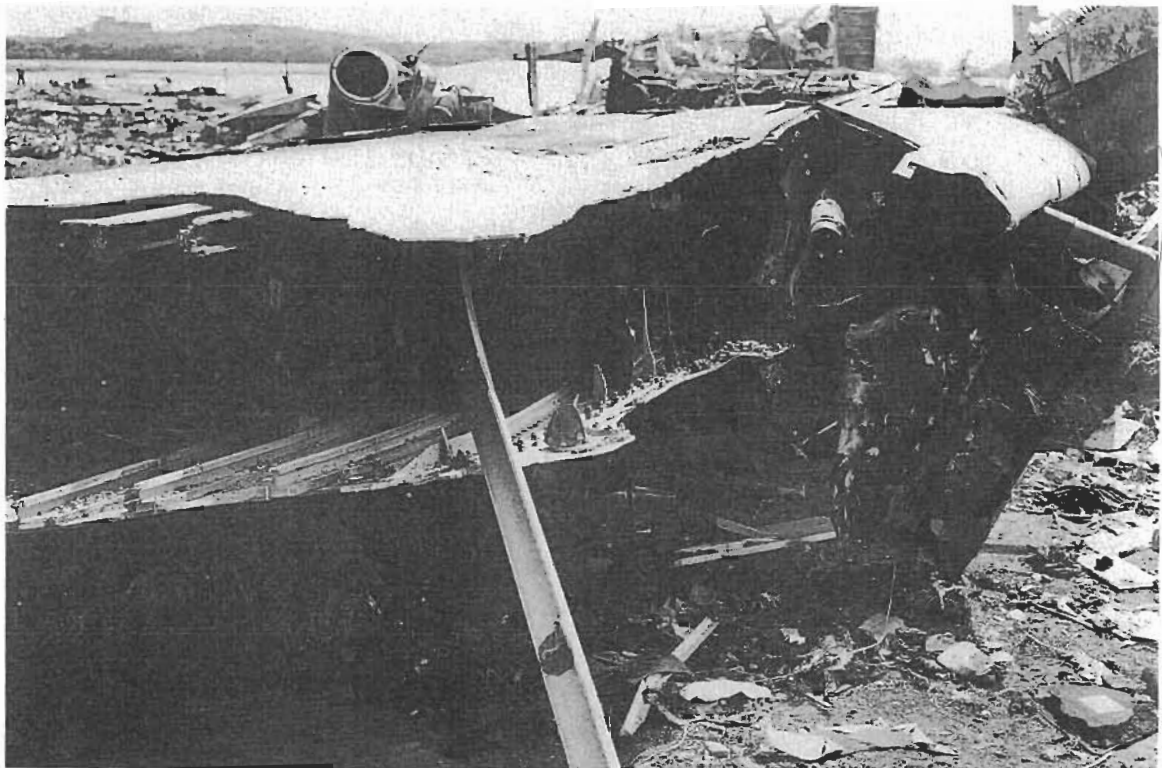
Photo.20 Fractures of the Right Wing

- ② RH wing
 - Almost all portions of the leading edge located on the inboard side of the No. 2 engine pylon were destroyed by fire.
 - The skin in the rear part of the aft main spar, inboard the aileron, was partly destroyed by fire.
 - The upper skin and the aft main spar near W.STA 879/RIB 12 were cracked.
 - The RH wing was fractured and had torn off near W.STA 1132/ RIB 16; the detached wing outboard structure had fragmented into small pieces, some of which were burnt.
 - The wing tip was fractured, had torn off near W.STA 1624/RIB 24, and was burnt.
 - Tip fence was fractured and had torn off with its top deformed. (See attached Photograph 20)

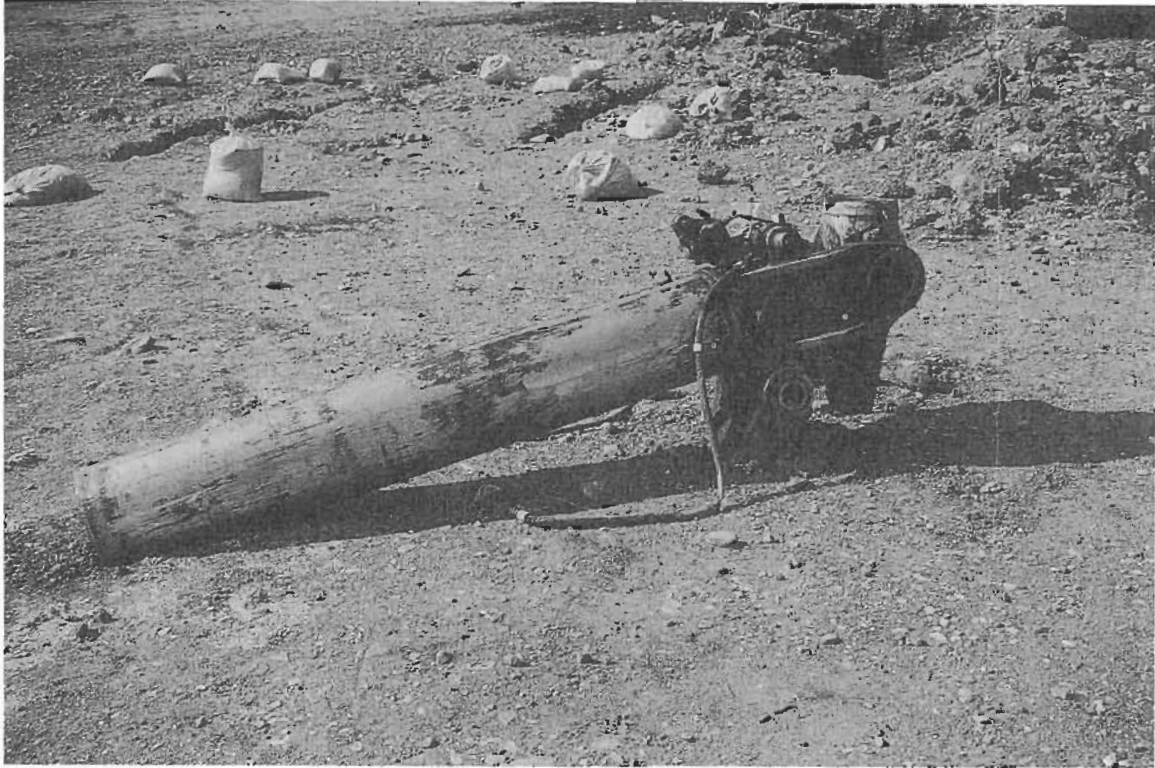
Photo.21 Shock Absorber of the Left Main Landing Gear

- The upper section of the shock strut was fractured, and had broken off and burnt.
- Fractured drag strut and torque link remained attached to the lower section of the shock strut.
- The shock strut was fractured; its upper section was partly burnt and had been detached with the actuating cylinder, fractured drag strut and other parts still attached to it.

- The wing side rear mount was fractured and remained attached to the aft hinge point in the upper section of the shock strut.
- The shock absorber had been displaced from the shock strut and was detached.

- The shock absorber contained pieces of the fractured bogey beam and torque link still attached to it.
- The shock absorber's piston was detached from the cylinder.

- No. 1 and No. 5 tires were burnt.
(See attached Photographs 21 and 22)

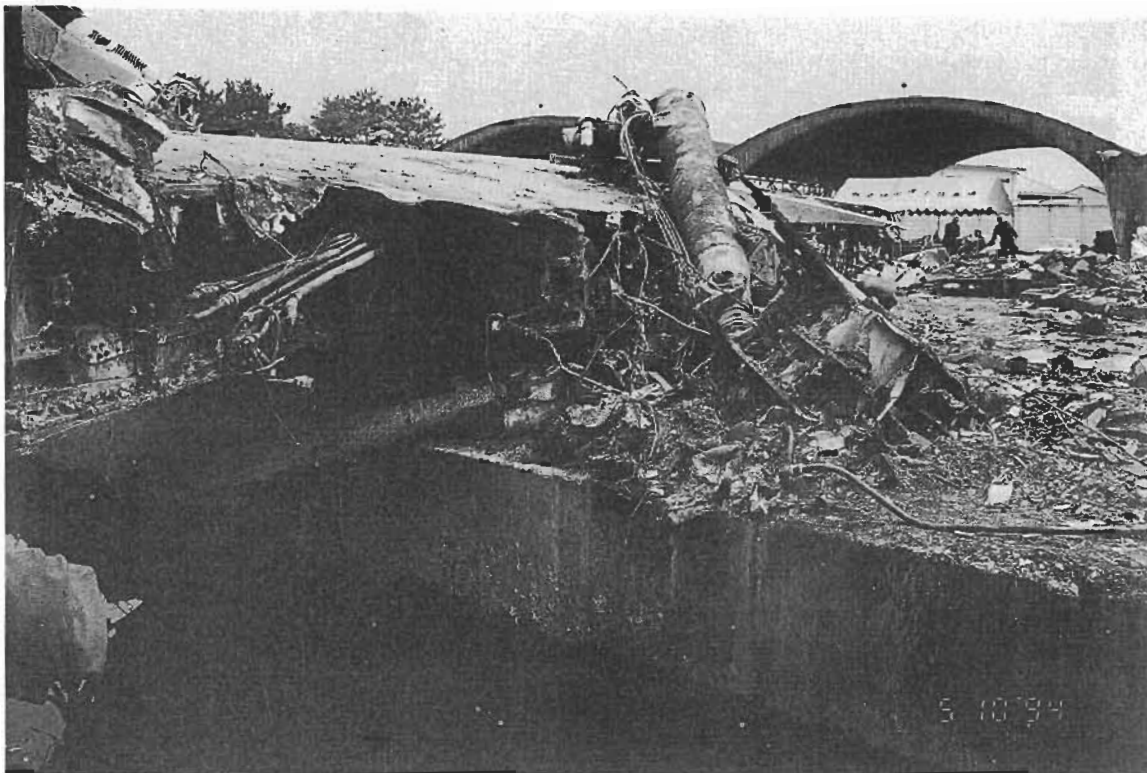
Photo.23 Shock Strut of the Right Main Landing Gear

- The shock strut was partly burnt and detached, with parts including the actuating cylinder and fractured drag strut, etc, still attached to its upper section.

- The drag strut, torque link, and part of the folding brace strut, all fractured, remained attached to the lower section of the shock strut.
- The shock strut rear mount, fractured and detached from the wing, remained attached to the aft hinge point in the upper section of the shock strut.

- The shock absorber had been displaced from the shock strut and was detached.
- The shock absorber had the fractured bogey beam and pieces of torque link still attached to it.

- The shock absorber's piston had torn off.
- The folding brace had a fractured lower strut, and was burnt and detached with a part of airframe structural element still attached to it.

- The No. 7 and No. 8 brakes, as well as the corresponding tires and wheels (two each) were burnt in an assembled state.
- The No. 3 and No. 4 tires had burst, and the No. 4 tires were burnt.
(See attached Photographs 23 and 24)

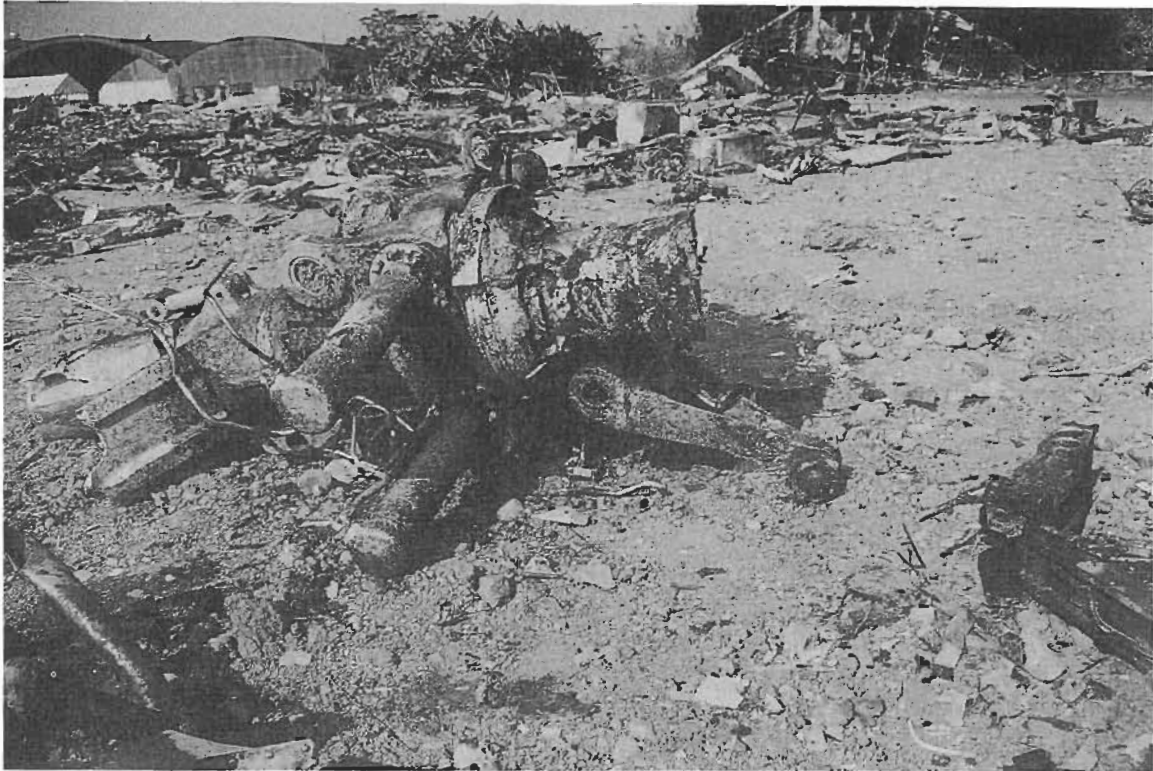
Photo.25 Leg Assembly of the Nose Landing Gear

- The shock strut was fractured at its upper and lower sections.
- The upper section of the barrel had fragmented into small pieces.
- The telescopic drag strut was found bent in the down-lock state and was burnt.
- The lower part of the torque link was fractured.
- Both tires and wheels were in place on the axle and were found in the irrigation water channel. The axle was bent and the LH tire had burst. (See attached Photographs 25 and 26)
