**AIRCRAFT ACCIDENT
INVESTIGATION REPORT**

**CHINA AIRLINES
B 1 8 6 1 6**

Japan Transport Safety Board

**CHINA AIRLINES (TAIWAN)
BOEING 737-800, B18616
SPOT 41 AT NAHA AIRPORT
AUGUST 20, 2007, AT ABOUT 10:33 JST**

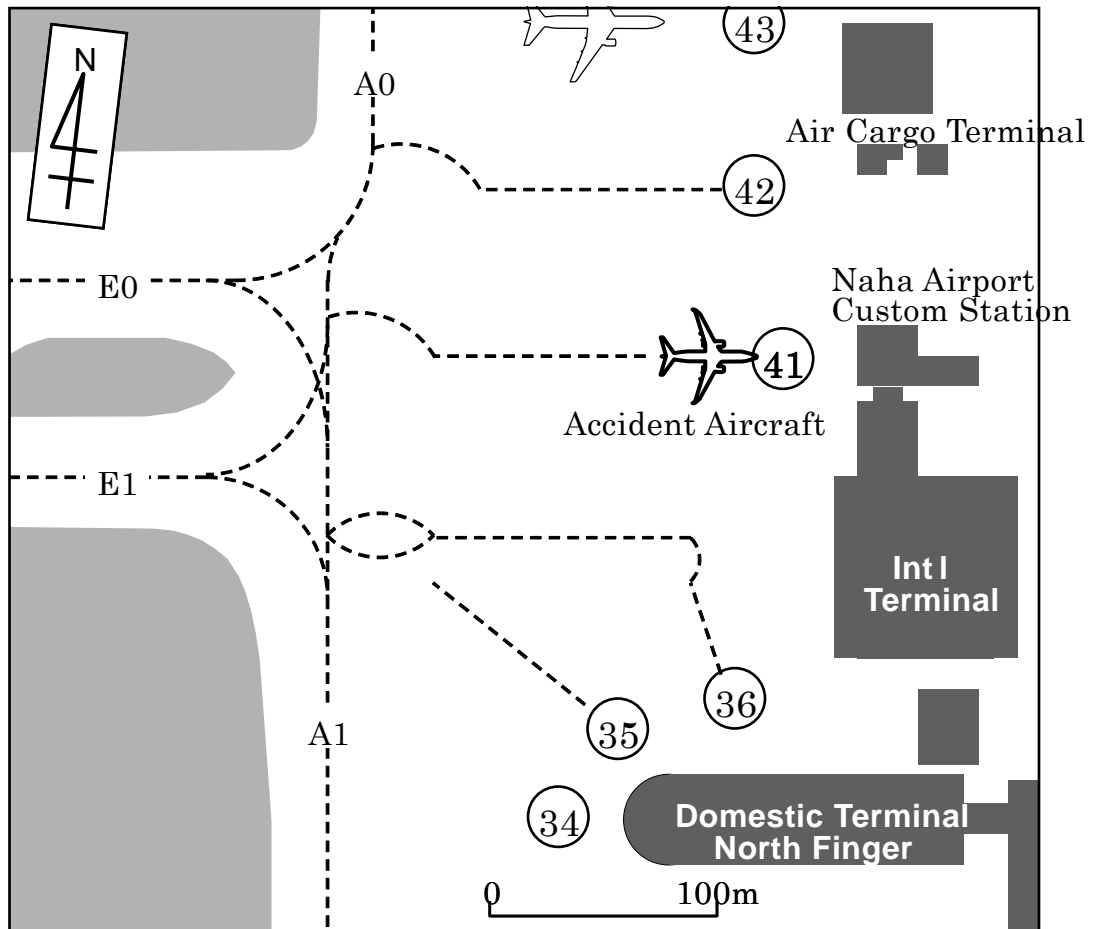
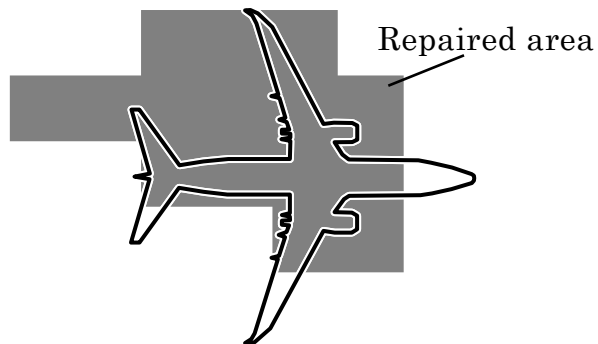
Figure 3 Parking Spot of the Aircraft and Damage to the Apron

The Aircraft stood parked in Spot 41 and burned out. At the time of the accident, Spot 42 immediately north of Spot 41, and Spots 35 and 36 immediately south of Spot 41, were free of any parked aircraft.

The apron surface had numerous dents caused by broken pieces from the airframe bottom structure, which became detached from the airplane due to several explosions of the right- and left-wing fuel tanks and then hit the surface. Burning of the Aircraft also left a large pile of burnt residue on the apron. In the area between the right engine and the right wing joint to the fuselage, there were scattered pieces of cargo (fruit and fish), which had fallen out of the cargo compartment damaged by the fuel tank explosions.

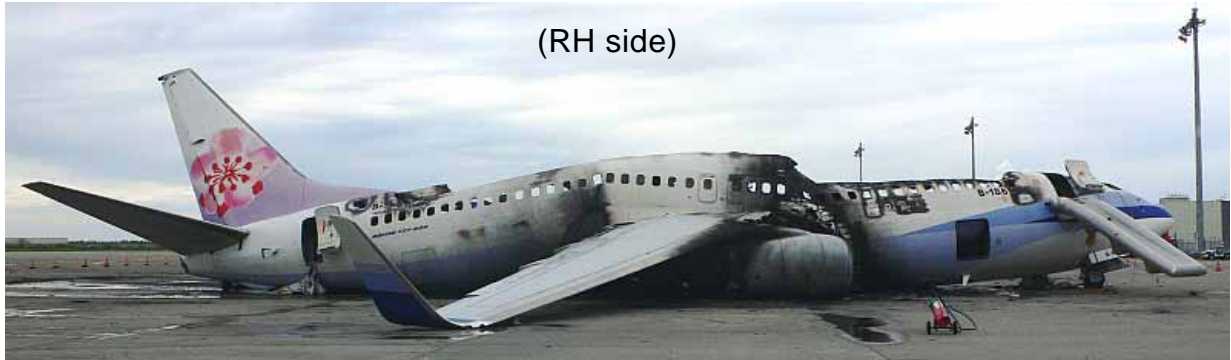
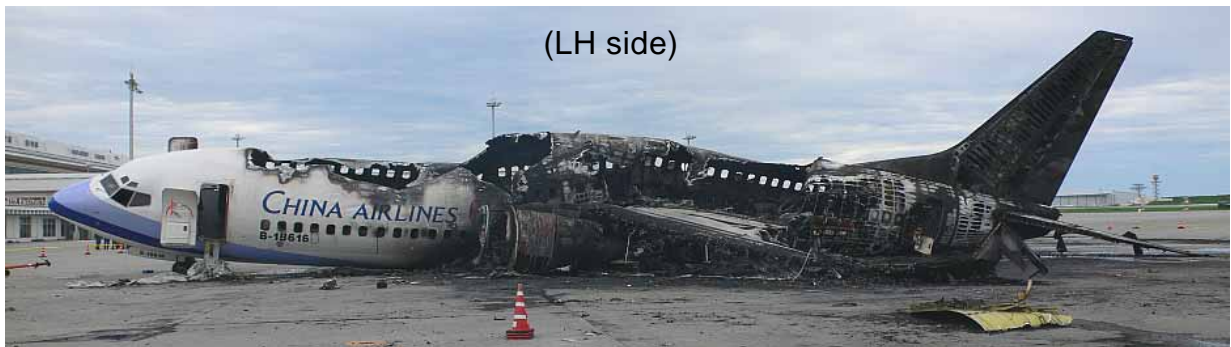
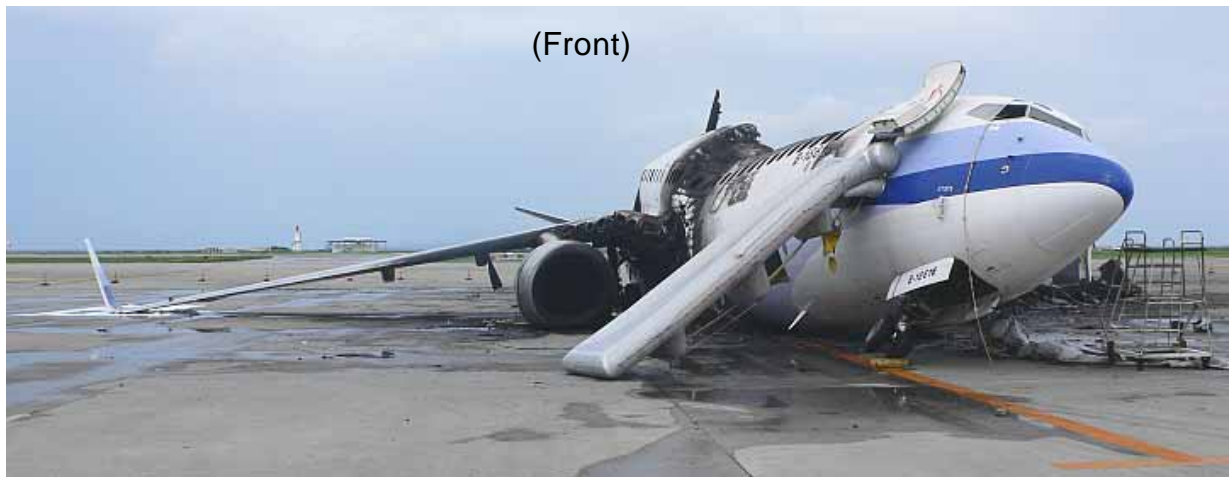
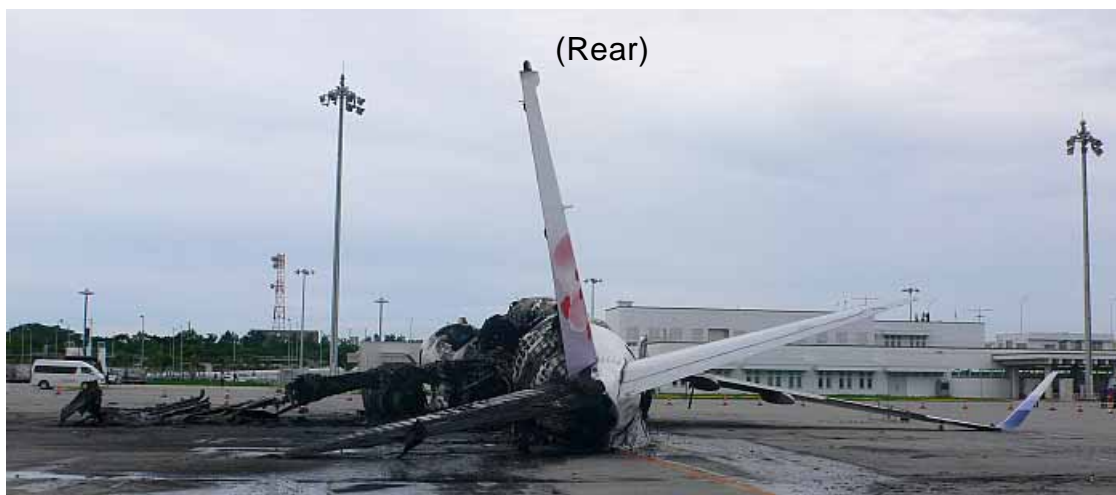
Photograph 1 Accident Aircraft

- (1) Fuselage: The fuselage had broken off at the part immediately forward of the wing roots with the forward half largely tilted to the left and the bottom touching the

ground. The fuselage was longitudinally bent at the part immediately aft of the wing roots and its aft half lay tilted to the left with the tail touching the ground. The cockpit and nose landing gear were intact, but in the forward fuselage, the cabin interior was burned and the upper skin and floor in this area were consumed by fire. The lower fuselage near the wing roots was destroyed and burned by fire. The cabin interior in the aft half of the fuselage was entirely burned to the extent that there was no trace of the original shape, and the top and left-side skins as well as the floor in this section were lost in the fire. The aft galley remained intact.

- (2) Left wing: The left wing, which was almost entirely burned and had lost its original shape, lay over the engine resting on the ground. The wing portion between the engine and fuselage was destroyed by explosion of the fuel tank and the burnt main landing gear was tilted forward. The top skin of the wing between the fuselage and engine had been torn off and lay on the ground about 7 m to the left of the wing tip.

- (3) Right wing: The main landing gear was burned and stood upright, while both the engine and the wing tip were resting on the ground. The underside of the wing between the engine and fuselage was broken and burned due to the fuel tank explosion. The wing portion from the engine mounting area to the wing tip remained nearly intact.

- (4) Engines: The cowling of the No. 1 (left) engine was consumed by the fire and the engine itself was entirely burned. The leading edge of the air intake that was made of a different material from that of the other part of the cowling remained unconsumed. The fuselage-side cowling of the No. 2 (right) engine was consumed by the fire and the engine itself was partially burned at the fuselage-side and fan sections. The pylon was burned on the outside surface but the interior was neither burned nor broken.

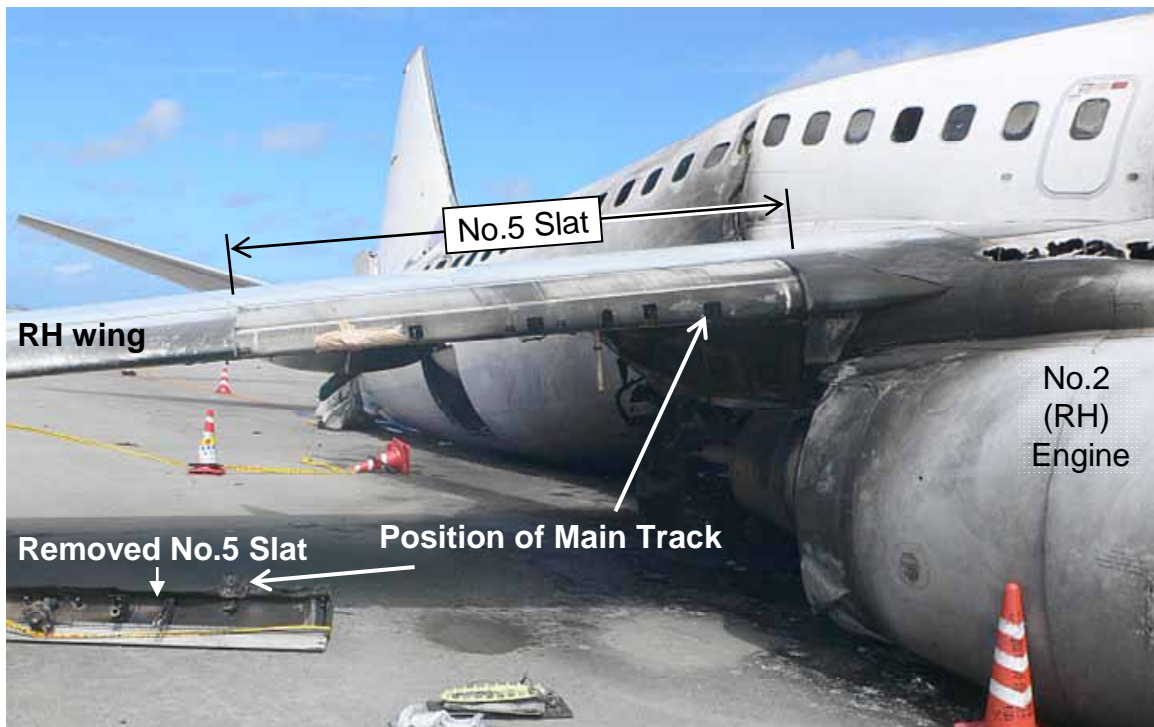
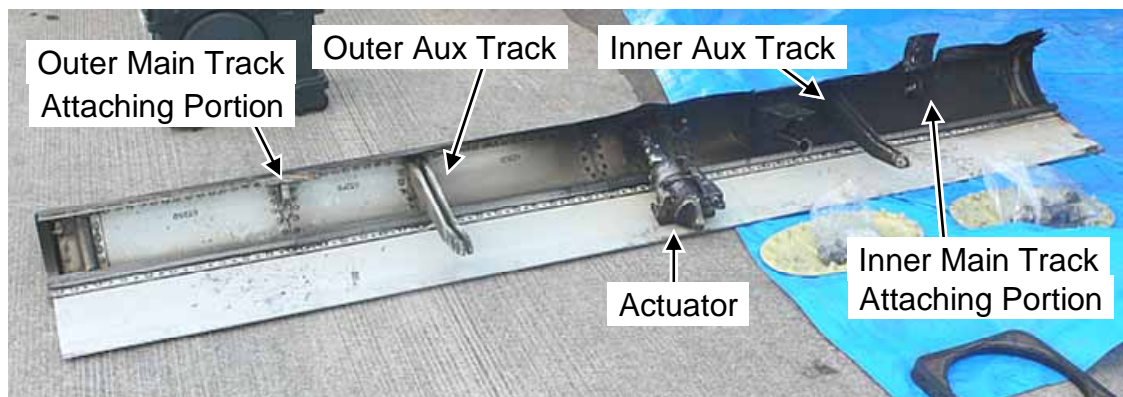
Photograph 2 No.5 Slat

Through the inspection conducted based on the eyewitness statements described in 2.1.4 and other information, indicating that fuel had been leaking from the right engine area and the wing leading edge near the engine immediately before the breakout of the fire, a puncture hole was found in a slat's track can on August 22, 2007, two days after the accident. The track can housed the inboard main track of the No. 5 slat on the right wing leading edge and protruded inside the fuel tank from the wing forward spar.

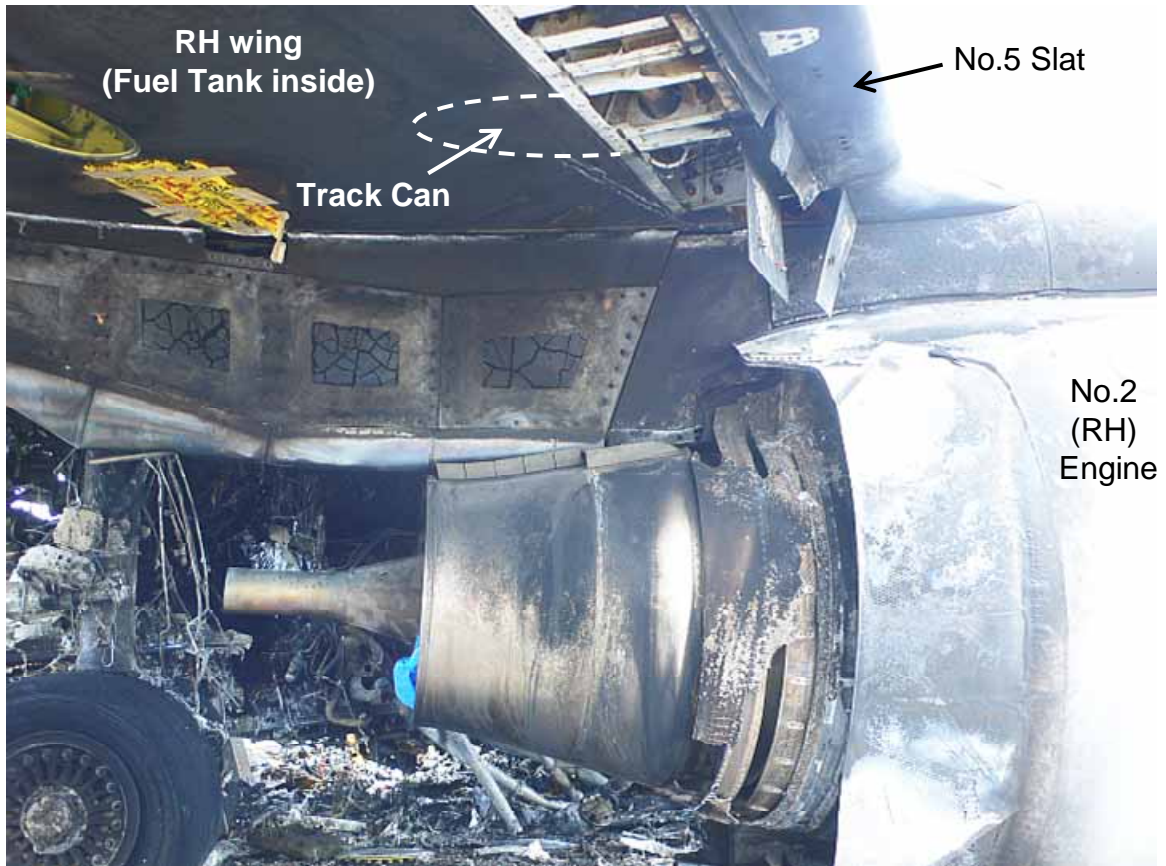
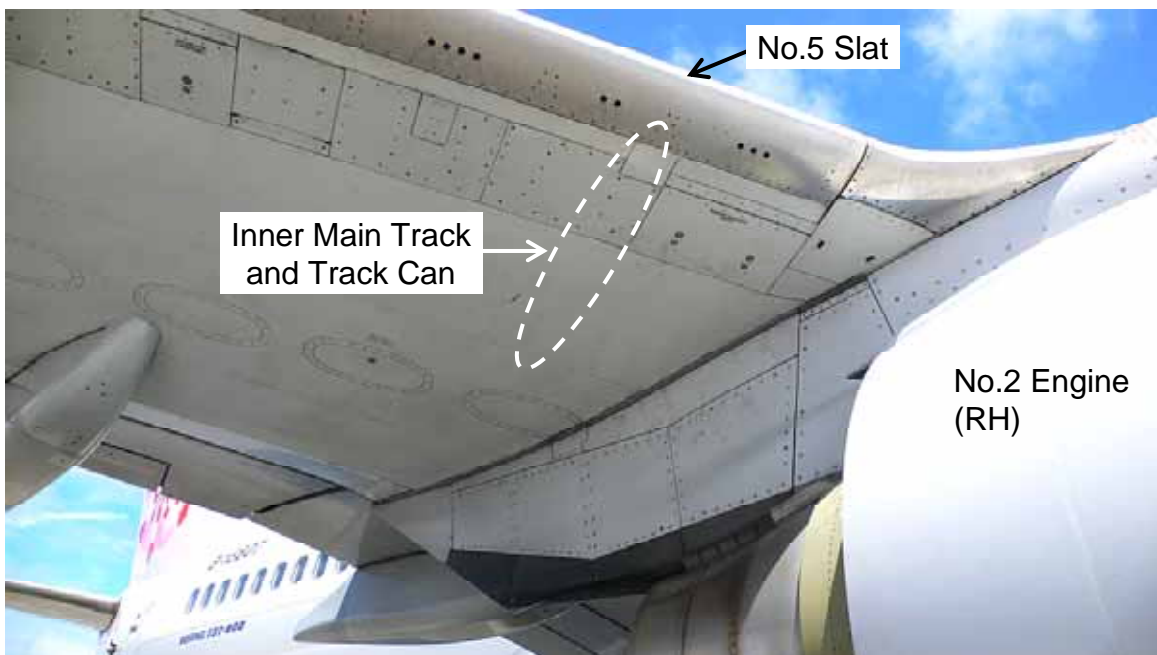
Photograph 3 No.5 Slat and No.2 Engine

Shortly after the Aircraft left the taxiway and aligned itself with the Aircraft Stand Lead-in Lines, I noticed that the ground beneath the Aircraft was wet. I then saw liquid falling in torrents from the underside of the No. 2 engine cowling, and I identified it as leaking fuel. It formed a cascade falling from the bottom of the engine fan cowl in a width of about 30 cm lengthwise. The Aircraft stopped in Spot 41 following the guidance of the marshalling staff. The China Airlines' maintenance engineer pointed to the wet ground and the area around the wing leading edge, signaling me to shut down the engines. After the engines were shut down, the marshalling staff set chocks under the nose wheels according to my instruction, and I then turned on the interphone switch at the Aircraft's nose.

When the Aircraft reached the midpoint or a point about 50 m short of the end of the straight line (Aircraft Stand Lead-in Lines) along which the Aircraft was moving toward its spot, I noticed an abnormal condition. The exhaust outflow (blast) of the engine was blowing fuel from the Aircraft in a spray state, making the area appear misted. The fuel was flowing downward from the root of the wing in a range of 50 cm or above in width. What I mean by "in a spray state" is that the engine exhaust was carrying the fuel. Fuel was swiftly flowing out in large amounts from around the root of the wing. I can say that fuel was flowing out from around the root of the wing

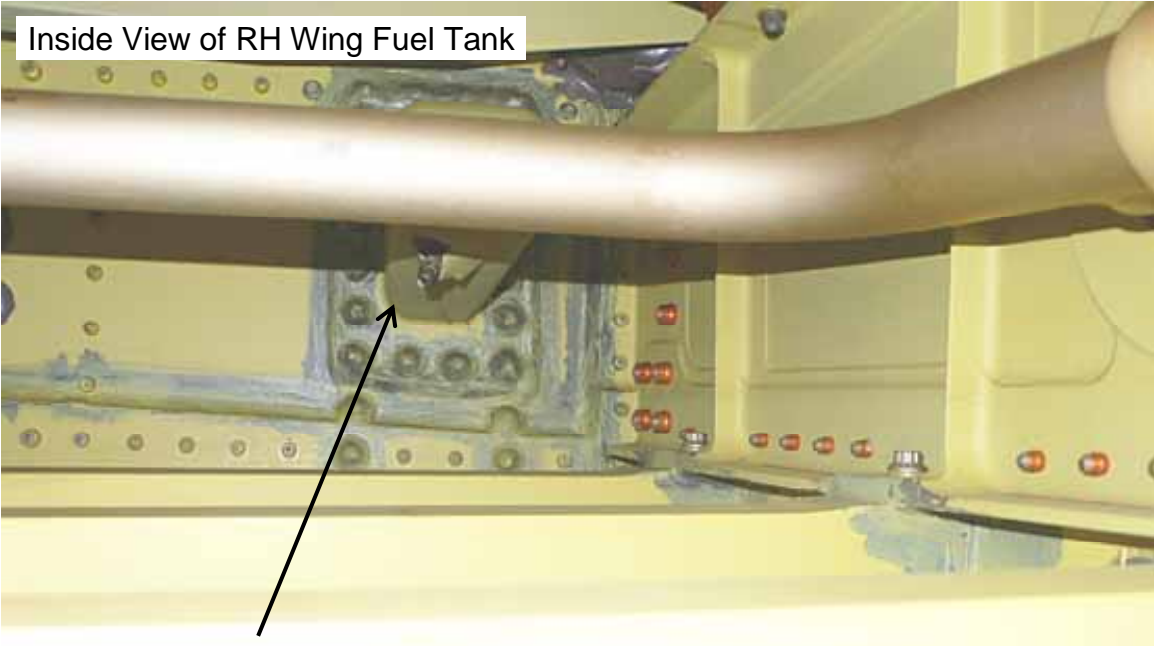
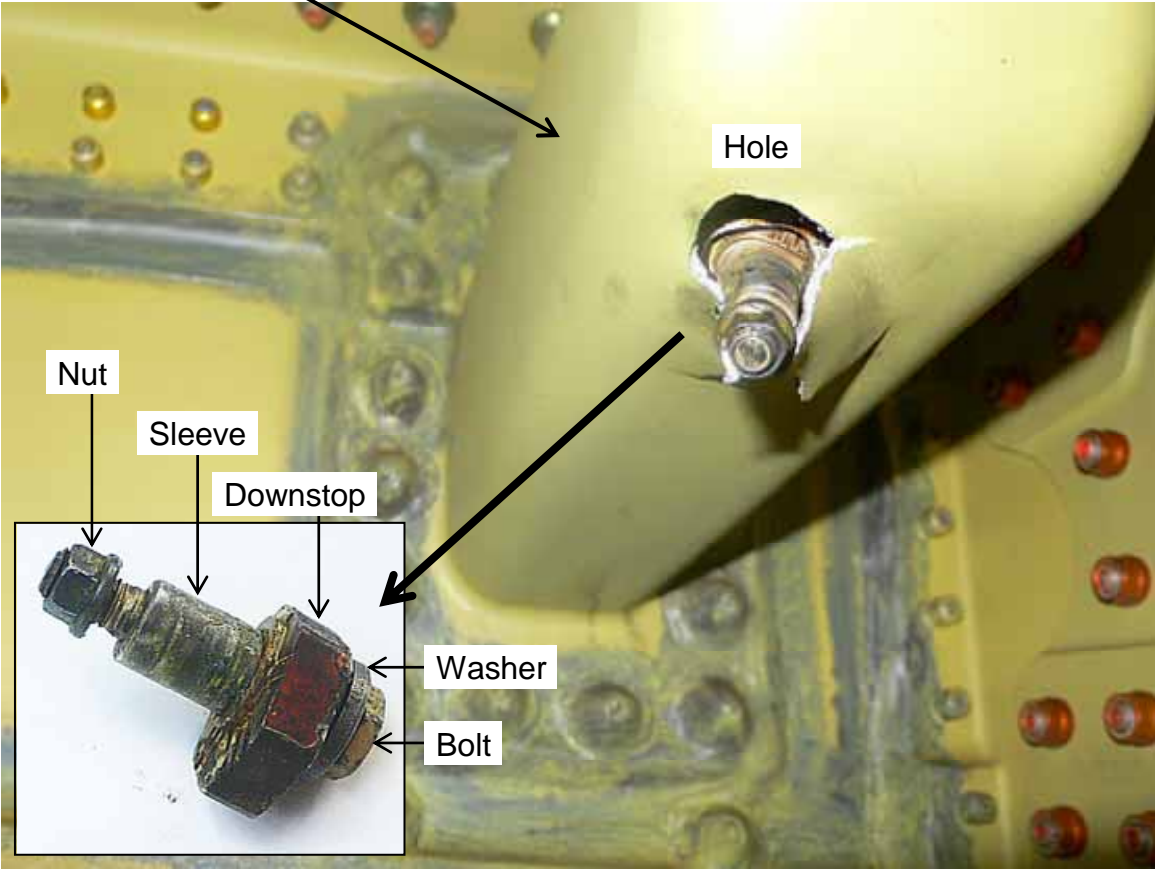
Photograph 5 Damaged Inner Track Can of No.5 Slat

- (a) The puncture hole was found on the bottom of the track can and extended from a point about 60 mm to a point about 100 mm, both from the aft end of the track can, showing signs of being pushed from inside.
(The track can was made of aluminum alloy and measured 220 mm in length, 80 mm in height at the highest portion and 65 mm in width at the widest portion.)

- (b) The puncture hole including the cracks measured 41 mm in maximum length and 23 mm in maximum width.
- (c) A piece of hardware headed by a nut protruded through the puncture hole toward the inside of the fuel tank.

- (d) The inside of the track can was inspected using a borescope from the slat side. The inspection revealed that the hardware protruding toward the inside of the fuel tank was the downstop assembly consisting of a bolt, washer, downstop (on the bolt-head side), stop location, sleeve and nut. One flat of the bolt head was in contact with the bottom surface of the main track. One flat of the downstop (on the bolt-head side) was in contact with the inside surface of the track can. The downstop (on the nut side) was found lying inside the track can at a place close to the puncture hole but not in contact with the bottom surface of the main track.

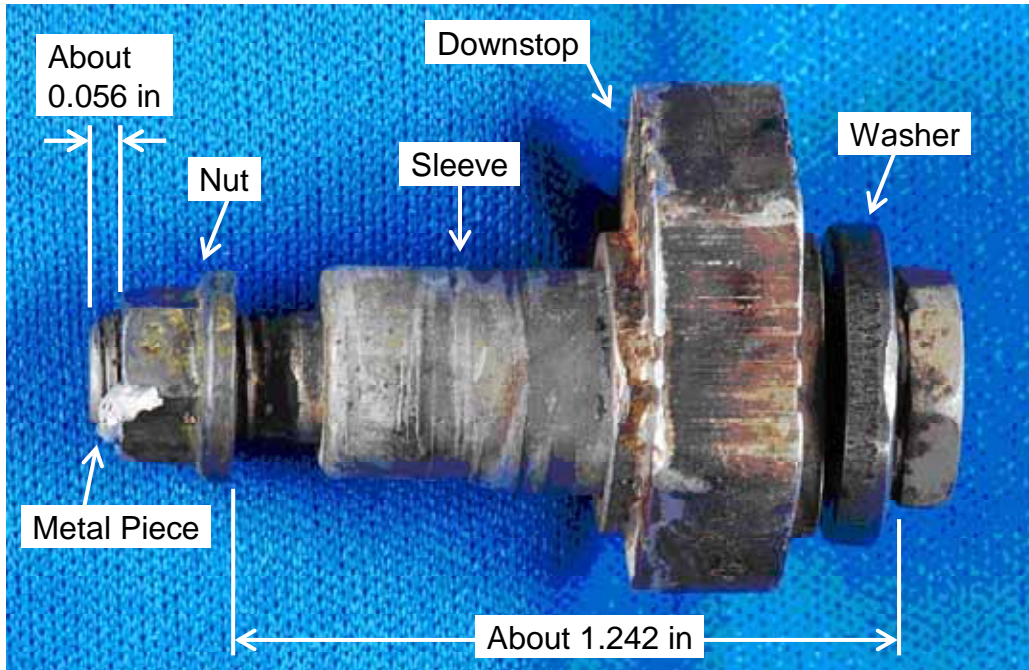
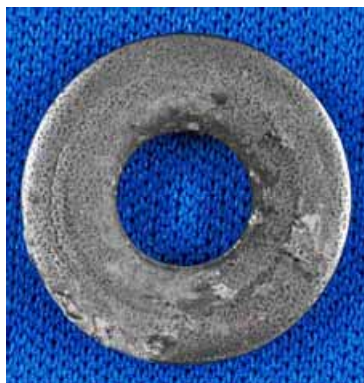
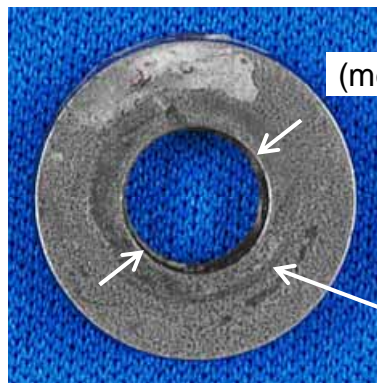
Photograph 6 Downstop Assembly

A washer was found lying just below the opening provided in the front end of the wing forward spar, through which the main track passed.

During recovery of the downstop assembly, which had been protruding from the track can, and the downstop, which had been lying inside the track can, the stop location came off the bolt and fell inside the track can and a loose piece of the track can near the puncture hole became detached from the track can.

A piece of metal was found sticking to the surface across the bolt's threaded end and the nut.
