**AIRCRAFT SERIOUS INCIDENT
INVESTIGATION REPORT**

**CHINA AIRLINES
B 1 8 6 6 7**

SHORTAGE OF FUEL REQUIRING URGENT MEASURES CHINA AIRLINES

BOEING 737-800, B18667

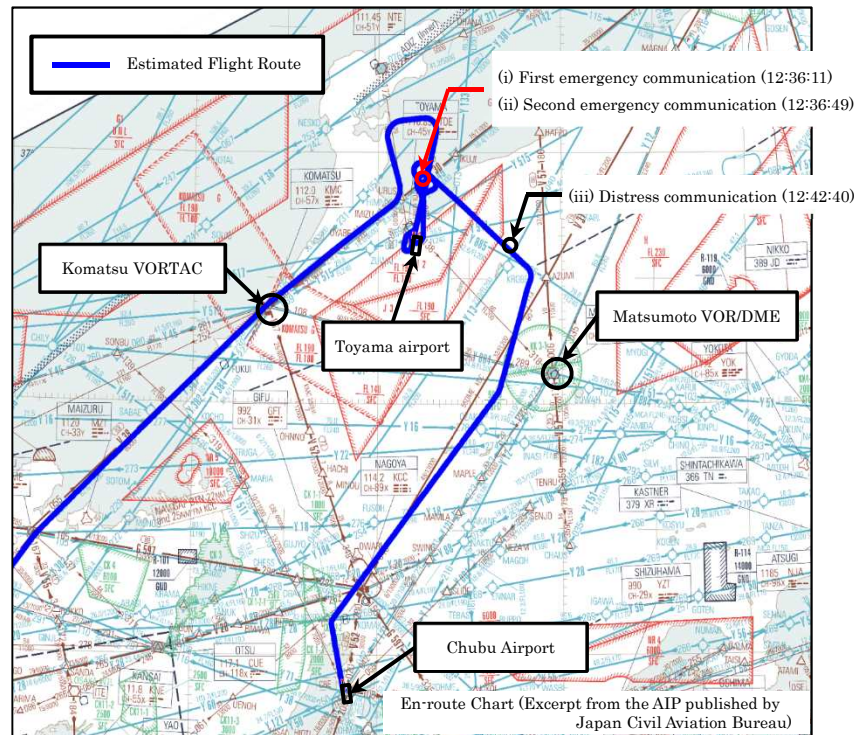
Figure 1: Estimated Flight Route

At 12:36:11, the aircraft conducted an emergency communication (communication commencing with urgent signal of PAN-PAN, PAN-PAN, PAN-PAN) to Tokyo ACC and requested clearance to Chubu Airport (see Figure 1 and 2 (i)). According to the flight crew, he informed Tokyo ACC that the remaining fuel quantity was in a tight situation before this emergency communication, however, he did not receive an explicit response. On the other hand, according to the ATC communication records, transmission that was said to have been conducted prior to the emergency communication was not confirmed. Furthermore, emergency communication from the aircraft at this time was in low and muffled and the voice was unclear overlapped by back noises. Tokyo ACC was unable to hear the transmission and asked for the call sign (flight number) again. The aircraft responded with the call sign and requested clearance to Chubu Airport. The transmission sent again by the aircraft this time included the call sign and request for clearance, and did not include the urgent signal. Taking the busy situations in the airspace into consideration, Tokyo ACC intended to issue clearance after ATC communications with other aircraft calmed down, and commenced radar vectoring of the aircraft firstly at magnetic heading of 140° in order to let it join the flow of other arriving aircraft from the northern Japan to Chubu Airport and Kansai-Osaka Airport.

At 12:36:49, the aircraft conducted the second emergency communication, and simultaneously requested short cut to Chubu Airport due to running short remaining fuel quantity (see Figure 1 and 2 (ii)). ATC communication records showed that the emergency communication from the aircraft at this time was again in low and muffled and the voice was unclear. Tokyo ACC was unable to recognize the urgent signal, and again asked the aircraft for its desired flight route to Chubu Airport, but the aircraft reverted with request to repeat the message again. Then, Tokyo ACC instructed the flight at magnetic heading of 140° again. The aircraft responded saying that they understood the instruction.

At 12:42:40, the aircraft sent the distress communication (communication commencing with distress signal of MAYDAY, MAYDAY, MAYDAY) (see Figure 1 and 2(iii)). Tokyo ACC gave the priority on the air traffic control to the aircraft and instructed to fly directly to Chubu Airport.

The actual flight route of the aircraft from Toyama airport to Chubu Airport was different from the one via Komatsu VORTAC (KMC) planned by the flight log of the aircraft before flight. Calculation of the distance of the flight route showed that the flight route via Matsumoto VOR/DME (MBE) was shorter than the planned flight route.
