**AIRCRAFT SERIOUS INCIDENT  
INVESTIGATION REPORT**

**CHINA SOUTHERN AIRLINES CO., LTD.**

**ALL NIPPON AIRWAYS CO., LTD.**

3.2NM ON FINAL APPROACH PATH TO RUNWAY 36,  
CHUBU CENTRAIR INTERNATIONAL AIRPORT  
AT ABOUT 13:04 JST, NOVEMBER 11, 2007

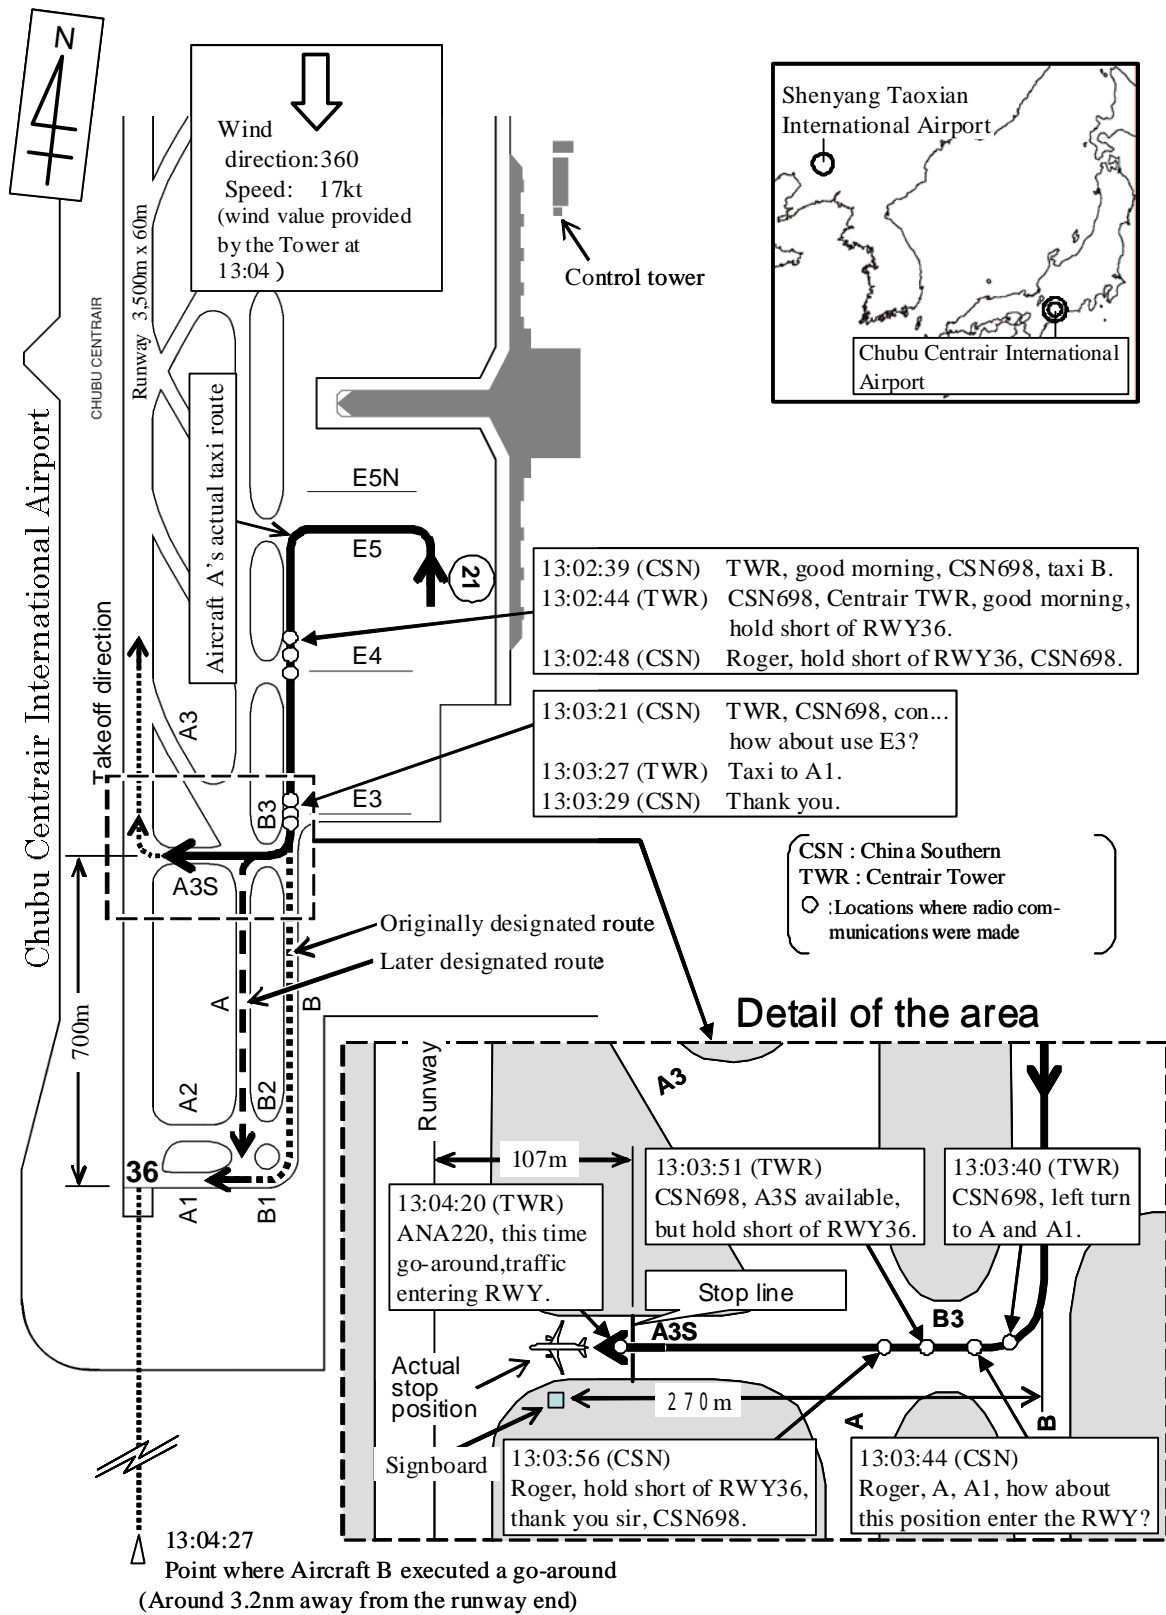
Figure 1 Estimated Taxi Route

It is considered highly probable that this serious incident occurred due to the Aircraft A's intrusion into the runway without stopping in front of the stop line laid before the runway, against the instruction of the Tower, while the Aircraft B was on final with the landing clearance.

It is considered probable that the Aircraft A's intrusion into the runway against the controller's instruction was the result of the following contributing events: after the impromptu change of mind for intersection departure against originally planned departure during taxiing; the aircraft requested a new takeoff procedure to the Tower with insufficient preparation for it; at this moment the PIC's attention was overly directed to takeoff preparation so that he failed to monitor the landing clearance for the Aircraft B and misinterpreted the information "A3S available" as a permission to enter the runway.
