**AIRCRAFT ACCIDENT
INVESTIGATION REPORT**

**AIR FRANCE
FGSPD**

Japan Transport Safety Board

**AIR FRANCE
BOEING 777-200, FGSPD
ABOVE ABOUT 21KM SOUTHEAST OF NIIGATA AIRPORT
AT ABOUT 08:19 JST, MARCH 5, 2009**

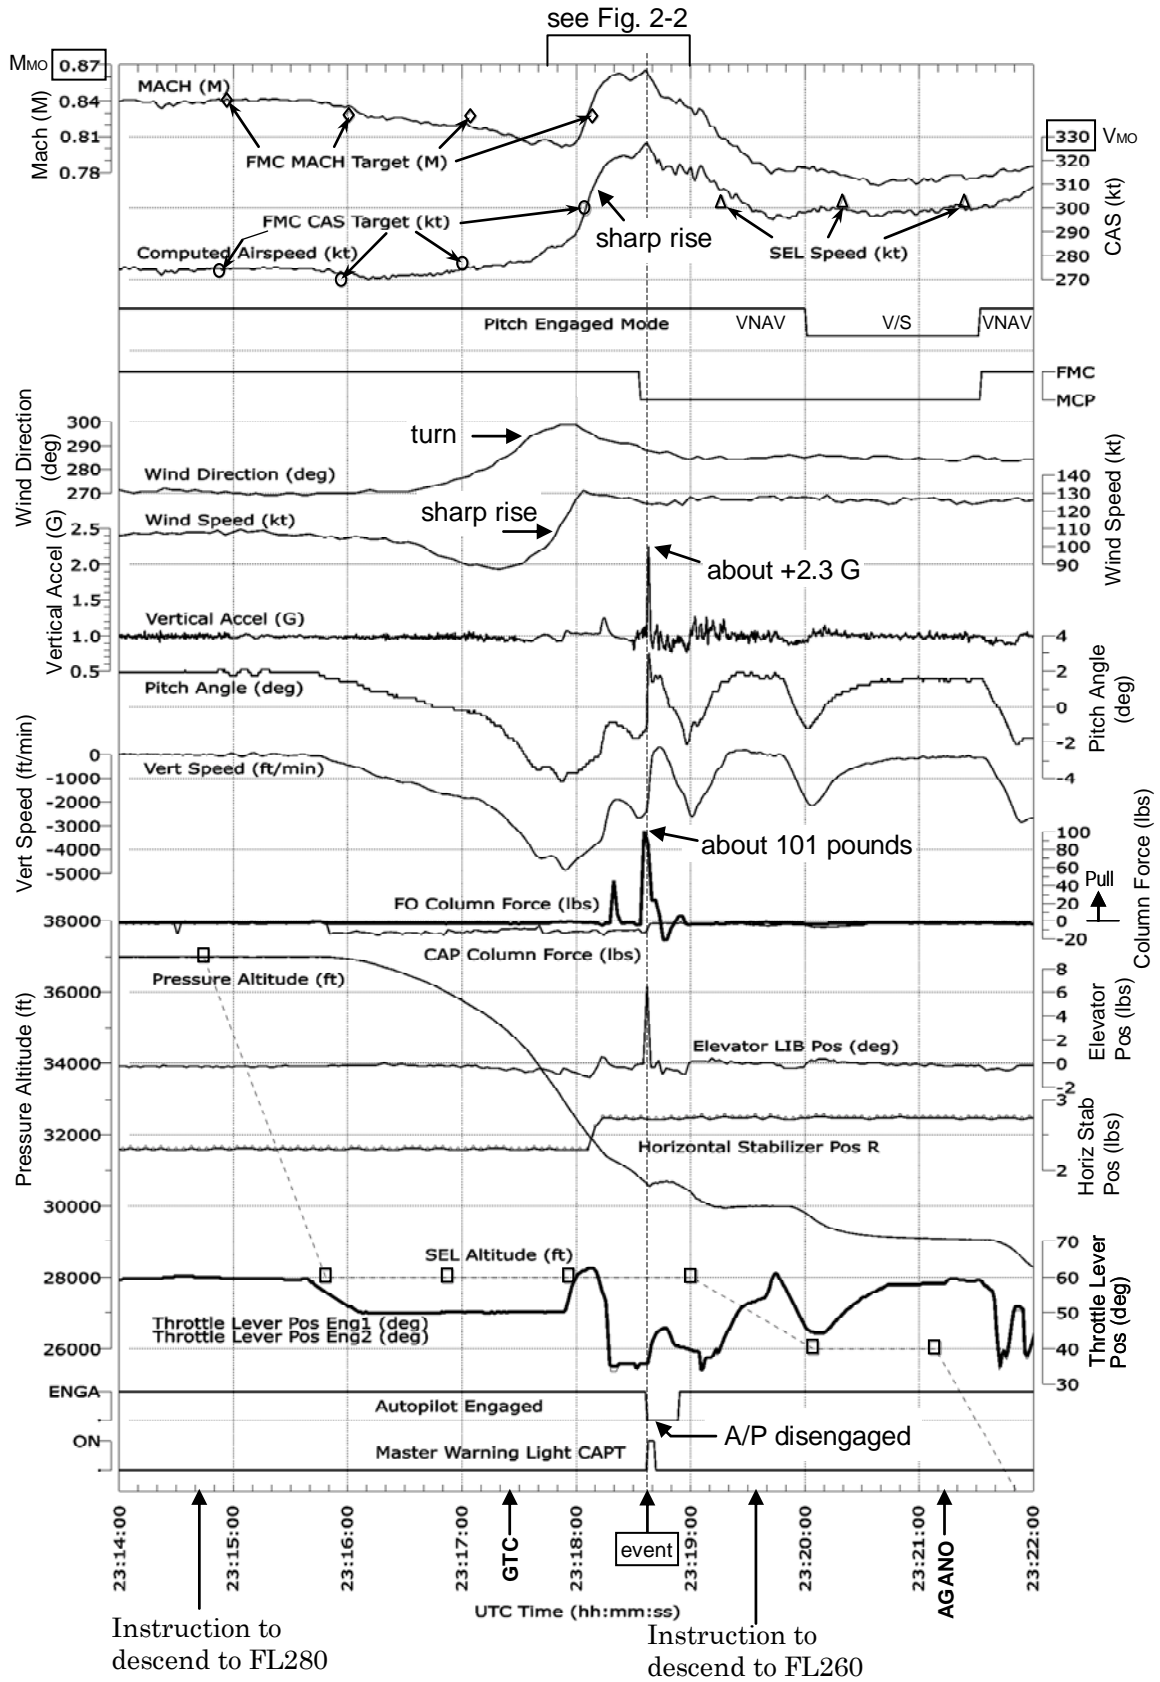
Figure 2-1 DFDR Records 1

- 08:00:28 The Tokyo Area Control Center (hereinafter referred to as “Tokyo Control”) instructed the Aircraft to fly directly to GTC.
- 08:14:42 Tokyo Control instructed the Aircraft to descend to FL 280 with an altitude restriction of passing AGANO (reporting point) at or below FL 300. PIC read back the instruction.
- about 08:15 The selected altitude of the autopilot (hereinafter referred to as “A/P”) was changed from the previous set value of 37,000 ft to 28,000 ft.
- 08:15:41 The throttle lever angle gradually began decreasing.
- 08:15:47 The Aircraft began descending from FL 370.
- about 08:16:30 – about 08:19:00
The wind direction was gradually changing to the north, from about 270 to

about 300 degrees at about 08:18. Then it gradually moved back to the west to about 285 degrees. The wind velocity decreased about 15kt during the first 50 seconds and increased about 45kt during the next 40 seconds. Then it stabilized between about 125 and 128kt.

- 08:17:25 The Aircraft passed above GTC at about the altitude of 34,900ft.
- 08:17:54 The rate of descent, as it was gradually increasing, reached the highest in this flight: about 4,900 ft per minute. The throttle lever angle began increasing.

- 08:18:18 The throttle levers moved to the idle position.
- 08:18:20 The airspeed of the Aircraft, as it was increasing from starting descent, exceeded 320kt. (the Maximum Operating Limit Speed of the Aircraft is 330kt / MACH 0.87, Mach Number shall be used at the altitude over about 30,000ft.)
About 45 pounds (about 21kg) of force to pull the control column of FO side was recorded.

- 08:18:35 – about 08:18:36
101 pounds (about 46kg) of force to pull the control column of FO side was recorded.
- 08:18:37 – about 08:37:38
At about 21km southeast of GTC and the altitude of about 30,600ft, A/P was disengaged, and the master warning light came on with the warning sound. At that time, the signal of A/P manual disconnect and that of auto-throttle disengagement were not recorded. The pitch angle increased (nose up) rapidly and vertical acceleration of about +2.3G was recorded.

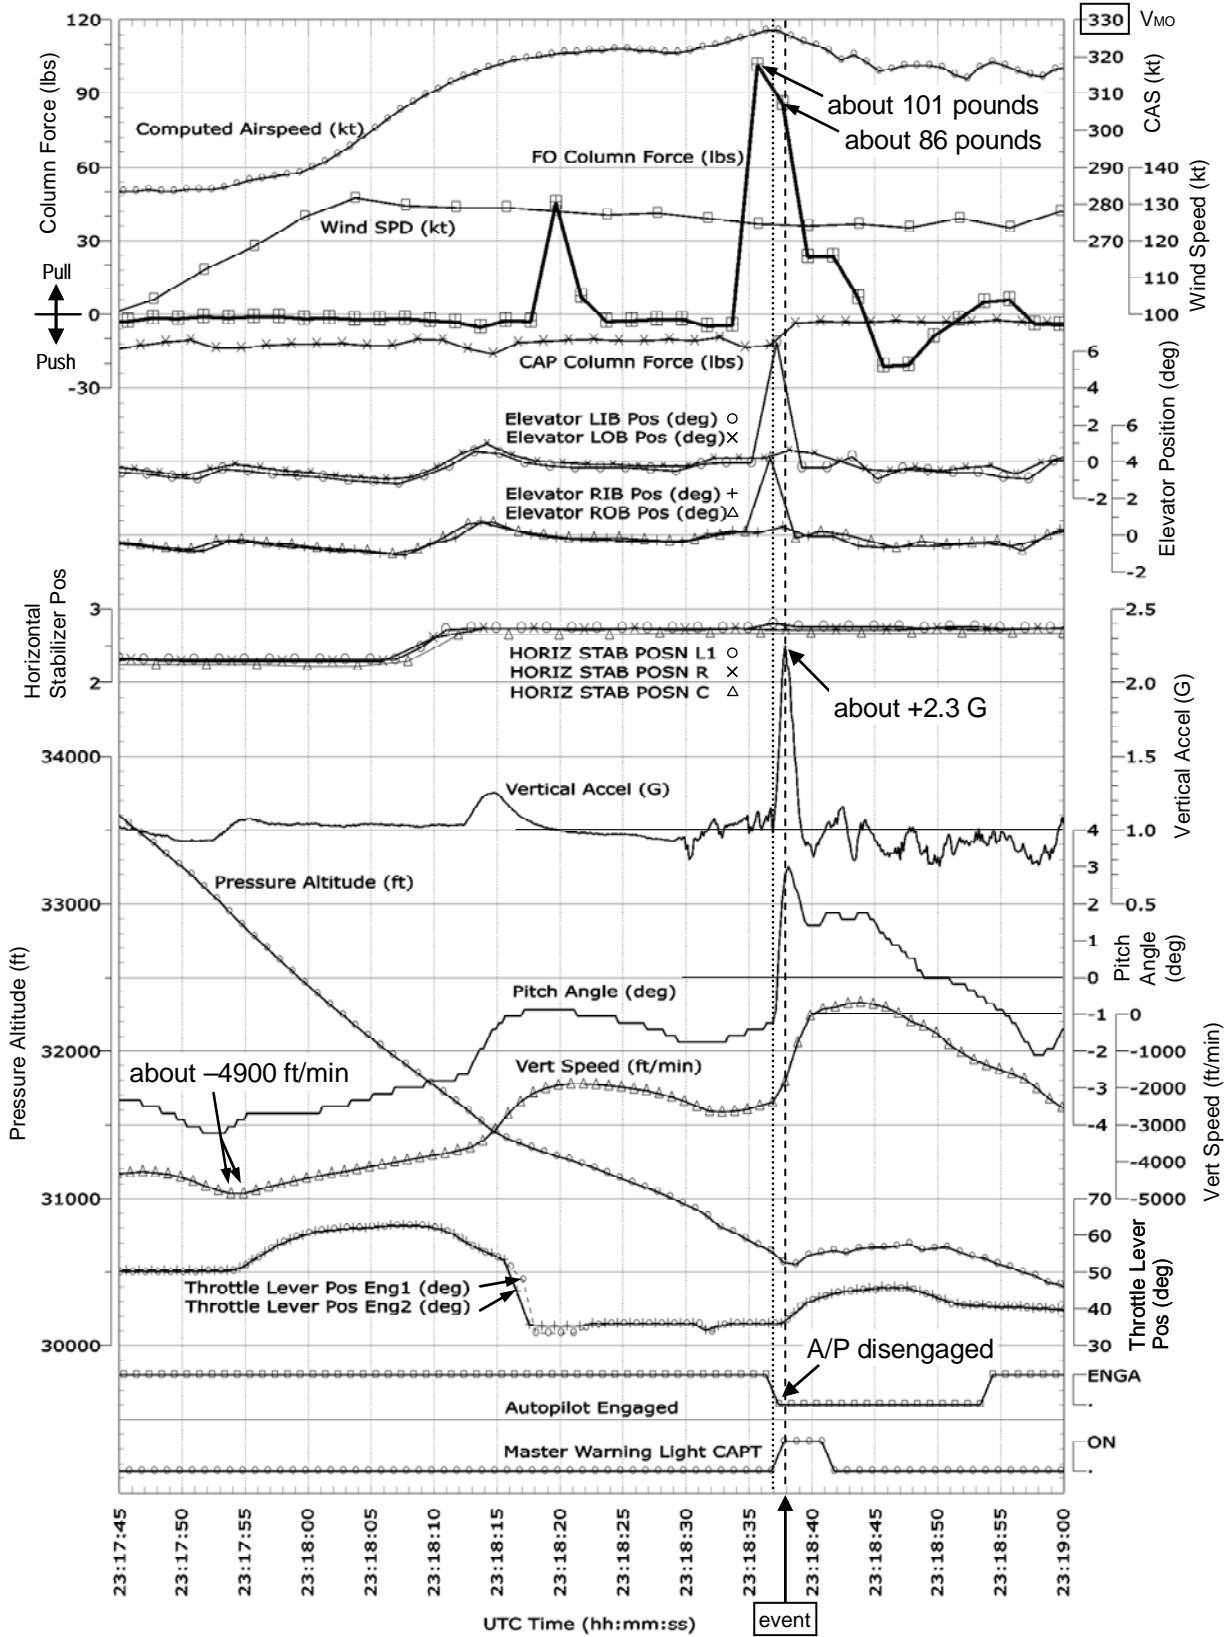
Figure 2-2 DFDR Records 2

According to Figure 2-2 DFDR Records 2, minor fluctuations in the vertical acceleration were recorded from about 08:18:30 and also some of minor fluctuations had been recorded before

that. Therefore it is considered probable that there was some air turbulence.

As described in 2.1.1, A/P was disengaged and the master warning light came on at about 08:18:37. As the signal of A/P manual disconnect was not recorded, it is considered highly probable that it was not because that the crew pushed MCP or the disconnect switch on the control column but because that about 101 pounds force was applied to the control column held by FO at about 08:18:36 and that force satisfied the A/P disconnect condition (A crew applies the force more than 60 pounds force to the control column) described in 2.10 (2).

At about 08:18:38 the pitch angle of the Aircraft rapidly increased more than 4 degrees to the direction of nose up, and at the same time the Aircraft suddenly shook so largely that about + 2.3G vertical acceleration was recorded. Then the descent rate which had been 2,600ft per minute decreased to nearly zero rapidly.

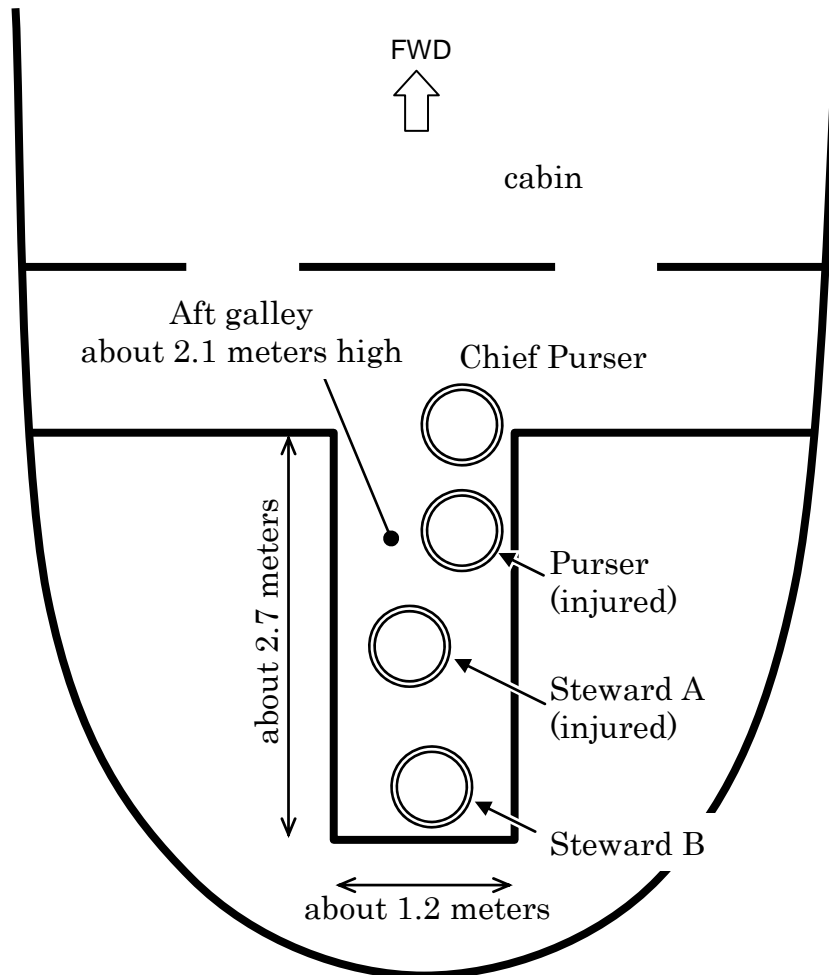
Figure 3 Aft Galley and Flight Attendants

Judging from the description in 2.1.3 and 3.4.2, it is considered highly probable that because the pitch angle of the Aircraft rapidly increased and the aft section of it suddenly fell down, four FAs near the aft galley were thrown up in the air, Chief Purser fell down over the Purser who had fallen down first, and as a result, the underlain Purser was injured. It is also considered highly probable that Steward A was thrown up in the air as he was having his meal and could not do anything toward the sudden shake of the Aircraft and that he fell down on the floor and was injured. Actually, there was no handle to brace.

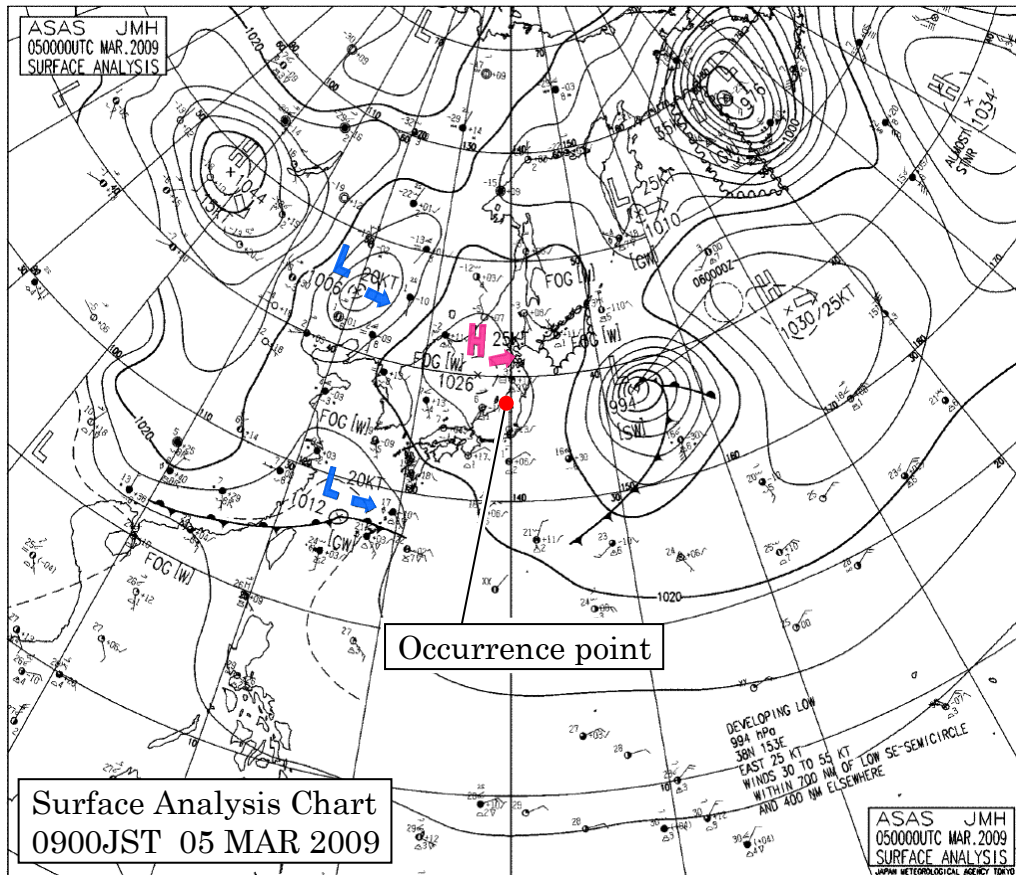
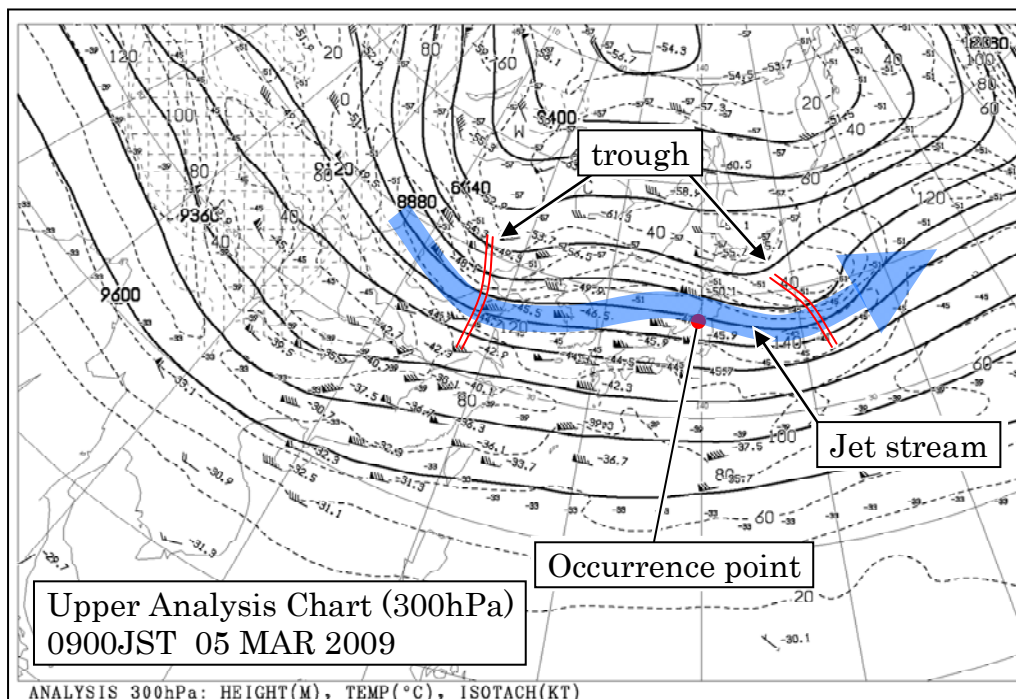
Figure 5 Surface Analysis Chart and Upper Analysis Chart (300hPa)

According to the Surface Analysis Chart at 09:00 on March 5, 2009, the main island of Japan was widely covered by a high-pressure system over the Sea of Japan, and the west side of it was a pressure trough. Northeastern China (north of Korean Peninsula) and East China Sea were covered by a low-pressure system. Both of the pressure systems were going east.

According to the Upper Analysis Chart of 300hPa at the same time, a pressure trough corresponding with the surface low pressure system was in the north region of China and a moderate pressure ridge was around Japan area. A jet stream of 300hPa was going southward along the contour of 9,000m (about 30,000ft) in the north of Tibet and was flowing over the middle region of China to the ocean of the east of Japan via the middle of the Sea of Japan. (See Figure 5 Surface Analysis Chart and Upper Analysis Chart (300hPa))

According to the descriptions in 2.6.1 and 2.6.3 and to the flight route of the Aircraft, it is considered highly probable that the Aircraft was flying near the strong wind axis of the jet stream.

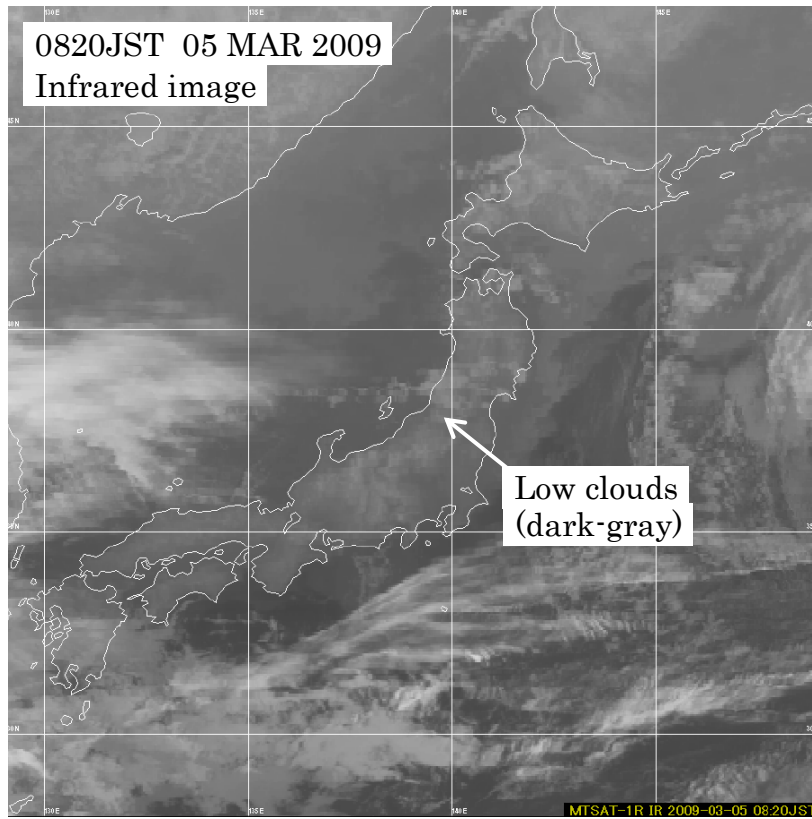
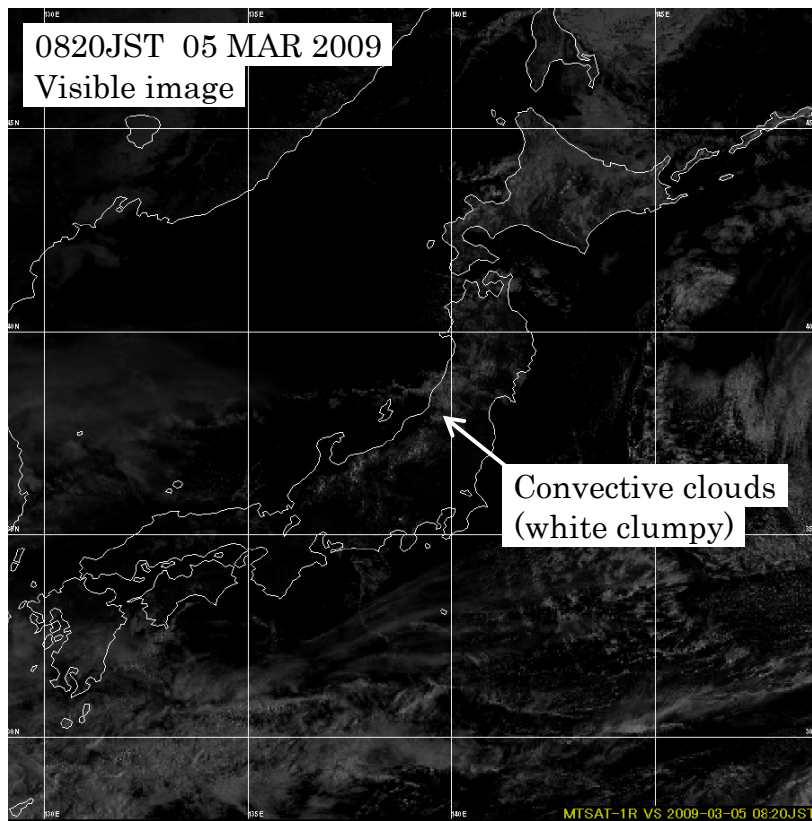
Figure 6 Meteorological Satellite Imagery

According to the infrared image and the visible image at 08:20, the time which was the nearest to that of the accident, around the area where the accident occurred was covered by lower -layer convective clouds and the middle and the upper layer were in the clear region. (See Figure 6 Meteorological Satellite Imagery)

According to the descriptions in 2.1.2 and 2.6.2, it is considered highly probable that there were no clouds around the area where the accident occurred.

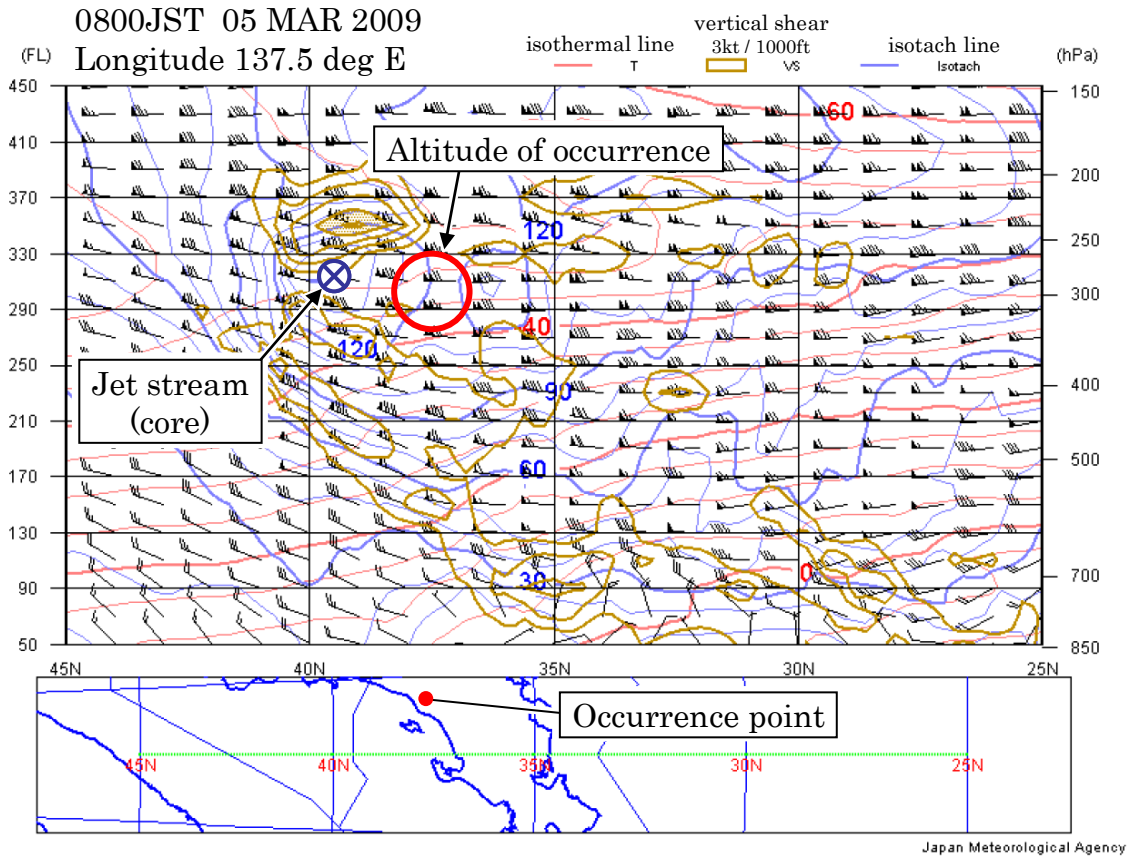
Figure 7 Hourly-Analysis Chart

According to the Hourly-Analysis Chart of Longitude 137.5 deg E at 08:00 on the day of the accident, there was a jet stream of about 140kt around FL 310 but was not seen a clear frontal zone in the lower part of it. But strong vertical wind shear ^{*1} was analyzed in the vicinity of the adjacent altitudes (FL260 ~ FL340) where the accident occurred.

As described in 2.6.3, there was not a clear frontal zone below the jet stream. However, as of 08:00 of the day at Longitude 137.5 E, while any vertical wind shear was not analyzed at the adjacent altitudes where the accident occurred, strong vertical wind shear was analyzed in the vicinity. Therefore, it is considered possible that the wind velocity was significantly varied according to the change in the altitude and the location at the time and the area of the accident.
