AA2006-4

AIRCRAFT ACCIDENT INVESTIGATION REPORT

PRIVATERY OWNED
PIPER J3C-65, G-KIRK
KANAZAWA CITY, ISHIKAWA PREFECTURE
OCTOBER 21, 2005

September 29, 2006

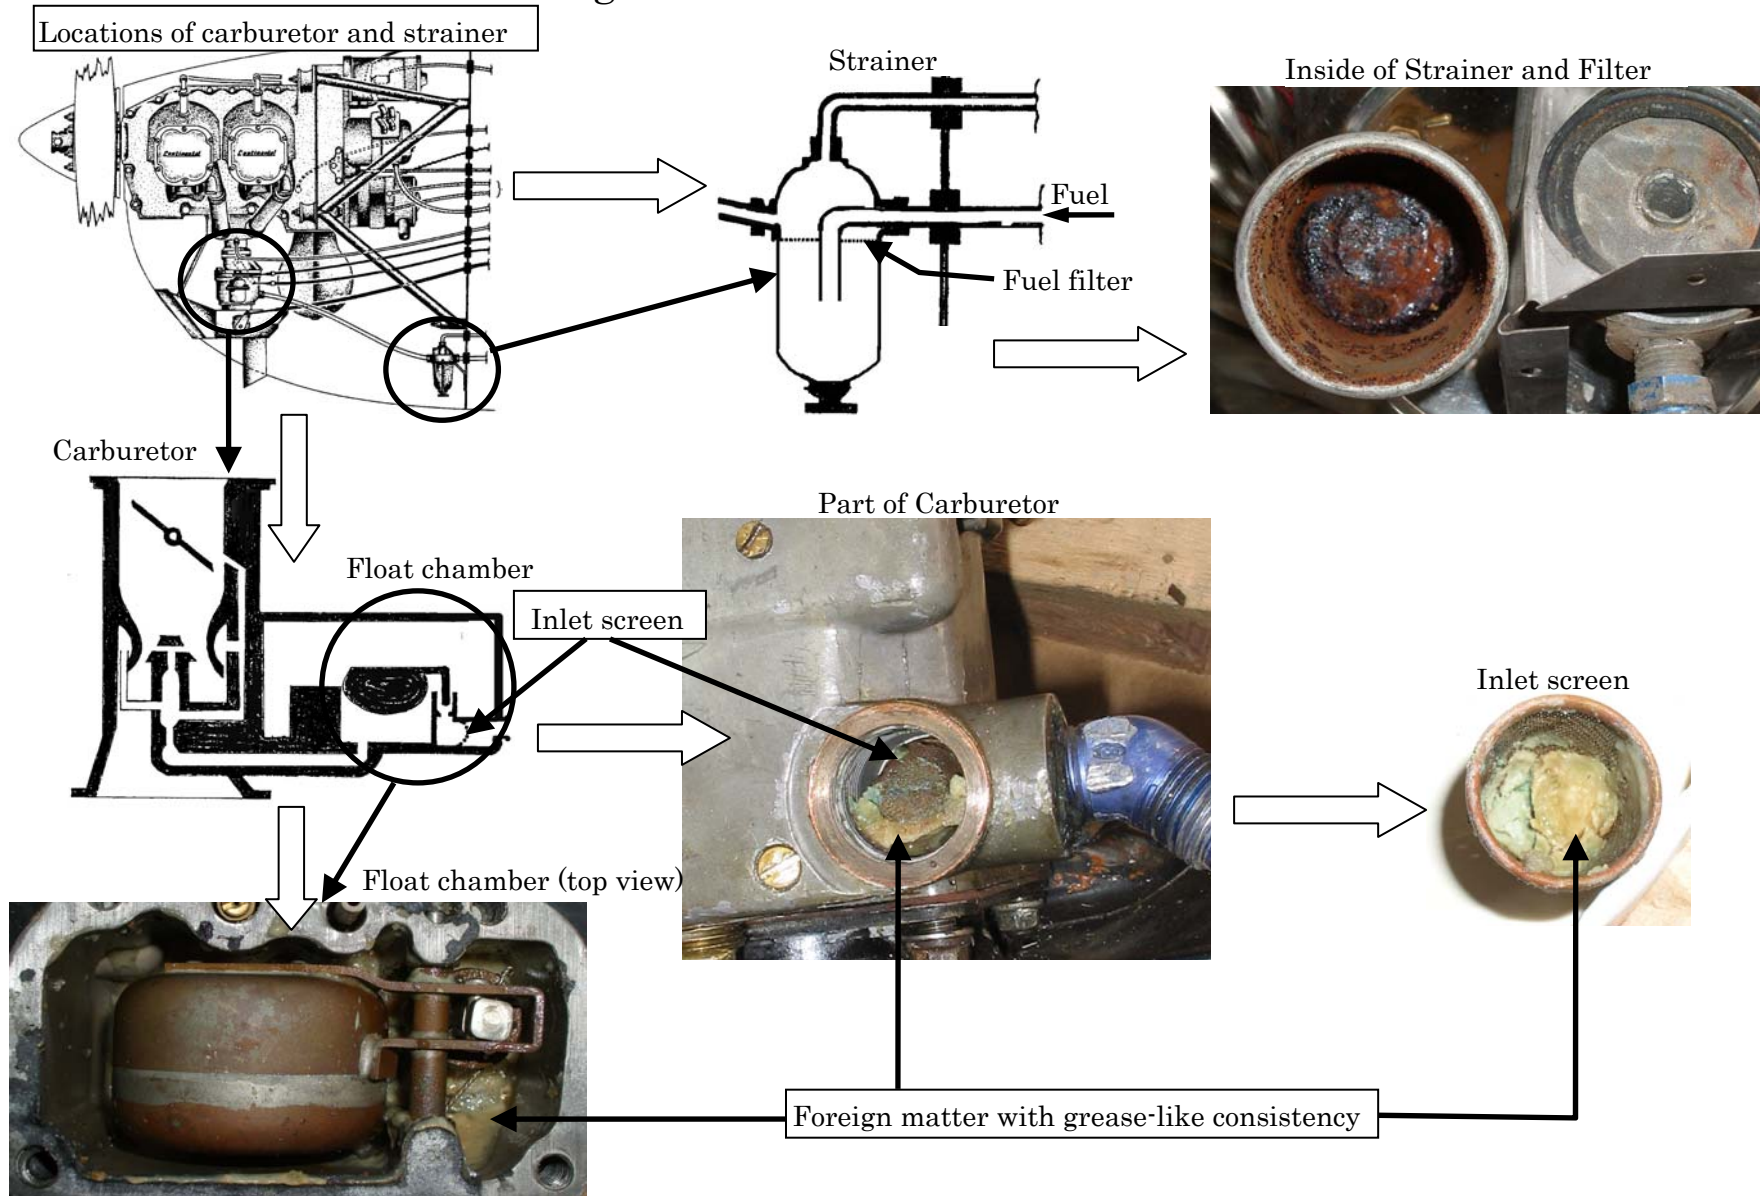
Figure 3 Float Chamber & Strainer

(1) A large amount of foreign matter with a grease-like consistency (hereafter called “foreign matter”) had collected in the vicinity of the carburetor’s inlet screen. The foreign matter blocked most of the inlet screen.

(2) Corrosion and rust were observed inside the strainer, but no filter blockage was observed.

(6) In the strainer, no bacteria (aerobic bacteria, yeast, and anaerobic bacteria) were detected.

Rust was seen inside the strainer and in part of the fuel filter.

Peaks that were thought to correspond to water were seen in the results of infrared absorption spectrography analysis.

(a) As stated in part 2.9.1(1) of this report, a large amount of foreign matter had collected in the vicinity of the carburetor's inlet screen and had blocked most of the inlet screen. It is estimated that the fuel flow was restricted by this foreign matter such that engine trouble occurred.

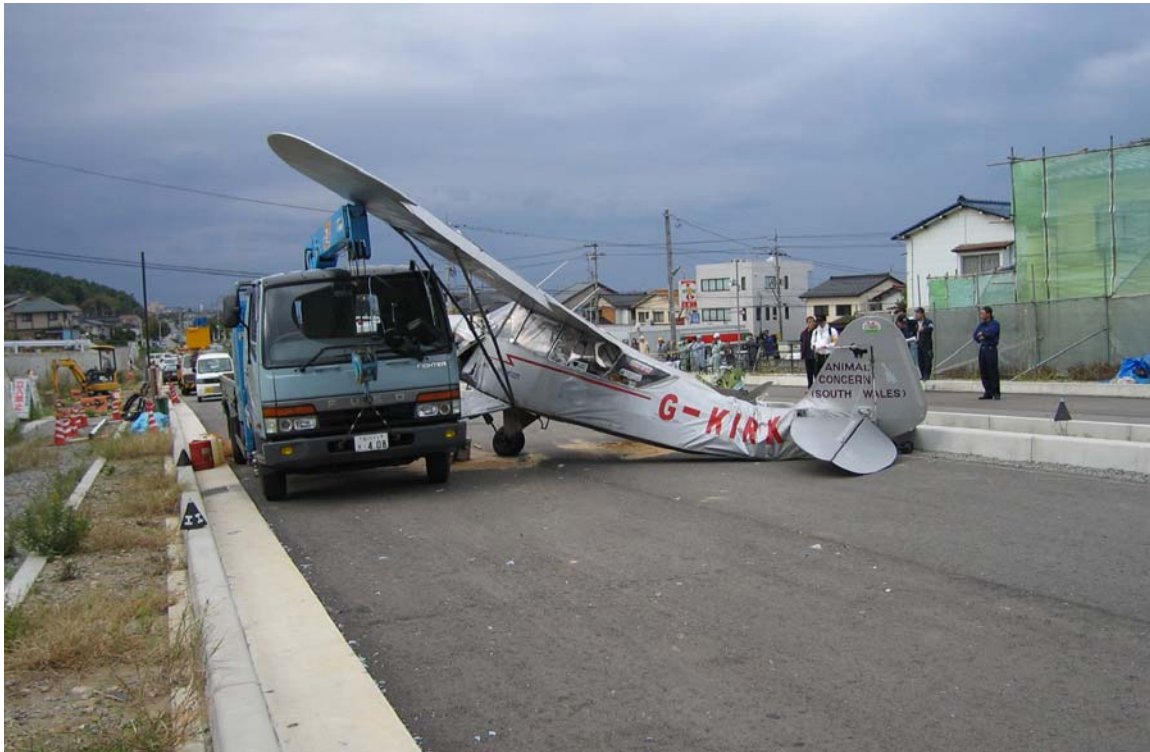
Picture 1 Accident Aircraft — 1

The accident site was on a road under construction in the Kubo district of Kanazawa City. The aircraft stopped with its nose pointing south-southwest and its left wing riding up onto the load bed of the truck. The bottom of the forward fuselage was damaged by contact with the vehicles on the ground.

The engine mounting was severely damaged, and the bottom of the cowling was severely damaged. The skin of the bottom surface was distorted and severely damaged. The aft fuselage was deformed and severely damaged.

The right wing was severely damaged at its bracing, and its main spars and fabric were broken.

The carburetor was damaged, and it was torn off from the engine.

The tips of the propeller blades flew off. Also, the one of the blades was caught in the load bed of the truck and fractured at its metal-protected leading edge.

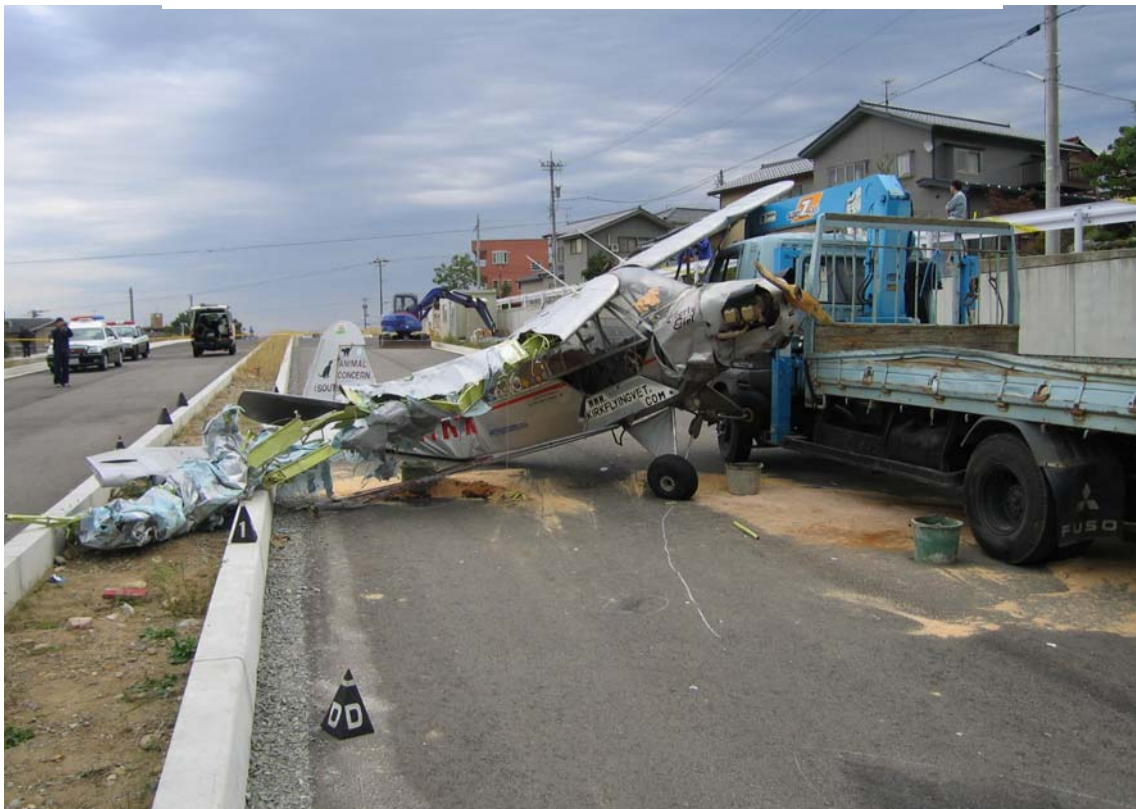
Picture 2 Accident Aircraft — 2

Subsequently, the light aircraft struck a mini-truck, turned rightward, hit a normal-size cargo truck (hereafter called “the truck”), and stopped. I was not aware whether the light aircraft had struck a special-purpose vehicle that was in a place nearer to me than the abovementioned vehicles.
